ACCIDENT REPORT

5Y BLA

AIRCRAFT: BEECHCRAFT KING AIR 200

DATE: 28 MARCH 2010

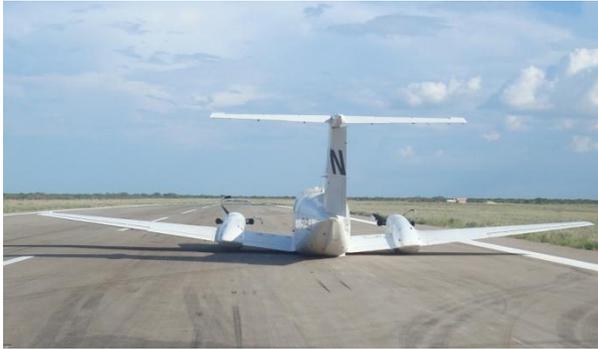
position. The belly area had abrasions and damage from scraping along the runway. The aircraft was towed to a secure long term parking area.

Wreckage on its belly

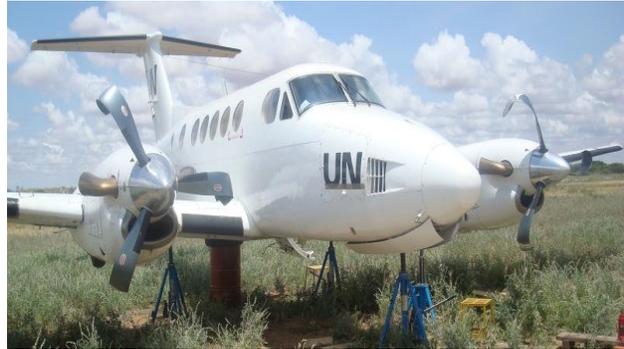
The aircraft was dragged from the runway to the side and then lifted manually. The aircraft was placed on jacks and inspected. The emergency gear handle was pulled. The landing gear was hand pumped to the down and locked

After recovery before gear extension.

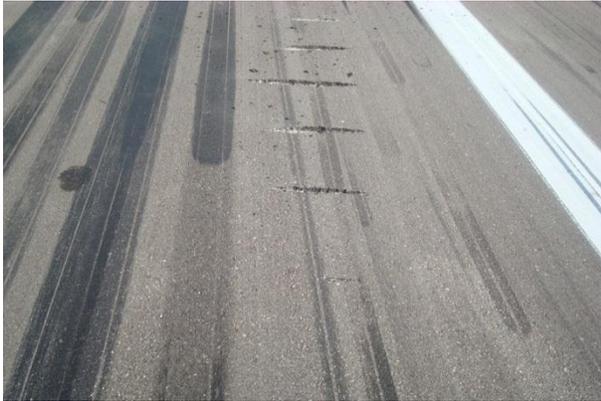
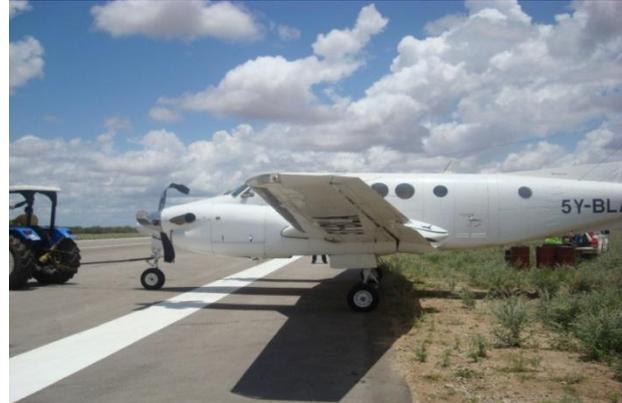
The presence of scoring on the runway attributed to 5Y-BLA followed by the propeller markings indicated that the aircraft touched down first with the ventral fin. All the three landing gears were well tucked in their respective wheel wells. No damage at all on the gear, the wheel well wall or the nose gear doors indicated that the gear was extended by the time the aircraft touched down.

The abrasion on the ventral fin was an indication that 5Y-BLA was in a flare attitude and the tail section touched the ground first.
