PRELIMINARY
KNKT.10.04.09.04

**Aircraft Accident Investigation Report
PT. Merpati Nusantara**

PK-MDE

**Rendani Airport, Manokwari - Papua Barat
REPUBLIC OF INDONESIA**

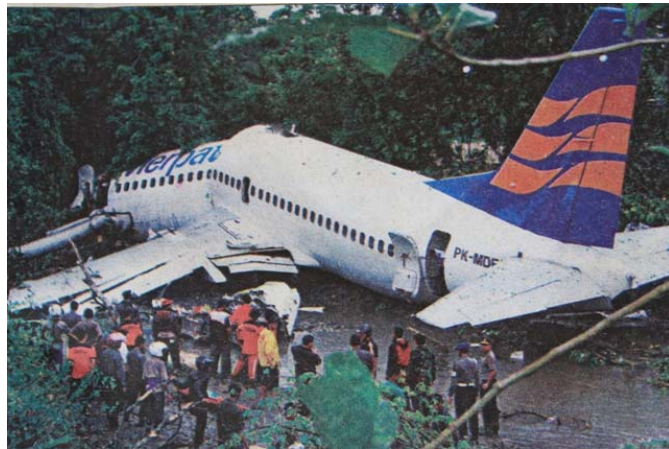
Figure 1: The fractured aircraft fuselage

The aircraft was substantially damaged. The radome was detached from the aircraft's nose section. The electronic equipment compartment was buried in the mud. The forward fuselage was fractured adjacent to the wing leading edge and bent downward, remaining connected to the rear fuselage via the floor beams. Both wings and adjacent structure, and the nose and main landing gears were substantially damaged. Both engines, including their pylons, were separated from their respective wings.

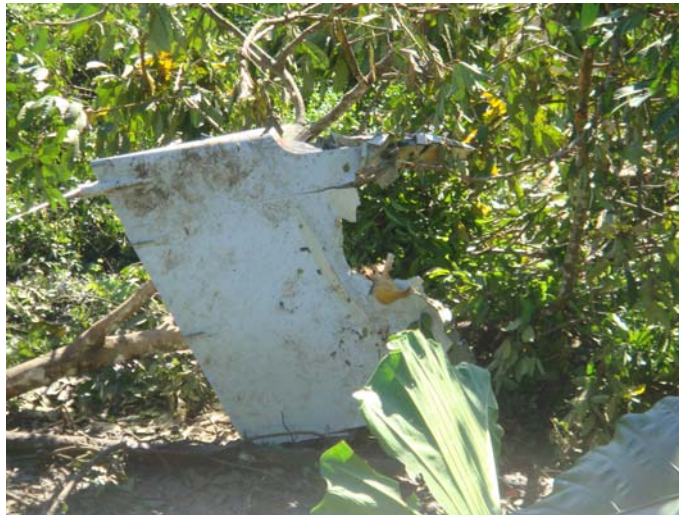
Figure 2: The left wing tip sheared off from the wing

One mango tree situated about 185 meters from the end of runway 35 was clipped by the aircraft's left wing. One langsung tree about 4 meters to the left of the mango tree was also clipped by the left wing tip. There was substantial damage to the mangrove vegetation along aircraft's ground impact trail.

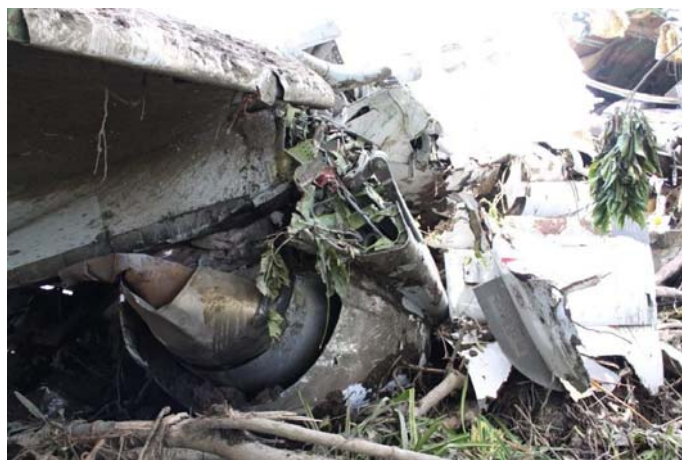
Figure 3: The right wing and number-two (right) engine damage

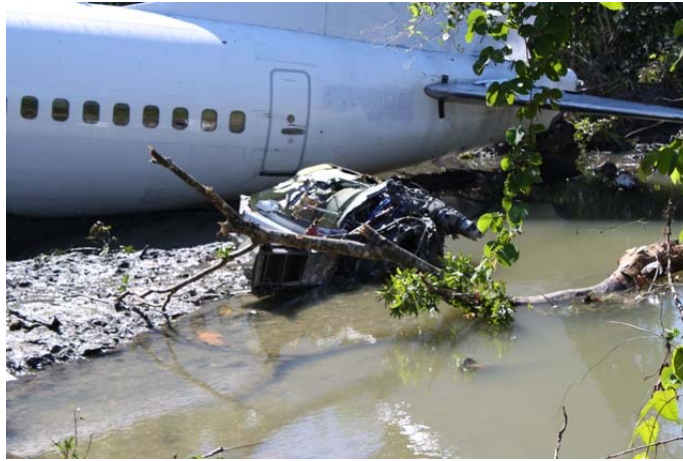
Figure 4: The left engine separated

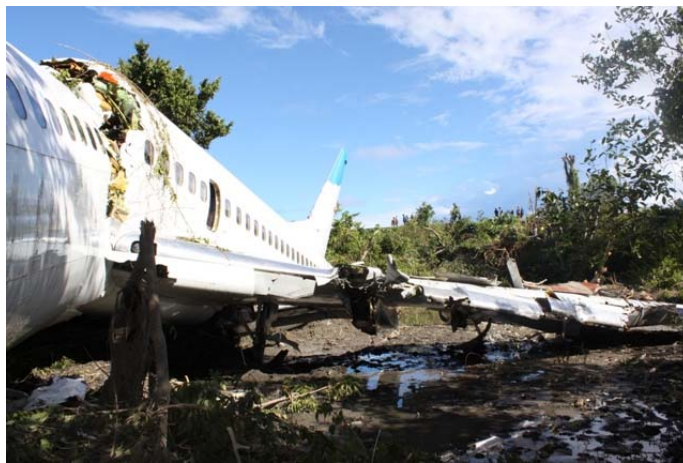
Figure 5: Left wing damage

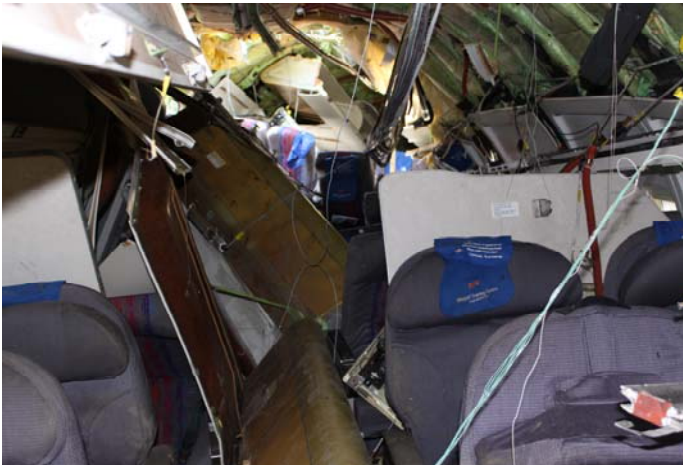
Figure 6: Passenger cabin damage
