AIRCRAFT ACCIDENT REPORT AND EXECUTIVE SUMMARY

Reference:	CA18/2/3/8793	
Aircraft Registration	ZS-ZOC	Date of Accident	13 June 2010		Time of Accident	0900Z
Type of Aircraft	Swearingen SA 226 TC Metro II		Type of Operation		Charter Flight	
Pilot-in-command Licence Type		Airline Transport	Age	37	Licence Valid	Yes
Pilot-in-command Flying Experience		Total Flying Hours	6900.00		Hours on Type	400.0
Last point of departure		Lanseria International Airport (FALA)				
Next point of intended landing		Polokwane Airport (FAPP)				
Location of the accident site with reference to easily defined geographical points (GPS readings if possible)						
On Runway 24R at Lanseria International Airport (FALA), at GPS reading: S25°56.151 E027°55.757						
Meteorological Information		Surface Wind:030°/5 kts , Temperature: 17°C, Visibility: >10 km, Cloud base: Nil, Cloud cover: Nil ,				
Number of people on board	2 + 13	No. of people injured	0	No. of people killed	0

AIRCRAFT ACCIDENT REPORT

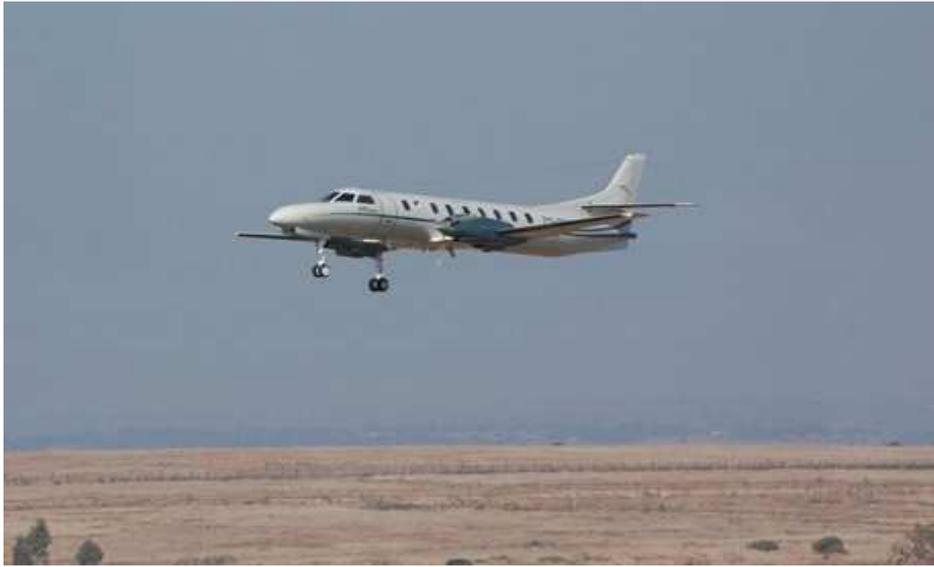
Figure 1 shows a fly-past in front of FALA tower to inspect undercarriage.

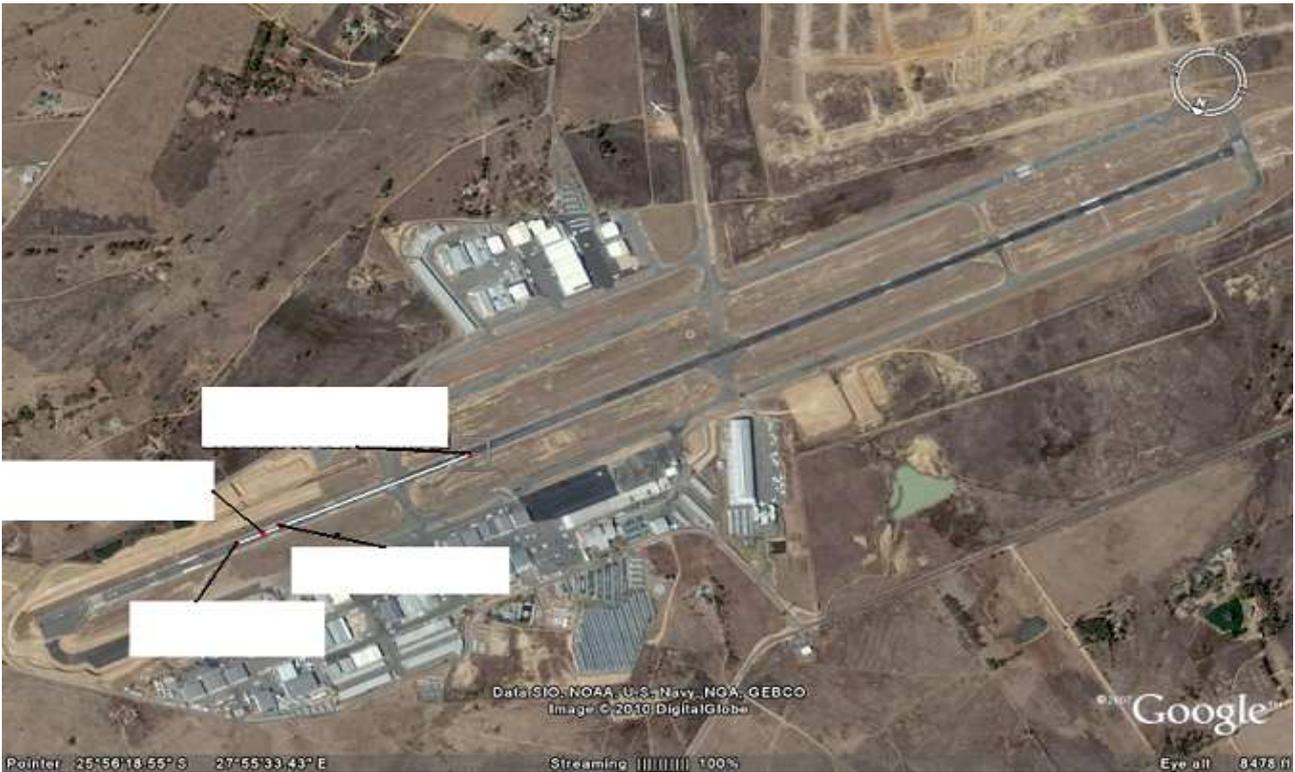
Figure 2 shows Runway 24R used for the “wheels up” landing.

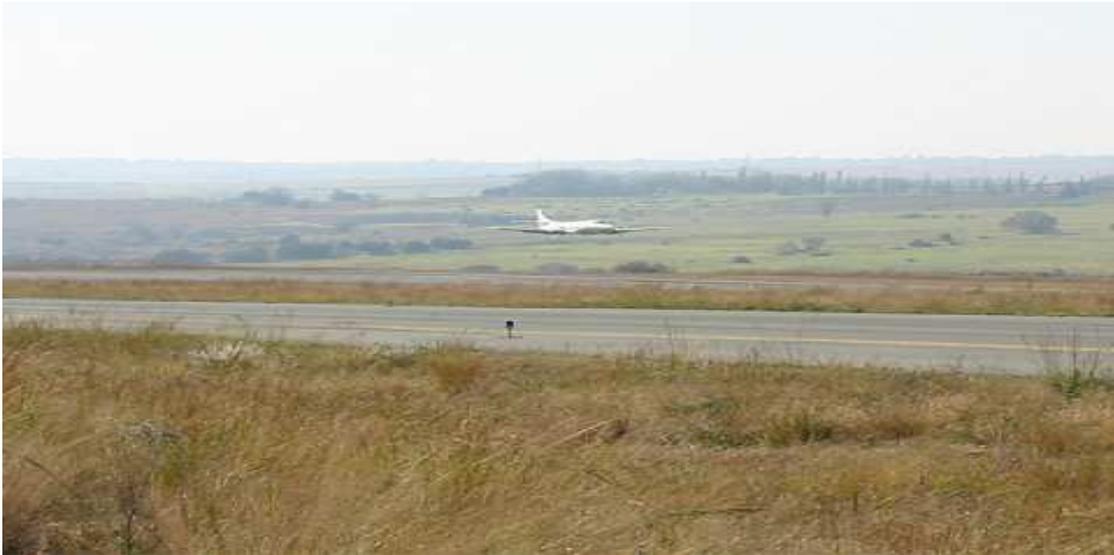
Figure 4 shows aircraft flying over the threshold on Runway 24R, ready to do a “wheels up” Emergency landing.

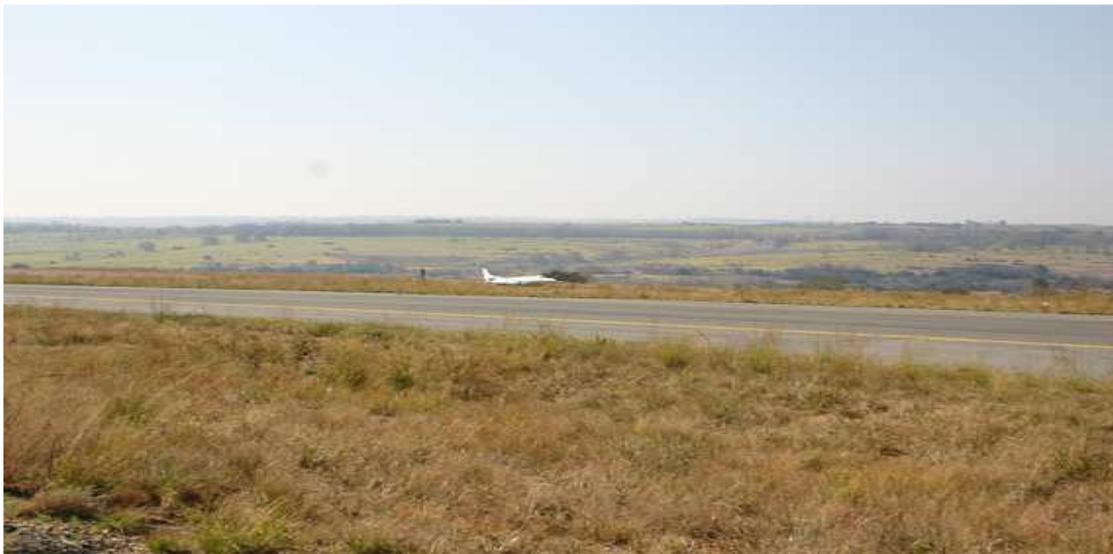
Figure 5 shows the aircraft tail section touching down on the runway at approximately 370 metres past the threshold.

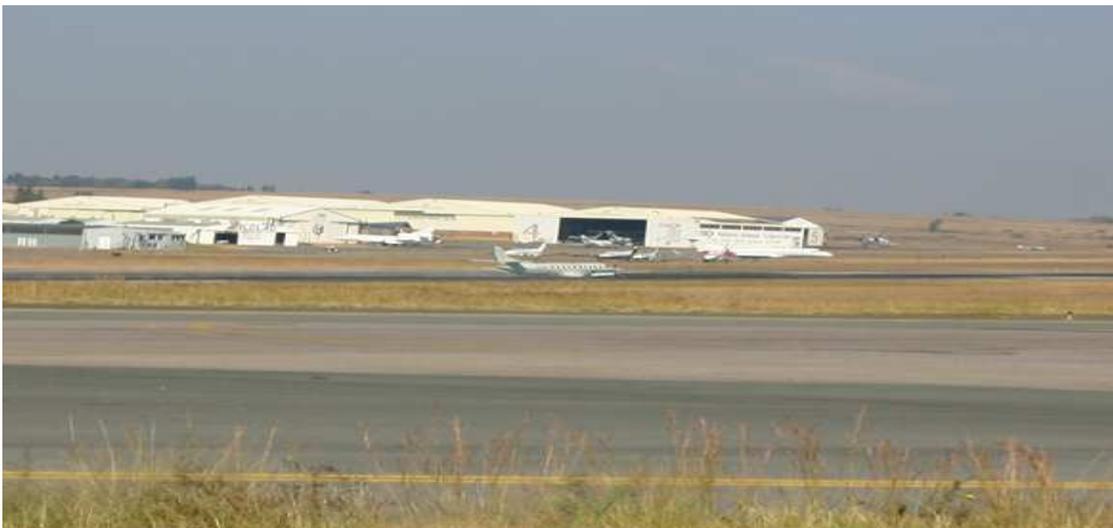
Figure 6 shows the fuselage skidding on the runway and coming to a stop approximately 930 metres past the threshold.

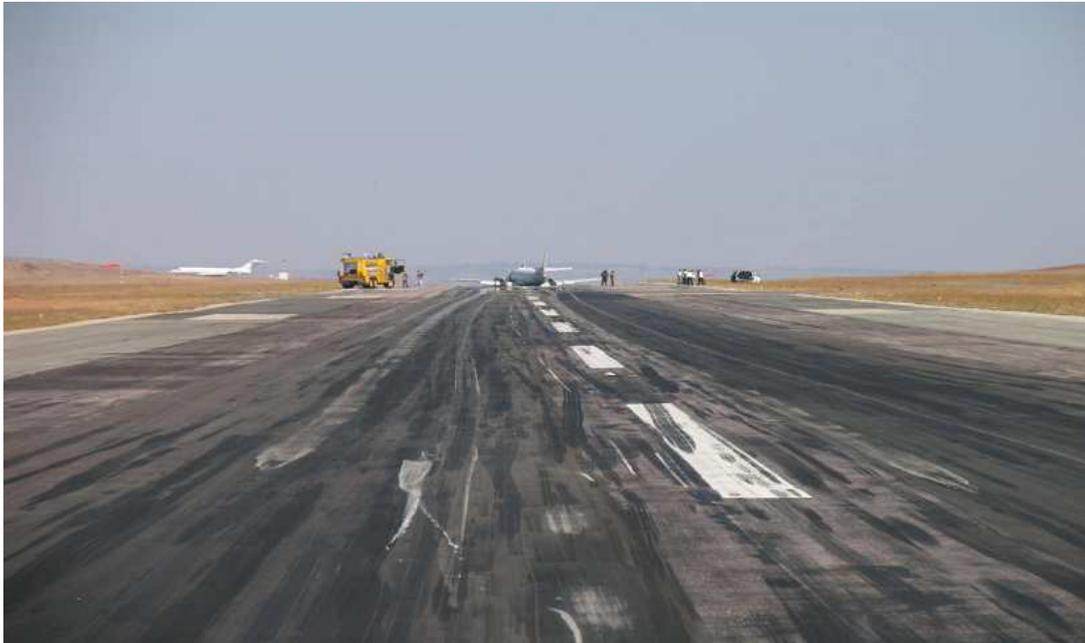
Figure 7 shows the skid marks on the runway caused by the aircraft.

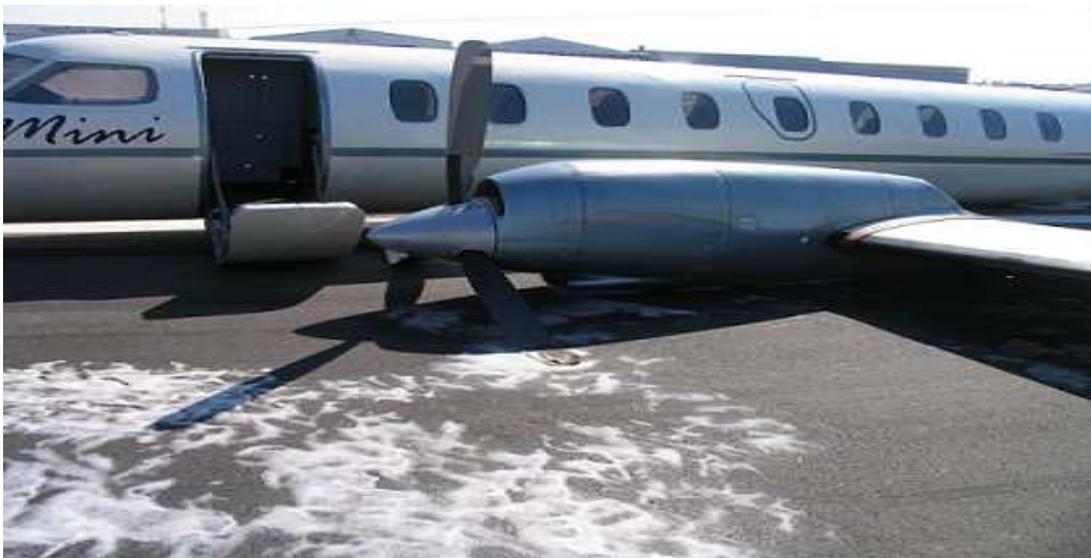
1.12.2 The damage caused to the aircraft was limited to the lower fuselage, wheel well (left and right side landing gear doors), flaps and propellers. The damage caused to the aircraft was mainly as a result of the aircraft skidding on the runway.

Figure 8 shows damage caused to the landing gear doors and left propeller.
