**AVIATION INVESTIGATION REPORT  
A10P0244**

**COLLISION WITH TERRAIN**

**CONAIR GROUP INC.  
CONVAIR 580 C-FKFY  
LYTTON, BRITISH COLUMBIA, 9 NM SE  
JULY 31 2010**

Report Number A10P0244

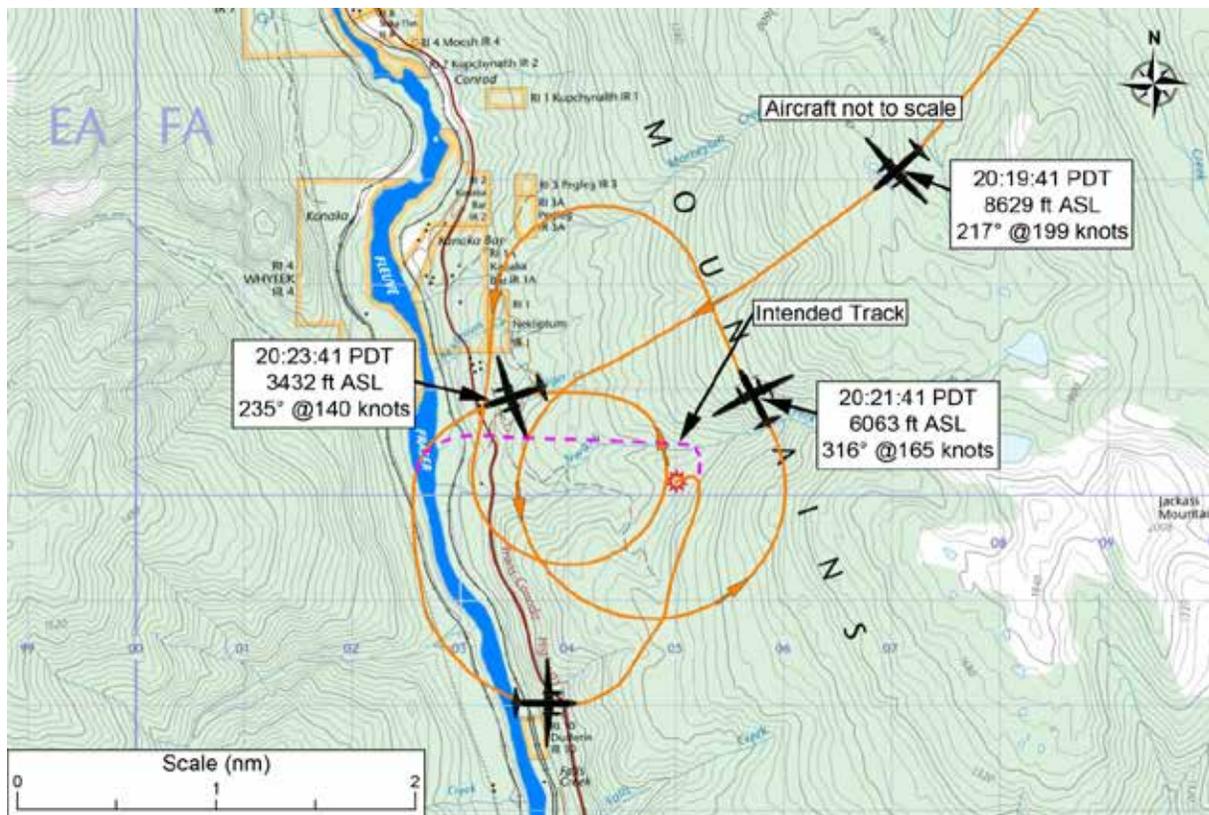
Figure 1. Estimated flight path

The plan was for Tanker 448 (T448) to make 8 left-hand circuits, dropping 1/8 of its retardant load each time. The terrain imposed a requirement to modify the standard rectangular circuit<sup>1</sup> to a triangular-shaped circuit (Figure 1). This consisted of flying a combined downwind/base leg from the Fraser River northbound over the rising east side of the canyon to a point at the edge of the ravine.

A single left turn to final required a change of direction greater than 90° at a bank angle of up to 40°. T448 then had to descend 900 feet into the ravine to make the drop. After each drop, T448 was to proceed straight ahead over descending terrain in the ravine back toward the Fraser River.

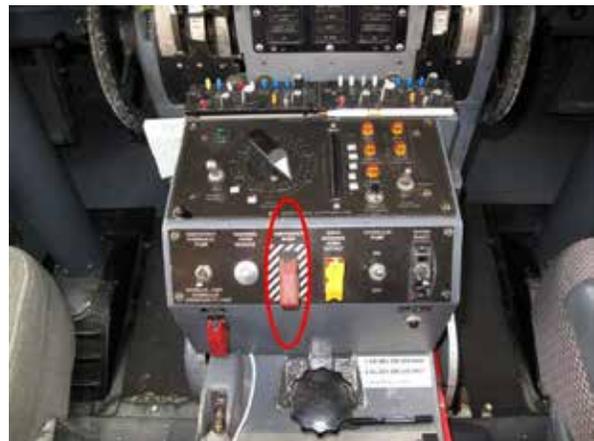
**Photo 1.** E-Drop Switch

The retardant delivery system included a separate emergency drop function to jettison the entire load in an emergency situation. The emergency drop switch was within reach of both pilots (Photo 1). It was determined that only part of the retardant load was jettisoned on the accident flight, which was consistent with the plan to drop 1/8 of the load each time. It could not be determined if an emergency drop (E-drop) was verbally commanded or physically attempted, but it was unsuccessful.

The retardant delivery system included a separate E-drop function activated through a switch located between the pilot seats on an aft-facing switch panel on the centre pedestal (Photo 1). This switch was 1 of 3 guarded switches on a panel of 6 adjacent switches which were located in proximity to the pilots’ elbows and which could be operated by either pilot. The system was functional any time both the aircraft electrical and hydraulic systems were energized. The system requires up to 5 seconds to jettison a full retardant load, approximately 18 000 pounds.

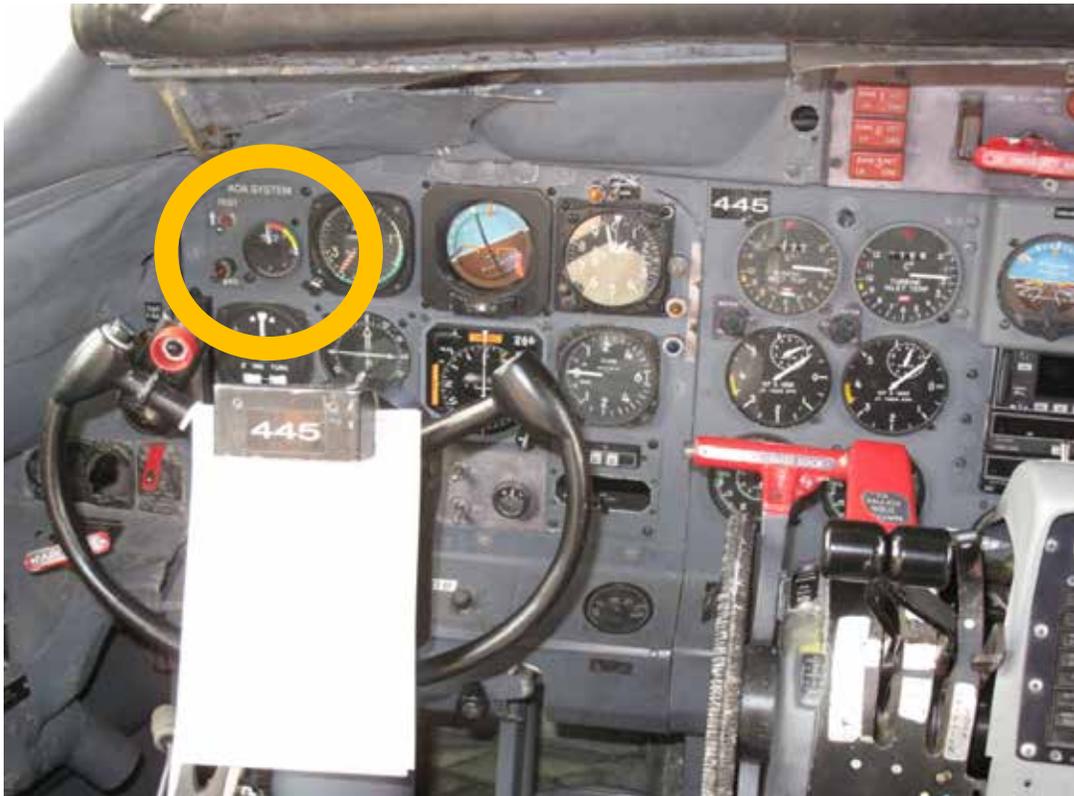
**Photo 2.** Angle-of-attack (AOA) indicator

The AOA indicator was located on the far left side of the captain's instrument panel adjacent to the airspeed indicator. The AOA indicator was marked with color-coded arcs. It did not provide any aural or visual warning annunciations. The indicator needle and the coloured arcs (on the right-hand side of the instrument face) were not completely visible from the right pilot seat.

5. The location of the angle-of-attack indicator on the instrument panel makes it difficult to see from the right seat, reducing its effectiveness.
6. When cockpit recordings are not available to an investigation, this may preclude the identification and communication of safety deficiencies to advance transportation safety.
