Investigation Report

Type of Occurrence:	Accident
Date:	26 November 2010
Location:	Frankfurt/Main Airport
Aircraft:	Transport aircraft
Manufacturer / Model:	The Boeing Company / B747-400
Injuries to Persons:	None
Damage:	Aircraft severely damaged
Other Damage:	None
State File Number:	BFU 1X005-10

During line-up, the right Wing Landing Gear (WLG) fractured in the area of the aft mounting of the landing gear.

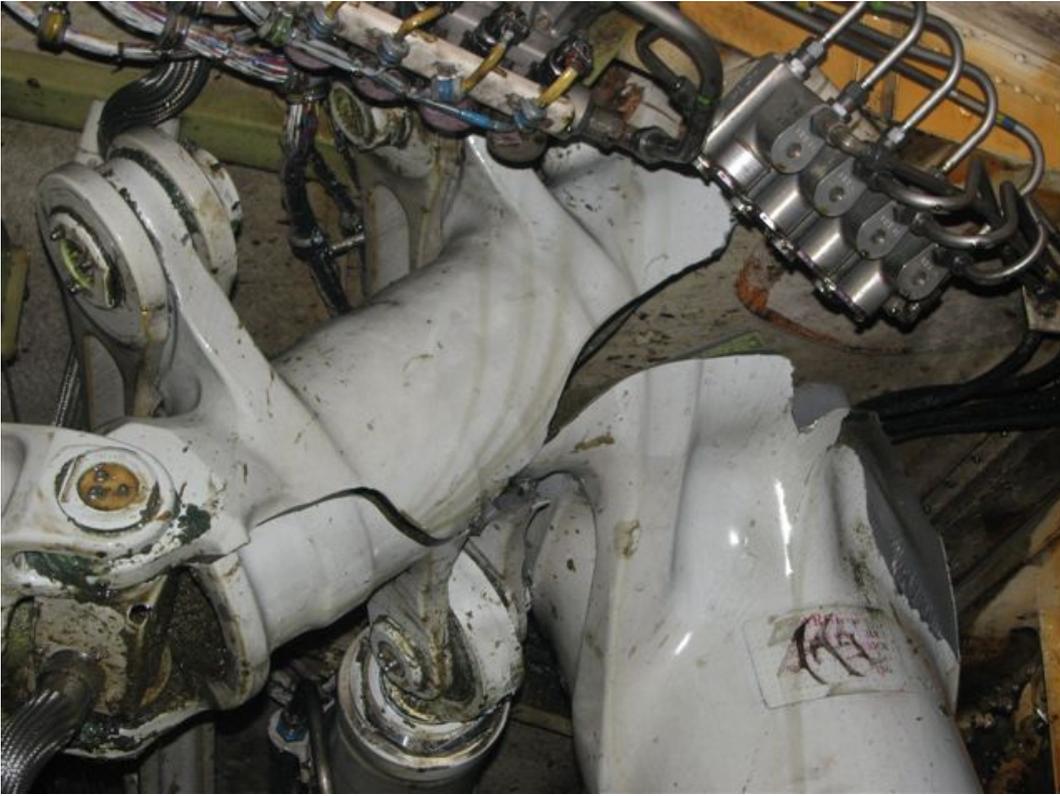
Personnel of the operator and the responsible maintenance organisation, respectively, appraised the damage at the site on taxiway L and determined that the right wing landing gear had fractured in the area of the trunnion, the aft bearing of the landing gear cylinder (Appendices, Fig. 1). The wheel well and the wheel well door were also damaged. It leaked hydraulic fluid.

Fig. 1: Fractured outer cylinder

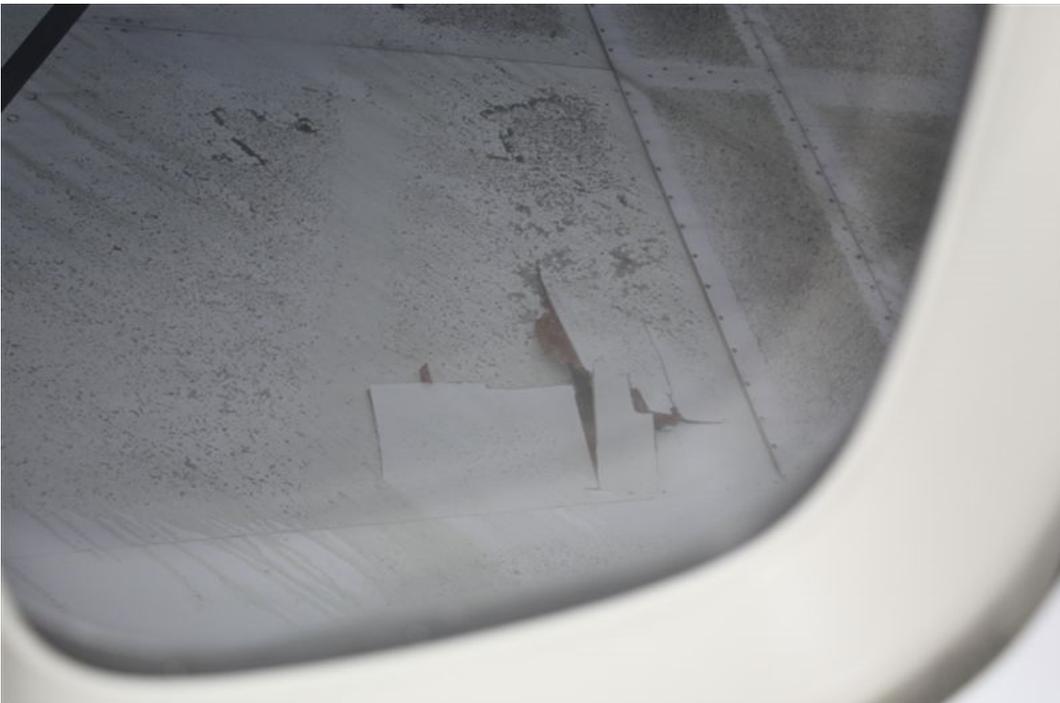
The wing in the area of the landing gear was punctured (Appendices, Fig 2). The outer skin of the fuselage above the right wing between Station STA 1335 and STA 1350 abreast of Stringer STR 21 was punctured inward (Appendices, Fig 3). These damages were due to the fill plug of the former load evener system, which had been pressed out of the fill plug bore.

Fig. 2: Punctured R/H wing, viewed from the window

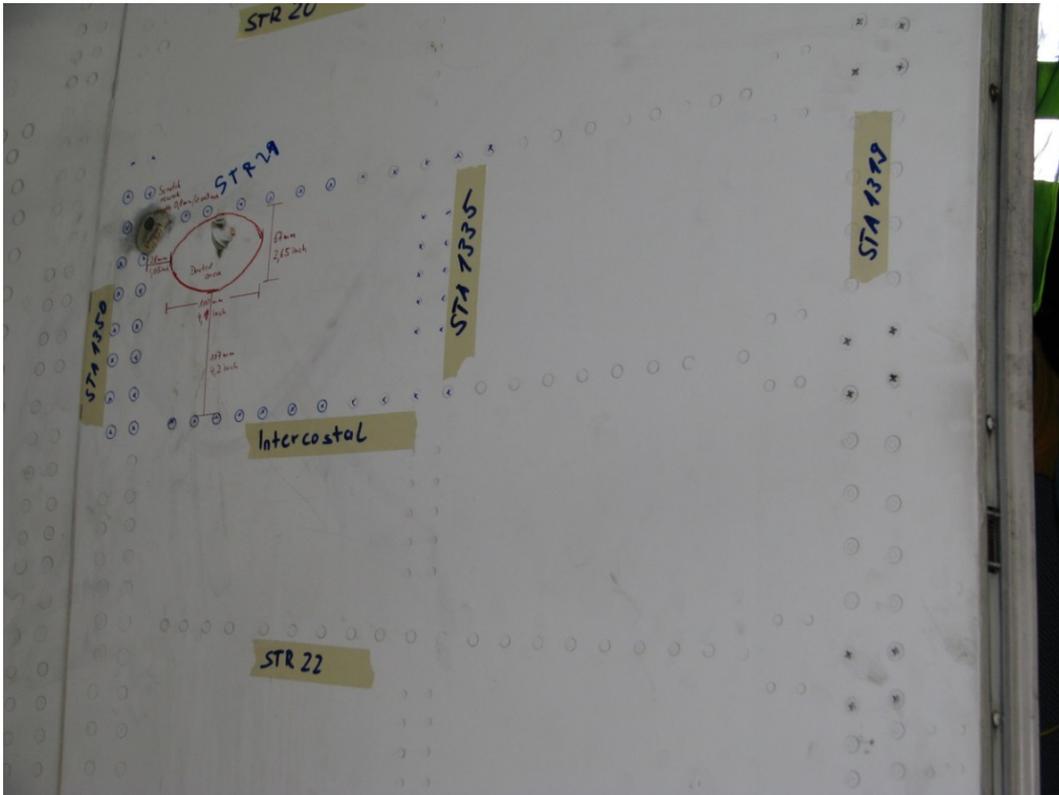
Fig. 3: Damaged outer skin

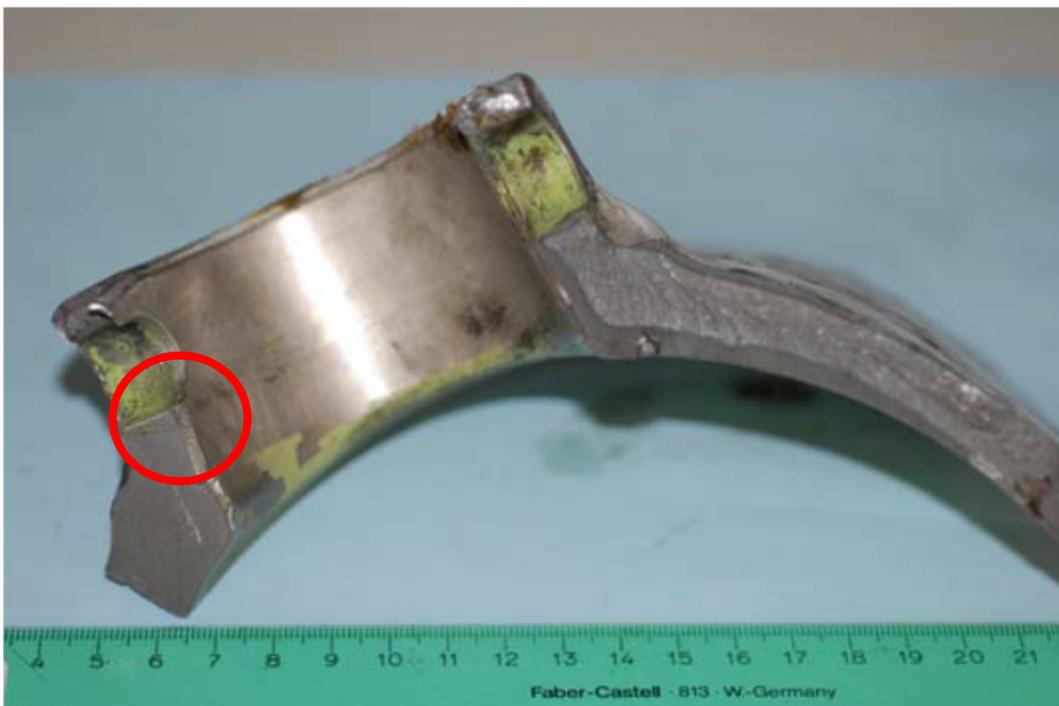
The fracture origin was located in the area of the fill plug bore of the former load evener system. Further inspection showed that the fracture origin had occurred at the inner diameter below the nickel coating. The fracture surface of the fracture origin was surrounded by brown areas.

The examination with the scanning electron microscope confirmed the fracture origin at the inner diameter (Appendices Fig. 4 - 6). The fracture origin showed minor corrosion. The fracture origin proceeded transcrystalline followed by forced rupture

which showed a ductile structure. The fracture was caused by stress corrosion cracking.

Fig. 4: Fracture piece including fracture origin

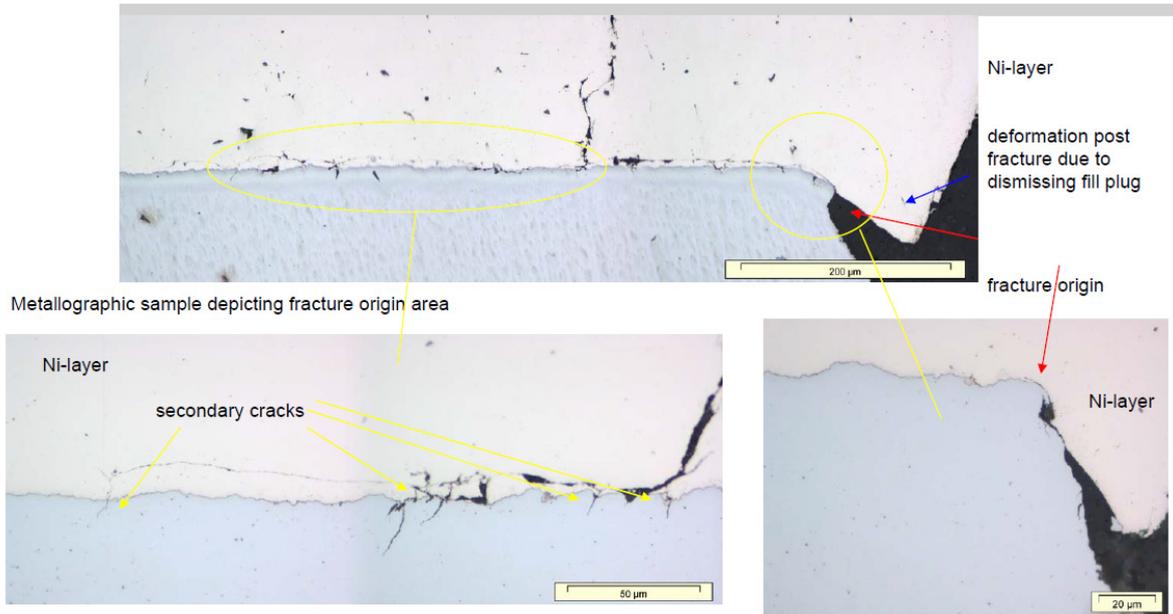
Fig. 5: Metallographic images of the fracture origin

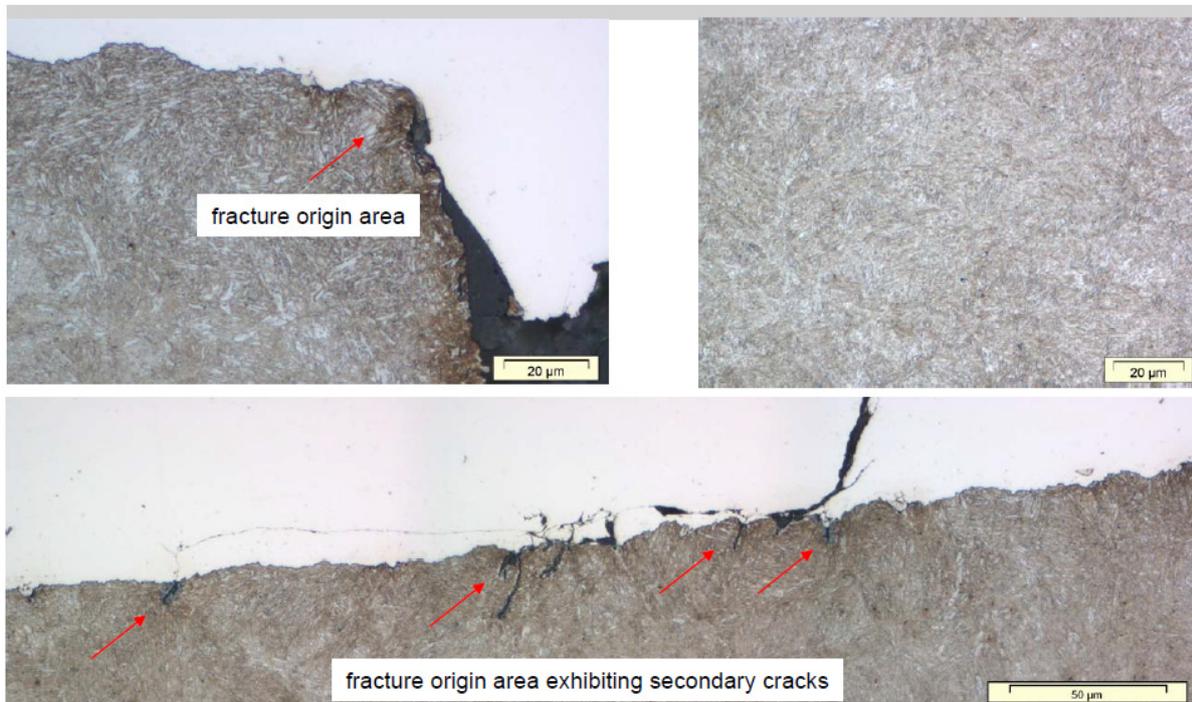
Fig. 6: Scanning electron microscope image of the fracture origin

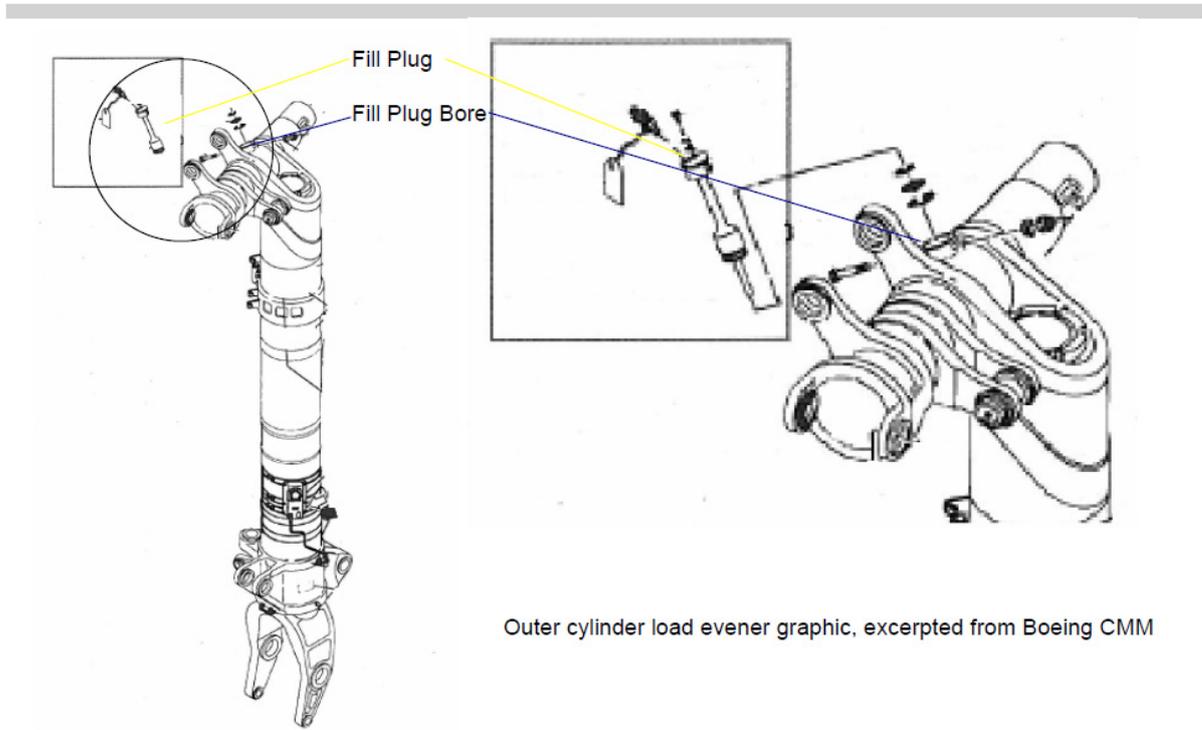
The fractured outer cylinder was an older version which originally had been used in the B747-200/300. For these airplanes, there was a 'load evener' system which would apply an even pressure to all four main landing gear struts in order to keep the airplane level anytime the airplane weight was being carried by the landing gear. Based on service experience, the 'load evener' system was omitted for the B747-400 model. In order for an 'older style' (with the load evener system) outer cylinder to be used in aircraft types such as the B747-400 the manufacturer modified it by filling the fill plug hole (for the evener system) with a plug. It was secured with a bolt (Appendices Fig. 7). The plug was subject to the pressure of the nitrogen fill of the landing gear. The surface of the fill plug bore was coated with nickel.

The fractured outer cylinder on the accident aircraft was manufactured in 1976 for an older model of the B747 which had the load evener system installed. For use on the B747-400, the fill port on the strut for the evener system was plugged. The landing gears of the B747 do not have a life span limitation due to the redundancy of having 4 main landing gears to support the weight of the airplane. If a main landing gear fails, the other three are certified to carry the weight of the airplane during taxi, take-off and landing. Therefore no detailed information as to the number of cycles on the fractured gear was available. Maintaining cycle/hour counts are therefore not required for components which are not subject to life span limitations. Estimates show that the outer cylinder had completed about 27,750 cycles. During its life span the outer cylinder was subject to maintenance actions in 1996 and 2003. Among other things, the area of the fill connection was overhauled so that it could be fitted to a B747-400 model. Since the last overhaul it had completed about 4,500 cycles.

Fig. 7: Fill plug bore including fill plug

The fractured outer cylinder was the last of this kind which the operator had still used. During maintenance work it was replaced by the newer version which was manufactured without the evener system fill plug.
