FINAL REPORT
A - 012/CENIPA/2013

| <u>AIRCRAFT:</u> | PR-TTI |
| <u>MODEL:</u> | ATR72-212 |
| <u>DATE:</u> | 21 February 2011 |

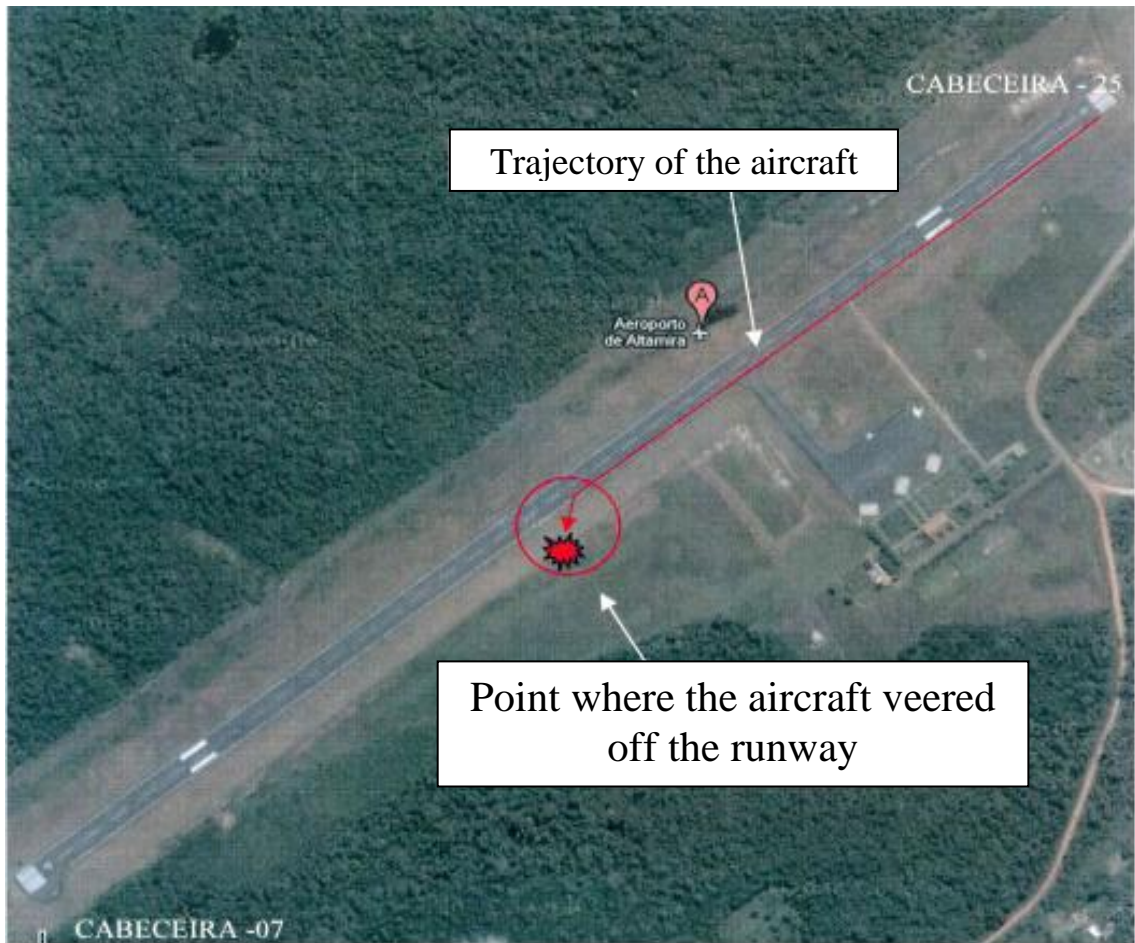
Figure 1 – Trajectory of the aircraft after landing.

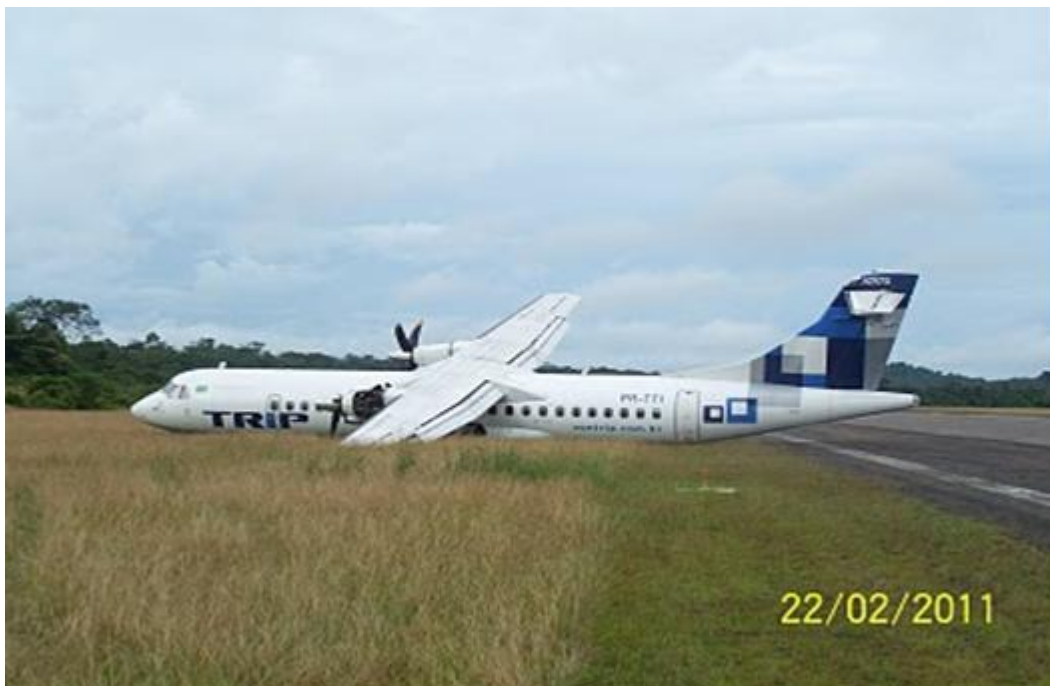
Figure 2 – Situation of the aircraft after the runway excursion.

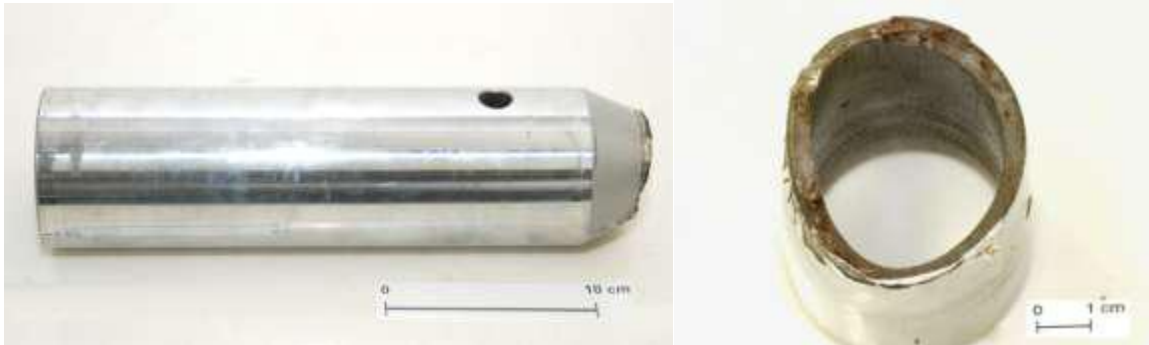
In the visual and stereoscopic tests of the pin D61999 MN 319 (Figure 3), it was possible to see that it had broken, showing signs of kneading and fracture with inclination of $\pm 45^\circ$, suggestive of overload.

Figure 3 – Aspect of the pin identified as D61999 MN 319.

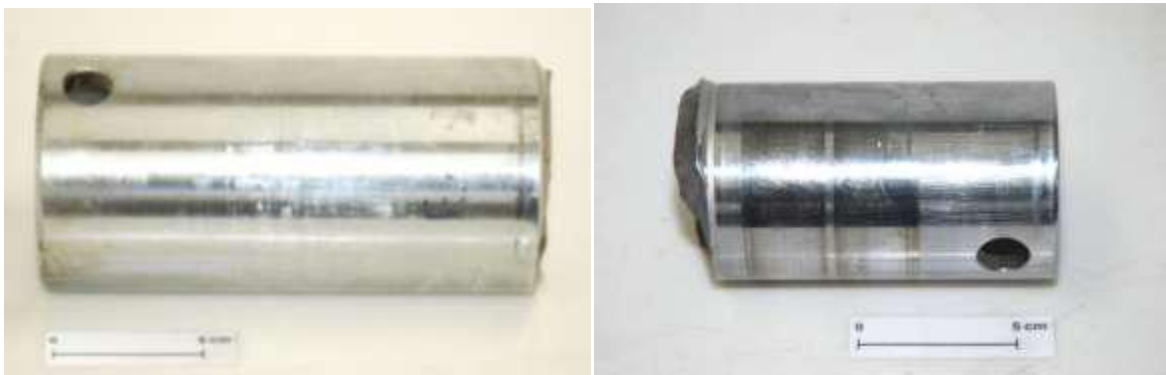
In the visual and stereoscopic tests of the *AFT PIVOT PIN* (D61000 E1 and SN 25) (Figure 4), it was possible to see that it presented a fracture surface with an inclination of $\pm 45^\circ$ and a flat region with multiple initiations, indicative of a mechanism of fracture due to fatigue (Figure 5).

Figure 4 – Aspect of the pin identified as D61999 MN 319.

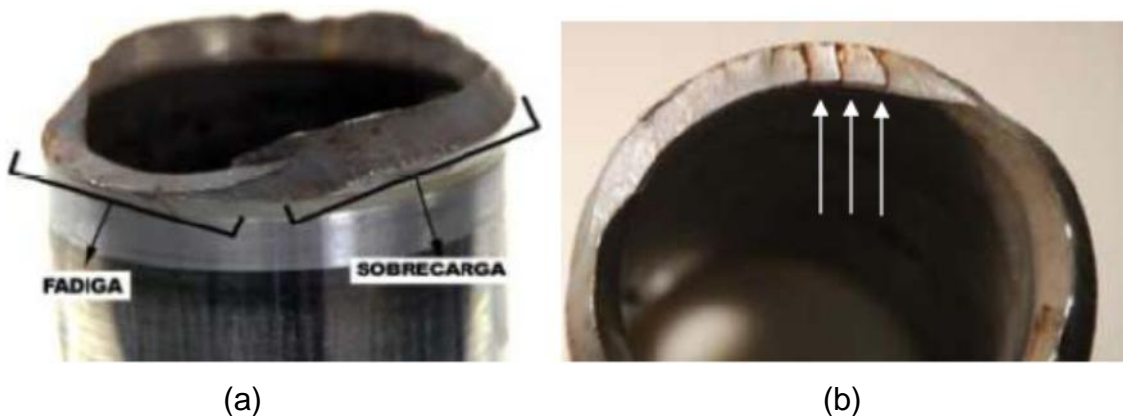
Figure 5 – Aspects of the pin (D61000 E1 SN 25). It is possible to see a flat fracture surface and another one at $\pm 45^\circ$ (a). It is possible to observe multiple fracture plans, indicative of play, with various initiations (indicated by arrows) (b).

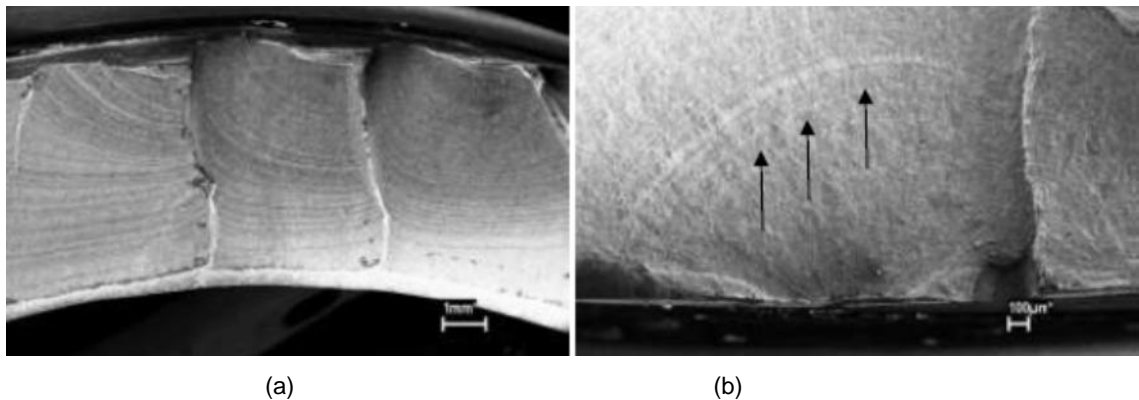
In the SEM examination of the pin fracture surface, it was possible to observe multiple planes of fracture and beach marks, indicative of fatigue (Figure 6).

Figure 6 – Electrophotography. (a) Multiple planes of fracture can be observed. (b) The arrows point at beach marks, characteristic of fatigue.

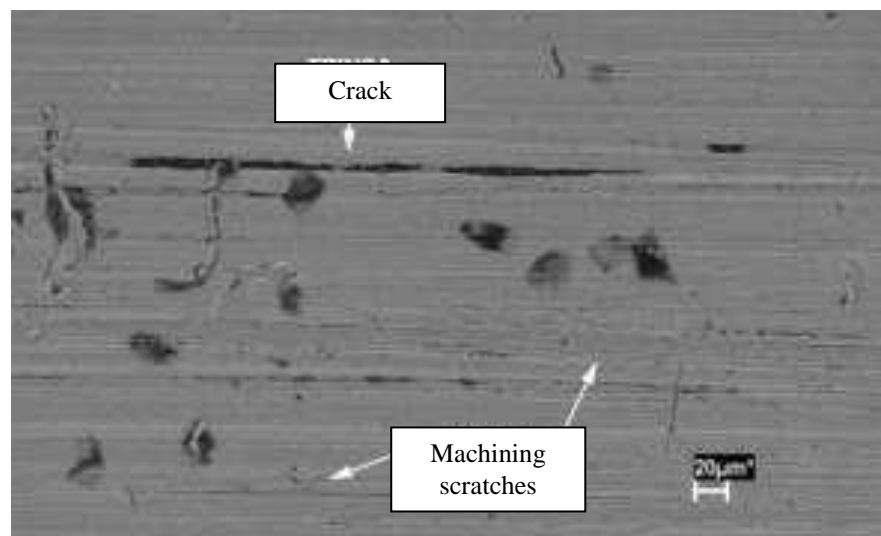
In the stereoscopic exams of the pin external surface, in a region close to the fatigue fracture, it was possible to observe cracks that had initiated from scratches caused by the machining process (Figure 7).

Figure 7 – Electrophotography: It is possible to observe cracks associated with machining scratches (indicated by arrows).

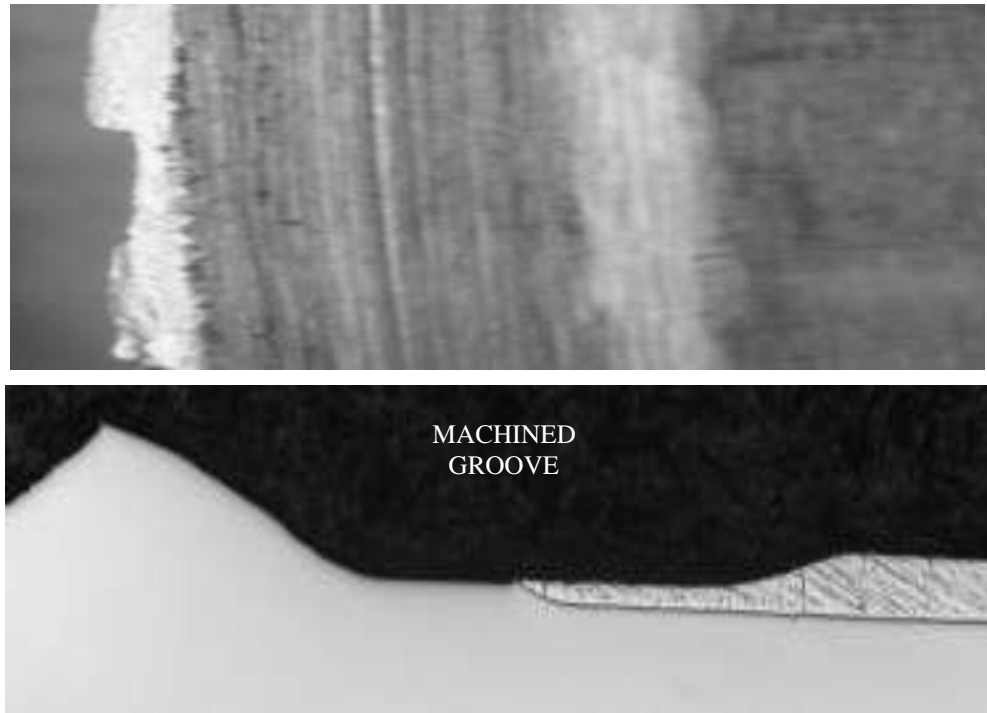
In the area of the pin where the overload-related fracture occurred, it was possible to observe that the machining process had generated an alteration of the part profile in the region of section transition, by bringing in a depression, as can be seen in Figure 8.

Figure 8 – Photographs showing the machined groove, and the area of the groove where the fatigue process occurred.

Based on the results obtained, it can be stated that the pin D61000 E1 SN 25 of the PR-TTI left main landing gear broke on account of fatigue, whose onset was facilitated by a machining process carried out in the section transition region of the pin.

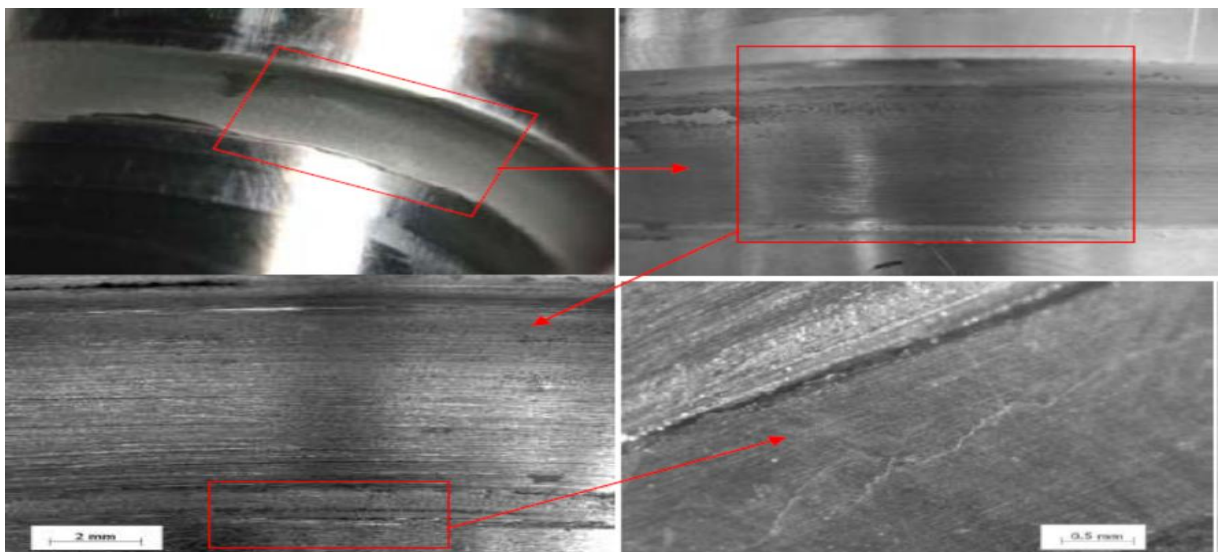
Visual and stereoscopic examination of this pin, conducted after the protective paint was removed, revealed rough machining scratches and a crack in the chrome layer, in the same area where the fatigue-related crack of the pin D61000 E1 SN 25 had occurred (Figure 9).

Figure 9 – Photographs. Surface of the pin D61000 MN 254, in the area of section transition, depicting the same position at which there was a fatigue-related rupture of the pin D 61000 E1 S/N 25. In the image detail, it is possible to see a rough machining aspect.

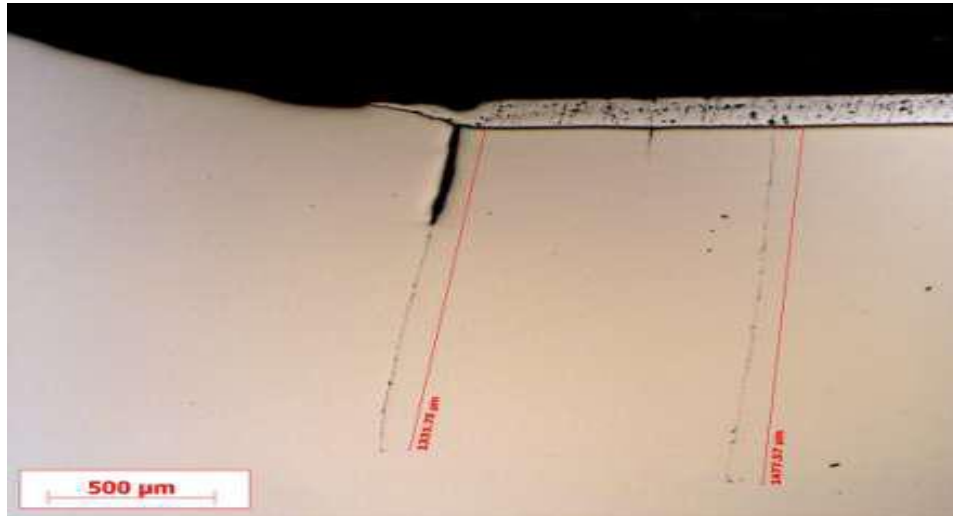
In metallographic examinations performed in the longitudinal section of the pin D61000 MN 254, in the same region where the fracture of the pin D61000 E1 SN 25 occurred, cracks were detected, associated with machining scratches, and also superficial overheating of the microstructure, probably due to the grinding process (Figures 10 and 11).

Figure 10 – Photomicrography. Region where the transition from shorter to longer diameter begins. It is possible to see two cracks with a depth of approximately 1.5mm, in addition to another smaller crack.

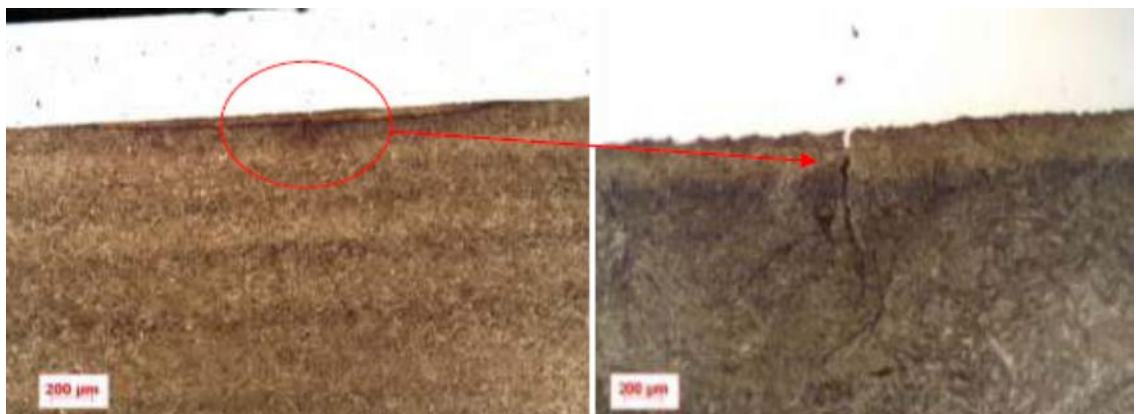
Figure 11 – Photomicrography. View of the section transversal to the crack, showing that the crack originated in a region that had sustained overheating.

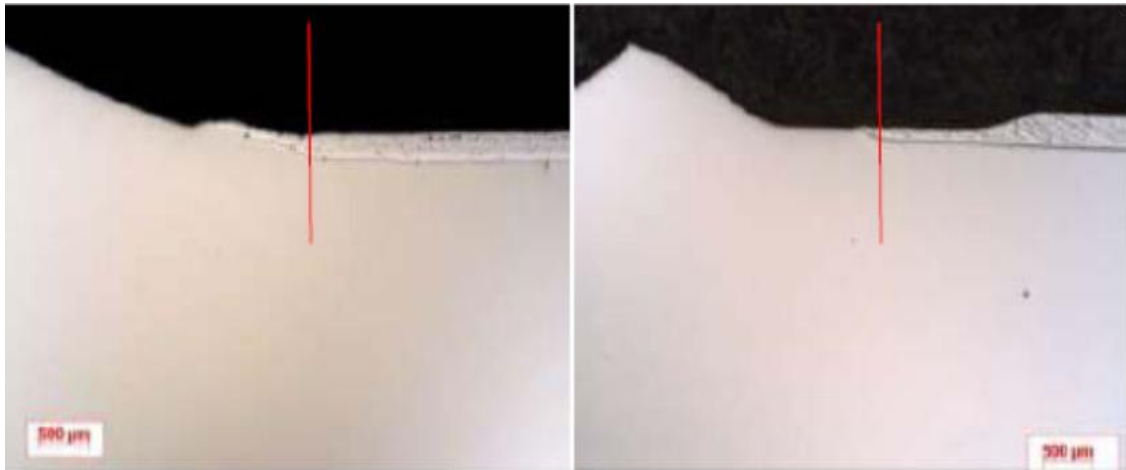
During the work conducted at the DCTA, it was observed that, despite the different machining processes carried out in the section transition region of each pin, in both cases the coarse finish served as a facilitator for the initiation of the fatigue process in the pins. As for the pin E1 D61000 SN 25, the machining interference was more critical, because it altered the local geometry of the part significantly (Figure 12).

Figure 12 – Photomicrography. Comparison of the metallographic profiles between the pins D61000 MN 254 and D 61000 E1 SN 25, respectively, indicating that they were machined differently.
