<p>Permanent office of investigations of aviation Accidents/Incidents</p>	<p>FINAL REPORT OF TECHNICAL INVESTIGATION ON THE ACCIDENT OF THE CRJ-100 PLANE, REGISTER 4L-GAE</p>	<p>Page 1</p>
---	---	-----------------

**INVESTIGATION REPORT OF ACCIDENT
INVOLVING GEORGIAN AIRWAYS AIRCRAFT
CRJ-100ER (4L-GAE)
AT KINSHASA'S N'DJILI AIRPORT
DEMOCRATIC REPUBLIC OF CONGO (DRC)
ON 04 APRIL 2011**

Investigation report of accident involving Georgian Airways CRJ-100ER (4L-GAE), which occurred at Kinshasa's N'DJILI Airport, Democratic Republic of Congo (DRC) on 04 April 2011.

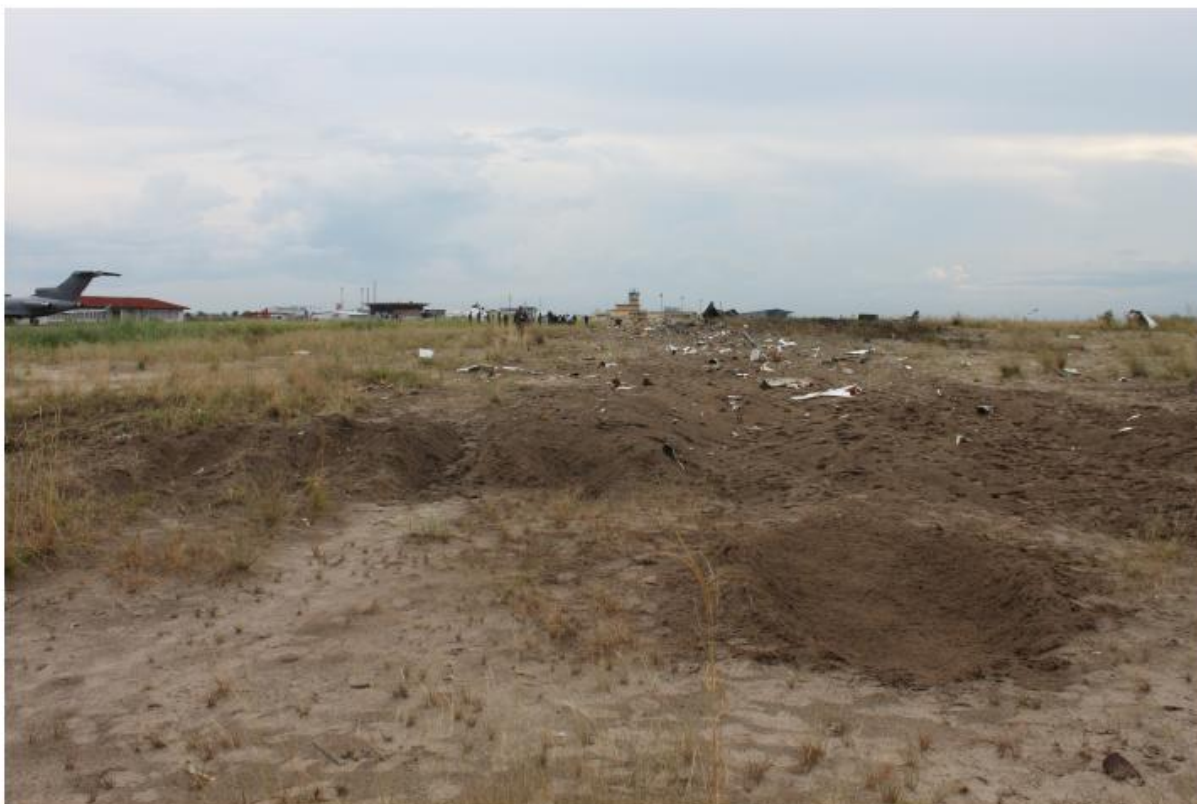
Image shows the initial impact marks of the aircraft. At the moment of impact, the indicated air speed was 180 knots, aircraft attitude was 10 degrees nose down and magnetic heading was 220 degrees. Notice that aircraft components started breaking off immediately following initial impact. The fuselage came to a rest in inverted position about 400 meters beyond the initial impact point.

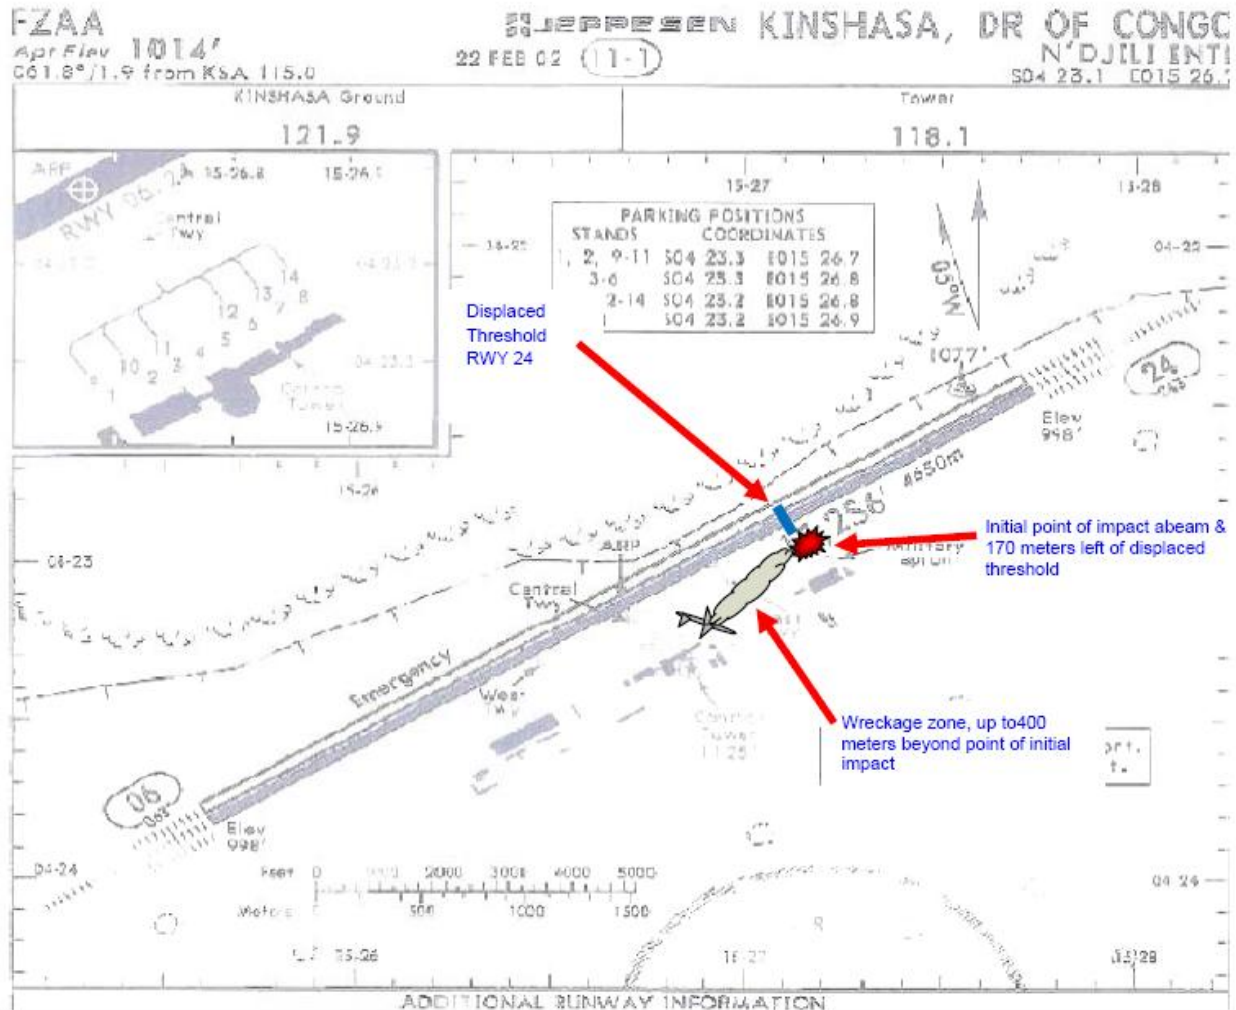
Threshold of Runway 24 was displaced by 1400 meters. Initial point of impact of the aircraft was abeam and 170 meters left of displaced threshold. Wreckage was spread over 400 meters in impact direction (about 220 degrees).

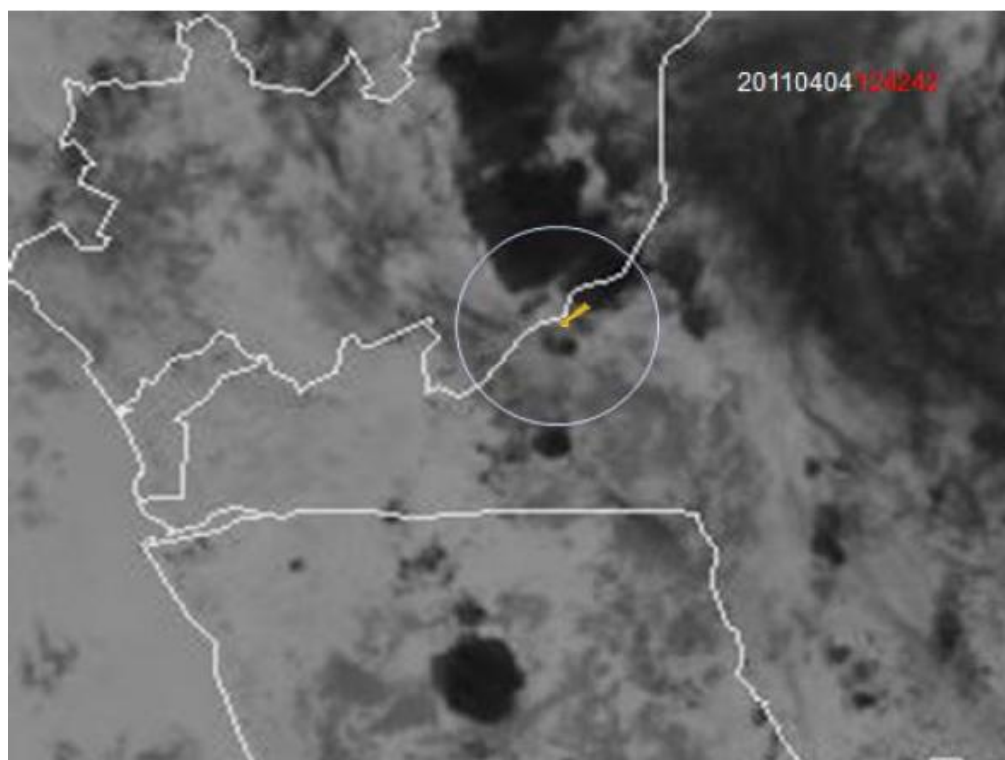
Above: EUMETSAT Infra Red photo of 1242 42 (about 16 minutes before the accident) showing Kinshasa airfield and Runway 24 Localizer Approach path (not to scale).

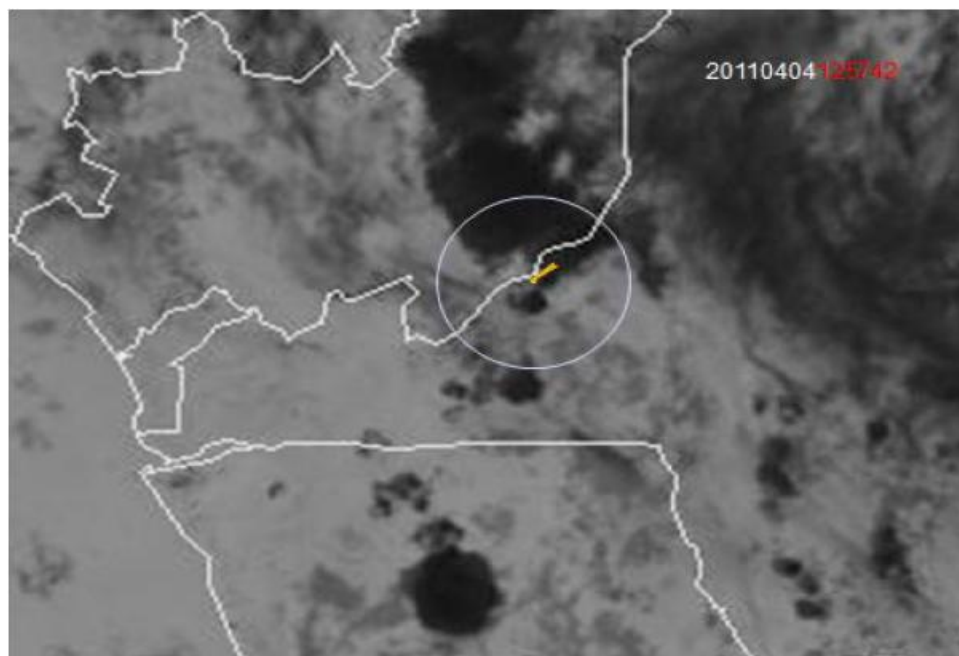
Above: EUMETSAT Infra Red photo of 1257 42 (about 50 seconds after the accident) showing Kinshasa airfield and Runway 24 Localizer Approach path (not to scale).

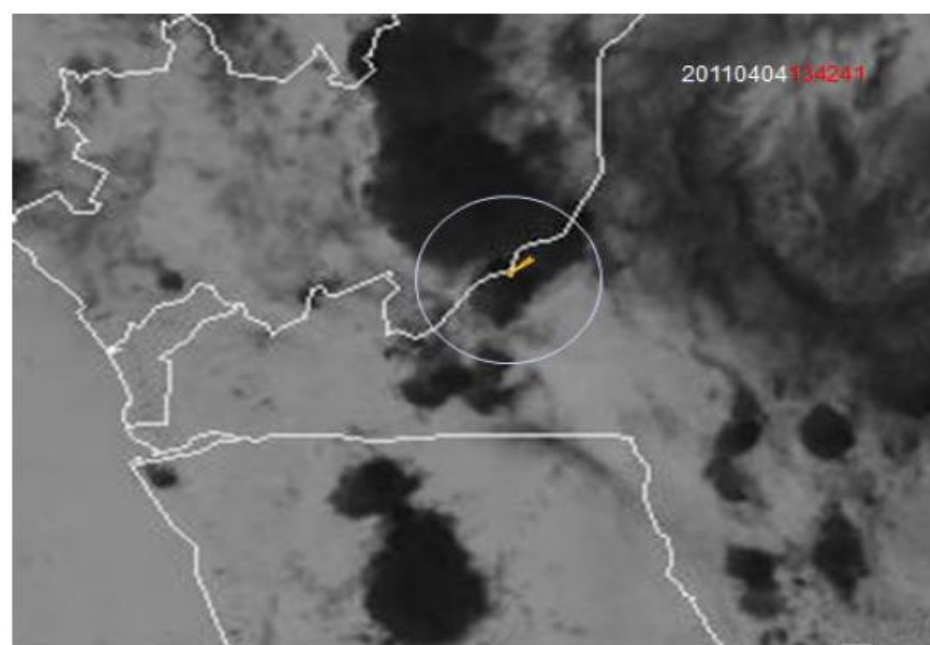
Above: EUMETSAT Infra Red photo of 1312 41 (about 16 minutes after the accident) showing Kinshasa airfield and Runway 24 Localizer Approach path (not to scale).

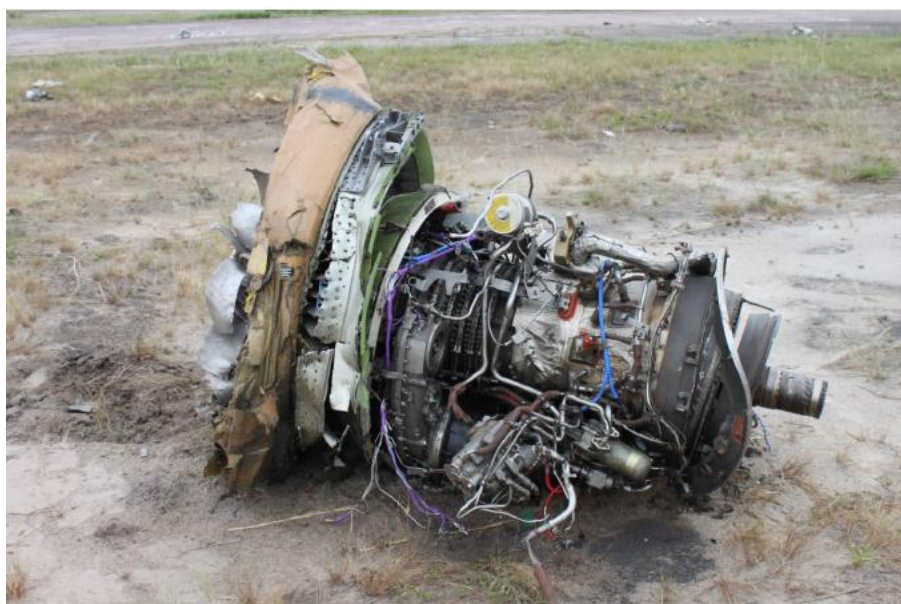
One of the engines separated from the fuselage

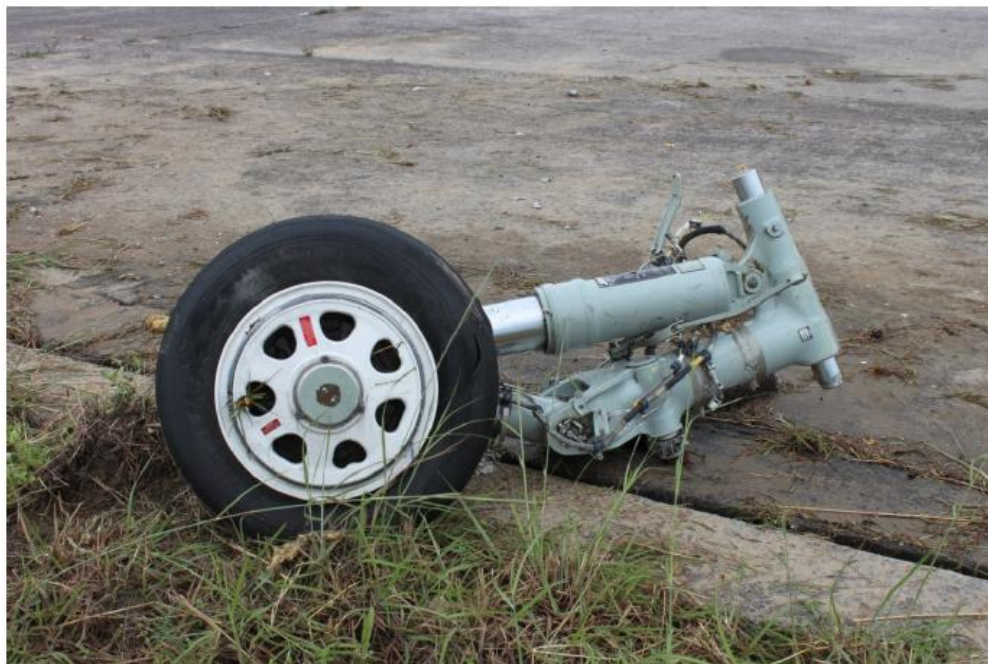
The main landing gear broke off.

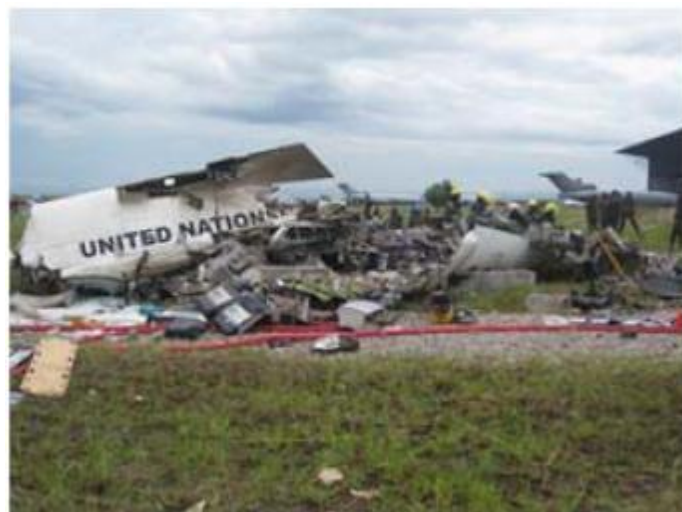
Above: Major part of the fuselage came to a rest about 400 meters away from initial impact point.
