**Hard landing, inappropriate stopover maintenance procedure,
take-off with a substantially damaged aeroplane**

Aircraft	Airbus A330-211 registered F-GZCB
Date and time	13 April 2011 at 18 h 25 ⁽¹⁾
Operator	Air France
Place	Caracas-Maiquetía Simón Bolívar Airport (Venezuela)
Type of flight	Scheduled international public transport of passengers
Persons on board	Captain (PF), copilot (PNF), copilot (relief), 10 cabin crew, 202 passengers
Consequences and damage	Aeroplane substantially damaged

This is a courtesy translation by the BEA of the Final Report on the Safety Investigation. As accurate as the translation may be, the original text in French is the work of reference.

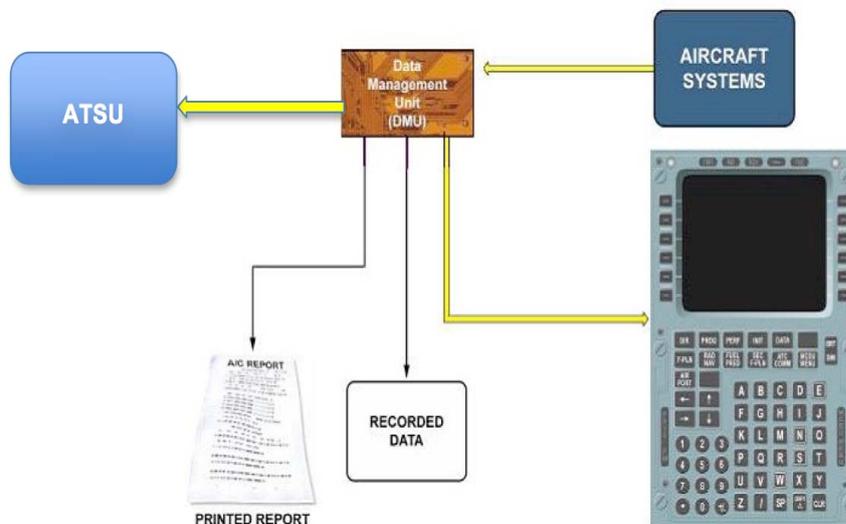
On 13 April, no R15 report relating to the hard landing had been received by the MCC. The last R15 found via the MCDU was dated 21 March 2011. An R15, generated by the DMU on 13 April, at 18 h 55 min 26 had been sent on 14 April at 21 h 14 min 02, or the day after the Paris - Caracas flight, at the beginning of the breakdown action. It is likely that the R15 associated with the last flight was not available at the time of the technicians’ operations.

Two malfunctions occurred during these flights:

- The DMU did not issue a R15 report immediately after the hard landing, yet the conditions to generate it were met;
- No R15 report associated with the last flight was available on the page of the ACMS menu of the MCDU.

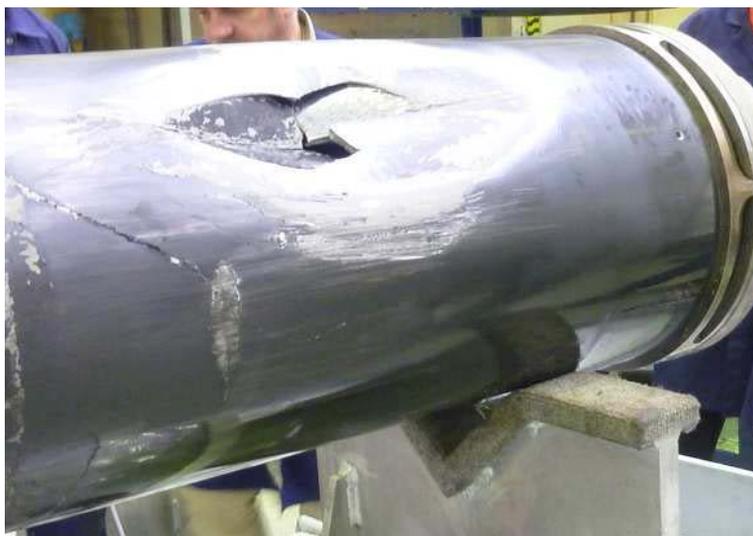
The landing gear was examined in two stages. The first examination carried out in an approved workshop enabled the absence of hydraulic fluid to be noted as well as internal fractures on the body of the fixed unit (Upper Piston). Further examinations, including in particular the characterisation of the fractures, were carried out at the manufacturer's. The examinations showed that the fractures were the result of abnormally high stress.

The incipient failure did not show any pre-weakening. Its characteristic fracture surfaces indicated that it was sudden. However the presence of an end mark was noted about twenty centimetres from the source of the fracture, indicating the development and propagation of the crack in two stages.

This mark corresponded to the end of the cracking during the immobilisation of the aeroplane on the tarmac, on arrival of the flight from Paris.

The final fracture was a result of deterioration of the landing gear which may have occurred either during taxiing to take-off on the return flight or during landing of the same flight.

The violent impact of the landing gear during the hard landing caused an excessive local increase in the damping hydraulic pressure in the lower part of the mechanism leading to constraints greater than the materials' resistance. There was excessive compression of the static piston, subsequently limiting its movement. This damage prevented the full operation of the landing gear retraction sequence.
