# Aircraft Serious Incident Report

**In-Flight Engine Shutdown**

**A330-300, HL7553**

**26 May 2011**

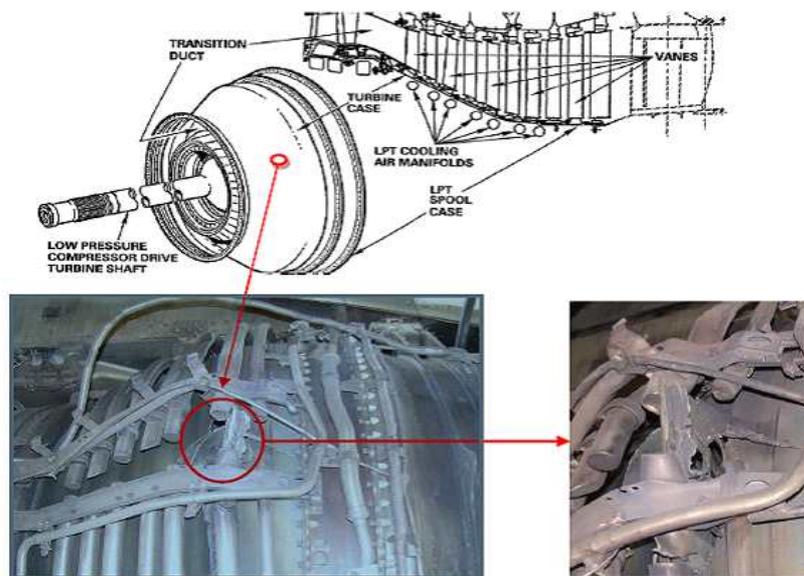
[Figure 2] LPT Case

As shown in [Figure 2], the aircraft sustained a hole puncture damage to the low pressure turbine (LPT) case at the 9 o'clock position. The fragments of airfoils, which damaged inside the engine, were caught in cracks, whereas some of them fell out to the ground when the engine cowl was open.

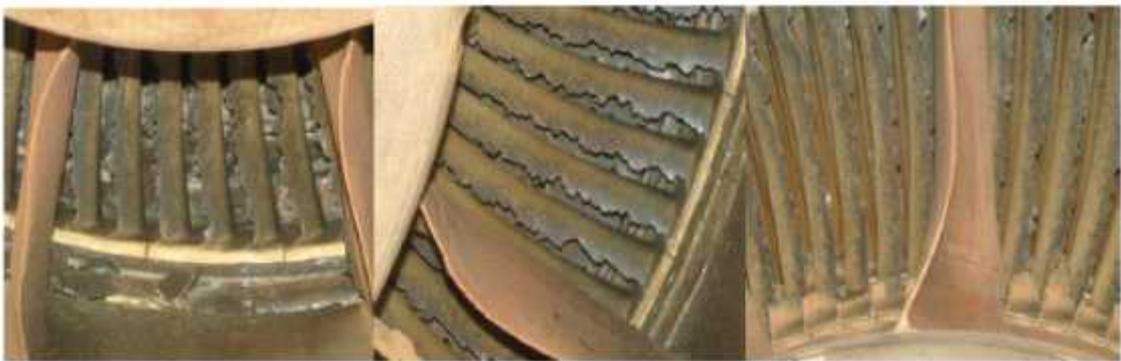
[Figure 3] 7th-Stage LPT

As shown in [Figure 3], all 7th-stage LPT blades and vanes were damaged.

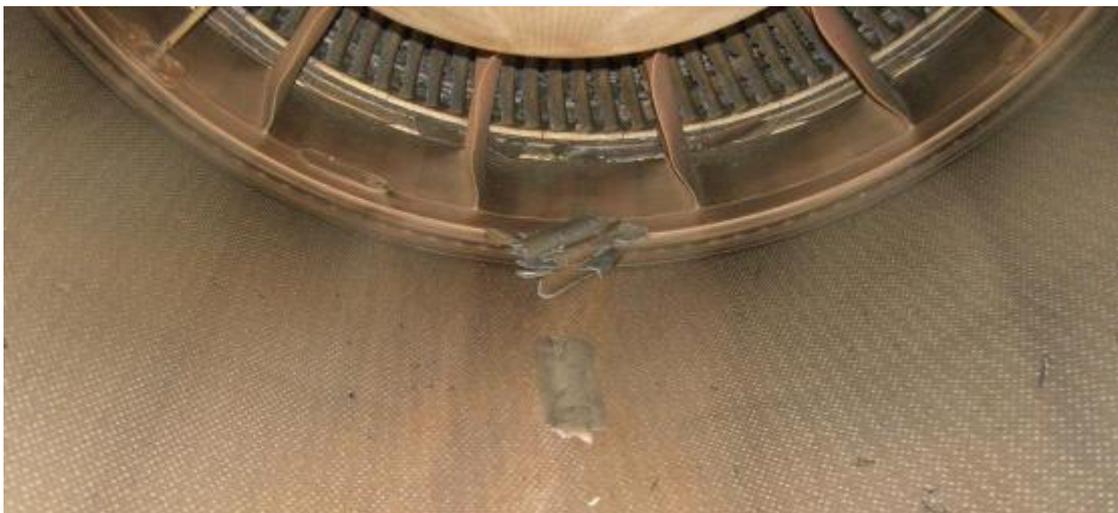
[Figure 4] Metal Fragments near the Exhaust Nozzle

As shown in [Figure 4], metal fragments were found near the exhaust nozzle, but the air inlet sustained no damage.

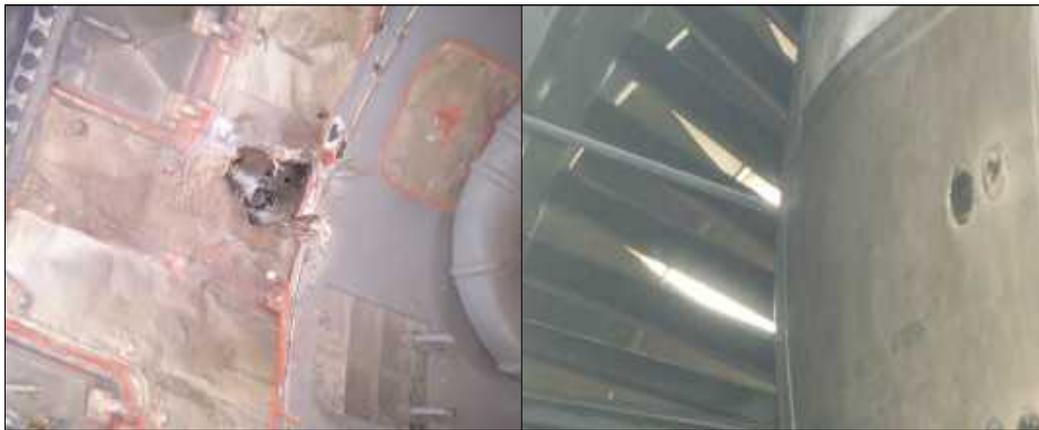
[Figure 5] Interior and Exterior of the Engine Cowl (9 o'clock position)

As shown in [Figure 5], engine debris, which penetrated the LPT case, all remained in the engine cowl, but there was no sign that the debris passed through the cowl.

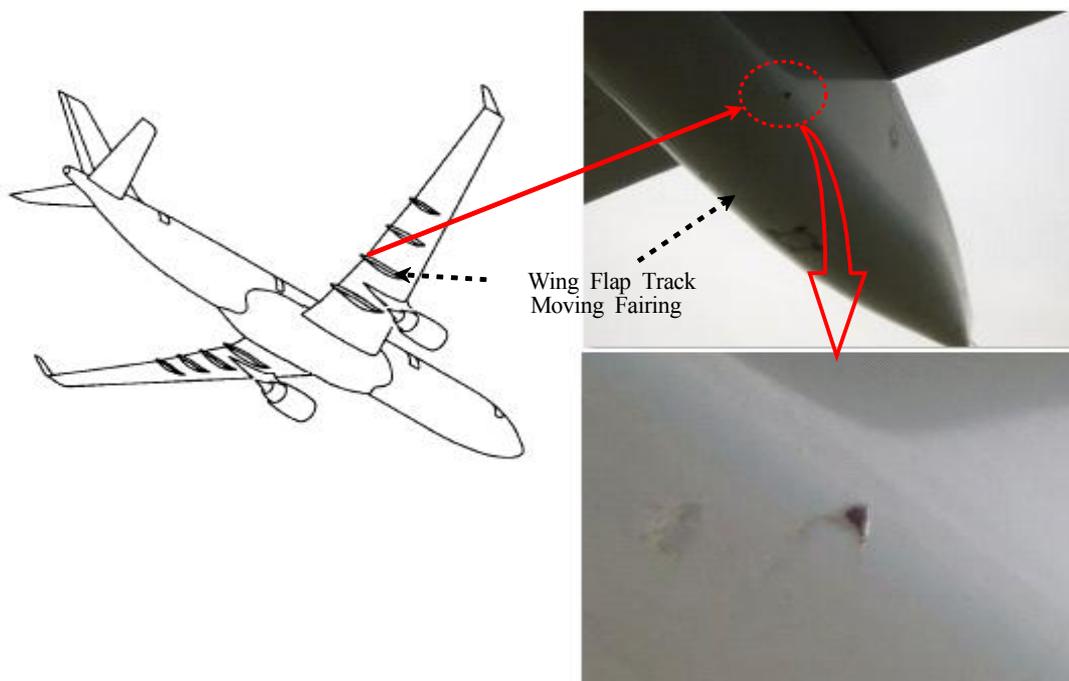
[Figure 6] Wing Flap Track Moving Fairing Damage

As shown in [Figure 6], a puncture with a diameter of 5 cm was found at the bottom surface of the right-hand wing flap moving track fairing.

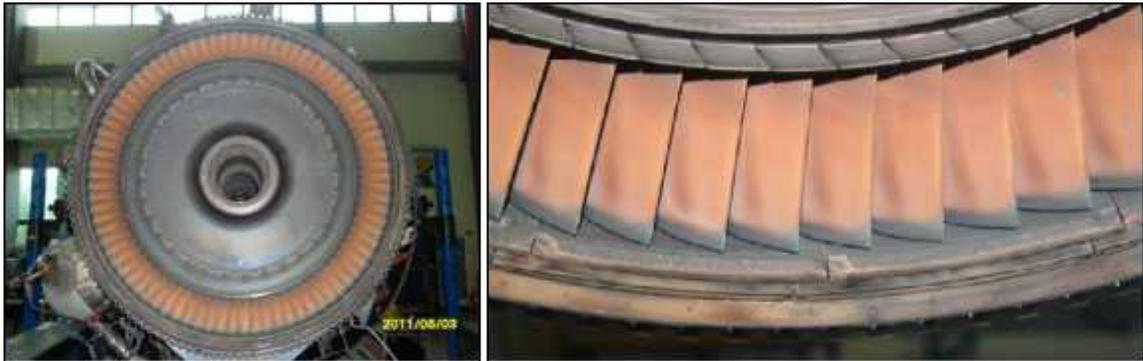
[Figure 7] 2nd-Stage HPT Blades and BOAS

As shown in [Figure 7], visual examination from aft of the HPT module revealed no apparent damage to the 1st- and 2nd-stage HPT blades. Although

rubbing damage was observed in the blade outer airseal (BOAS), their conditions are considered to be typical from service.

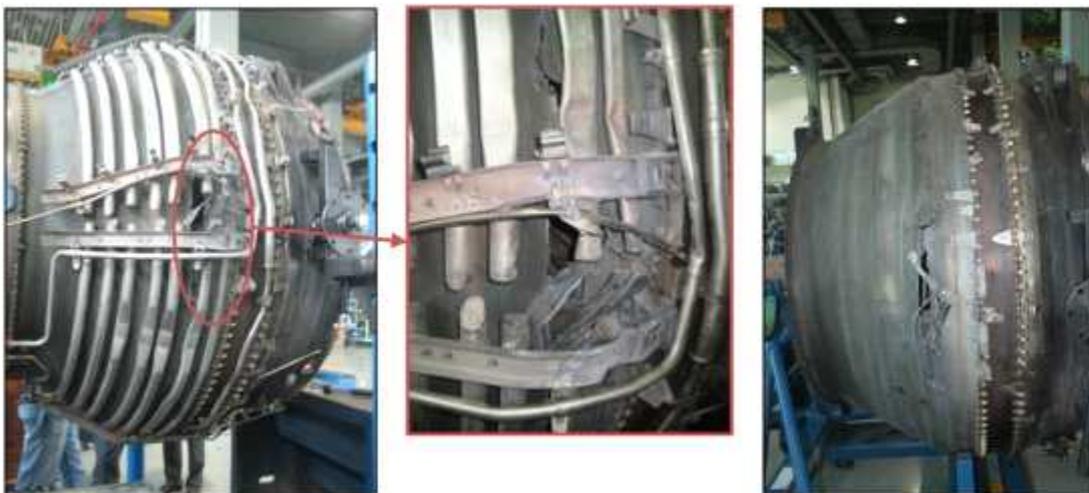
[Figure 8] Before & After the Removal of LPT Case Wrapping Components

As shown in [Figure 8], the LPT case was torn open circumferentially between 8:00<sup>17)</sup> and 9:30 o'clock positions in the plane of the 5th-stage LPT rotor, approximately 57 cm in length by 7 cm in width. Partial cracks were also found at the 11:00, 11:30, and 12:00 o'clock positions.

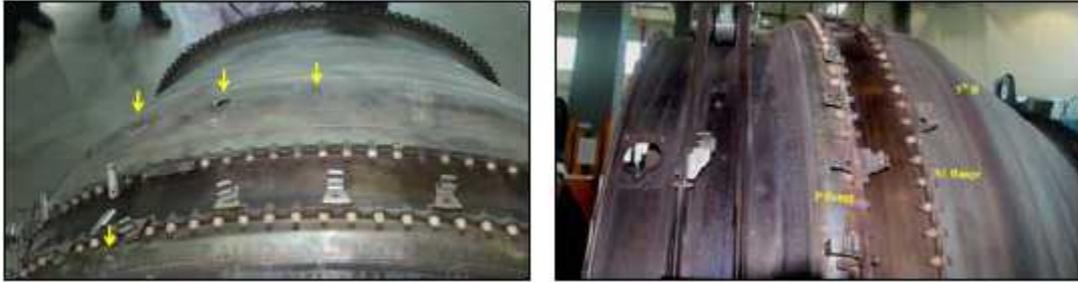
[Figure 9] Upper Surface of LPT Case and Turbine Exhaust Case

As shown in [Figure 9], the LPT case exhibited local bulges at the 6:00, 7:00, and 9:30 o'clock positions in the plane of the 4th-stage LPT rotor. Apparent bulge was also found along the full circumference of the N1 flange.

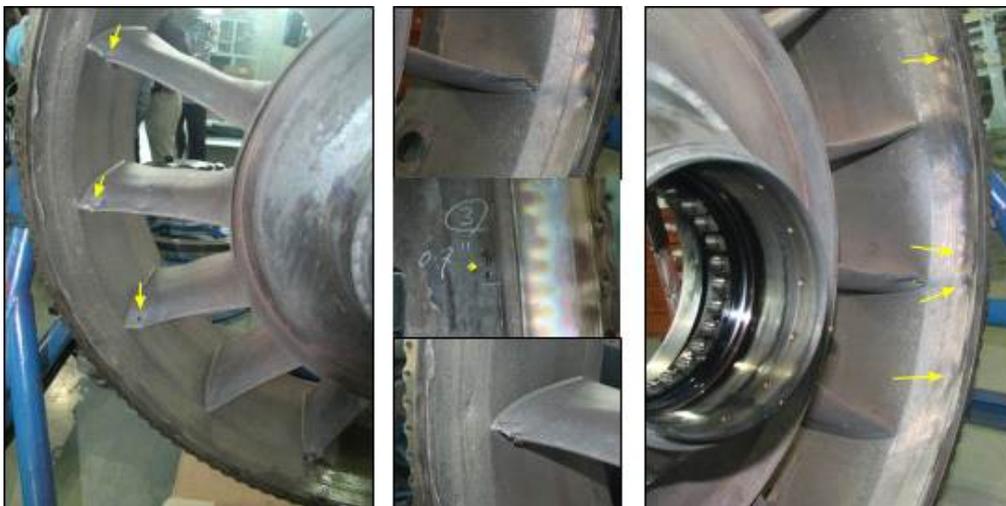
[Figure 10] TEC Struts and P-flange

As shown in [Figure 10], the turbine exhaust case (TEC) exhibited bulges along the circumference of the P-flange. One hole and one small crack/tearing were found at the 11:00 and 2:30 o'clock positions, respectively.

The TEC exhibited local tearing at the strut leading edge positions of the No. 1, 2, 13, 14, and 15 struts.

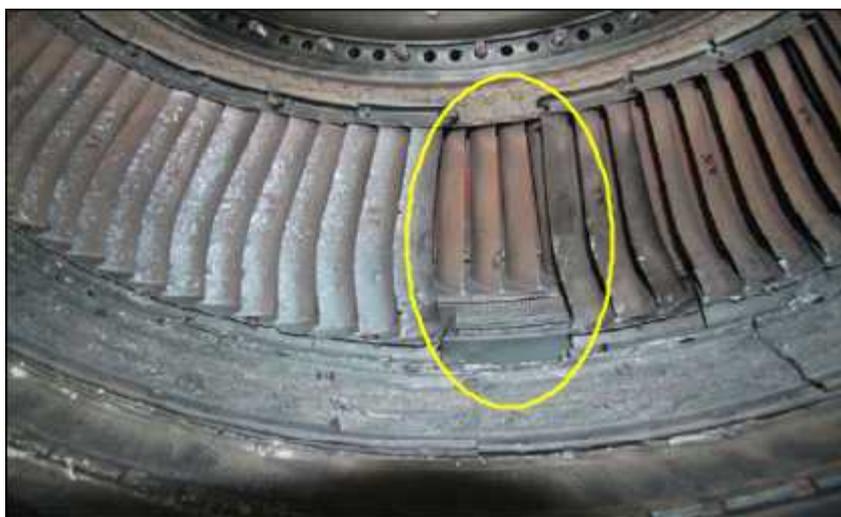
[Figure 11] Missing No. 27 T4 Vane Cluster

During the engine assembly, a total of 44 T4 vane clusters were installed, but as shown in [Figure 11], the No. 27 vane cluster was missing from the assembled position and was not recovered from the disassembly.

The C-channel in the T4 BOAS for the aft outboard foot of T4 vane clusters exhibited significant wear at multiple locations. Partial C-channel wear-through was observed at 10 T4 vane clusters. The C-channel material that was in contact with the No. 27 T4 vane cluster was all missing.

The outboard shroud locking features for the missing No. 27 T4 vane cluster were defeated and missing, including the forward hook in the case and the aft locking feature C-channel in the T4 BOAS. The pin-pocket at the inner shroud of the No. 26 T4 vane cluster was worn through, which was in contact with the No. 27 cluster.

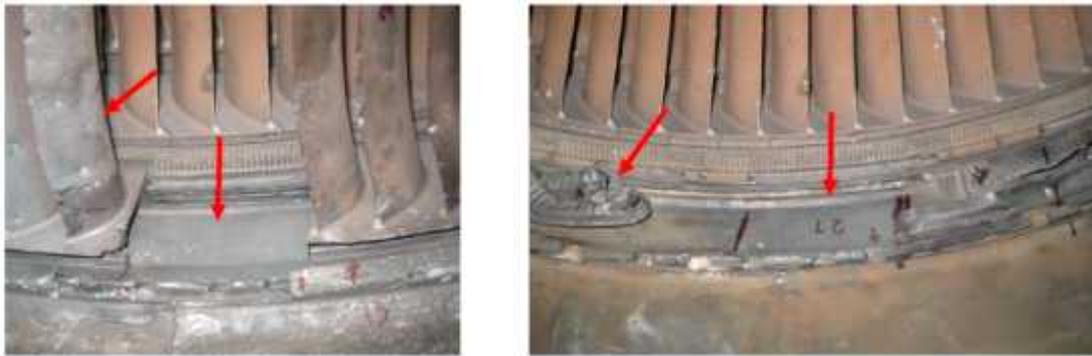
[Figure 12] Insulation Blankets of Vane Clusters

As shown in [Figure 12], the outboard insulation blanket of the No. 27 vane cluster was missing. Impact marks due to the part debris were found on the interior surface of the LPT case. The insulation blanket of the adjoining No. 28 vane cluster was wrinkled, whereas that of the No. 26 shortened, with no damage.

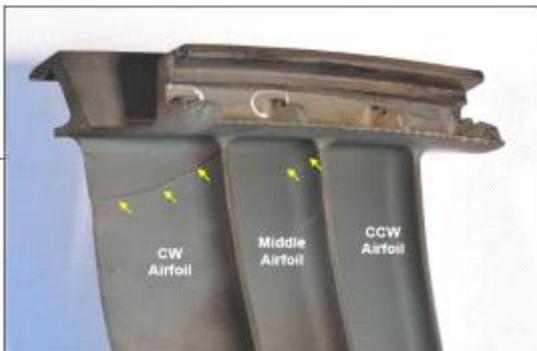
[Figure 13] No. 25 Vane Cluster

As shown in [Figure 13], the No. 25 vane cluster exhibited cracks in the clockwise (CW) side and middle airfoils, adjacent to the outboard shroud. The middle airfoil showed a crack running from the leading edge to the middle section.

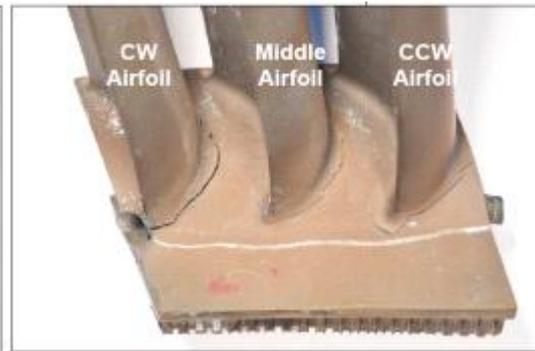
[Figure 14] No. 26 Vane Cluster

As shown in [Figure 14], the No. 26 cluster immediately adjacent to the No. 27 exhibited through-thickness cracks in the inboard shroud at the transition radius runout of each airfoil. Wear was found at the pin-pocket which was in contact with the No. 27 vane cluster pin.

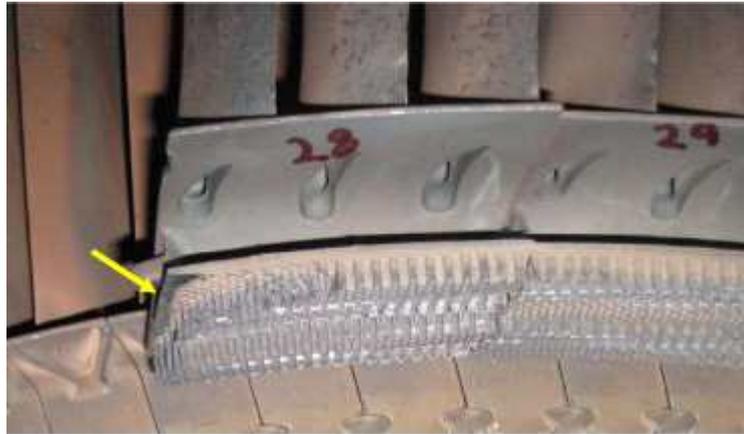
[Figure 15] Inboard Shroud of the No. 28 T4 Vane Cluster

As shown in [Figure 15], the inboard shroud of the No. 28 T4 vane cluster, which was immediately adjacent to the missing No. 27 cluster, showed missing honeycomb material of the inner airseal, and contact marks.

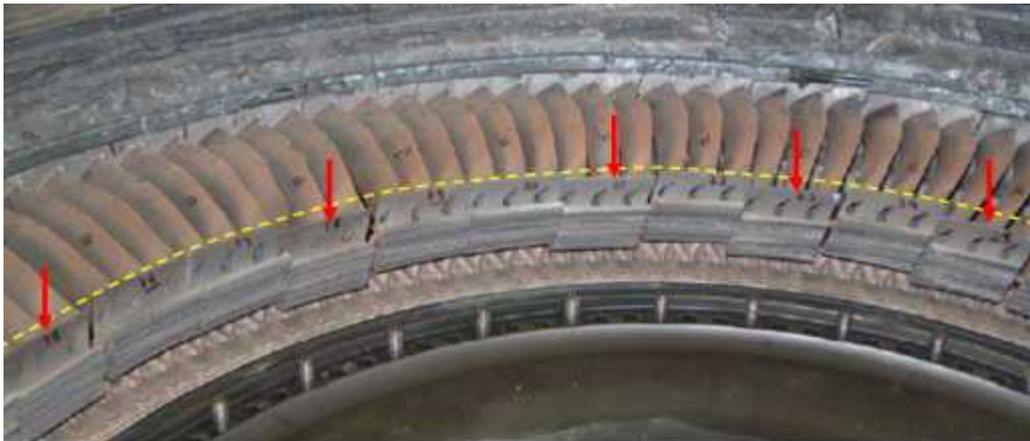
[Figure 16] Interior of the T4 Vane Clusters

As shown in [Figure 16], the inboard view of the T4 vanes showed that multiple cluster inner shrouds were displaced axially forward relative to others. The honeycomb of the inner airseal exhibited wide or multiple grooves.

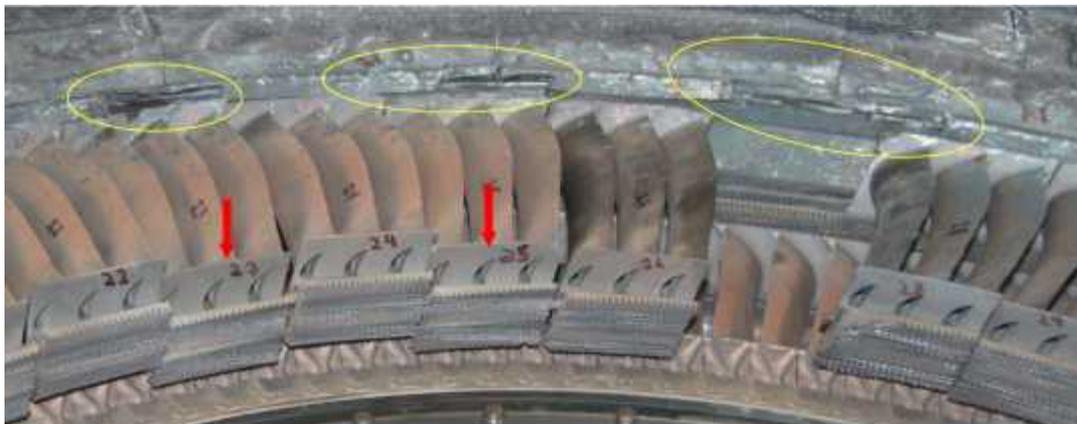
[Figure 17] T4 Vane Cluster C-channel

As shown in [Figure 17], the overall inboard view of the T4 vane clusters adjacent to the missing No. 27 cluster showed the missing aft outboard locking feature C-channel at the location of the missing No. 27 cluster. Parts of the C-channels for clusters No. 23 and 25 were also missing. Clusters No. 23 and 25 appeared to be displaced forward at the inner shroud.

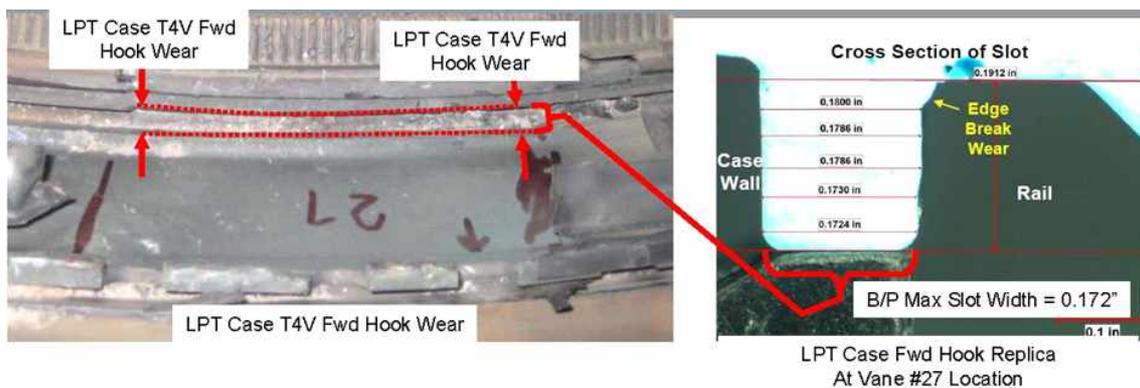
[Figure 18] LPT Case Forward Hook Wear

As shown in [Figure 18], the LPT case forward hook at the location of the No. 27 cluster exhibited material loss, without apparent deformation. The forward and rear hooks together showed wear, and in particular, the LPT case forward hook slot has worn down approximately 1.5 mm over the max. B/P dimension.

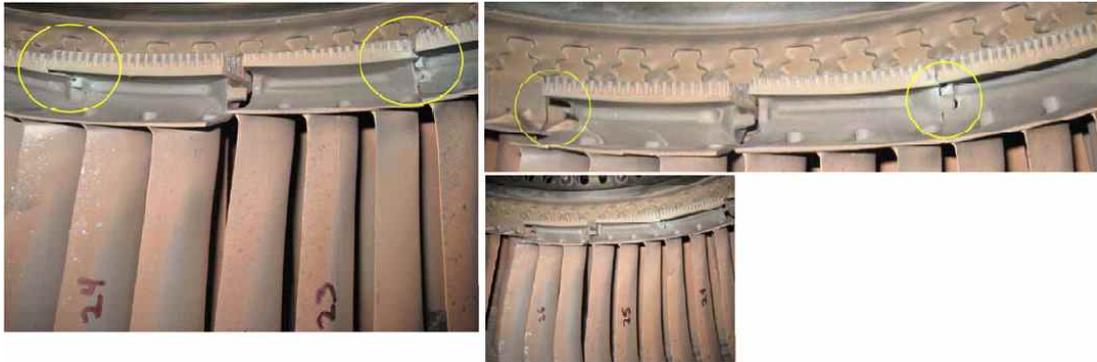
[Figure 19] T4 Vane Cluster Pin-Pocket Wear

As shown in [Figure 19], the pin-pocket has worn through<sup>19)</sup> in the vane clusters No. 22, 24, and 26 which were adjacent to the missing No. 27 cluster.

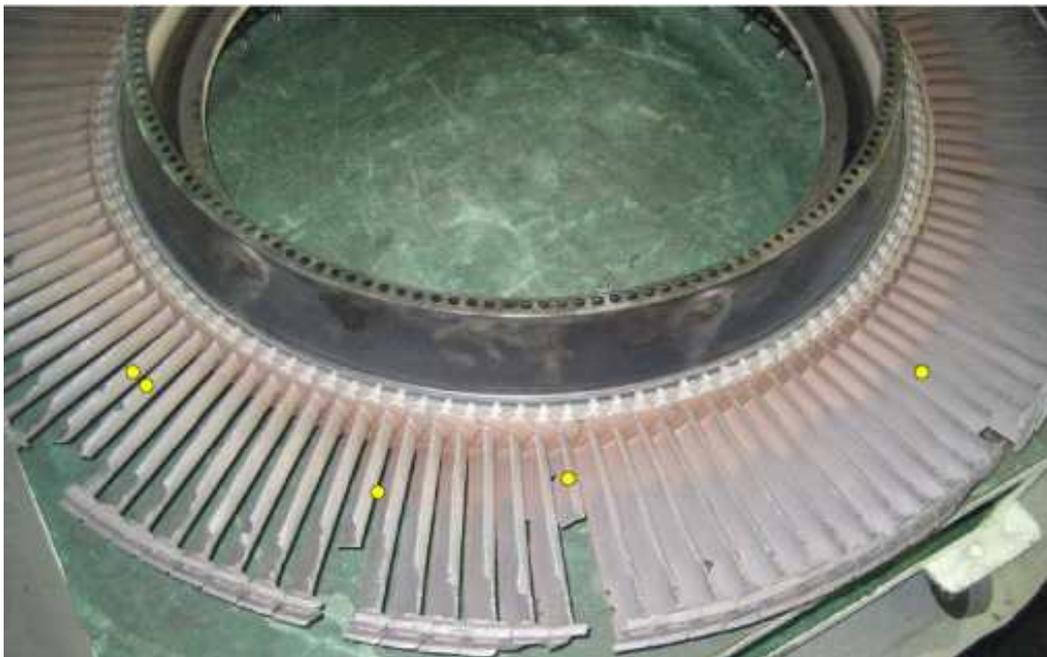
[Figure 20] 4th-Stage LPT Rotor

All 130 T4 blades were inside the disk blade slots, but five T4 blades within 90 degrees exhibited airfoil fractures at mid-span, between 50% to 80% of airfoil length from the platform. Other blades showed material loss mainly along the outboard circumference. The T4 disk was intact.

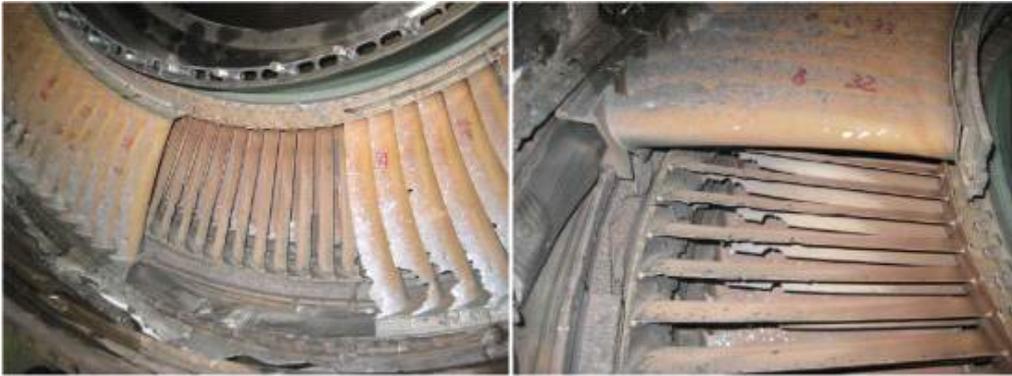
[Figure 21] 5th-Stage LPT Vanes

Three adjacent 5th-stage LPT (T5) vane clusters, No. 29, 30, and 31, were liberated from their assembly positions, which were directly adjacent to the largest LPT case breach location. The fragments of the two liberated clusters were recovered from the large torn area of the LPT case.

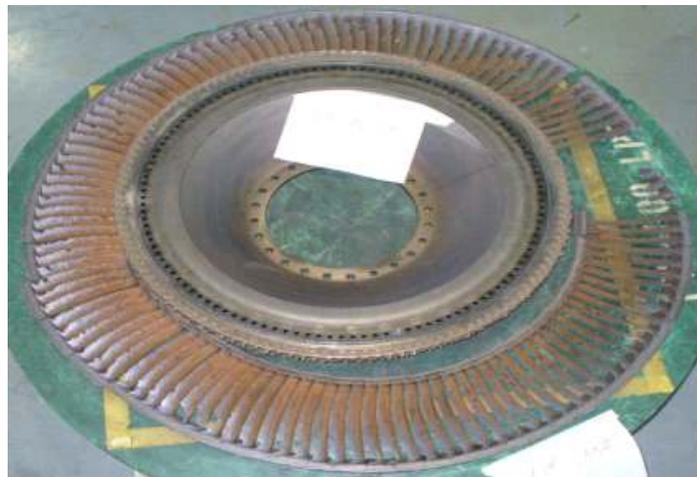
[Figure 22] 5th-Stage LPT Rotor and Vanes

All 118 T5 blade airfoils fractured adjacent to the platform. All blade roots remained in the disk blade slots. The T5 disk was intact.

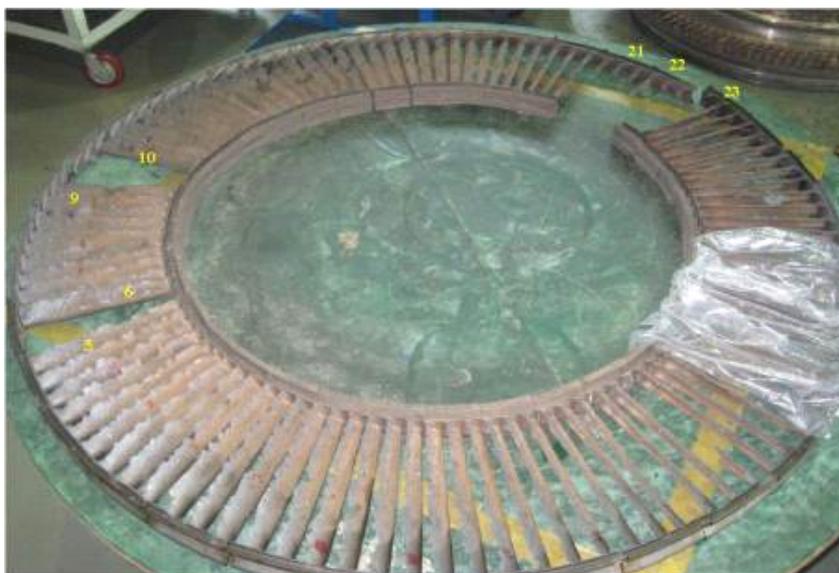
[Figure 23] 6th-Stage LPT Vanes

Three adjacent 6th-stage LPT (T6) vane clusters, No. 21, 22, and 23, were liberated from their assembled positions, and were recovered from the debris trapped forward of the 7th-stage LPT (T7) vanes. The front outboard hook in the outer shroud of all liberated T6 vane clusters was fractured, and the fragments were recovered from the debris that trapped before the T7 vanes.

Multiple T6 vane airfoils were fractured and missing as follows: two vane airfoils from cluster No. 6; one vane airfoil from cluster No. 9; two adjacent vane airfoils from cluster No. 10; one adjacent airfoil from cluster No. 23; and all three airfoils and inner shrouds from clusters No. 21 and 22.

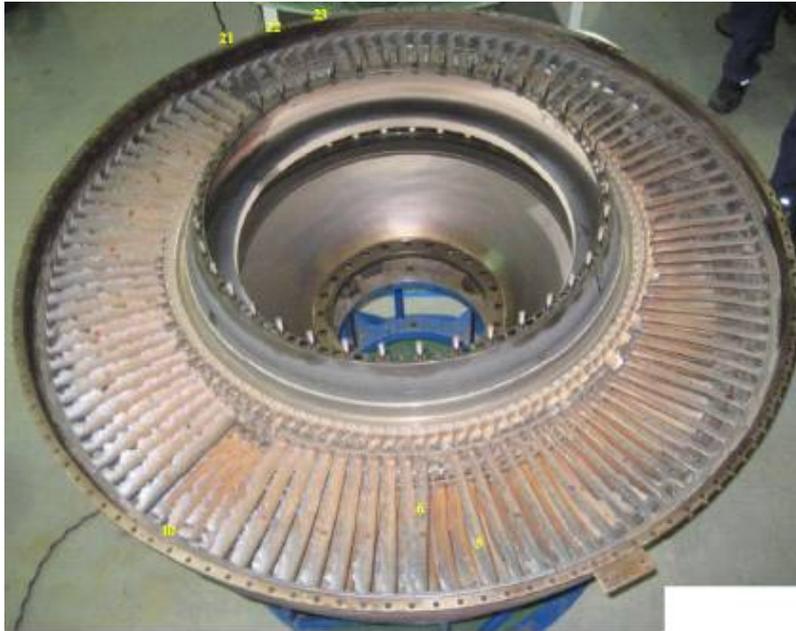
[Figure 24] 6th-Stage LPT Rotor

All 128 6th-stage LPT (T6) blade airfoils were fractured outboard of the platform within 20% of airfoil length. All blade roots remained in the disk blade slots. The T6 disk was intact.

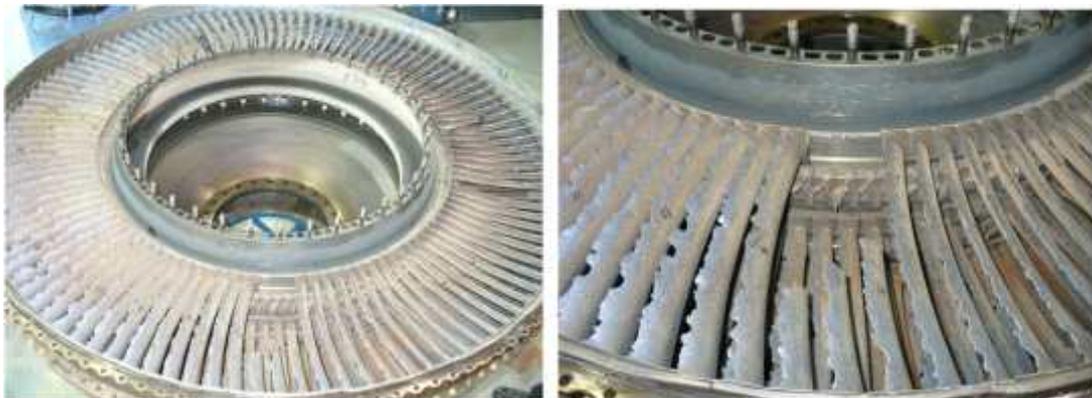
[Figure 25] 7th-Stage LPT Vanes

Multiple 7th-stage LPT (T7) vane airfoils were fractured and missing. Single airfoils were fractured and missing in clusters No. 24, 34, and 37. All three airfoils were fractured and missing in cluster No. 8, with the inner shroud section missing and the outer shroud still in the assembled position.

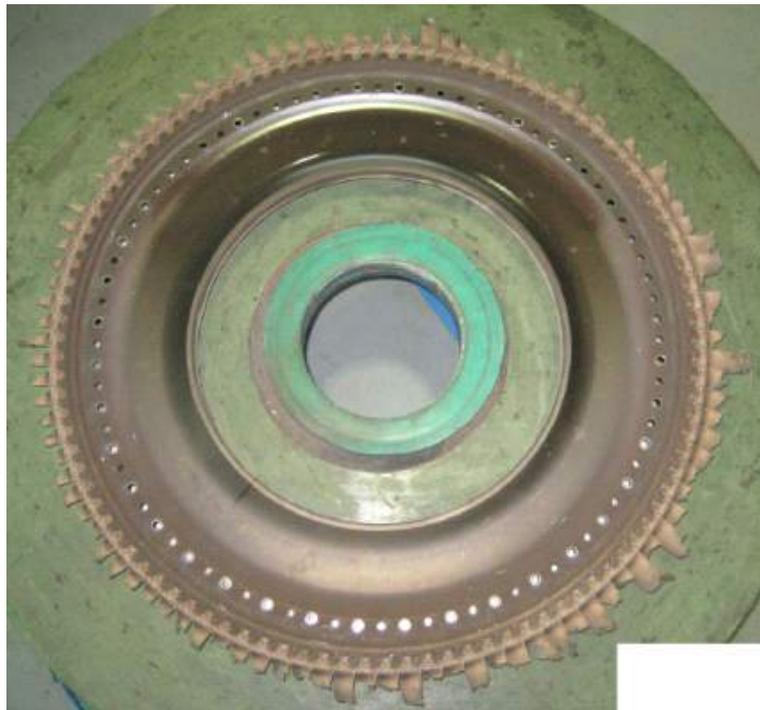
[Figure 26] 7th-Stage LPT Rotor

All 102 T7 blade airfoils were fractured and missing outboard of the platform within 20% of spanwise length from platform. All blade roots remained in the disk blade slots. The T7 disk was intact.

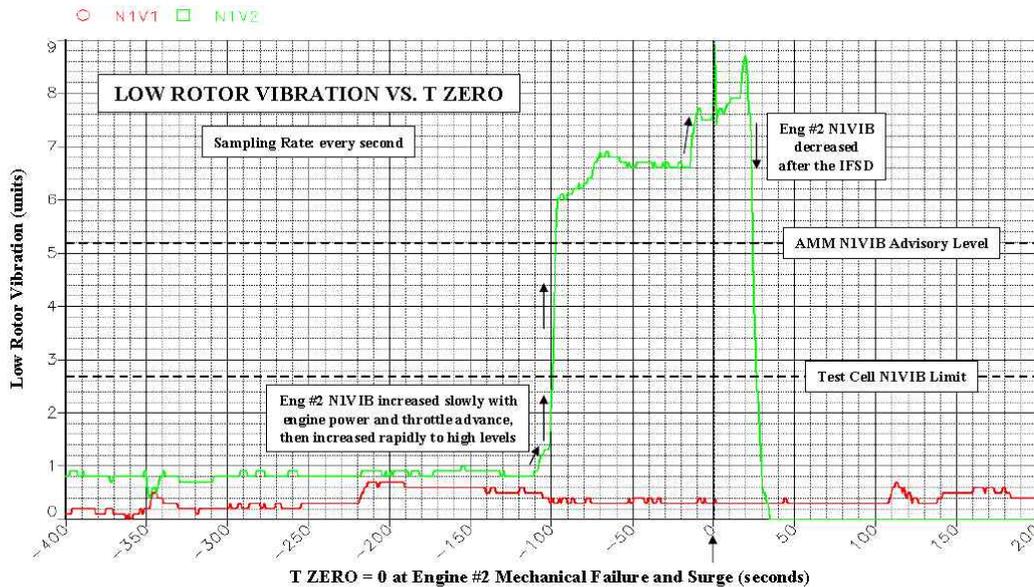
[Figure 27] N1 Vibration

The data showed that the mechanical failure and surge<sup>20)</sup> occurred during climb at an altitude of 11,900 ft and 260 kts CAS when the airplane was approximately 5 minutes after takeoff from Incheon Airport. As shown in [Figure 27], about 100 seconds prior to the mechanical failure and surge, N1 vibration increased significantly to above the AMM<sup>21)</sup> N1 vibration advisory level, 5.2 cockpit units.

When the throttles were increased, all engine parameters reflected the increase in engine power, and N1 vibration began a gradual increase before the sharp, significant increase that reflected the onset of engine damage. Afterward, N1 vibration maintained a level of at least 6.6 cockpit units, then showed another step increase just before the final mechanical failure and surge.

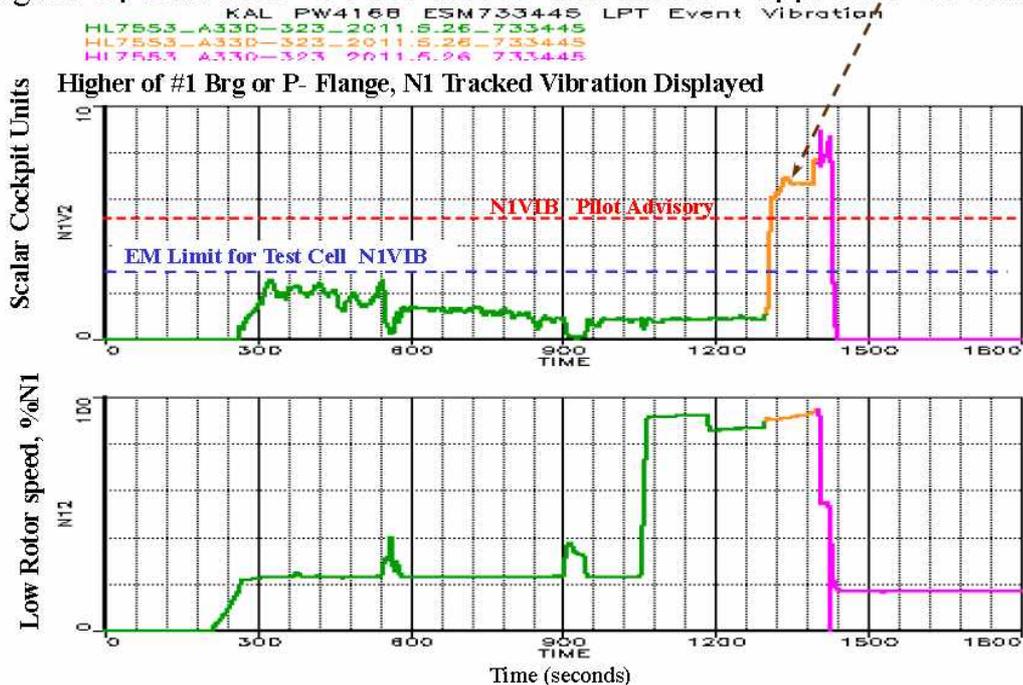
[Figure 32] Engine Vibration Analysis

Only "precursor" vibration observed was the Takeoff Report snapshot, where elevated P flange broadband vibration of 3.66 IPS suggested that vanes had rubbed on blades inside the LPT.

Engine Operated for >90 sec at LPT Unbalance = approx. 3 T4 blades

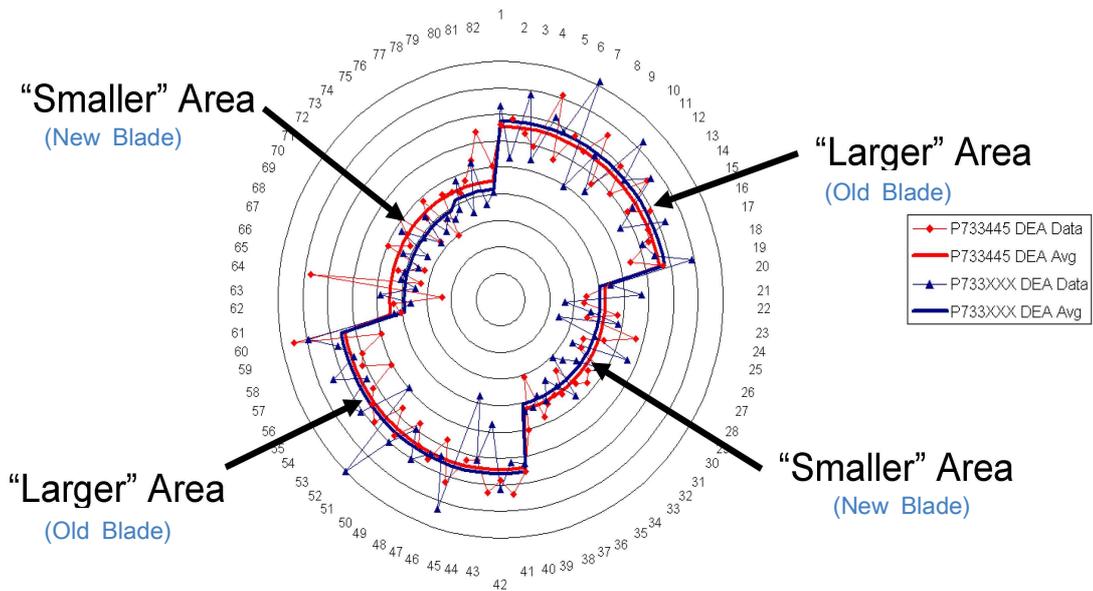
[Figure 33] T2 Blade Aerodynamic Pattern

Although this method result in a balanced rotor for rotor dynamics, it has been found to result in an aerodynamic pattern where a twice per revolution (2E) pressure pulses exit the rotor due to the area variation. This 2E pressure pulse has been found to result in excitation of LPT hardware which can increase wear and vibratory stresses. Previously an engine was tested at P&W with a 2E pattern and test data confirmed wear and vibrations in the LPT.

A comparison of the flow areas from the previously tested P&W engine to the P733445 event engine is shown in [Figure 33].

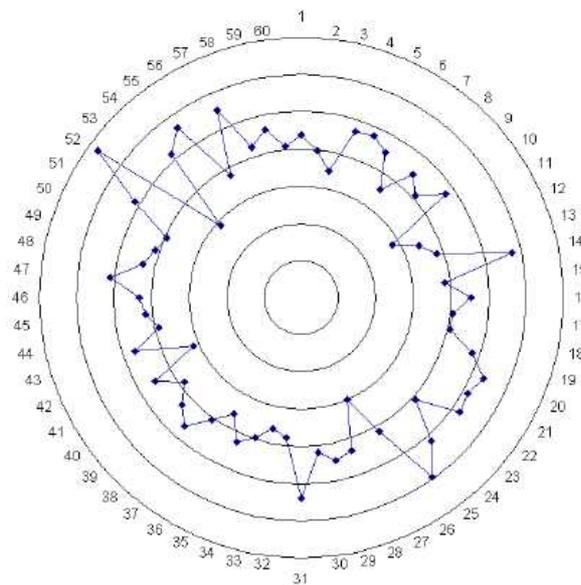
[Figure 34] T1 Blade Aerodynamic Pattern

Although the same Indian Trail method as the T2 blades was used to assemble the T1 blades, inspection revealed no apparent variations that would have caused aerodynamic vibration excitation since all new blades were installed, as shown in [Figure 34].

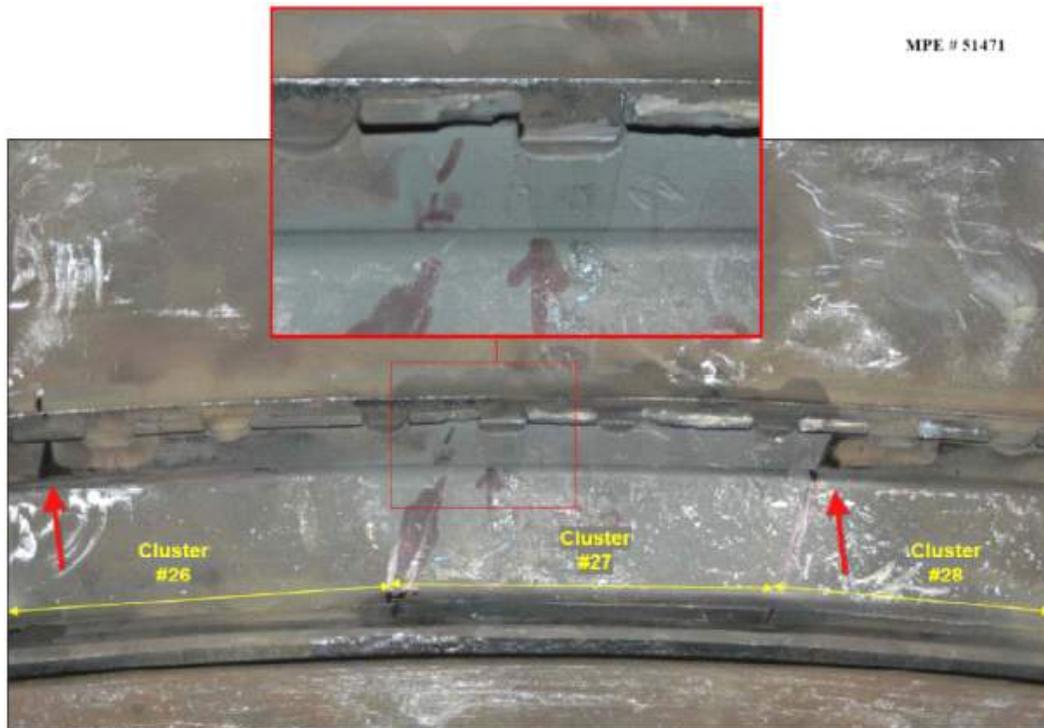
[Figure 35] LPT Case at T4 Vane Clusters Locations

As shown in [Figure 35], it was observed that there were T4 vane cluster contact marks (red arrows) on the radial surface in the LPT case just forward of

the aft rail at all T4 vane clusters locations except at the location of the missing No. 27 T4 vane cluster.

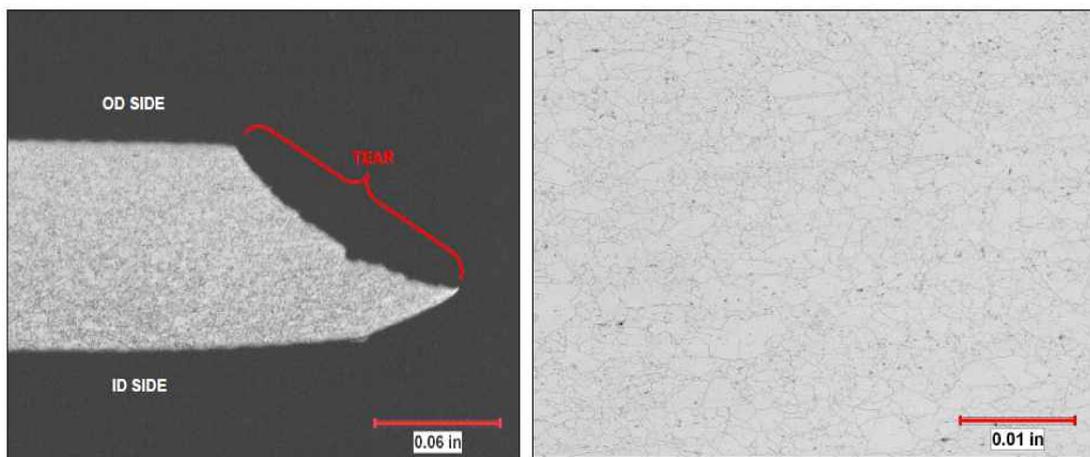
[Figure 37] Microstructure of the LPT Case

Microstructure of the case wall at the tear appeared typical of properly processed AMS 5707 material. Grain size at the tear met the drawing requirement. Energy Dispersive Spectrometer (EDS) analysis of the section revealed a composition consistent with Waspalloy.

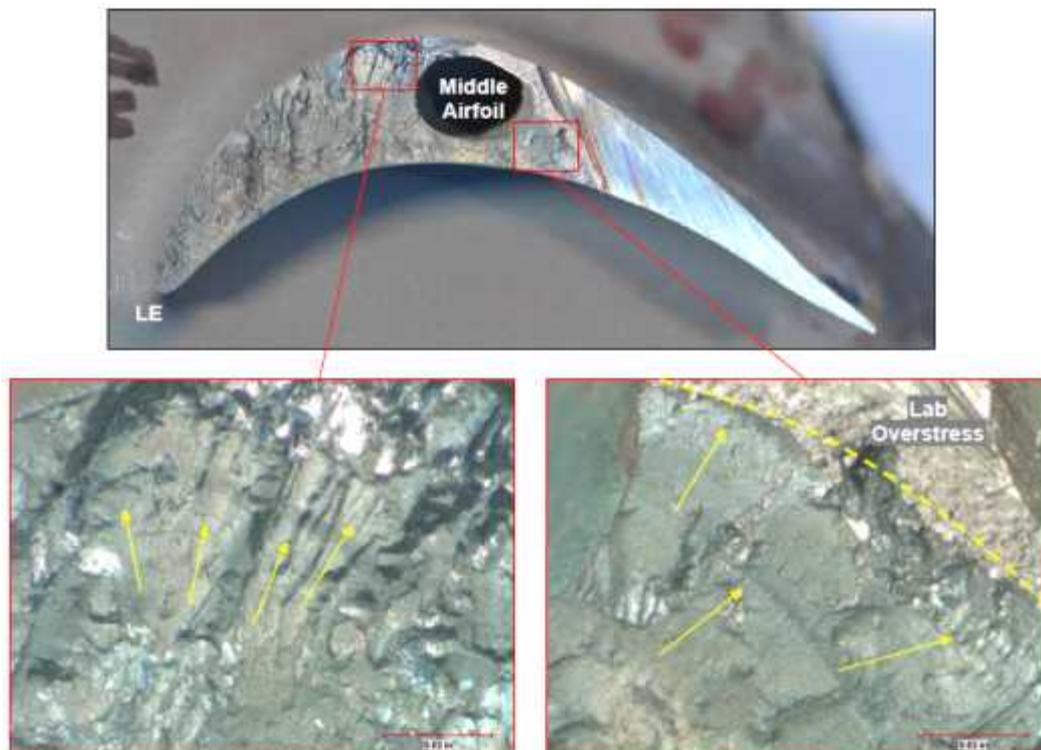
[Figure 38] Middle Airfoil's Crack in the No. 25 Cluster

As shown by the yellow arrows in [Figure 38], examination of the middle airfoil's chordwise crack in the No. 25 cluster revealed fatigue which progressed from the airfoil leading edge. Also, the fracture surface was heavily oxidized.

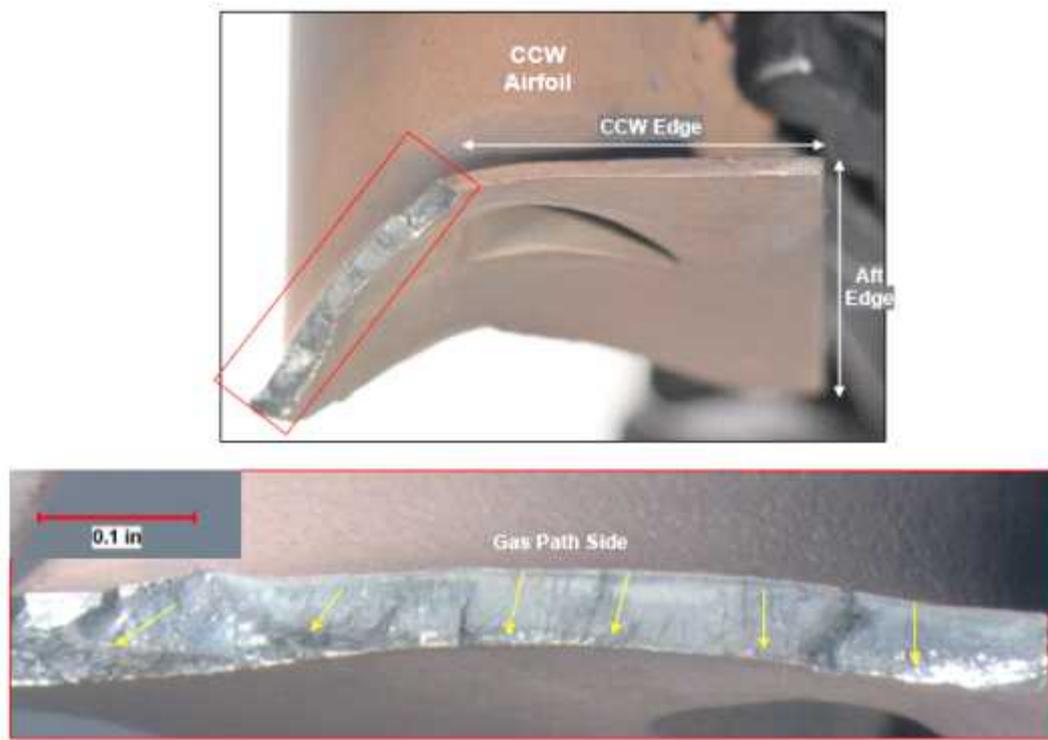
[Figure 39] Inner Shroud Cracks in the No. 26 Cluster

Examination of the inner shroud cracks in the No. 26 cluster revealed fatigue, which progressed primarily from multiple origins along the gas path surface of the inner shroud.

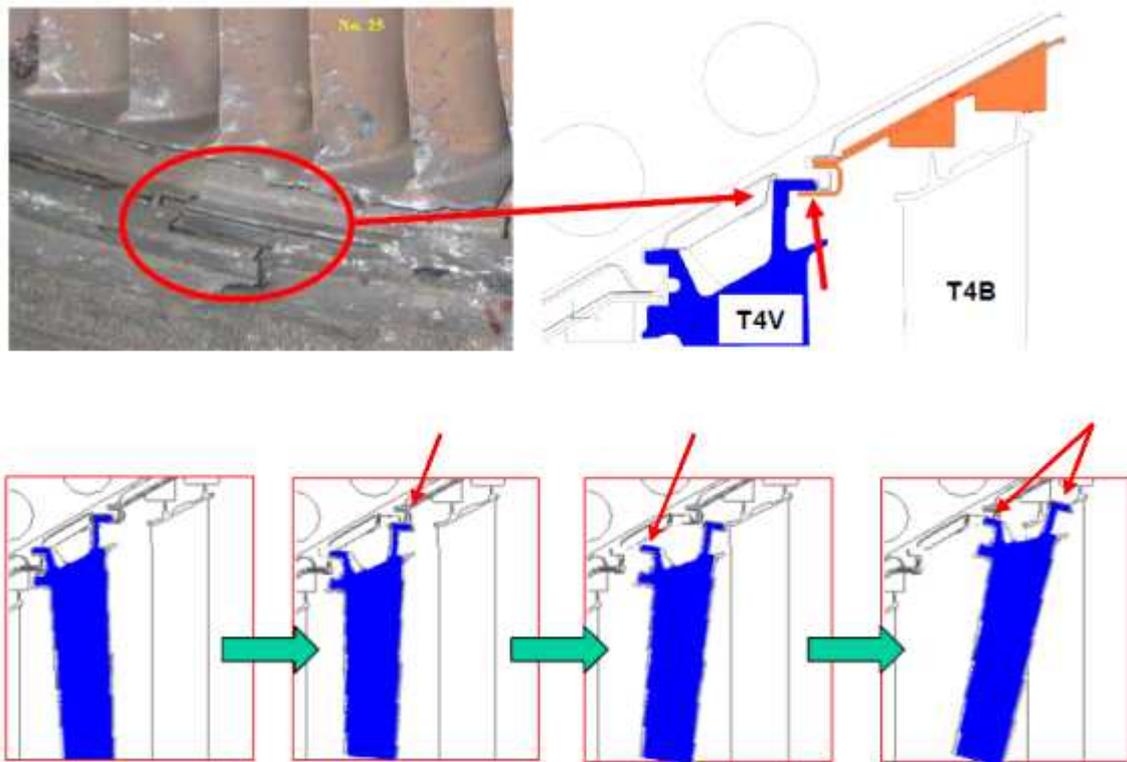
[Figure 40] T4 Vane Cluster Liberation Process

- ② Multiple other T4 vane clusters also exhibited pin-pocket wear-through, rear outboard foot wear, and cracking in the airfoil and inner shrouds. Those are indicative of excessive vibration in the T4 vane clusters.
- ③ According to the data previously generated from P&W's engine test, an aerodynamic pattern in the T2 rotor that could introduce significantly high 2E excitation in the LPT module was found.
