COMMAND OF AERONAUTICS
AERONAUTICAL ACCIDENT INVESTIGATION AND
PREVENTION CENTER

FINAL REPORT
A - Nº 019/CENIPA/2013

OCCURRENCE: ACCIDENT
AIRCRAFT: PR-NOB
MODEL: L410
DATE: 13 JULY 2011

This is the Final Report of the 13 July 2011 accident involving the model L410 aircraft, registration PR-NOB. The accident was classified as inflight engine failure.

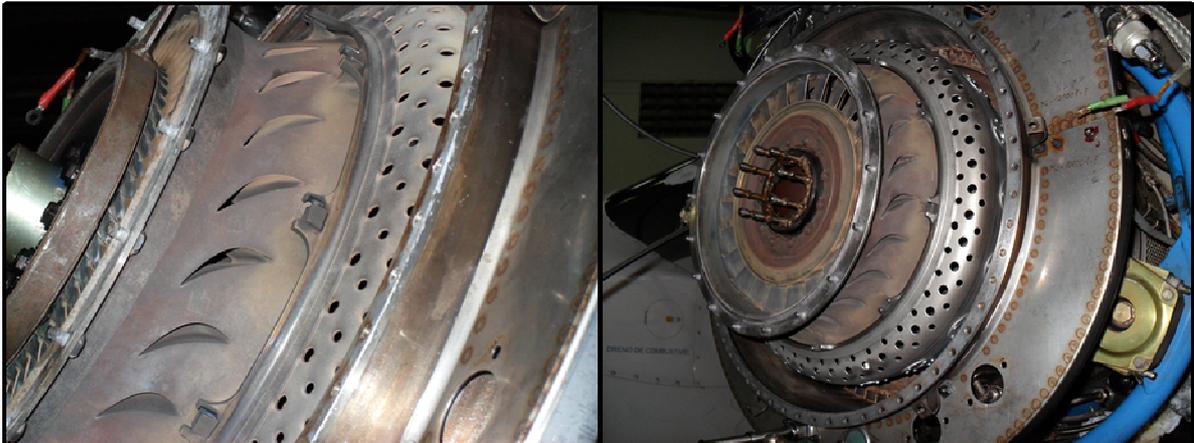
Figure 3 – Removed and installed combustion chambers.

Due to the evolution in the level of internal wear of the engine number 1 combustion chamber support (Figure 3), it was decided that the item would be replaced during the 10 July 2011 inspection in the Recife NOAR facilities.

In this service, the GE Aviation Czech technicians replaced the following components: combustion chamber support (they removed the PN-239.5 M601, SN 024, and

installed the PN-255.7 M601, SN 4282), and the oil cap PN-M601 308.3 (they removed the SN 4981, and installed the SN 3651).

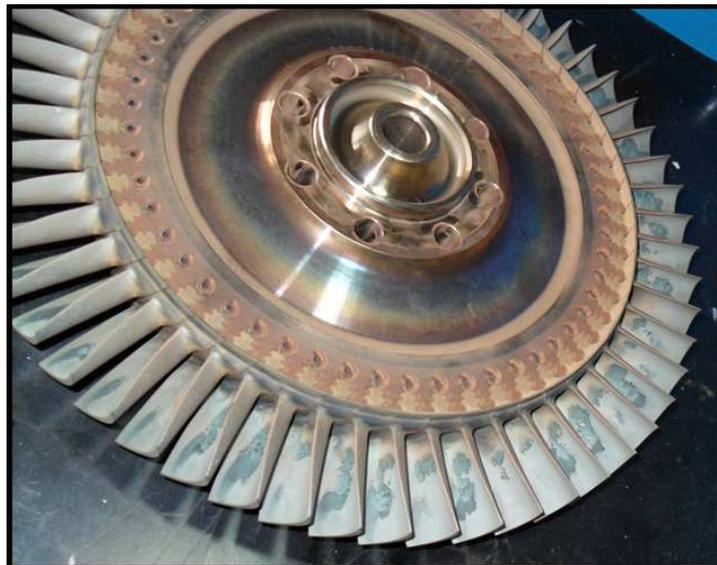
Figure 4 - Compressor turbine disk removed on account of corrosion at high temperatures.

During the execution of this service, the GE Aviation Czech technicians confirmed that the Gas Generator Turbine (GGT) Rotor Assembly of the turbine compressor removed from engine serial number 101-001 exhibited blade corrosion beyond the limits prescribed in the manual (Figure 4), and it was replaced.

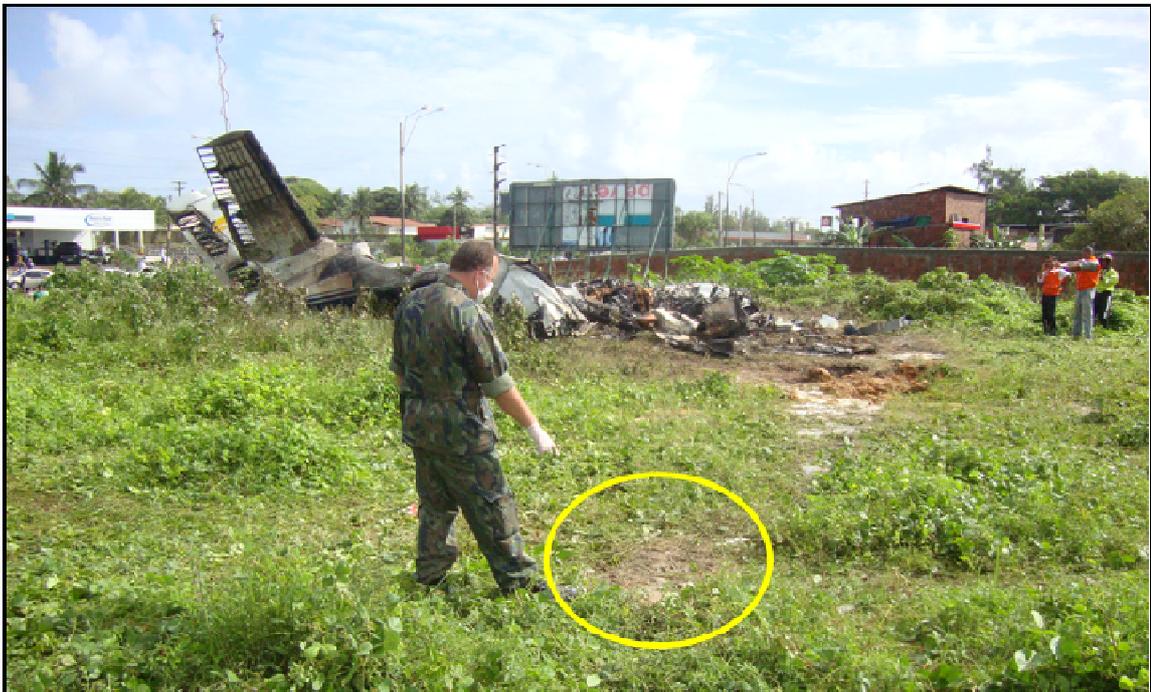
Figure 19 – Marks of the first impact.

The marks (Figure 19) of the first impact (at a few meters from the point at which the aircraft stopped) were possibly made by the right engine, which caused the right wing to rupture close to the fuselage, moving to the other side and coming to a rest to the left side of the aircraft.

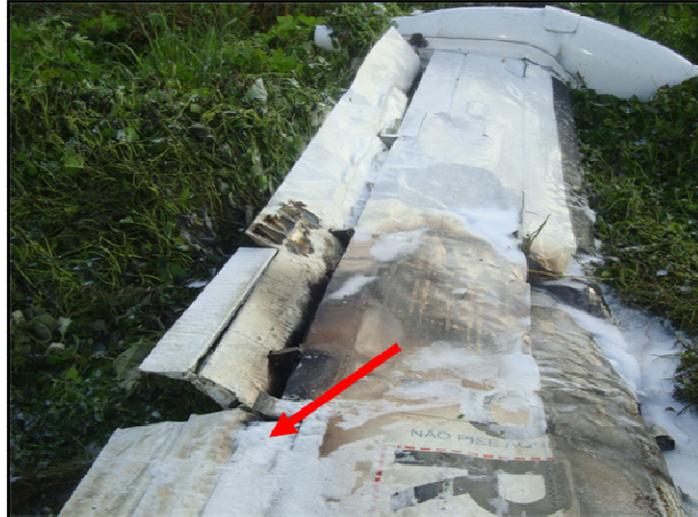
Figure 20 – Left wing flap 18-degree deflection (the same as the one of right wing).

The flaps were found in an 18-degree deflected position (Figure 20).

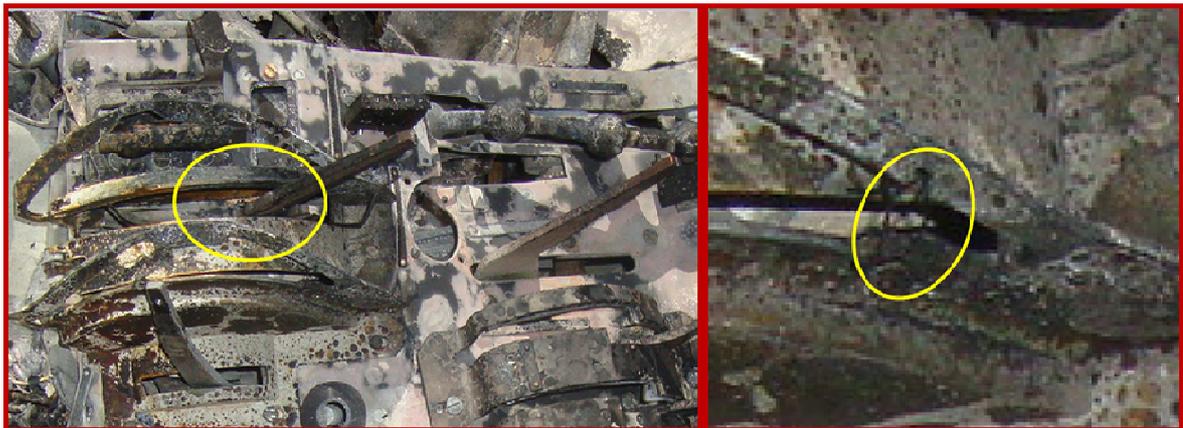
Figure 21 – Inviolable seal of the right engine power control lever.

In the central console, it is possible to identify the presence of an advance seal in the power control lever of the right engine, indicating that the resource of extra power was not utilized by the crew (Figure 21).

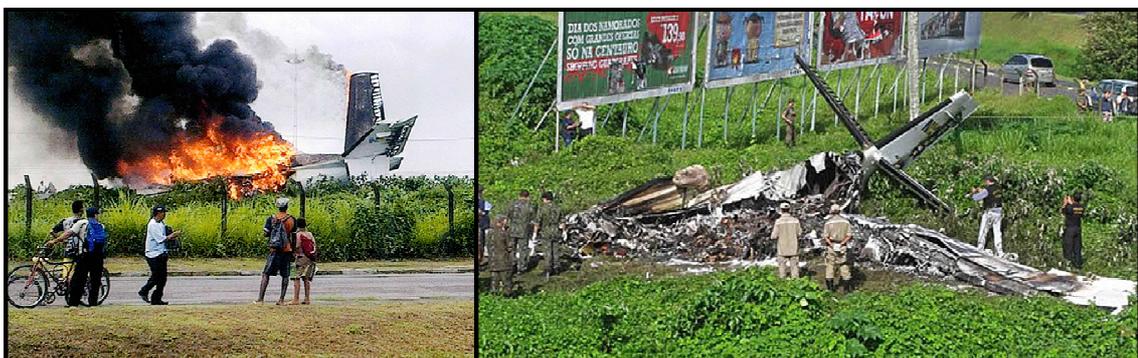
Figure 22 – The aircraft on fire, and after the fire was extinguished.

The aircraft caught fire immediately after impact (Figure 22), which occurred at 0654 local time. There were approximately 980Kg of fuel in the aircraft tanks.

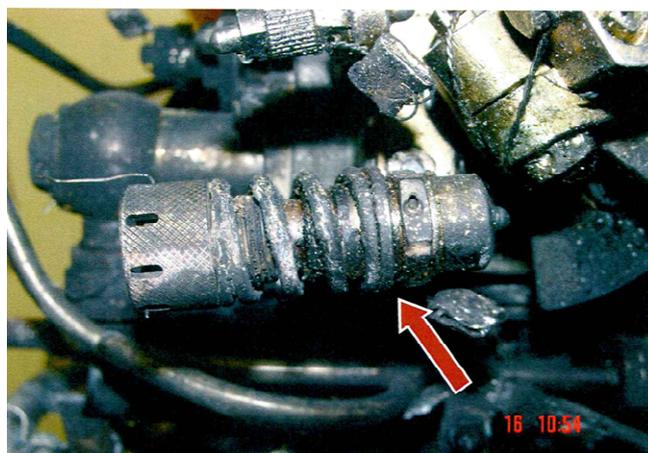
Figure 23 – FCU extra power latch with the seal ruptured.

Figure 23 shows the extra latch of the fuel control unit (FCU) broken. Since the wire seal of the power control lever was intact, it is not possible to determine when or how the FCU extra latch was broken.

Data from the SSFDR are not compatible with an increase in power of the engine number 2, on account of the use of this extra latch.

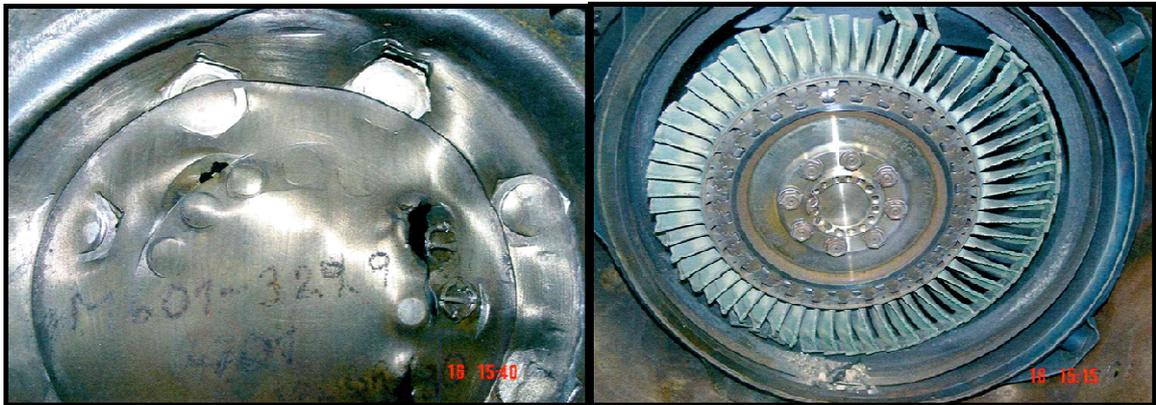
Figure 24 – Internal marks on the left engine.

The marks of impact found in the diaphragm and the fractures in some of the power turbine blades (Figure 24) also indicate that the left engine was not functioning at the moment of impact.

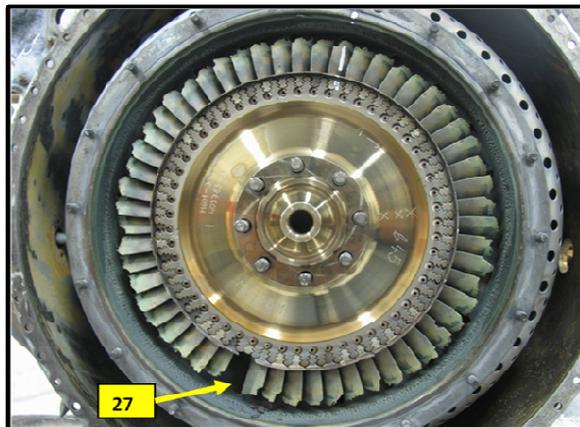
Figure 25 – Left engine GGT disk with the position 27 blade fractured.

In this engine, it is possible to observe the separated GGT blade S/N T52A175 which had occupied the position 27 in the GGT disk, as can be seen in Figure 25.

The left engine GGT disk had the same diameter measure as the original one of manufacture, indicating that it had not suffered any significant growth or plastic deformation on account of overspeed, after the breakage of the blade.

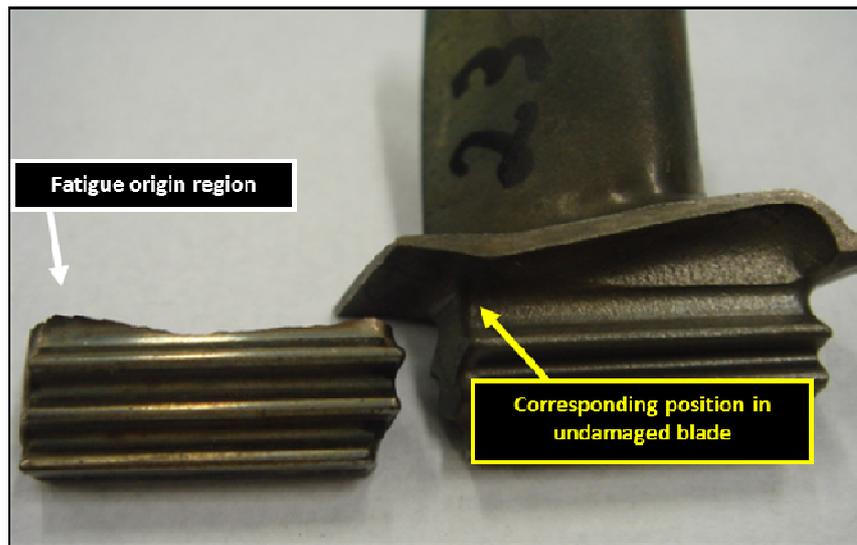
Figure 26 – Beginning of fatigue in the S/N T52A175 blade, and analogous image of an undamaged blade.

In Figure 26, the white arrow (on the left) shows the region where the fracture of the S/N T52A175 blade began, whereas the yellow arrow (on the right) shows the corresponding region of an undamaged blade.

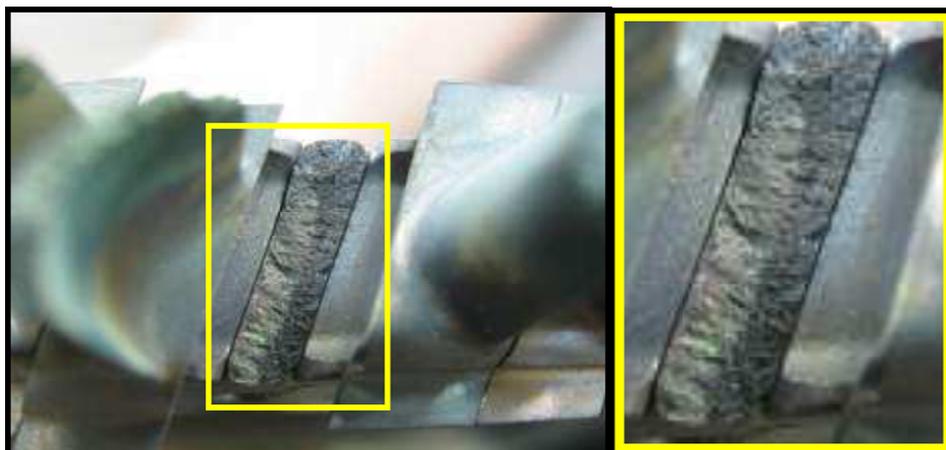
Figure 27 – View of the fractured area in the S/N T52A175 blade.

In Figure 27, it is possible to see the distinction between the area in which the fatigue spread and the area of final tensile overload.

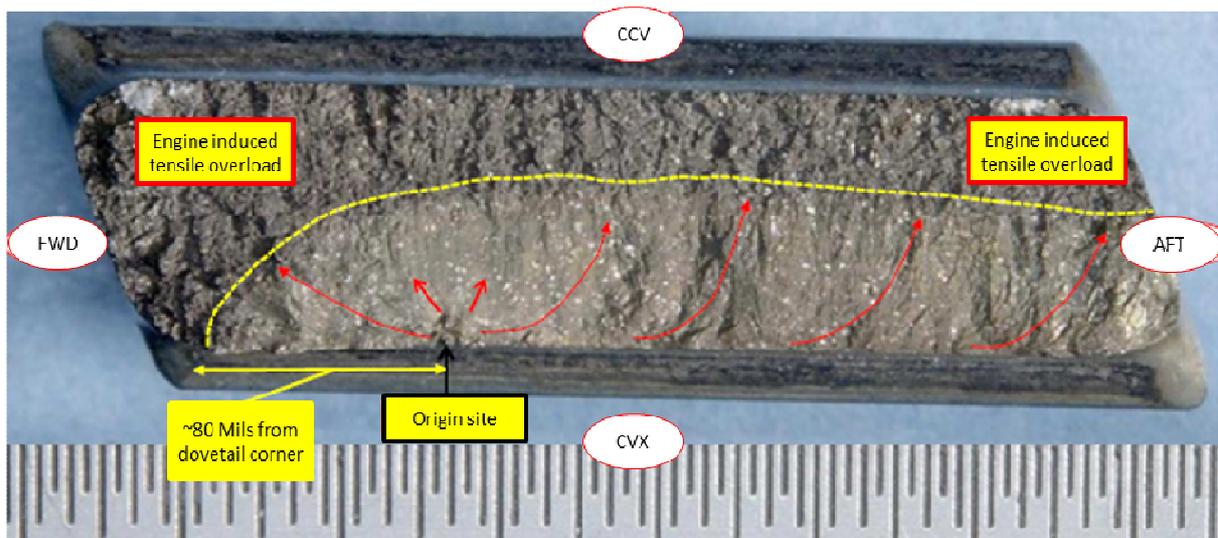
Figure 28 – View of the fatigue propagation in the S/N T52A175 blade.

The fracture of the S/N T52A175 blade occurred in the region of the blade shank, originating from an incipient, faceted subsurface fatigue, located close to the trailing edge of the blade, on its convex side. The propagation of the crack reached approximately 50% of the blade shank cross-section before it separated due to tensile overload mechanisms (Figure 28).

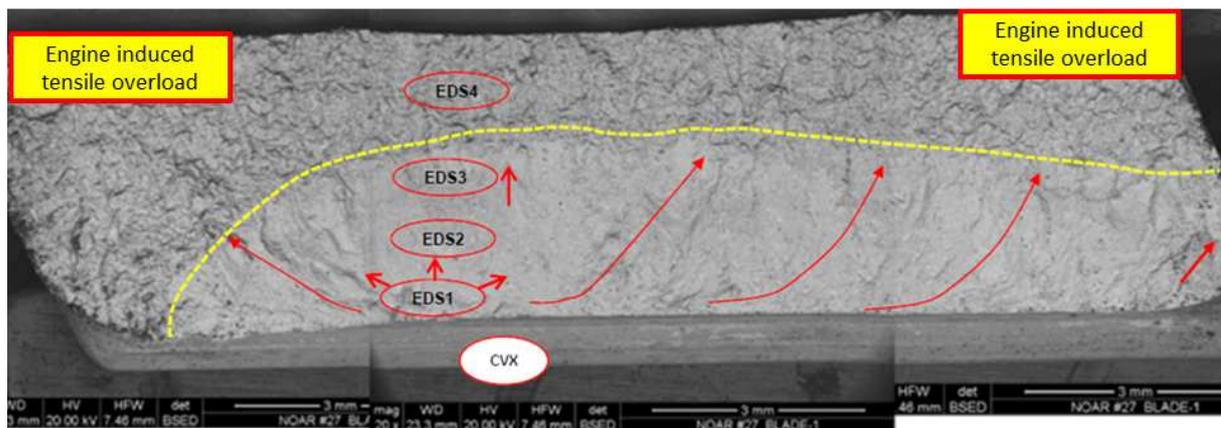
Figure 29 – Fractographic exams.

Detailed stereoscopic examinations did not reveal any evidence of other cracks in the shank area of the other blades of the left disk, or irregular marks, or unusual marks on the faces of the blades.

By means of fractographic examinations, the fracture surface of the S/N T52A175 blade was evaluated in the Scanning Electron Microscope (SEM) in the unclean condition, in order to assess which types of remains were present on the surface in various places, as shown in Figure 29. The Energy-Dispersive X-ray Spectroscopy (EDS) obtained spectrums of the fatigue regions (locations EDS1, EDS2 AND EDS3) and of the region induced by engine tensile overload (EDS4).

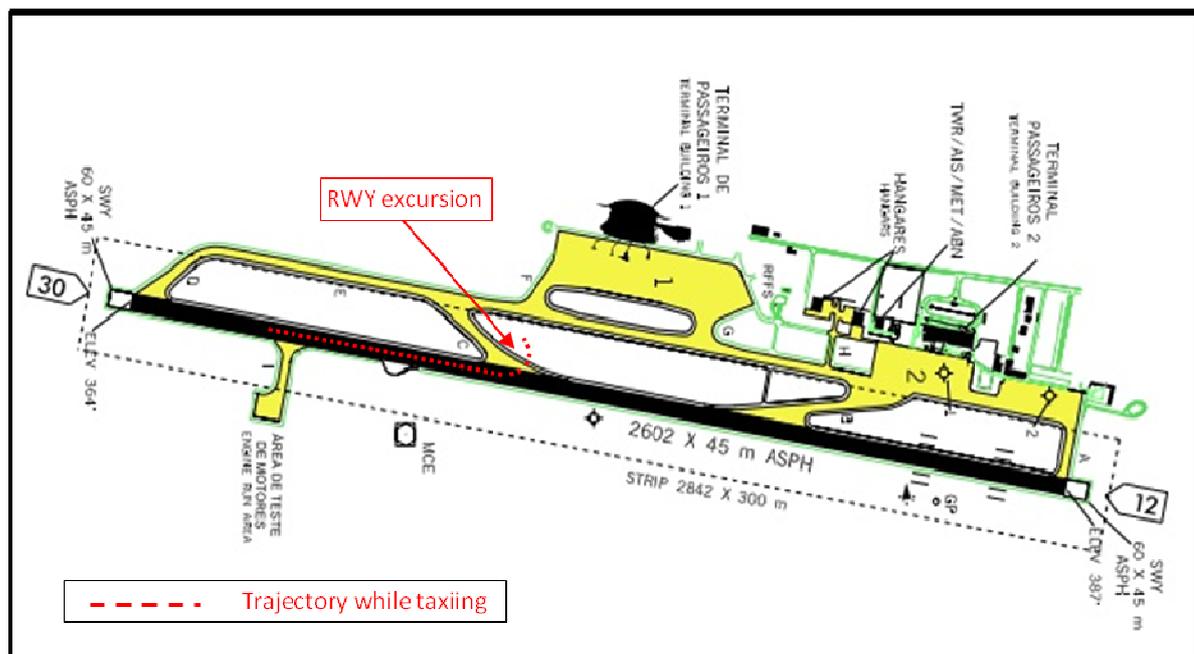
Figure 46 – Runway excursion in SBMO.

On the night of 27 October 2010, the PIC was in the Flight 4878 from SBRF to SBMO. At 2125, while taxiing after the landing run, the aircraft excused from the runway and stopped in a non-paved area (Figure 46). The PIC said that he had difficulty sighting the taxiway signage.

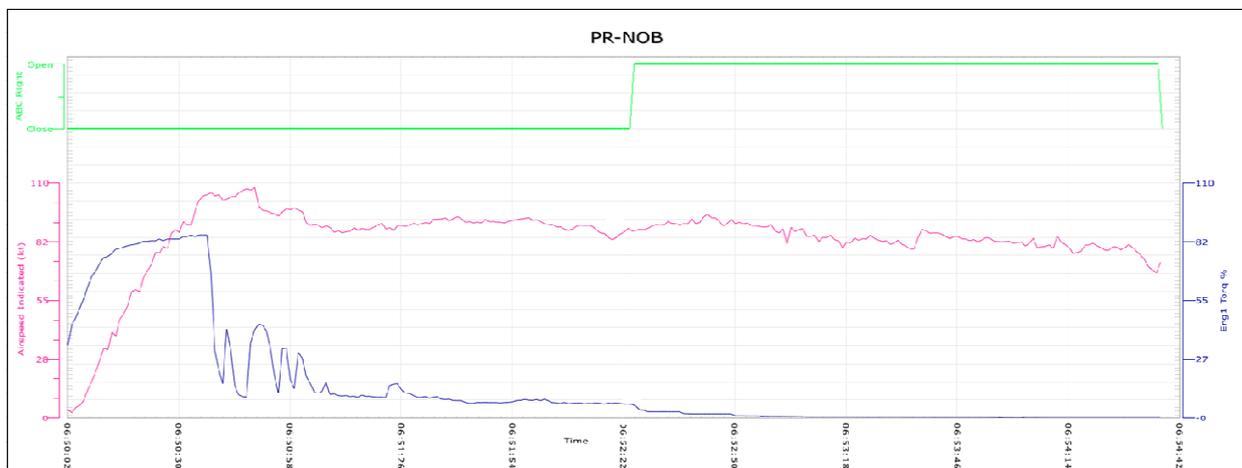
Figure 50 – Airspeed, engine number 1 torque drop and ABC opening.

With the information retrieved from the FDR, the graph shown in Figure 50 was made. From these parameters, it is possible to see that after 65 seconds (at 06:51:04) after the engines began to accelerate for the takeoff, the torque of the left engine dropped and remained below 24%, when the speed was below 95kt. Only 81 seconds later (at 06:52:25) did the ABC panel open.
