AIRCRAFT ACCIDENT REPORT

BH 2011/07/14/F

Report on the Accident Involving
Bristow Helicopters, Registration 5N-BMM
at Port Harcourt International Airport,
River State. Nigeria
On 14th July 2011

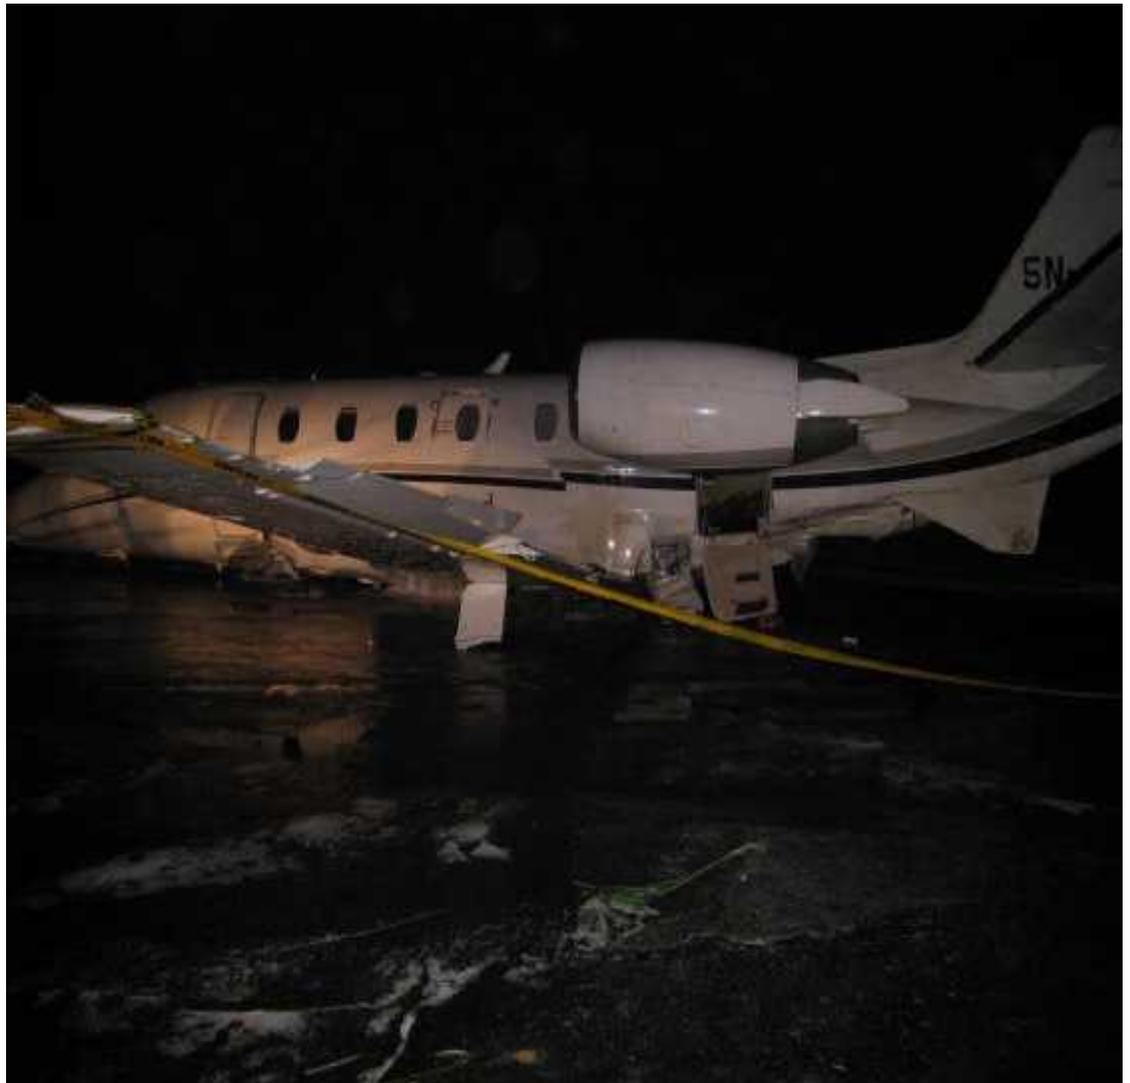
The aircraft was substantially damaged; see fig 1.3a-c below.

Fig 1.3a Damaged Aircraft

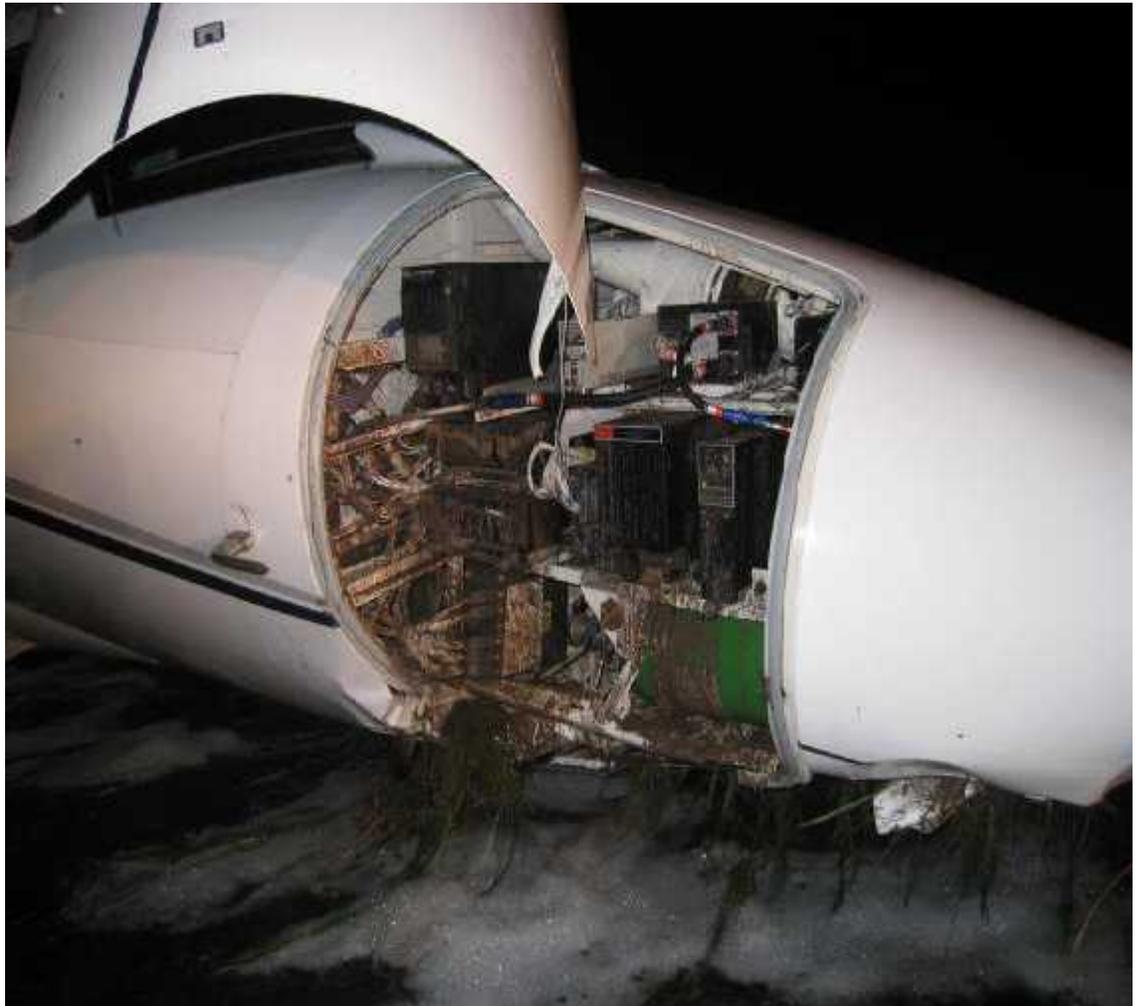
Fig 1.3b Damaged E and E Compartment

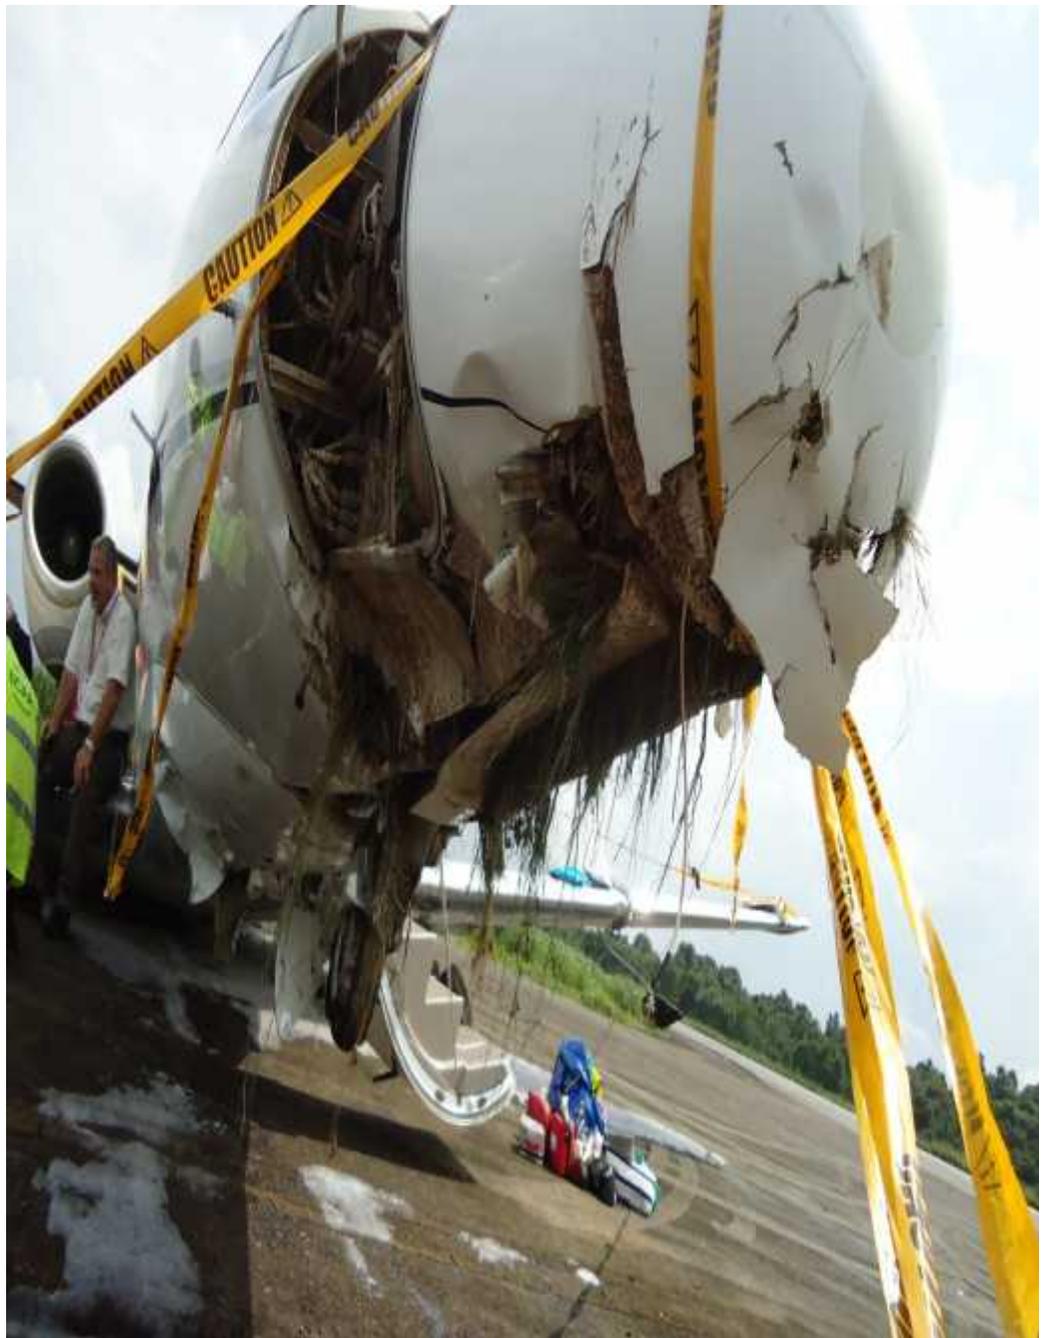
Fig 1.3c The damaged nose wheel and the Radome area

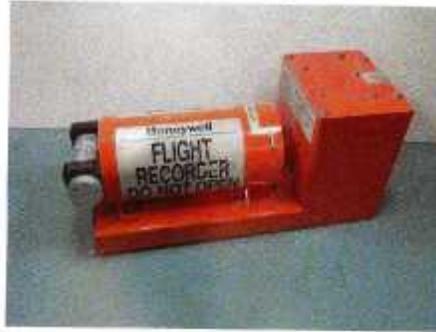
Figure 1. Exterior of flight recorder

Figure 1 shows the SSFDR was in good condition and the data were extracted normally from the recorder.

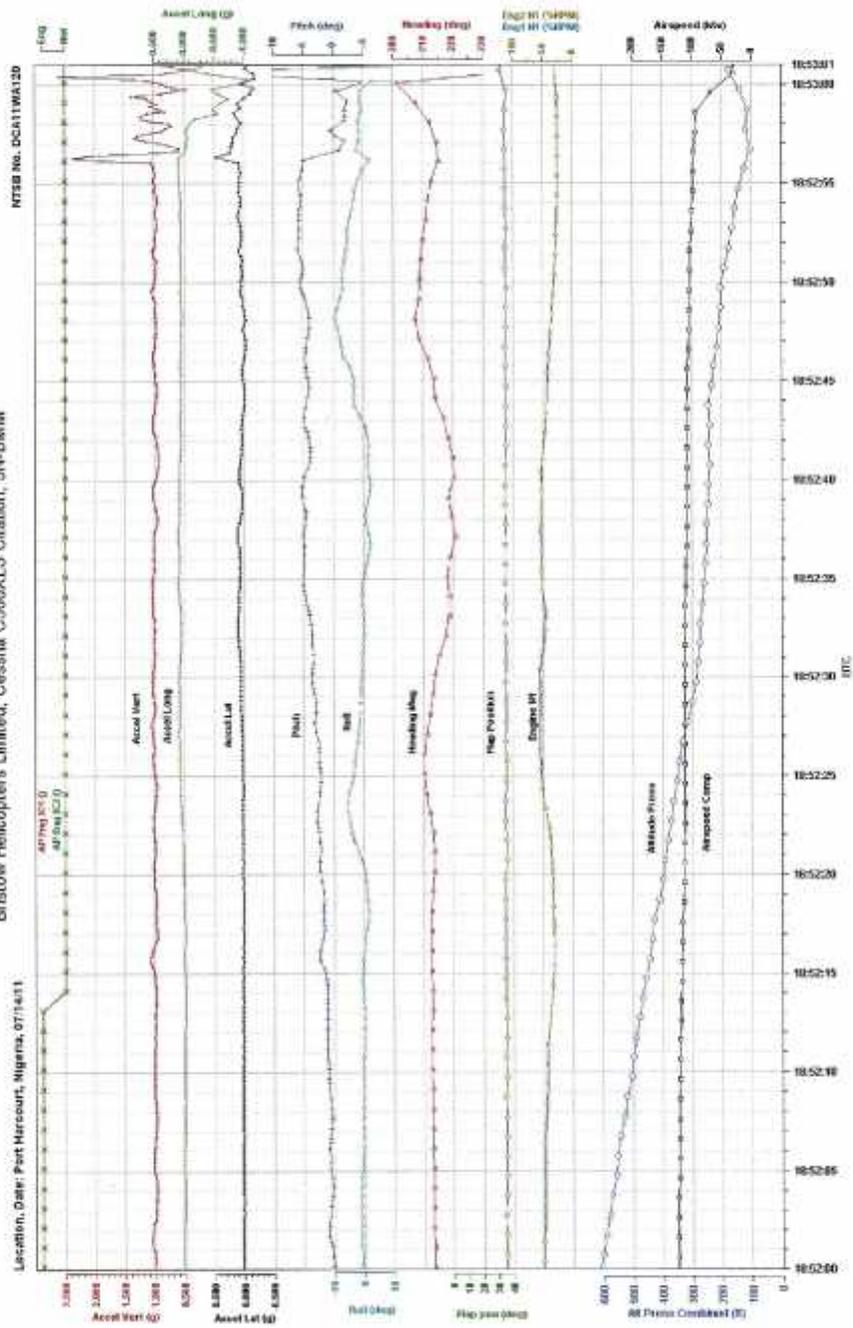
Figure 3. Basic parameters during landing
 Bristow Helicopters Limited, Cessna C560XLS Citation, 5N-BMM

After 18:52:56, there is a vertical acceleration spike of +2.43 g's, a lateral acceleration of +.46 g's, and a sharp decrease in recorded pitch angle from 5 degrees to -1 degree. This point most likely indicates aircraft initial touchdown. The recorded heading at this time was 215 degrees and the airspeed was 97 knots. The longitudinal acceleration values began to significantly decrease and the magnetic heading values indicated a left directional change. Four seconds later, a maximum vertical acceleration value of 2.58 g's and a maximum longitudinal acceleration value of -1.08 g's were recorded and the heading captured was 201 degrees. Following this point, the recorded values for most of the parameters on the SSFDR become suspect. There is a subsequent loss of recorded data for undetermined period of time. The SSFDR begins recording again for approximately 25 minutes. The data are consistent with the recorder being powered but not receiving valid systems input. Due to the nature of the impact and resulting damage, data recorded after 18:53 until the end of recording should be considered suspect and may not be representative of actual aircraft information.

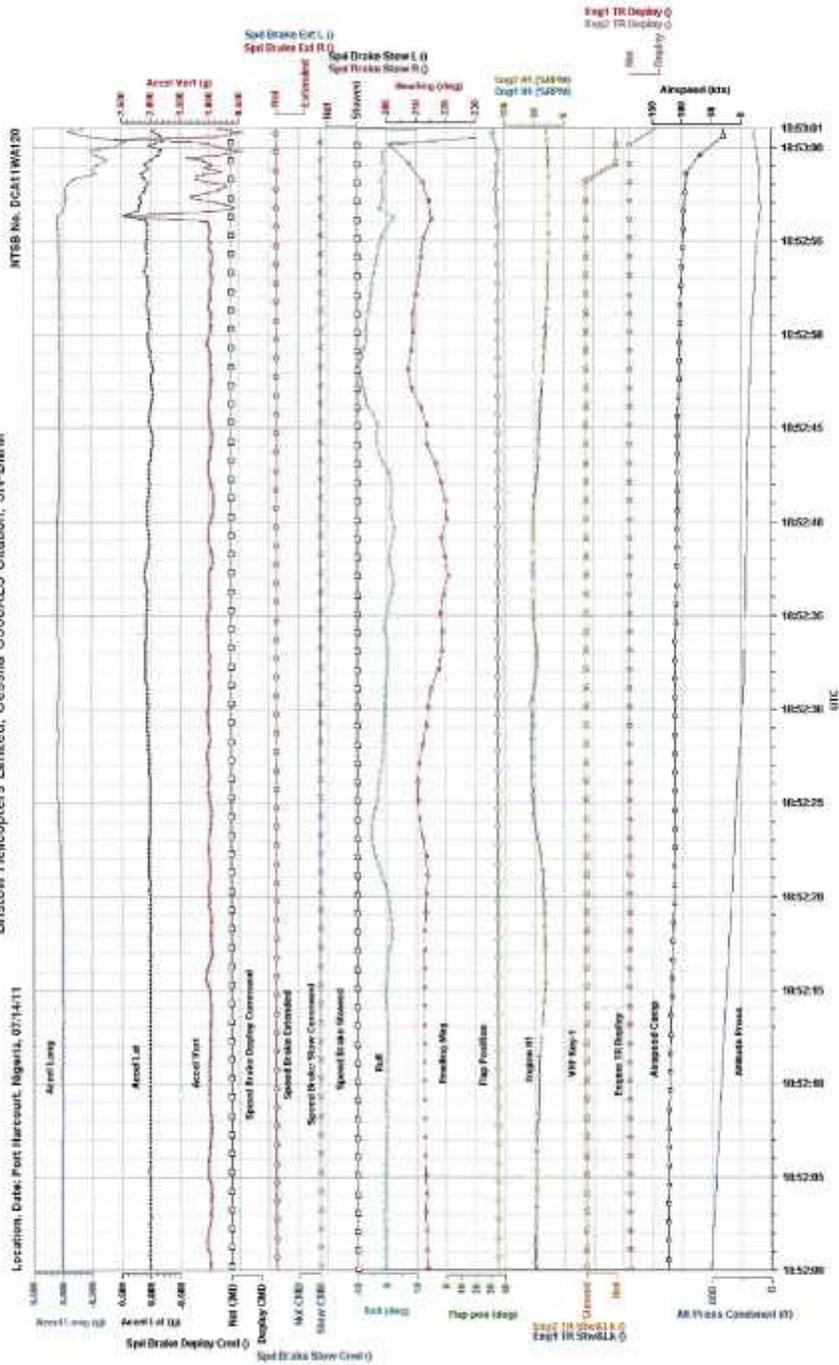
Figure 4. Discrete parameters during landing
Bristow Helicopters Limited, Cessna C560XLS Citation, 5N-BMM

The FDR data indicates that the aircraft took off about 17:56 GMT. The aircraft cruised at an altitude of 33,000 feet before beginning to descend at about 18:24. Around 18:49:50, the aircraft begins the final descent and the flaps transition to 35 degrees. The AP parameter transitions from engaged to not engaged at 18:52:14.

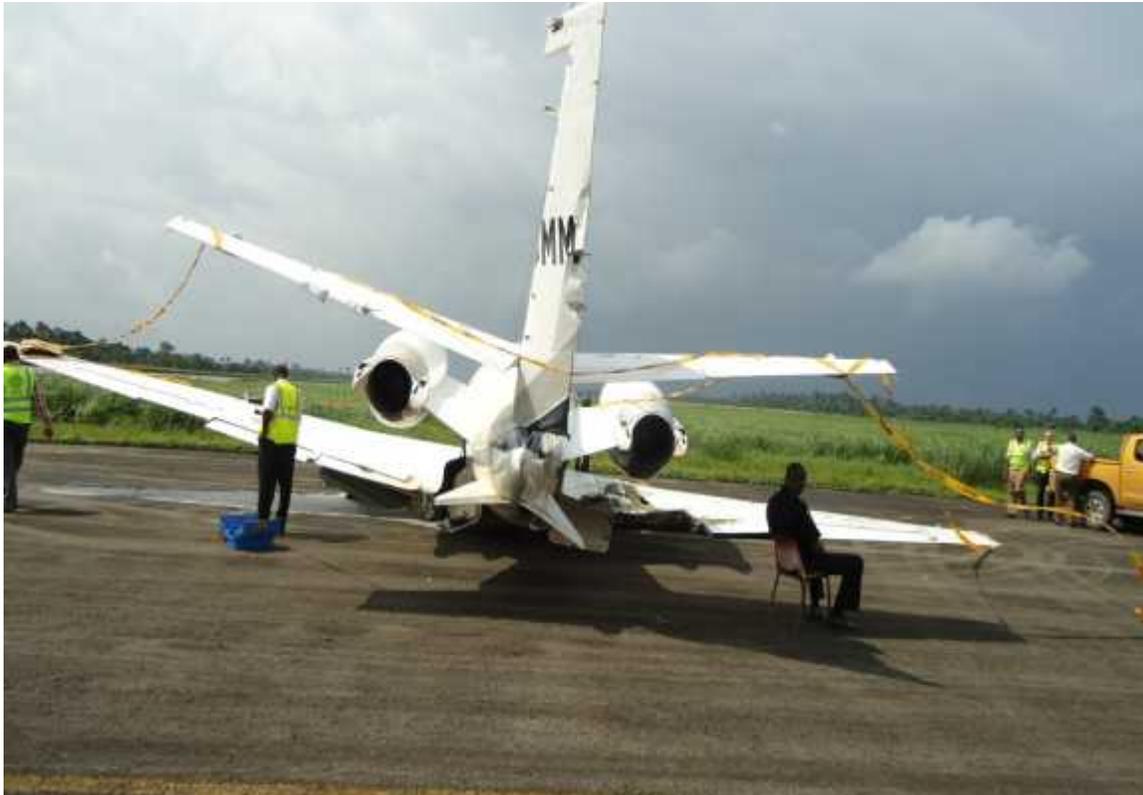
The aircraft was intact except for the right wheel assembly that sheared-off, the wheel was found about ten feet from where the aircraft came to rest. See fig 1.12a-b.

Fig 1.12a The wreckage of the Aircraft

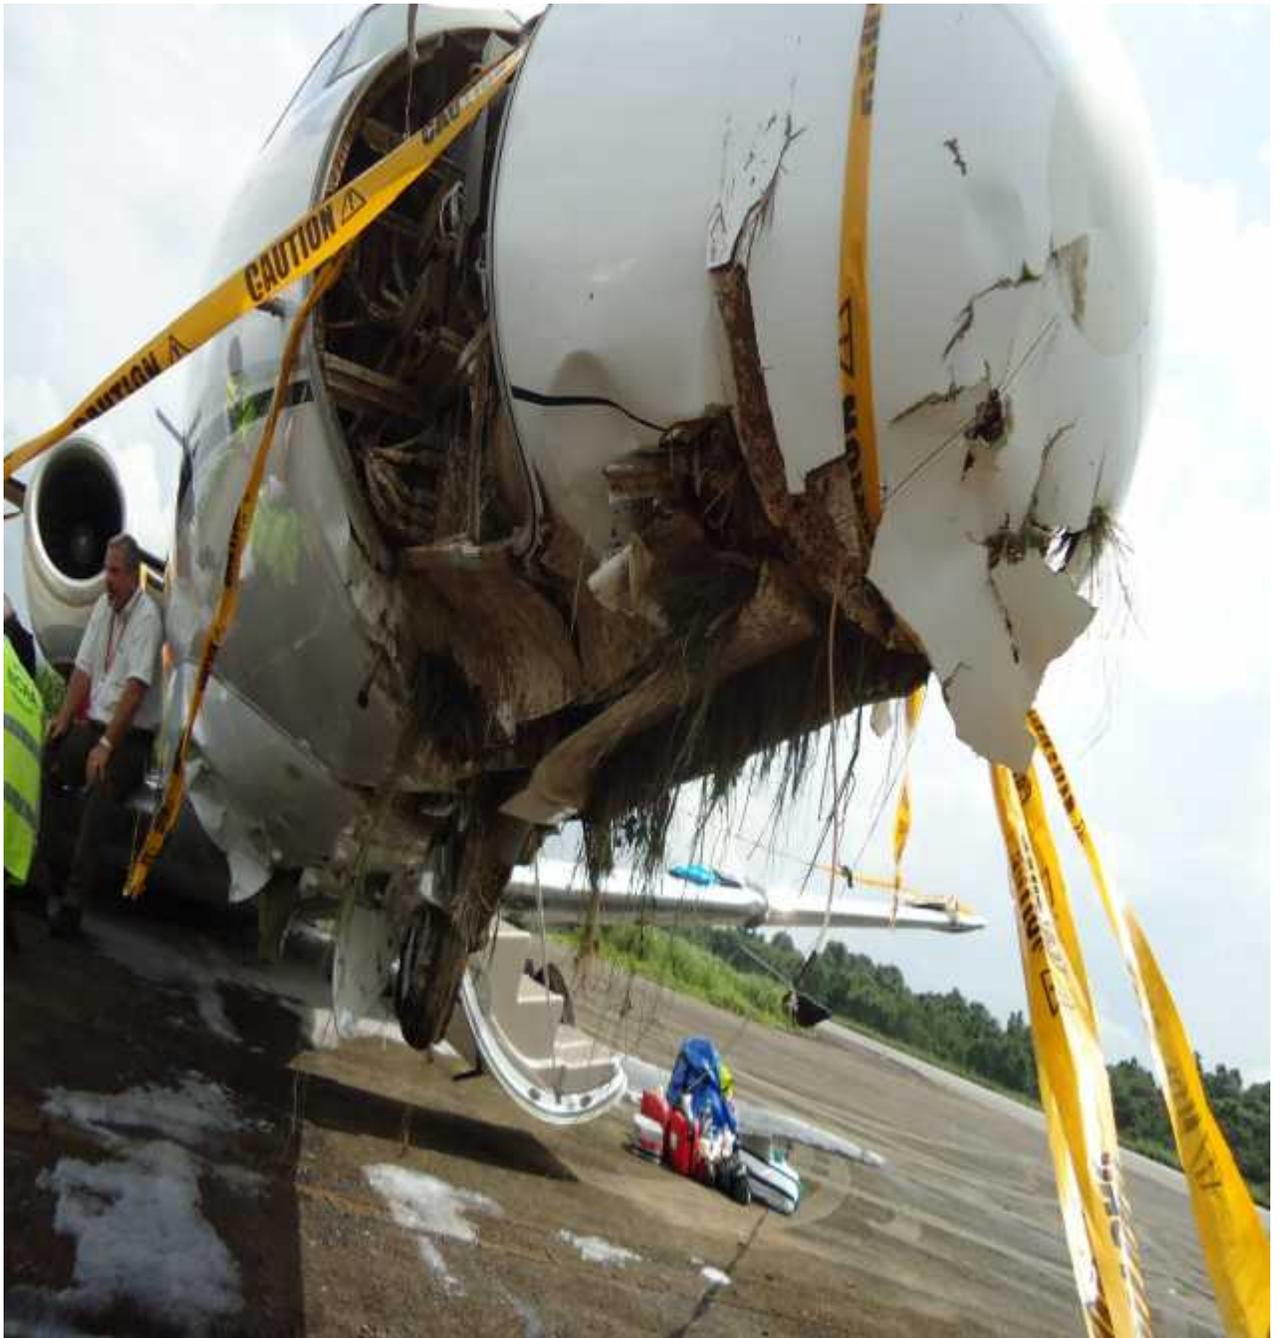
Fig. 1.12b The wreckage showing damaged Radome and Nose section

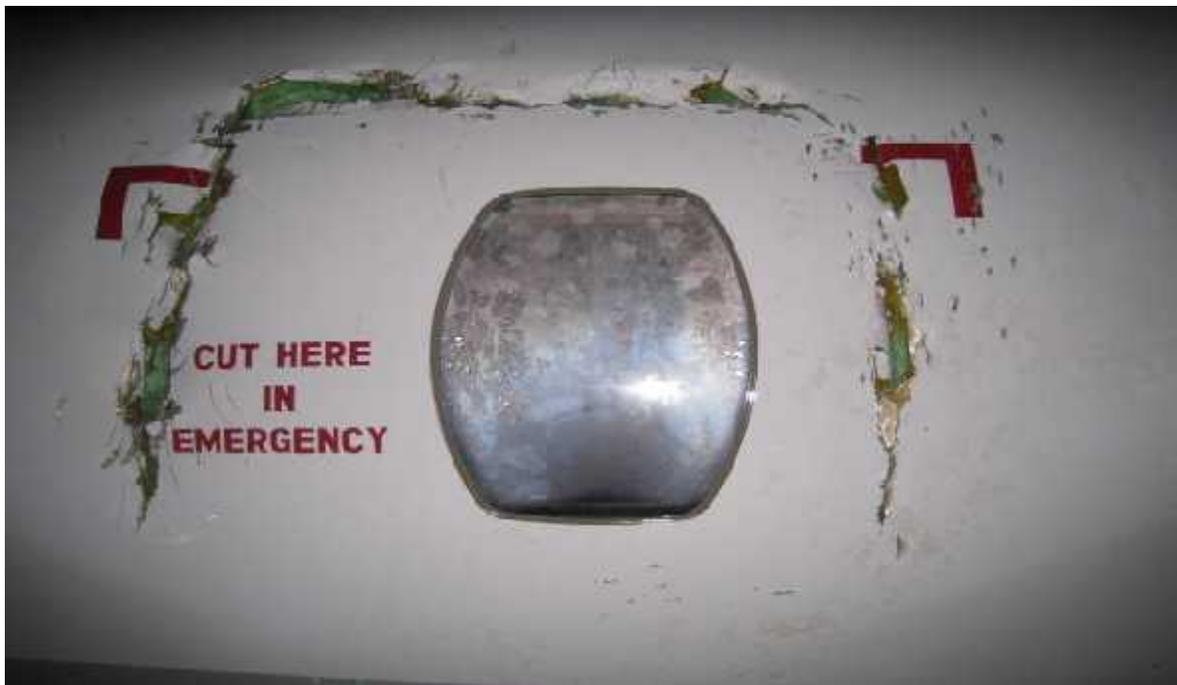
The Airport Fire Service was prompt at the crash site to help rescue the crew and passengers. The Fire Services tried to break into the aircraft with their axe (See fig 1.15a). One of the engines was still running while the fire services attempted to shut-down the running engine to prevent fire outbreak. The Fire Services finally stopped the engine with high pressure foam water.

Fig 1.15a Rescue team/ Fire Services tried to break into the Aircraft to rescue passengers.
