# Aircraft Accident Report

**Crash Into The Sea After An In-Flight Fire**

**Boeing 747-400F, HL7604**

**28 July 2011**

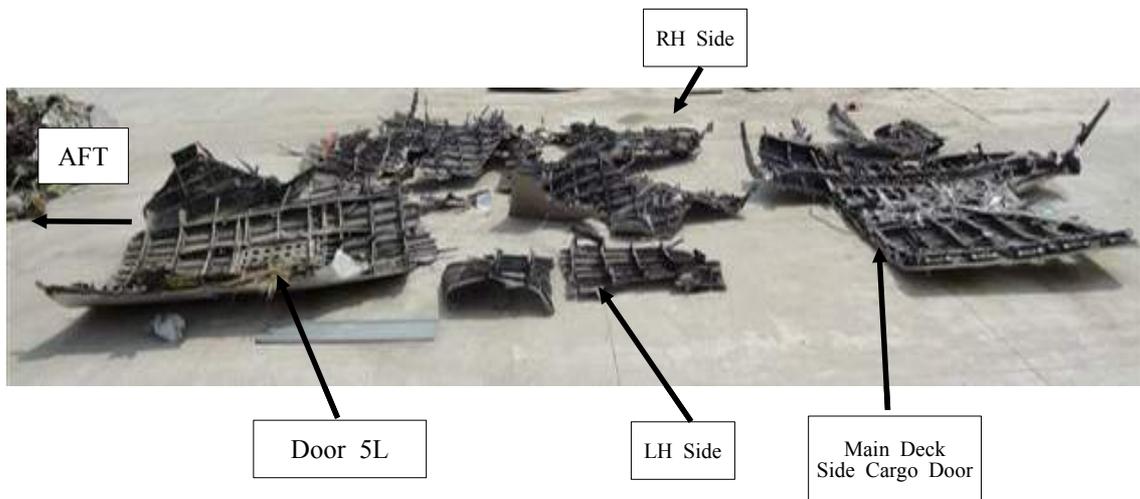
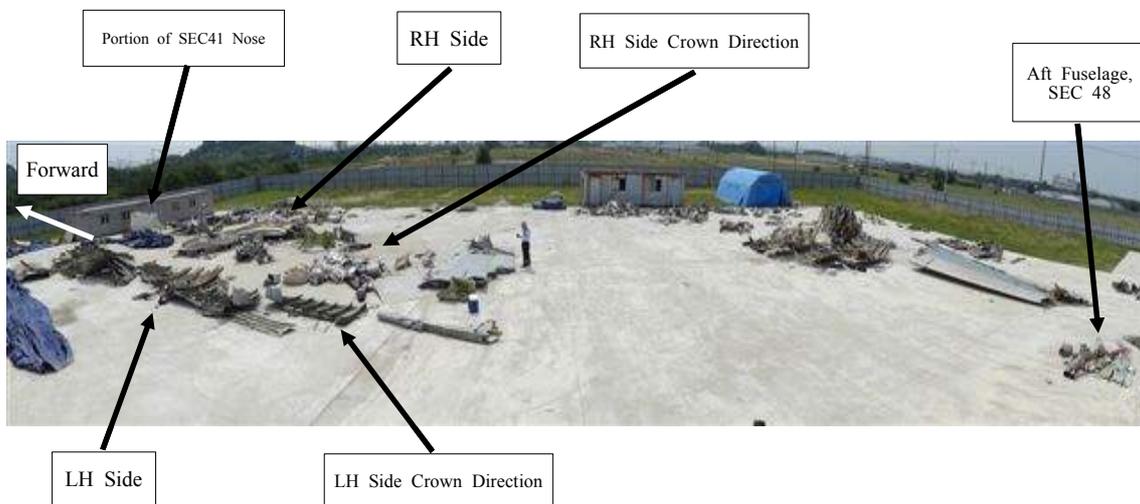
As shown in [Figure 16] and [Figure 17], the wreckage items were positioned in relative close proximity to one another in the yard of the Incheon wreckage storage facility in accordance with the level of fire damage, and their levels of damage and trace of fire were examined and documented.

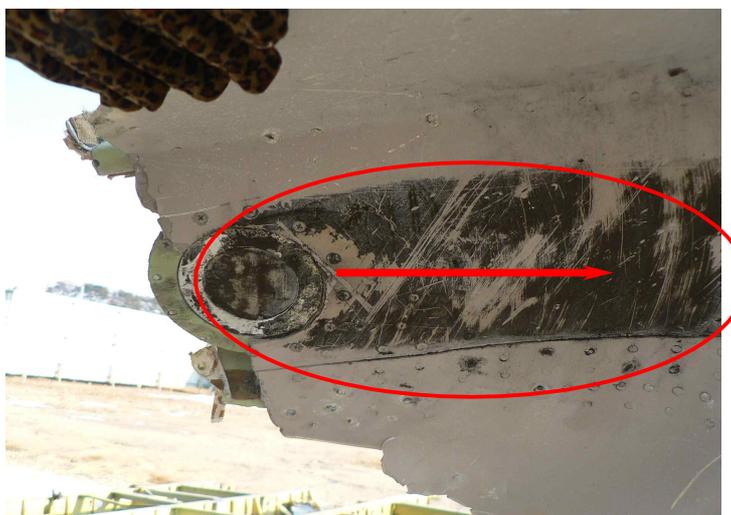
[Figure 19] Sooting on the Exterior Skin of Cockpit Smoke Evacuation Shutter

As shown in [Figure 19], the cockpit smoke evacuation shutter was found closed, but a well defined soot trail was discovered on the exterior skin of the shutter in the rear fuselage direction.

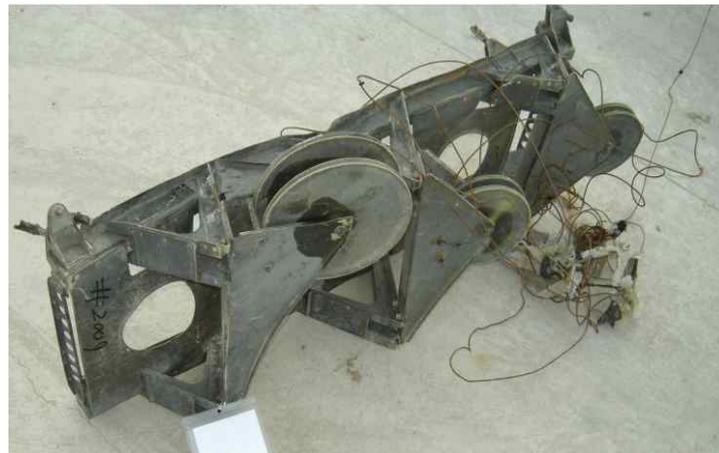
[Figure 22] Control Cables

As shown in [Figure 22], the flight control pulley at FS775 showed sooting and discoloration but did not exhibit thermal damage, and the flight control cables attached to the pulley exhibited rust.

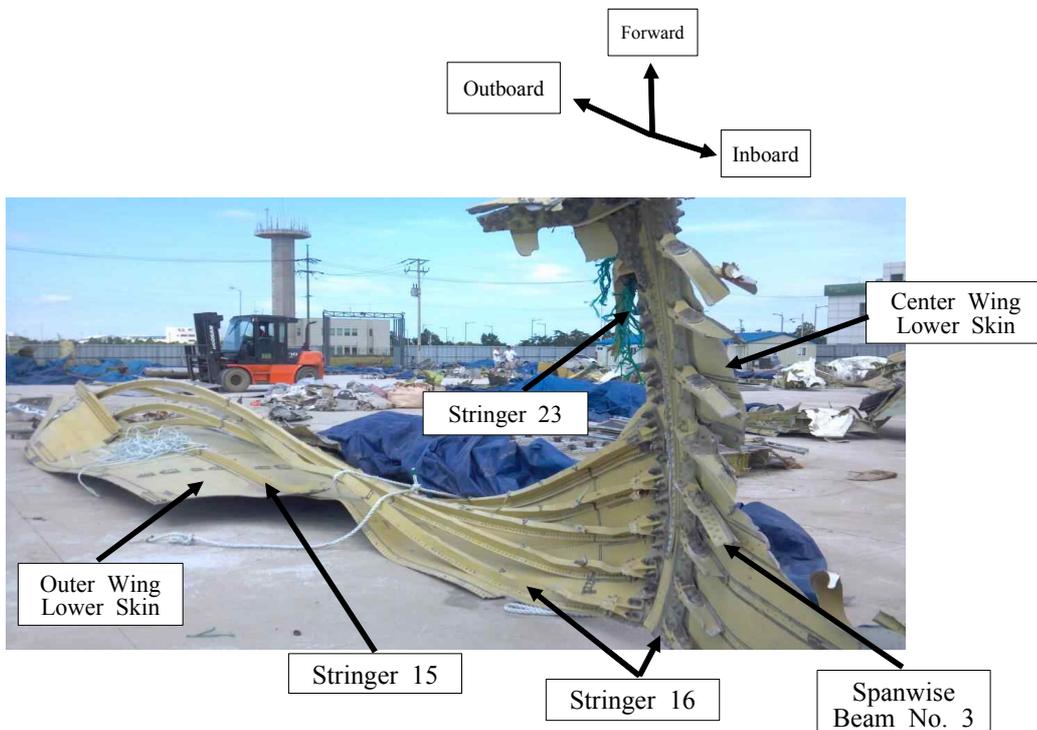
[Figure 23] LH Lower Wing Skin

As shown in [Figure 23], the LH lower wing skin measuring approximately 40 ft by 8 ft was recovered. It includes portions of two center wing skin panels and three outer wing panels. The skin section spans stringer positions 10 through 23 (from the midspar forward to the front spar), but not all of the stringers remain attached.

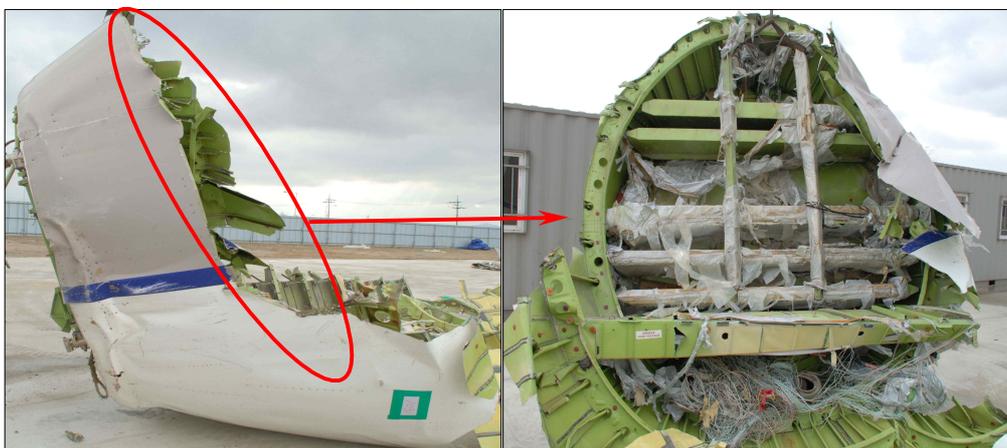
[Figure 24] Forward Cargo Door

As shown in [Figure 24], a forward section of the nose cargo door was separated from the fuselage at FS 160/180, and the radome was missing. The skin demonstrated compressive buckling 360 degrees along the leading edge. The forward pressure bulkhead was hydro formed. Upper portions of both sides of the door, including the hinges, were recovered with the cockpit section.

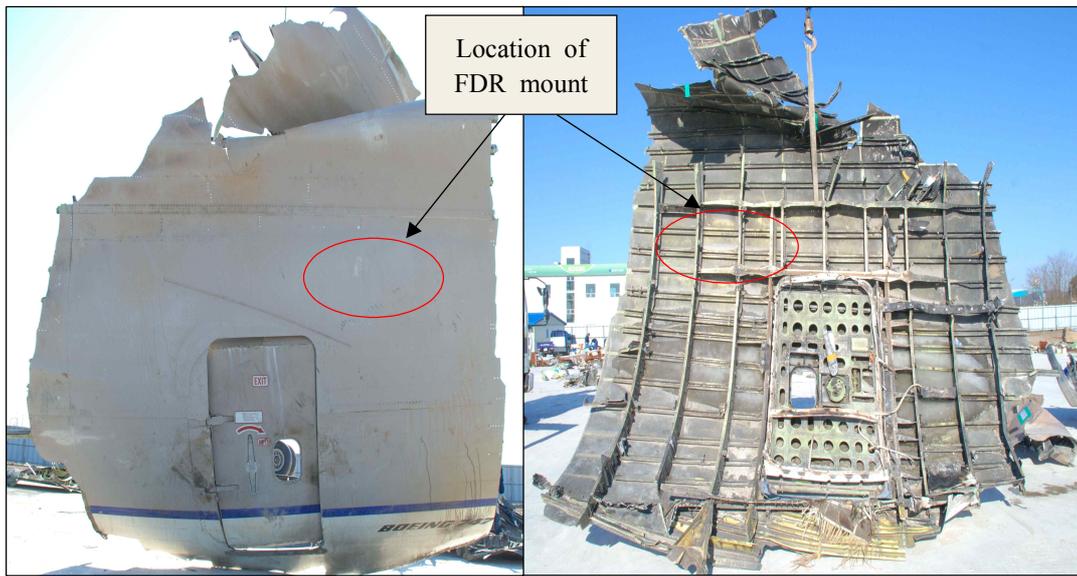
[Figure 25] Exterior (Left) & Interior (Right) Sides of L5 Door

As shown in [Figure 25], the flight data recorder rack was separated from the mount aft of the upper portion of the L5 door. The upper portion of the frame was thermally damaged, and its interior surface was heavily sooted. The paint of the exterior skin was partially discolored by inner heat.

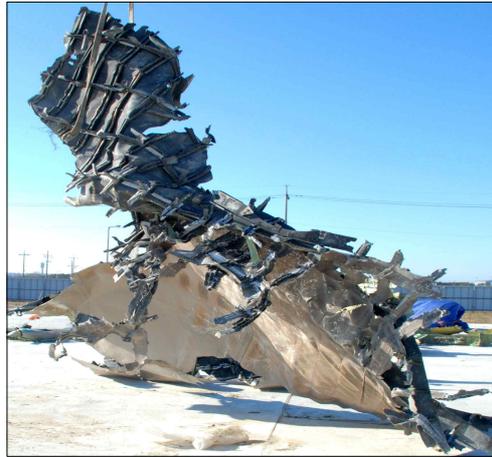
[Figure 26] Fire Damage to the Skin Between FS2180 & FS2360

Portions of the wreckage in the region between FS1740 and FS2360 contained direct thermal damage on the exterior skin as evidenced by melting of internal metal structure and discoloration of the exterior paint. As shown in [Figure 26], the skin panel that extended from FS2180 and FS2360 sustained severe thermal damage as evidenced by twisted and melted stringers and ribs, holes on the surface, and paint discoloration on the exterior of the skin. The skin panel also contained areas which were burned through.

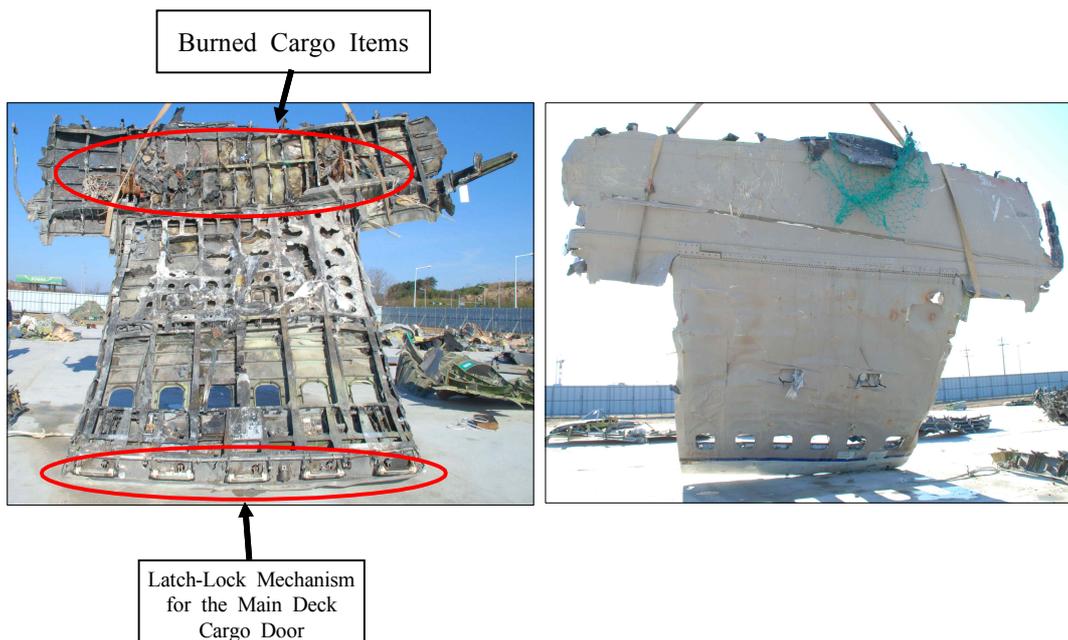
[Figure 27] Interior (Left) & Exterior (Right) Sides of Main Deck Cargo Door

The latch-lock mechanism of the main deck cargo door was in a closed position, and the paint of the exterior skin turned yellow by heat.

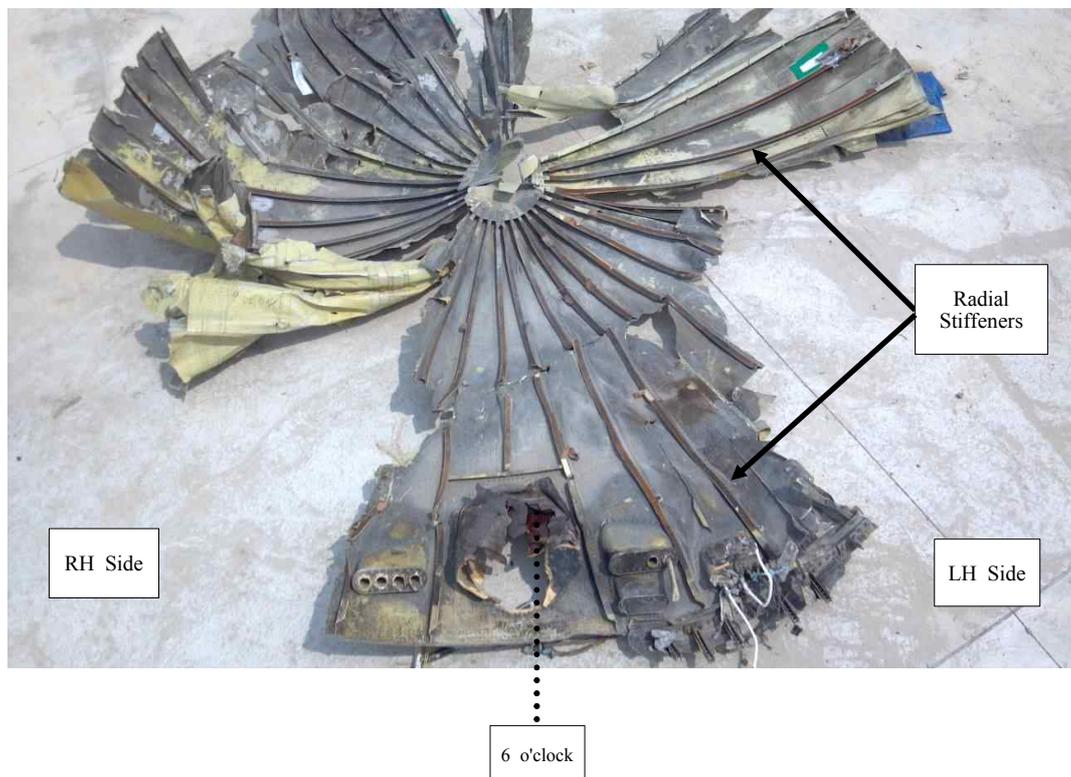
[Figure 28] Aft Pressure Bulkhead

As shown in [Figure 28], approximately 80% of the aft pressure bulkhead (APB) at FS2360 was recovered broken into six major pieces. Portions of the wreckage sustained fire damage consisting of sooting, and some fragments of the skin remained after fire. Almost the entire RH side of the bulkhead is accounted for, whereas part of the LH side disappeared.

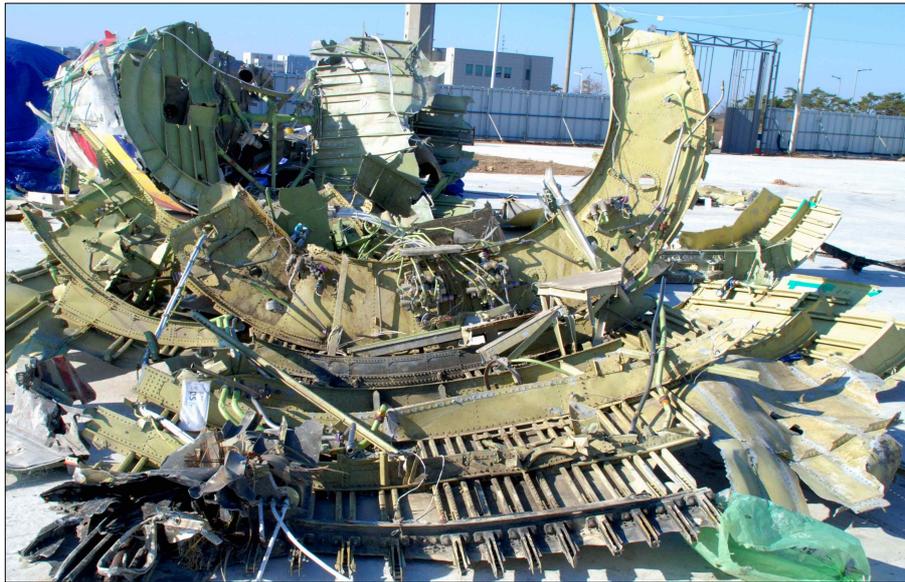
[Figure 29] Section 48 of the Aft Fuselage

As shown in [Figure 29], the section 48 of the aft fuselage contained no internal sooting or fire damage but did have external soot accumulation on the underside of the left and right skin panels. Most of the damage appeared to have been caused by impact forces during the crash into the sea.

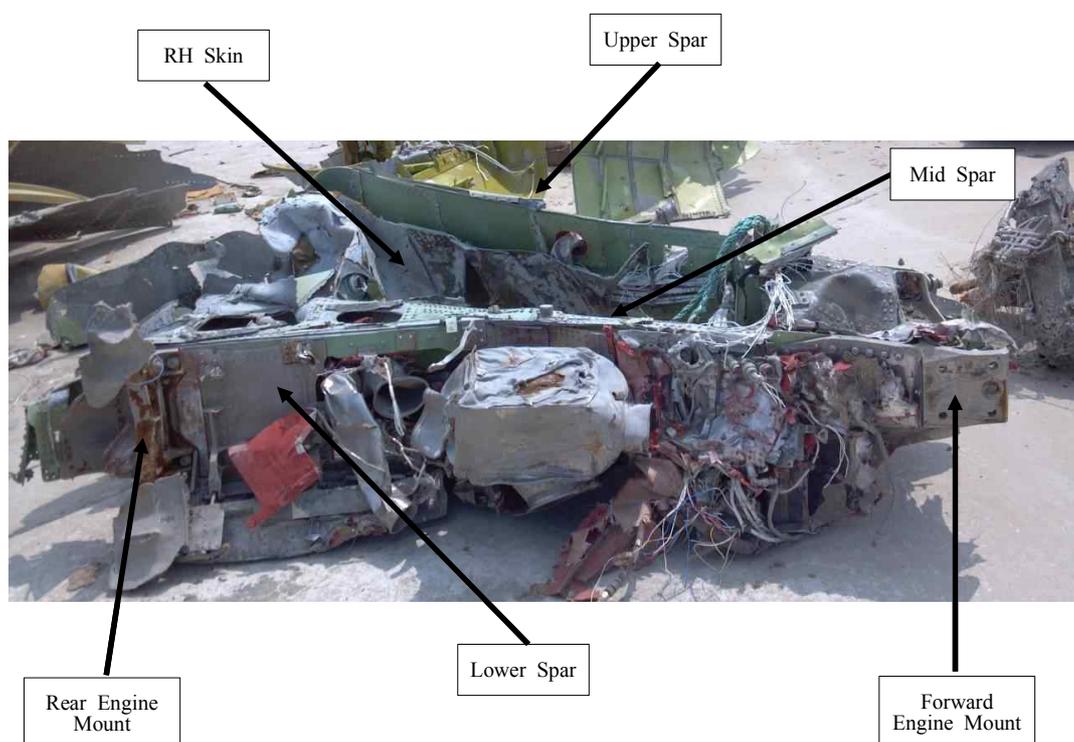
[Figure 30] No. 3 Pylon

As shown in [Figure 30], the No. 3 pylon includes the majority of the structure from the rear engine mount bulkhead forward to the forward engine mount bulkhead. The pylon also includes remnants of bleed air ducting, fuel lines, wire bundles and other systems but did not exhibit fire or abnormal damage.

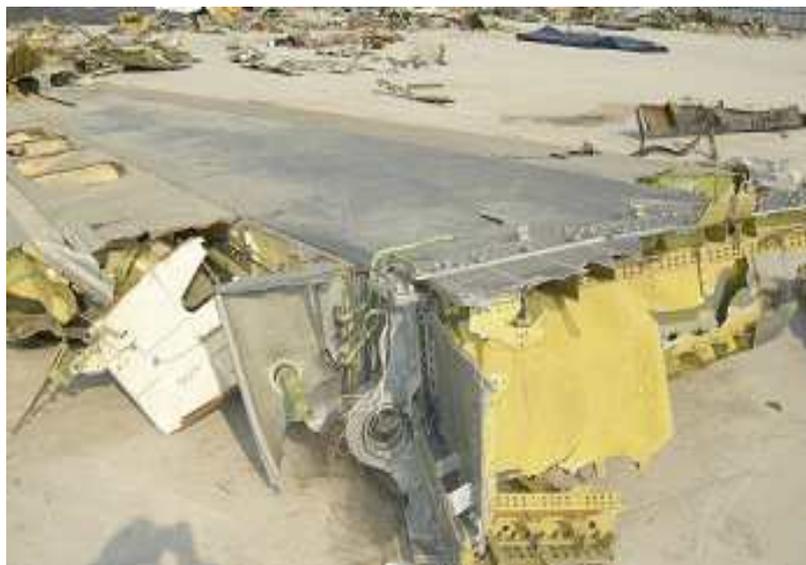
[Figure 31] Left Horizontal Stabilizer

As shown in [Figure 31], the left horizontal stabilizer was separated from the empennage. The remaining skin fragments along the upper and lower fracture areas were bent upwards and demonstrated compressive buckling tearing.

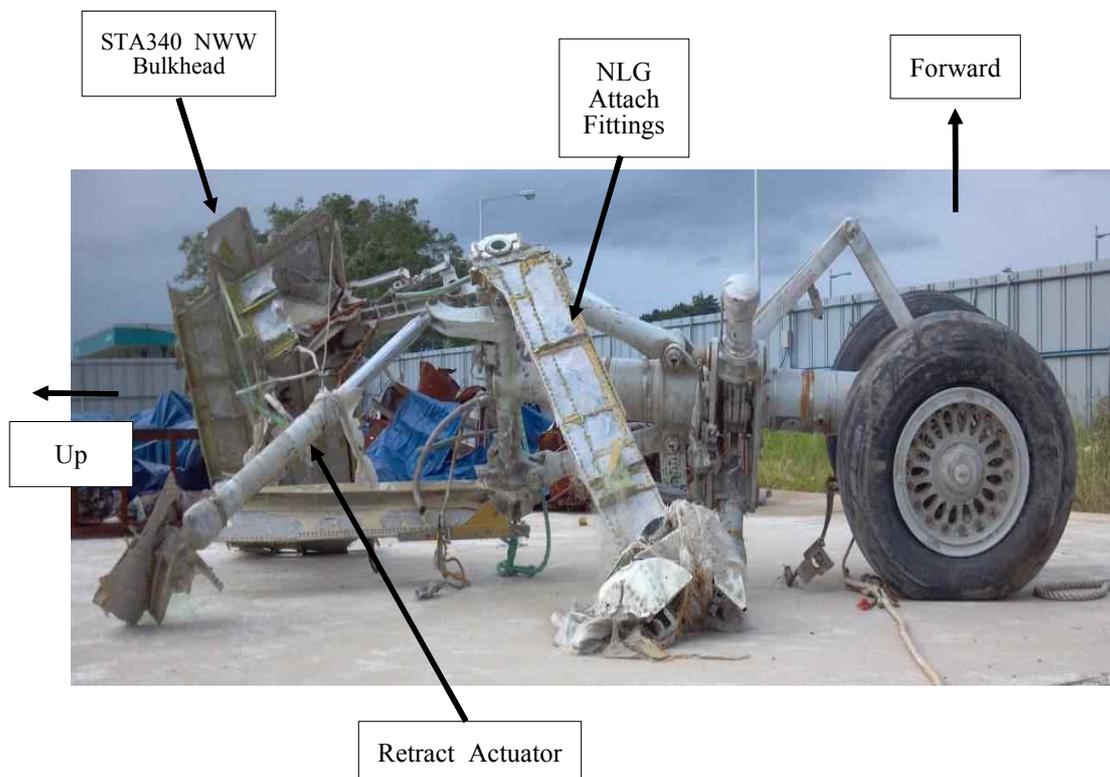
[Figure 32] Nose Landing Gear

As shown in [Figure 32], the nose landing gear was recovered relatively intact and contained no fire damage.

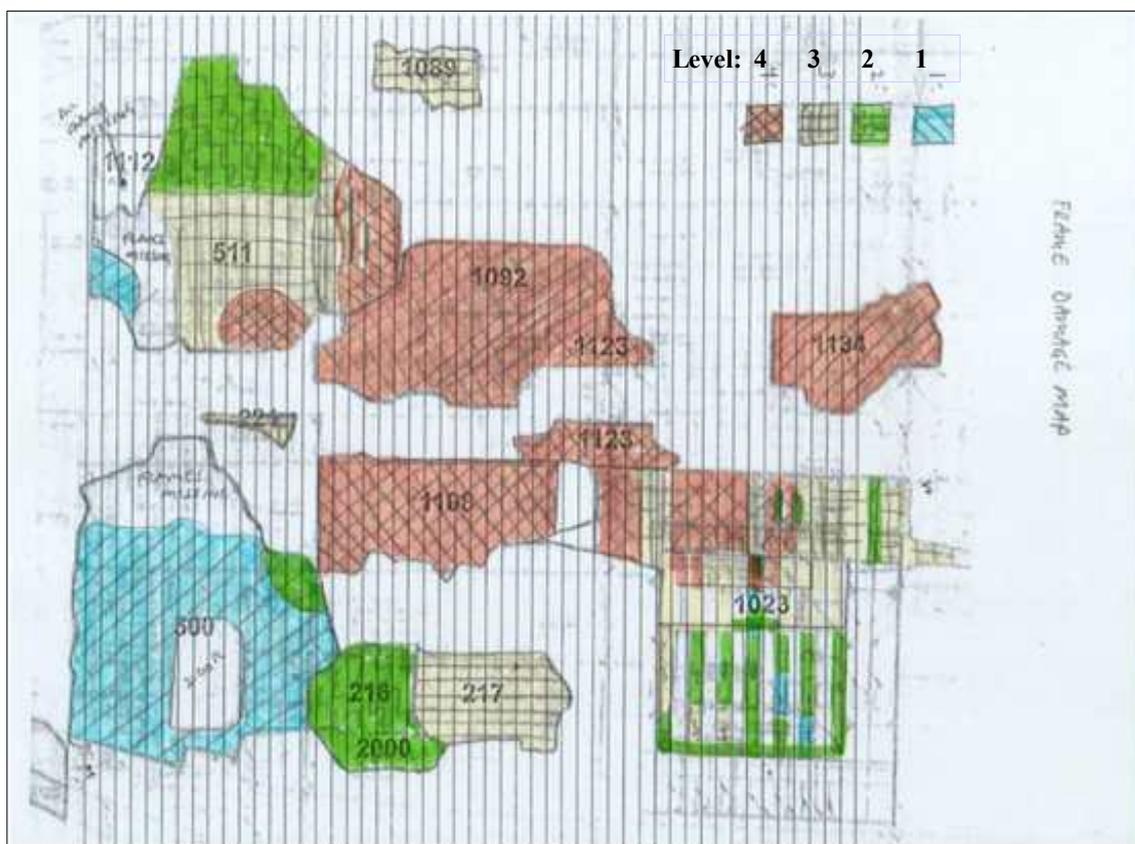
[Figure 33] Fuselage Frame Thermal Damage Map of the Wreckage Between FS1700 & APB

The wreckage between FS1700 and APB sustained the most severe fire damage. Detailed thermal damage maps were generated for these portions of the aircraft. These portions were mostly between the aft main deck cargo door and the L5 door as shown in [Figure 33]. This area can be characterized overall as having been exposed to high temperatures as evidenced by severe thermal damage on the interior structure and discoloration of the paint on the exterior of the aircraft's skin.

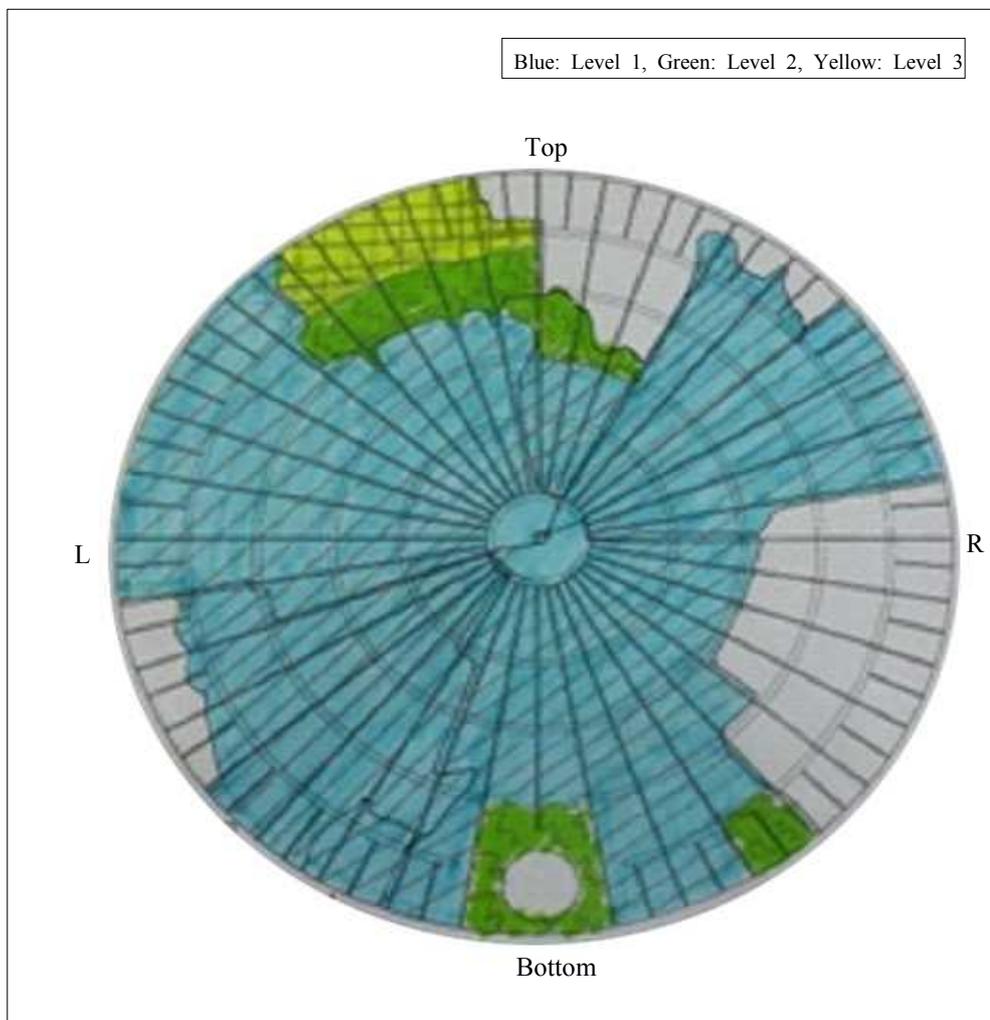
[Figure 34] APB Thermal Damage Map

Portions of the wreckage aft of the APB including the pressure bulkhead facing rear fuselage did not have the evidence of fire damage, but on the exterior of the skin panels on the right and left side of the wreckage aft of the APB were soot trails caused by smoke exiting the outflow valves.

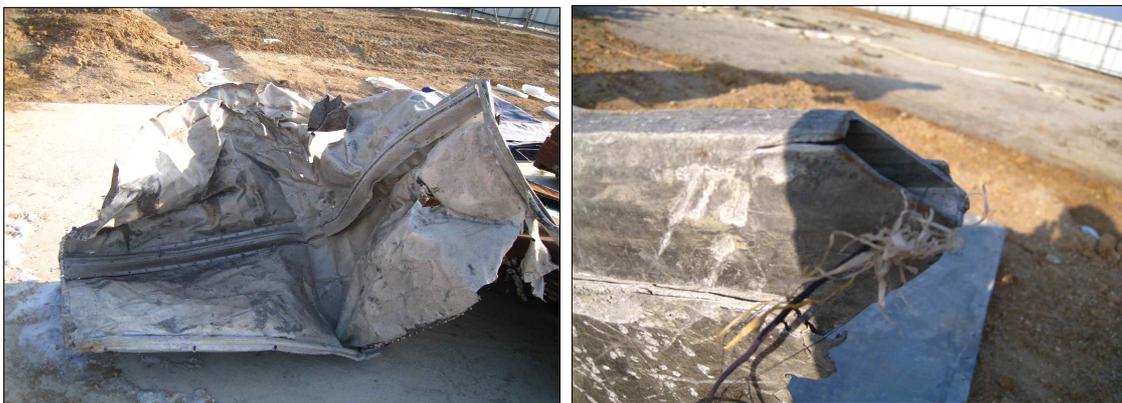
[Figure 38] Inside (Left) & Outside (Right) of the ULD Container

The cargo configuration of the main deck and lower cargo compartments on AAR991 can be found in [Figure 5]. The main deck cargo compartment was loaded with pallets and one ULD container (at position LL) which was recovered. No evidence of fire damage was found on the inside of the ULD as shown in [Figure 38], but the outside of it was heavily covered in soot.

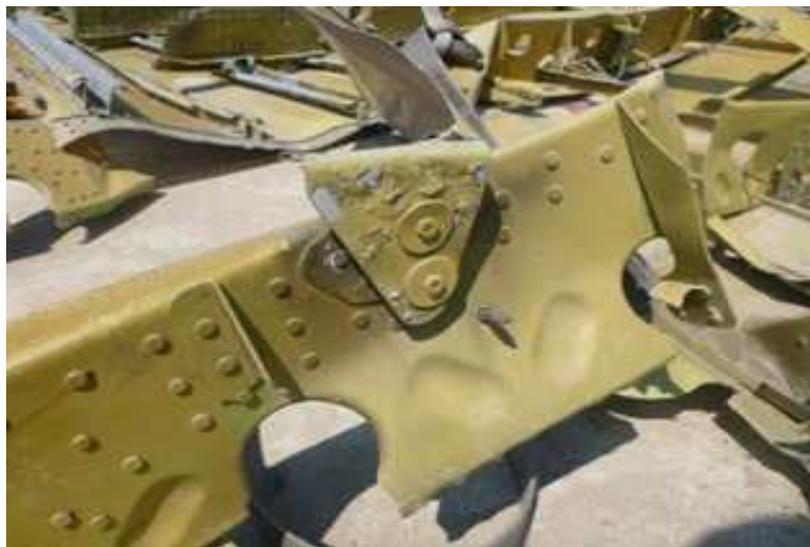
[Figure 42] Fuselage Frame at FS500 on LH Side in the Main Deck Cargo Compartment

As shown in [Figure 42], among the farthest forward wreckage (FS480 - 700), sooting was found on the fuselage frame at FS500 on the LH side in the area of the main deck cargo compartment. As shown in [Figure 43], sooting was also found on the upper deck floor beams as far forward as FS520.

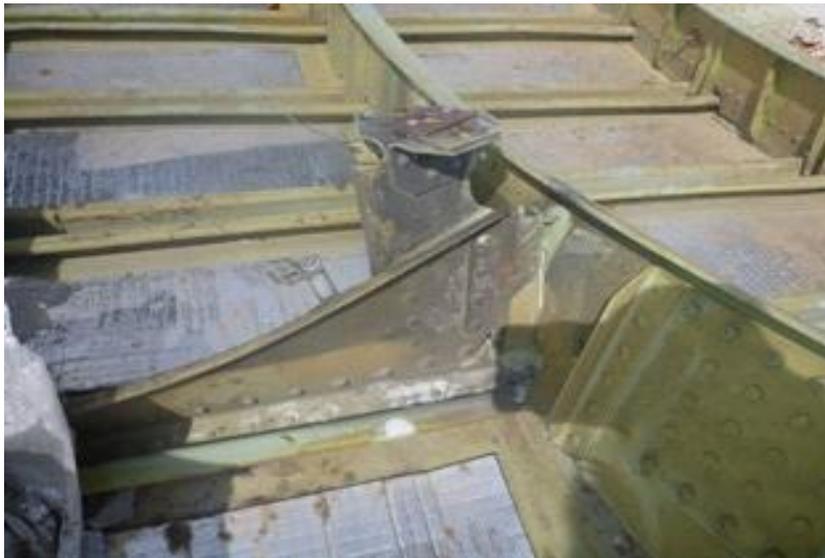
[Figure 44] Farthest Forward Evidence of Thermal Damage at FS580

The farthest forward evidence of thermal heat damage which caused paint discoloration was found on a crown fuselage frame at FS580 on the LH side. This damage is located at a stringer 6.
