FINAL
KNKT.11.09.20.04

Aircraft Accident Investigation Report

**CASA 212-200
PK-TLF
Leuser Mountain National Park,
North Sumatera
Republic of Indonesia**

29 September 2011

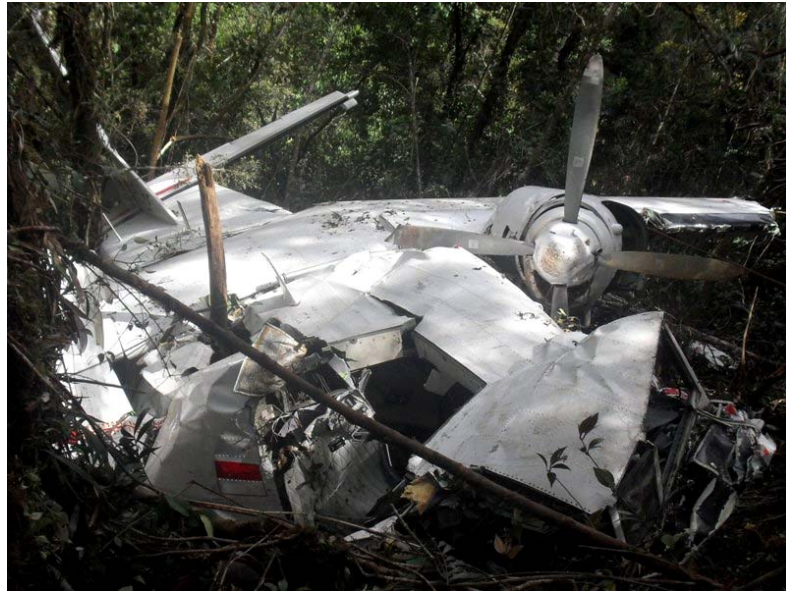
The aircraft was severely damaged. Severe damage found at the bottom part of the forward fuselage. Both wing tips detached at the outer wing area and wing leading edge severely damaged. Both engine propellers found in fine position.

Figure 1: The aircraft was severely damaged

There was a small trees area that was damage by the impact of the aircraft. The damage at the bottom part the forward fuselage indicated that the aircraft was on relatively level position while impacted to 70° slope ridge. These indicated that the aircraft was flying directly to the terrain and no indication or late of recovery such as a pull up action.

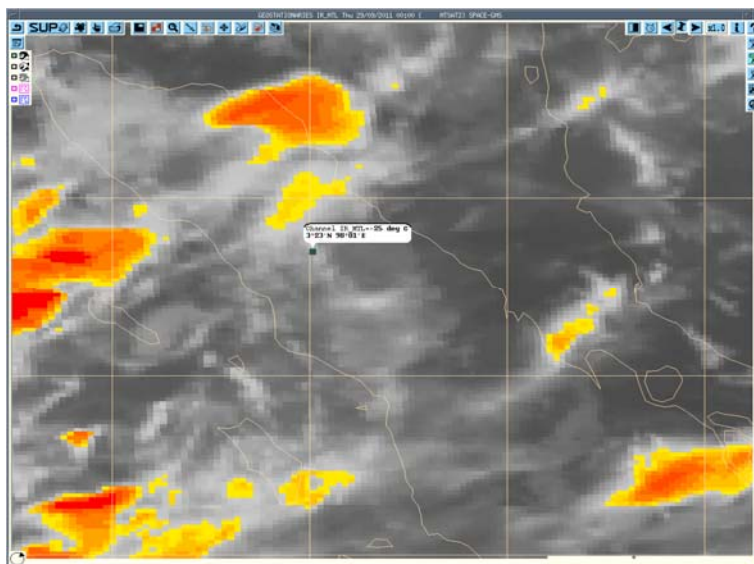
The satellite image at 0000 UTC indicated an active cloud around east coast line of Aceh and at the north of accident site (Figure 2).

Figure 2: Weather satellite image at Sumatera at time 00.00

The satellite image at 0100 UTC indicated an active cloud around east coast line of Aceh has decreasing on its intensity indicated by the changing of its colour from red to yellow. The satellite image also showed that the active cloud on the north of accident site has disappeared (Figure 2)

Both satellite images showed that there was no active cloud around the accident site.

The satellite image indicated a weather changing between 00.00 UTC to 01.00 UTC as shown by decreasing of active cloud observed over east coast of Aceh and dissipating of active cloud north of the accident site.

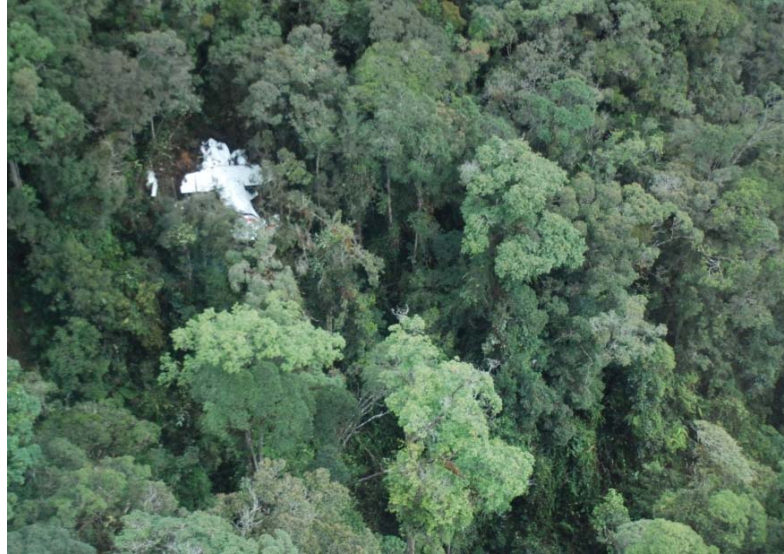
The aircraft impacted at Leuser Mountain, in slope of mountain which 70° and 5,055 feet high.

Figure 3: Impact area of the accident

The damage to the tropical rain forest of the accident site was narrow. There was damage to tree behind the aircraft final position. Both wing tips were detached. The detached wing tips were found near to the main wreckage.
