PRELIMINARY
KNKT.11.12.26.04

Aircraft Accident Investigation Report

PT. Merpati Nusantara Airlines

CASA 212-200; PK-NCZ

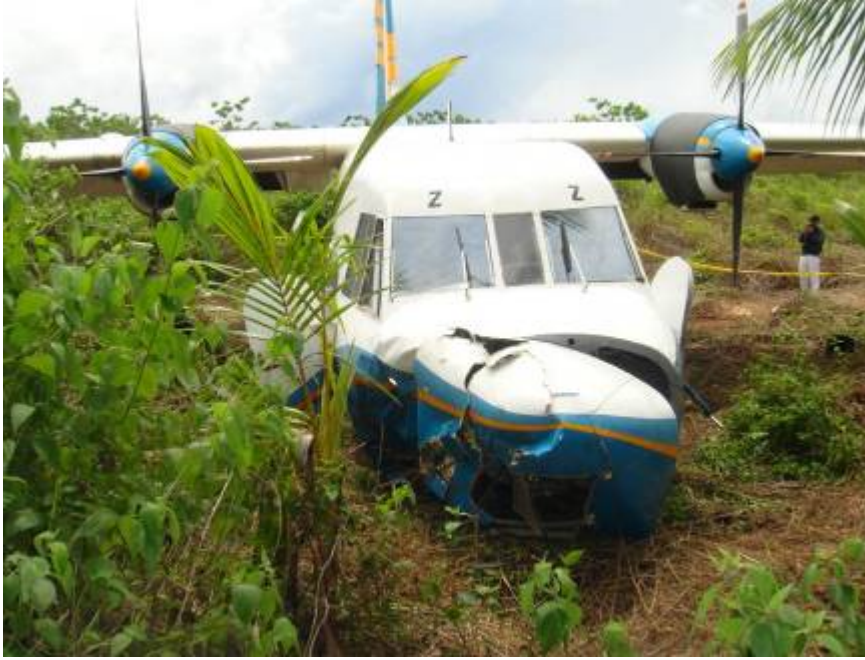
The nose section, and landing gears were severe damage.

Figure 4: Nose section was severe damage

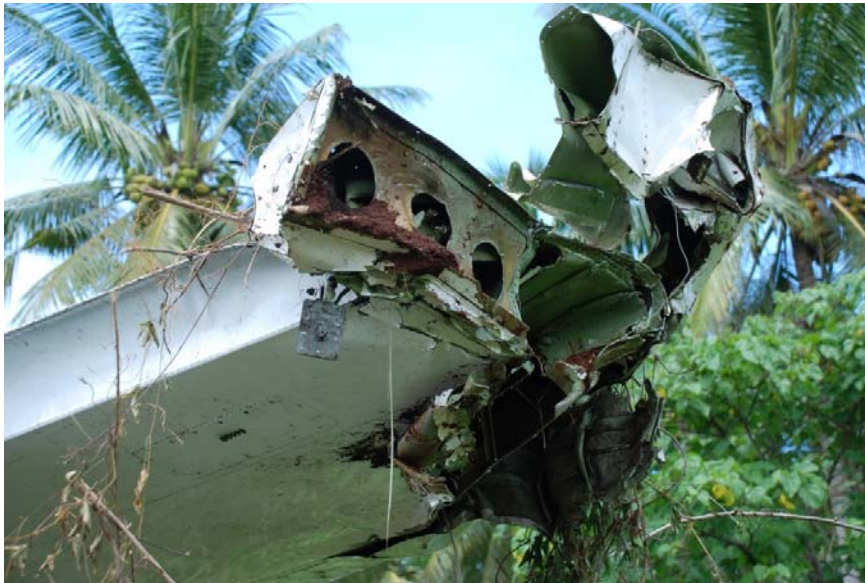
The right wing tip, and right aileron were severe damage.

Figure 5. Right Wing Tip and right aileron were severe damage.

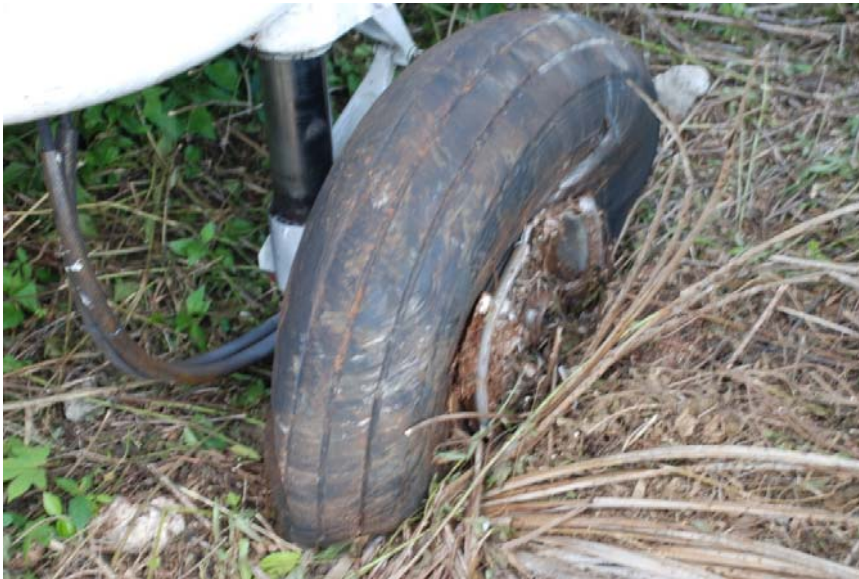
Figure 7: Right Wheel tire and skid mark on it

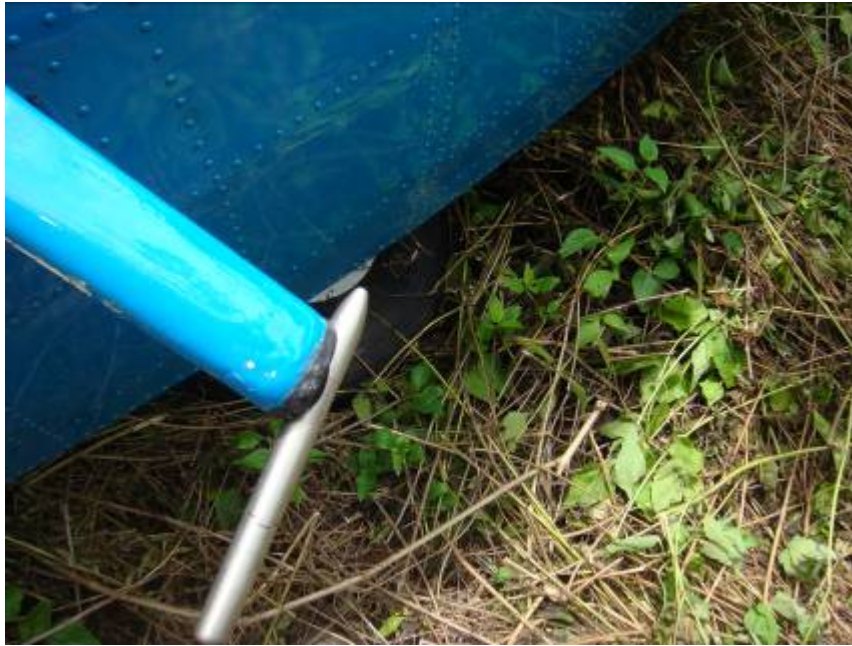
Figure 8: Nose landing gear collapsed backward to the left of fuselage
