Report

Accident on **13 July 2012**
at **Le Castellet aerodrome (83)**
to the **Gulfstream G-IV** aeroplane
registered **N823GA**
operated by **Universal Jet Aviation (UJT)**

BEA

Bureau d'Enquêtes et d'Analyses
pour la sécurité de l'aviation civile

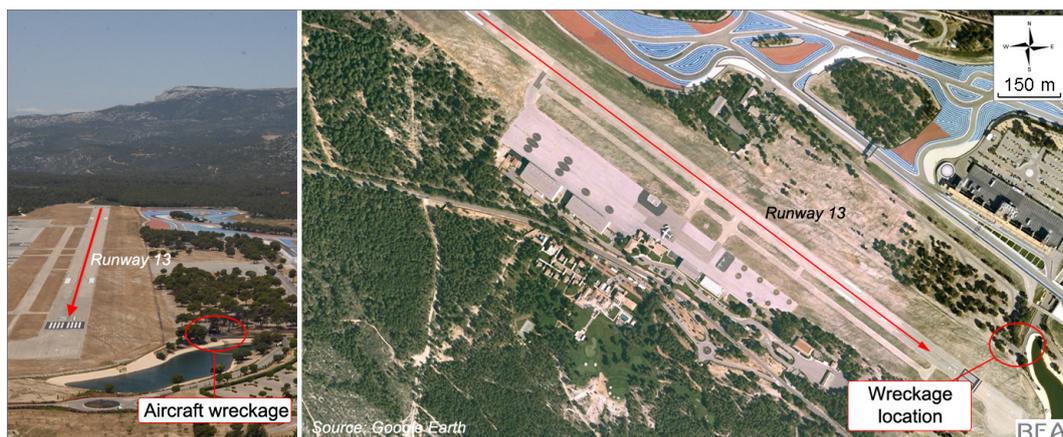
The wreckage was located outside the aerodrome perimeter fence.

Figure 10: location of the wreckage

No debris from the aeroplane was found within the aerodrome perimeter. The first part (piece of the nose gear) was located just behind the fence that the aeroplane went through.

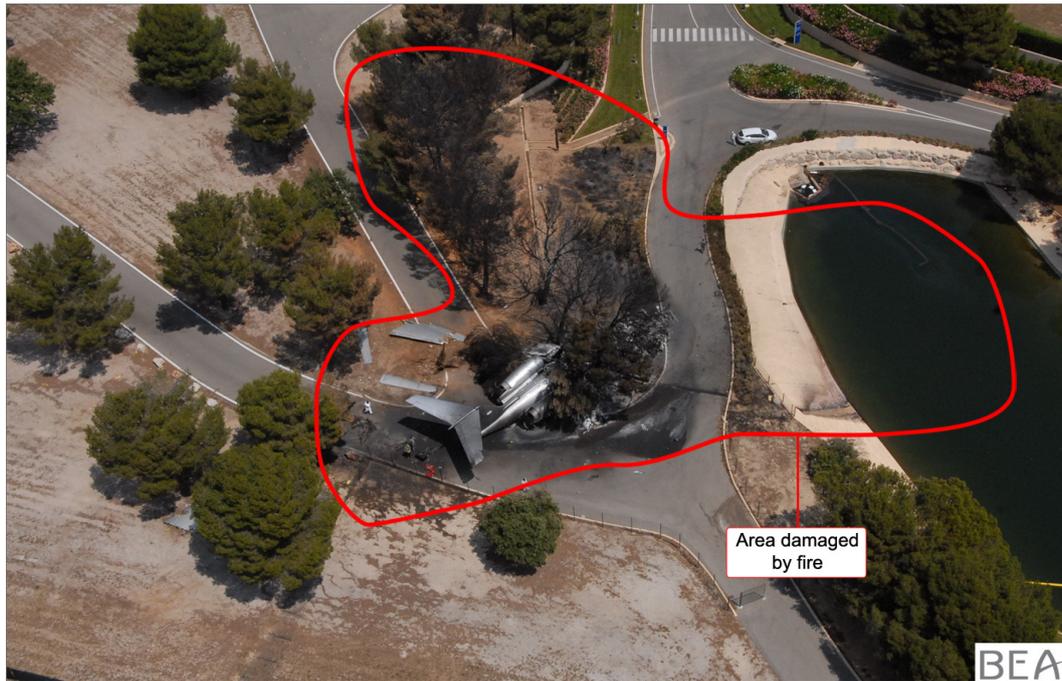
A large amount of debris from the aeroplane was found near the wreckage. This resulted from the contact between the aircraft and the fence demarcating the enclosure of the aerodrome, as well as the rocks and trees. Most of the aeroplane was destroyed by fire (figure 11).

Figure 11: area affected by the fire

A fire started after the impact of the structure with the rocks and trees. The wing tanks ruptured and the fuel immediately ignited. The fire spread to a few surrounding trees.

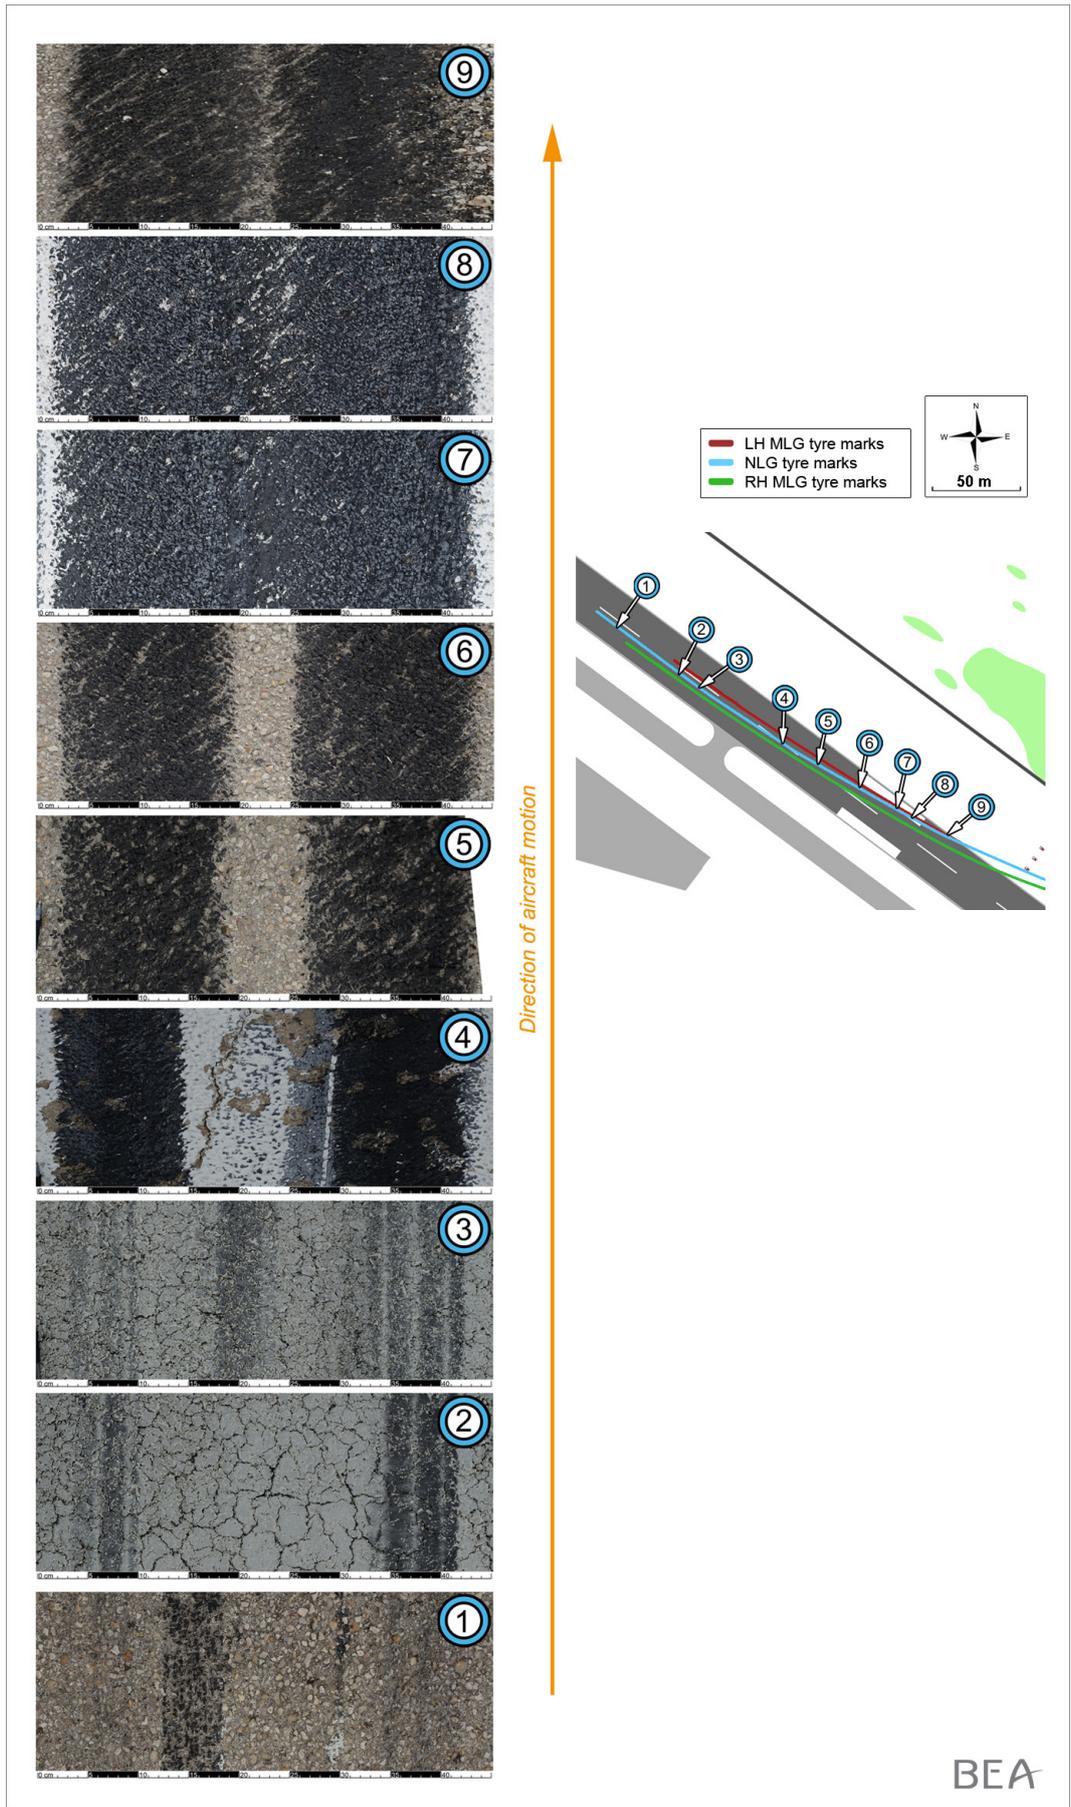
The first tyre marks observed on the runway attributed to N823GA were left by the nose gear⁽¹⁹⁾. They were continuous to the runway edge over a longitudinal distance (in relation to the runway centre line) of 270 metres. The marks from the right main landing gear start 30 metres after those of the nose gear, those of the left main landing gear started 25 metres after those of the right main landing gear (*see the diagram and photographs below*).

Figure 12: photos of the nose gear tyre marks

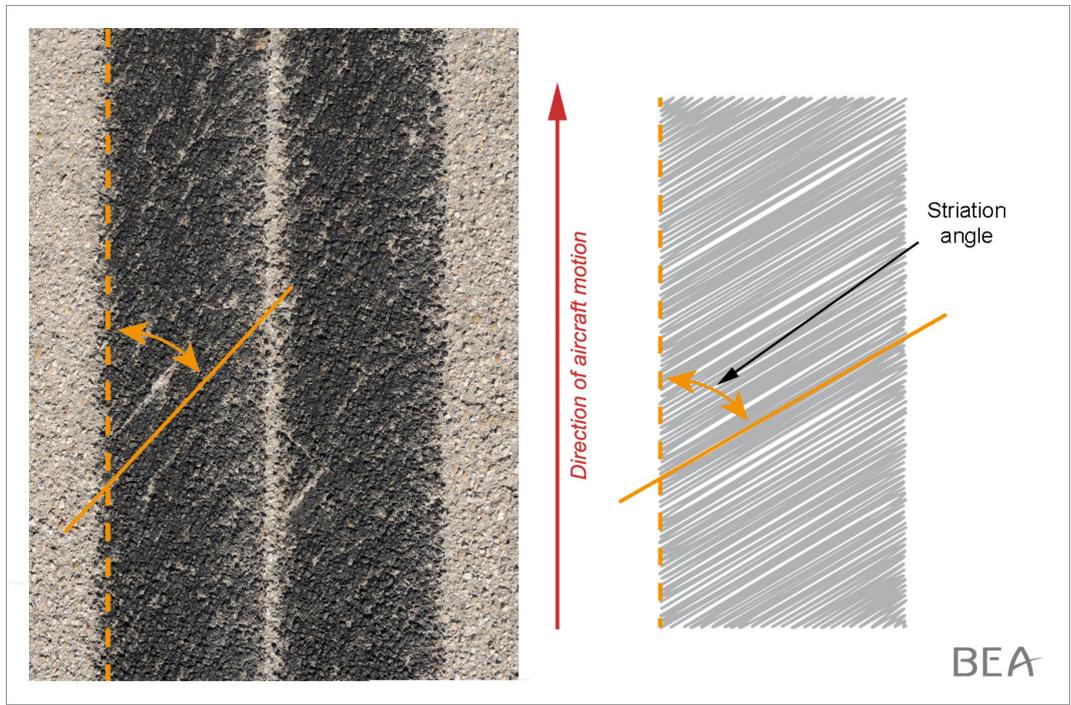
Shortly before the runway centre line (between points 3 and 4 of the diagram above) and until the runway edge these marks had striations trending towards the right in the direction of travel of the aeroplane. Their angle, measured between the edge of the mark and the striation, changed along the marks (see the measurements below).

Figure 13: striations observed on the nose gear marks and method for measuring the angle

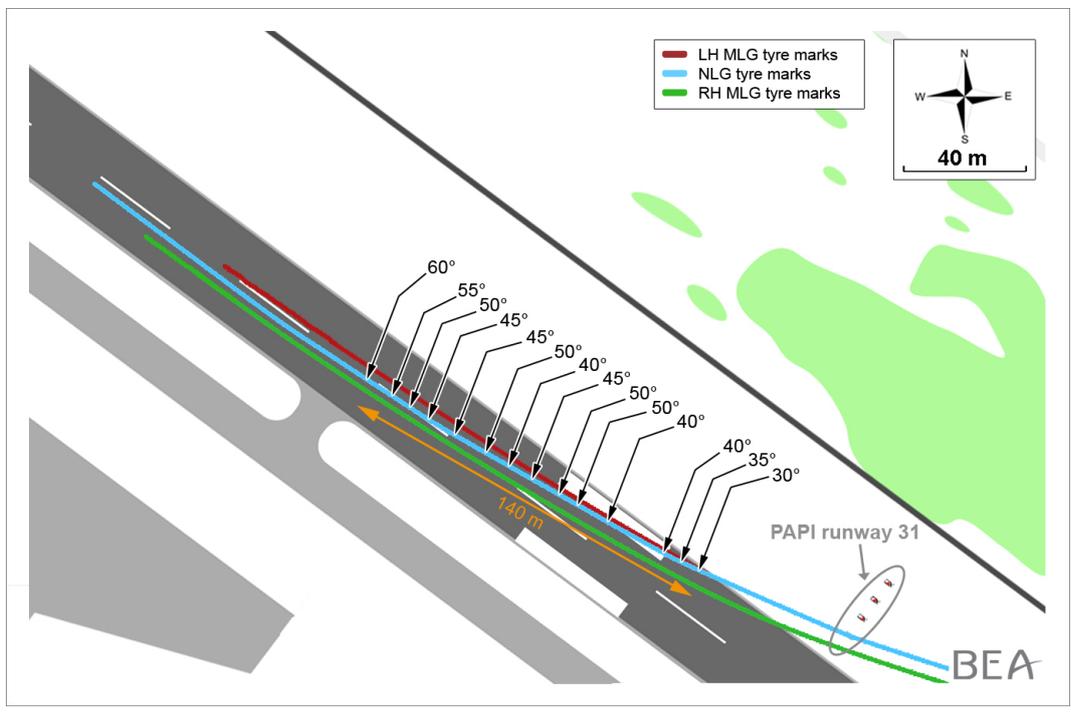
Figure 14: striation angle values along the nose gear marks

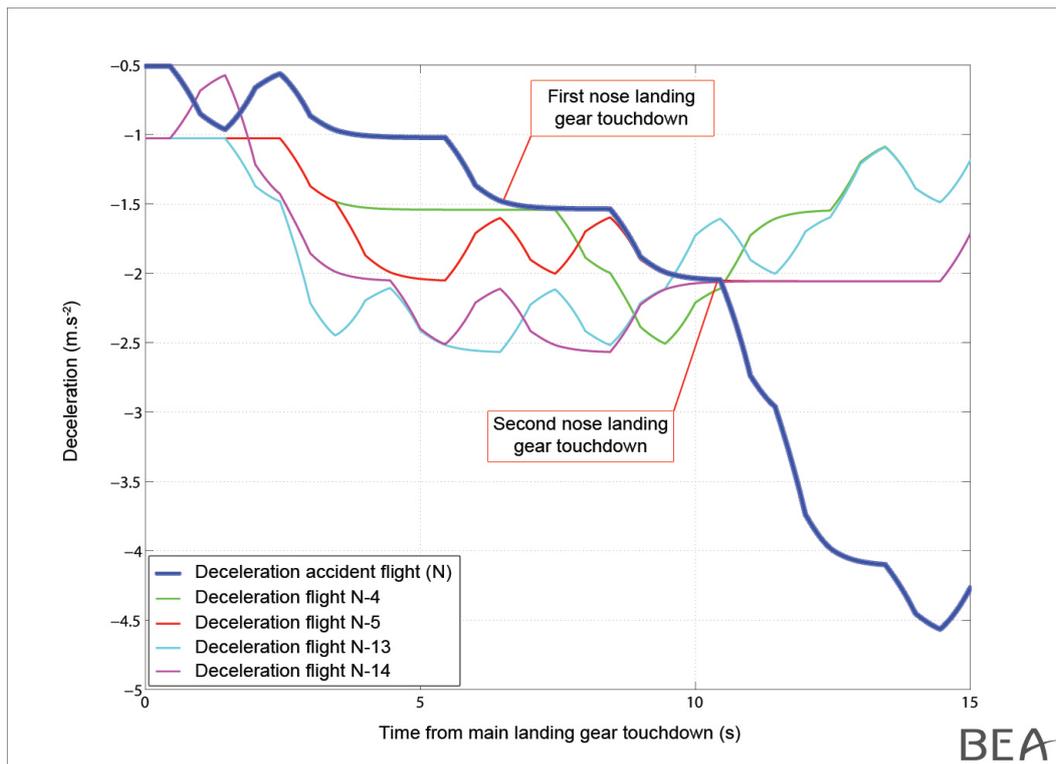
This deceleration was compared to that of four of the other touchdowns by N823GA recorded on the FDR, in which the technique used was found to be similar to that of the accident until the first touchdown of the nose gear wheels.

Figure 16: deceleration

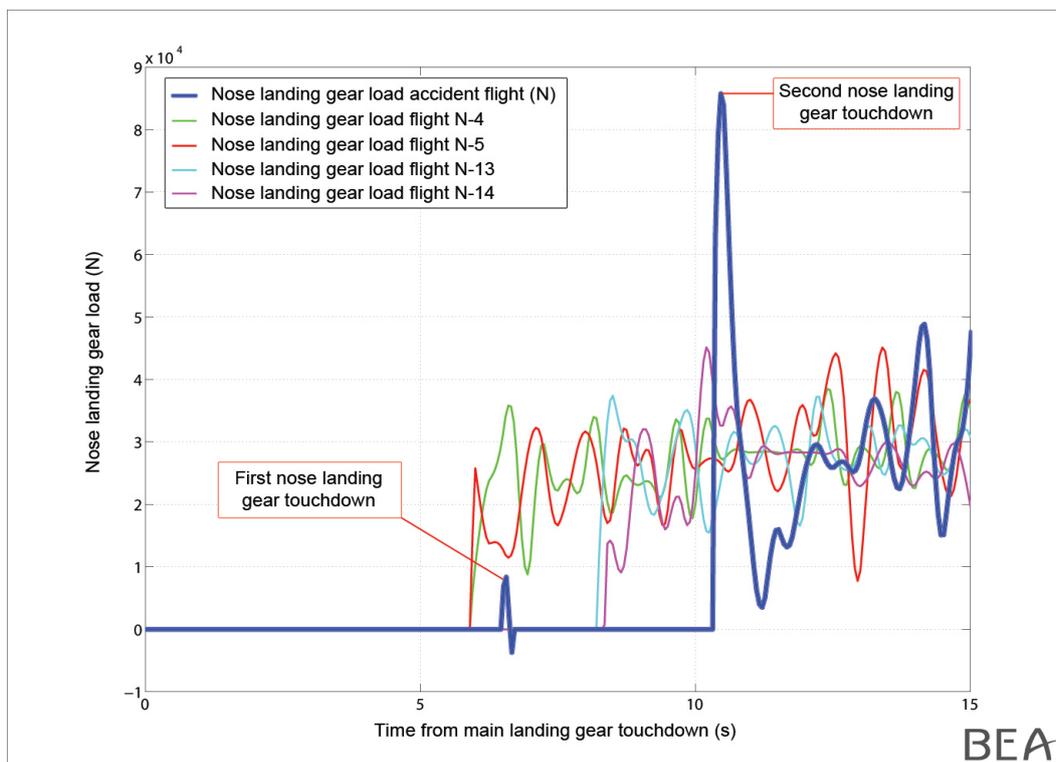
The results show that the vertical load on the nose landing gear at the first touchdown was of low value, lower than that observed on previous flights. On the second touchdown, the load reached the value of 85,000 N⁽²⁵⁾ (a value 3 times higher than the average value calculated for the other landings), close to the permissible nose gear limit load. Due to the precision of the calculations, it is nevertheless not possible to state that the limit load was not exceeded. This was followed by a rebound effect, a decompression of the nose gear characterized by a load 2 to 3 times lower than that of the other landings. The nose gear was then compressed again and the loads were similar to those of the other landings, in terms of their mean value, their amplitude and the frequency of the oscillations.

⁽²⁵⁾The nose gear of the G-IV has been certified for a limit load of 98,000 N (ultimate load is 147,000 N).

Figure 19: comparison of vertical loads on the nose gear

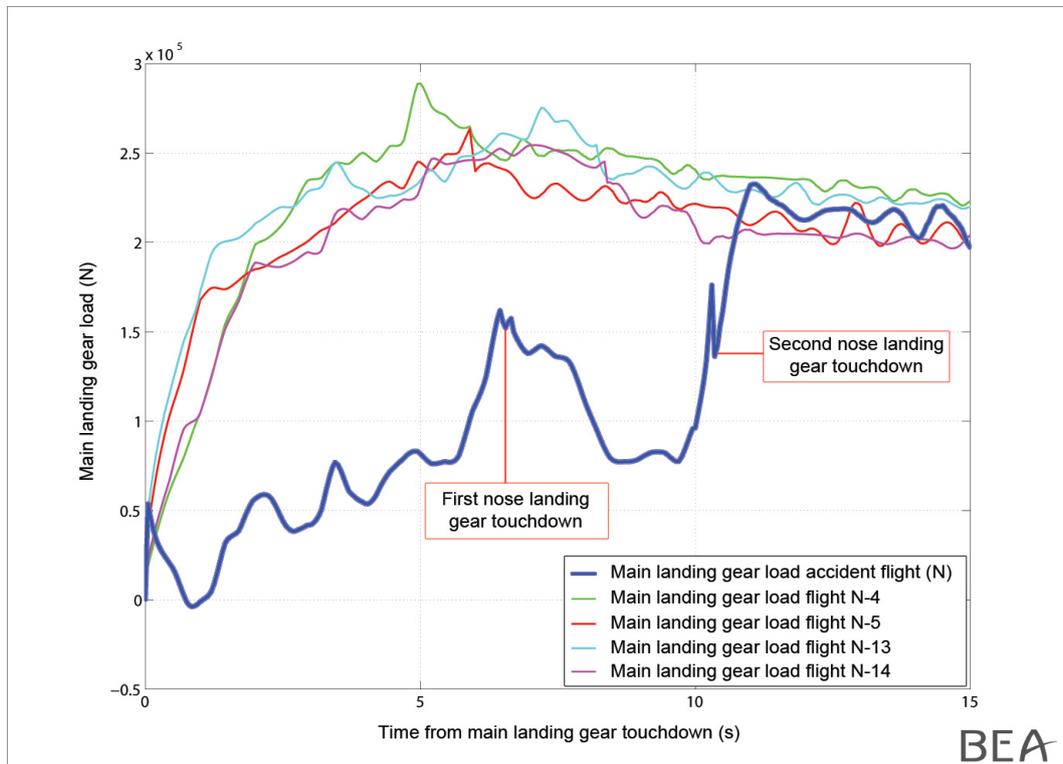
The calculated load on the main landing gear during the accident flight landing was about 2 to 3 times lower than for other landings during the first ten seconds of landing roll and then reached values similar to those of the other landings.

Figure 20: comparison of the vertical loads on the main landing gear

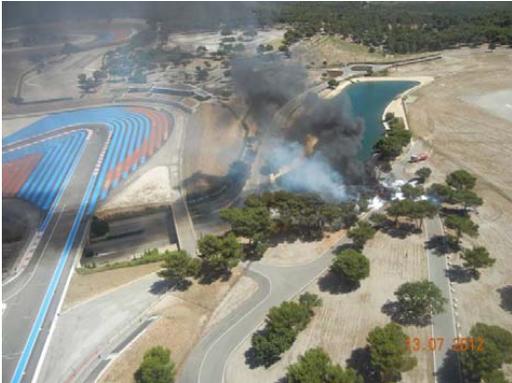
Photo 2

At 13 h 27 min 07s, the firefighter issued the following message: *"Except that the aeroplane is blocked ... it is cut into two and the rest of the aeroplane that is to say the cockpit is in the water"*.

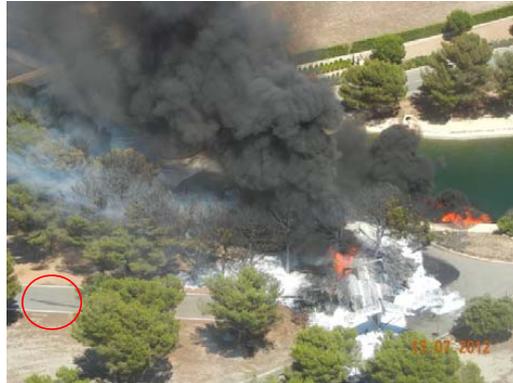
Photo 3

On photo 3, two outbreaks of fires are visible (wreckage and the slick of kerosene in the pond). The mark of water on the "east" road (red circle) shows the location of the first intervention (puddle caused by the drainage of the system).
