COMMAND OF AERONAUTICS
AERONAUTICAL ACCIDENT INVESTIGATION AND
PREVENTION CENTER

FINAL REPORT
A - 004/CENIPA/2014

<u>OCCURRENCE:</u>	ACCIDENT
<u>AIRCRAFT:</u>	PR-DOC
<u>MODEL:</u>	B200GT
<u>DATE:</u>	28 JULY 2012

This is the Final Report of the 28 July 2012 accident involving the B200GT aircraft, registration PR-DOC. The accident was classified as Controlled Flight into Terrain (CFIT).

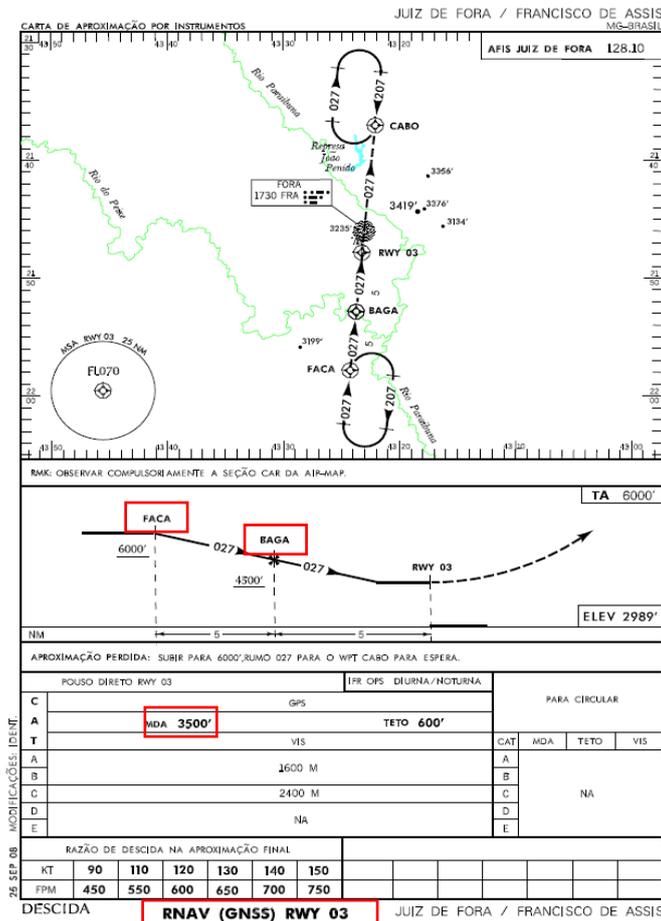
Figure 1 - RNAV(GNSS) Approach Chart for RWY 03.

According to the post-accident Inflight Inspection Final Report issued by the Special Group of Inflight Inspection (GEIV), the SBJF RNAV procedure utilized by the crew was considered satisfactory, and in accordance with the requisites and prescribed standards.

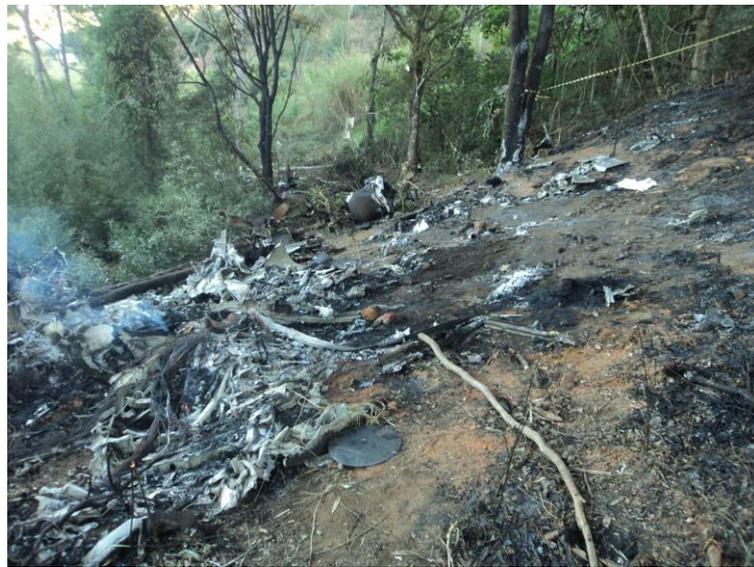
The first impact of the aircraft was against a tree at a distance of 245 meters from the runway threshold, at an elevation of 3,000ft.

Then, it collided with the ceiling of a kiosk of a resort known as *Pousada Hotel Aconchego de Minas* (at his moment, part of the right wing apparently detached, causing a leak of fuel). In the sequence, the aircraft hit the high voltage wires of the referred resort (with the resulting sparks igniting the fuel in the aircraft).

After moving approximately two hundred meters farther, the aircraft collided with the ground, and exploded on impact. The severity of the damage and the charring of the aircraft hindered a better verification of the aircraft equipment and instruments.

The final impact occurred 50ft below the level of the runway 03, with the trajectory of the aircraft aligned with the runway axis.

Figure 2 – Aspect of the wreckage.

The distribution of the wreckage was of the linear type.
