REPUBLIC OF KENYA
MINISTRY OF TRANSPORT AND INFRASTRUCTURE
DEPARTMENT OF AIR ACCIDENT INVESTIGATION

ACCIDENT REPORT

5Y-UVP

PRELIMINARY REPORT

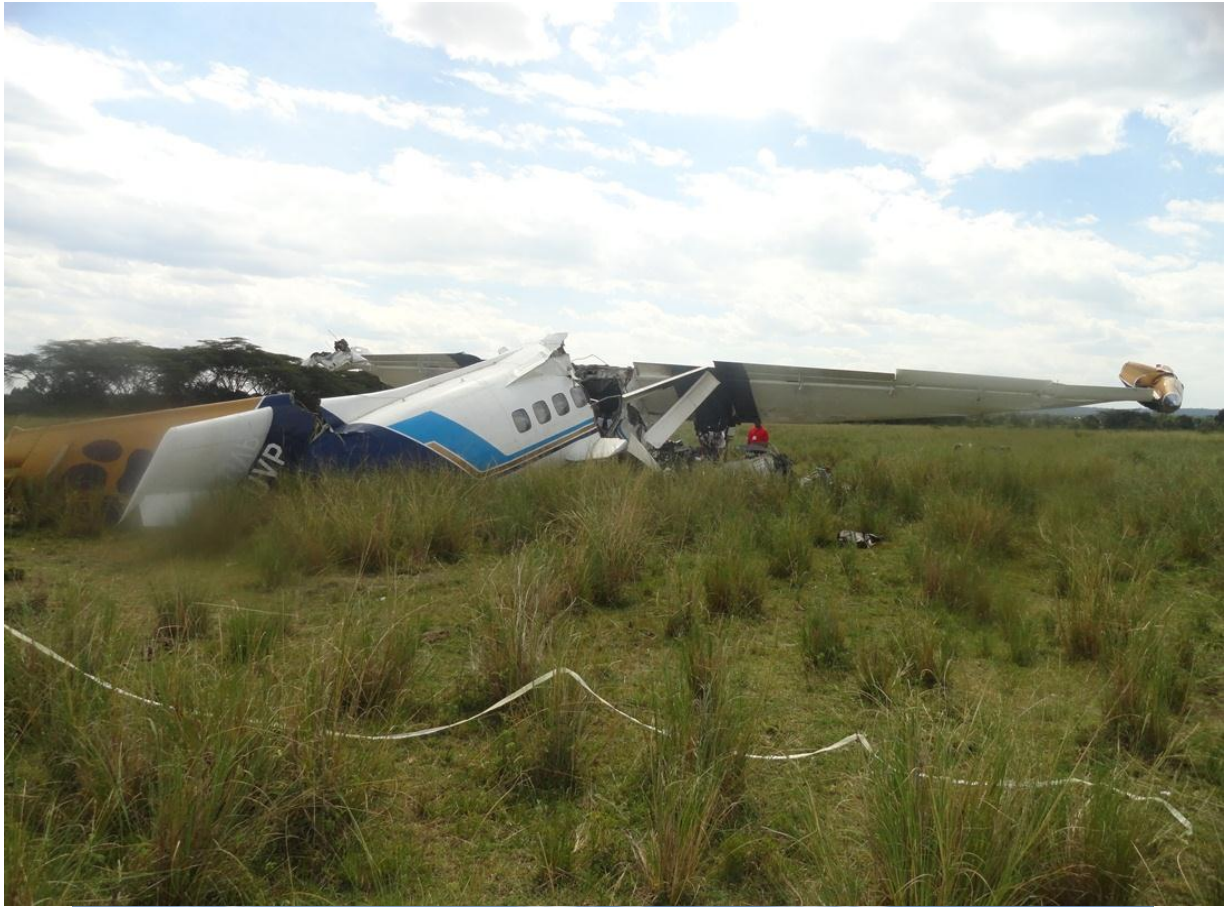
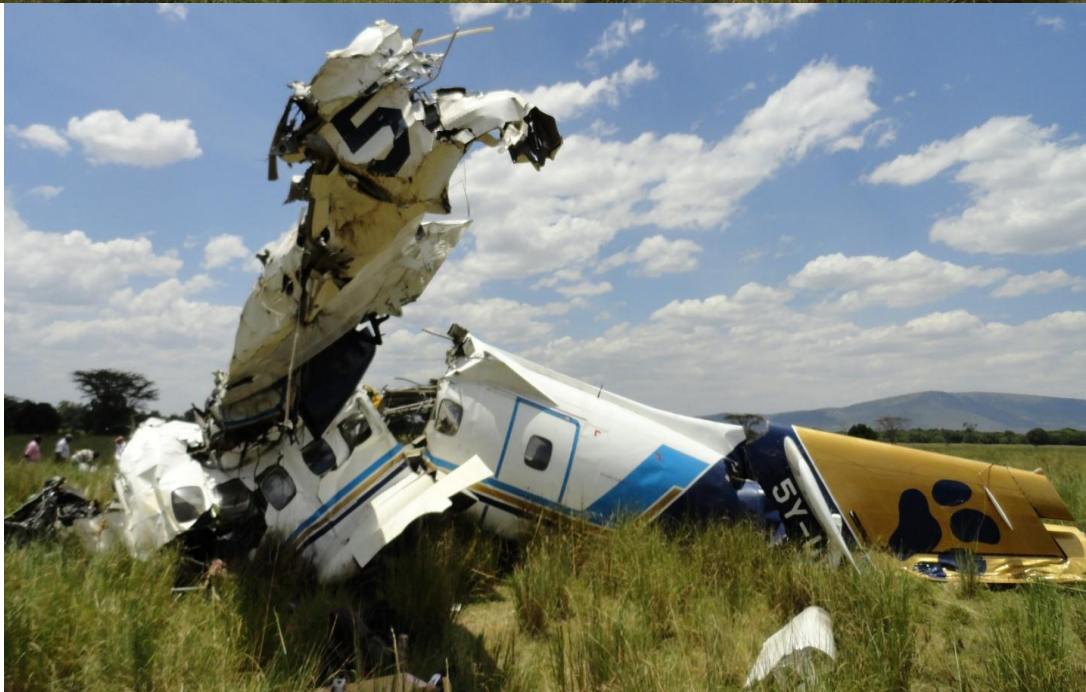
figure 1.1 accident site with the wreckage of 5Y-UVP

First responders reported the front/cockpit was completely destroyed. The passenger cabin had sustained severe damage.

The Aircraft was completely destroyed after it collided with terrain. No fire ensued afterwards.

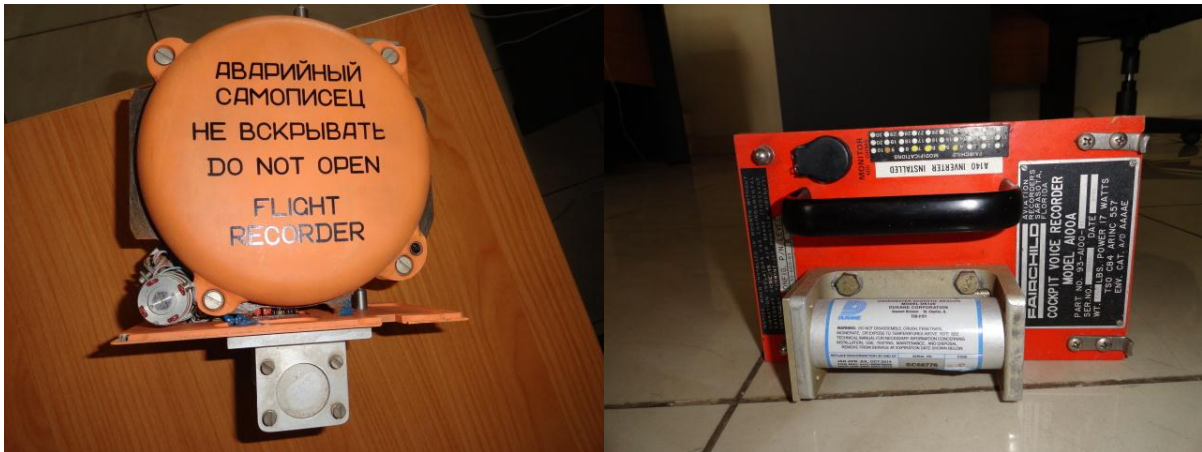
Fig 1.11.1: Flight data recorder & cockpit voice recorder recovered from the 5Y-UVP

The FDR of the aircraft LET-410 during the flight on August 22, 2012 was not serviceable and did not record any data pertinent to the accident flight. A copy of the FDR data was made and presented to AAID.

The CVR of the aircraft LET-410 during the flight on August 22, 2012 was not serviceable and did not record any data pertinent to the accident flight. The magnetic recording tape was severed and the drive unit assembly was also not serviceable. A copy of the CVR data was done and presented to AAID.

- i. KCAA to enforce the provisions of Kenya Civil Aviation Instruments and Equipment Regulations, specifically Part VI, regulation 36 and 37 and related sections
- ii. KCAA to consider inclusion of the aforementioned provisions in certificate of airworthiness inspection checklists
- iii. KCAA ascertain that aircraft in MAS are maintained in accordance with applicable laws, including but not limited to verification that facilities (AMOs) that carry out maintenance on MAS aircraft are duly approved.
- iv. Enhance training on single engine operation for twin engine aircraft, VMC roll procedures and other emergencies
- v. KCAA to establish an inspection program for aircraft fuel
- vi. KCAA to draw the attention of MAS and the industry at large to the provisions of ICAO Annex 6 – Operation of Aircraft, Chapter 6 dealing with the discontinuation of magnetic tape FDR/CVR
