AVIATION INVESTIGATION REPORT
A12Q0161

HARD LANDING AND AFT FUSELAGE STRIKE

**C-GUON DHC-8-301
OPERATED BY JAZZ AVIATION LP
GASPÉ AIRPORT, QUEBEC
10 SEPTEMBER 2012**

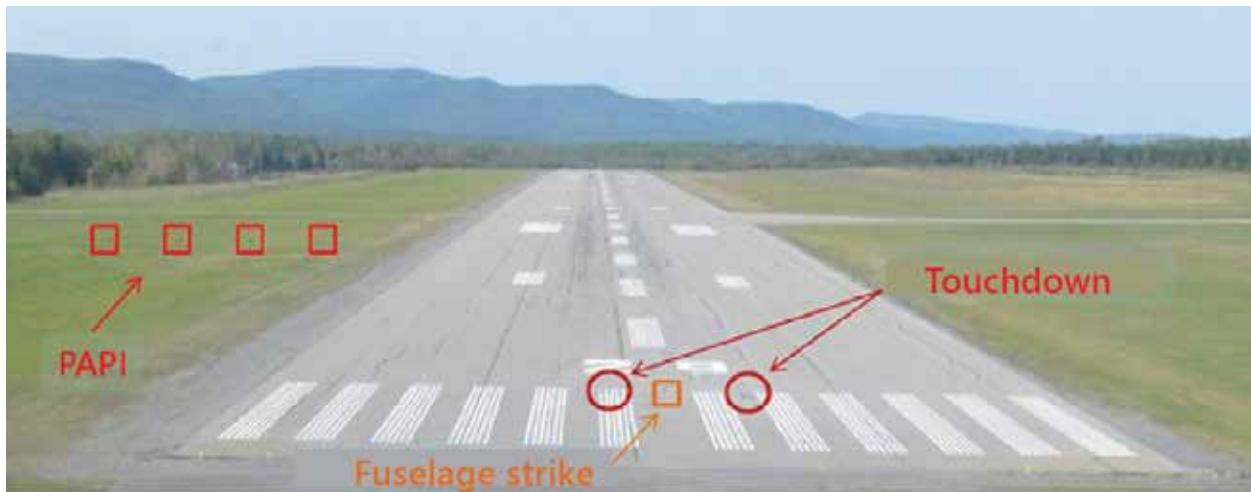
At 1412, the aircraft made a hard landing, during which the lower part of the aft fuselage came into contact with the runway and the “Touched Runway” indicator came on.⁶ The first wheel marks of the right main gear appeared at 109 feet from the threshold of Runway 29 (Photo 1). After landing, the aircraft backtracked normally on the runway, taxied, and parked in front of the air terminal at 1416.

Photo 1. Touchdown point of the wheels and fuselage

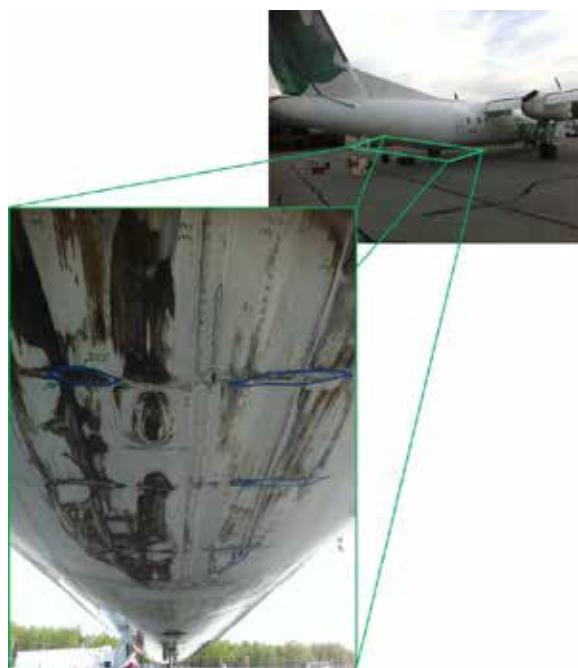
The examination of the aircraft revealed traces of the impact and scuff marks on the skin, structural stiffeners and longerons of the lower portion of the fuselage (Photo 2). Depressions and deformations of the skin were observed on the lateral surfaces of the fuselage under the wings and under the tail unit.

Photo 2. Damage observed under the fuselage (Source: Jazz Aviation LP)

1. The application of a pronounced nose-up control to reduce the rate of descent resulted in a nose-high attitude. This attitude, combined with a hard landing that compressed the oleos, resulted in the aft part of the fuselage striking the runway, causing significant damage to the aircraft structure.

The inspection after the hard landing was performed according to instructions in the aircraft maintenance manual (AMM)⁷ for the DH8C. Temporary repairs were made before the ferry flight to the manufacturer's repair centre at the Montréal–Mirabel Airport, Quebec. The permanent structural repairs were completed, and the aircraft was returned to service.
