Aircraft Serious Incident Report

In-Flight Engine Shutdown

Eastar Jet Flight 223

B737-700, HL8207

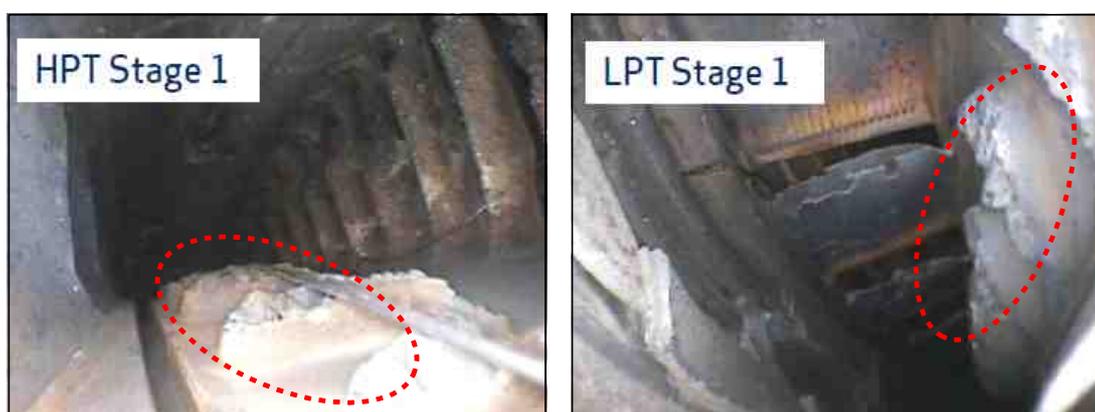
[Figure 3] Inside of HPT and LPT

After the airplane was transported to the maintenance facility, Eastar Jet's aircraft mechanic performed borescope inspection of the engine gas path. As shown in [Figure 3], all HPT stage 1 and LPT stage 1 blades of the right (#2) engine had missing airfoils.

4. The borescope inspection performed right after the event revealed that all HPT and LPT stage 1 blades of the right engine had missing airfoils, and that a lot of metal debris were found at the bottom of the turbine exhaust nozzle.

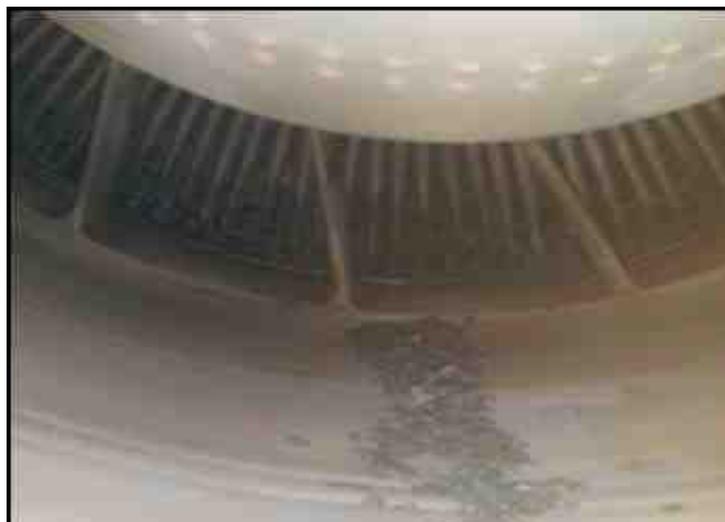
[Figure 4] Turbine Exhaust Nozzle

As shown in [Figure 4], a lot of metal debris were found at the bottom of the turbine exhaust nozzle at the 6 o'clock position. Damage of LPT stage 4 rotor blades and stator vanes was observed through the struts of the TEC.

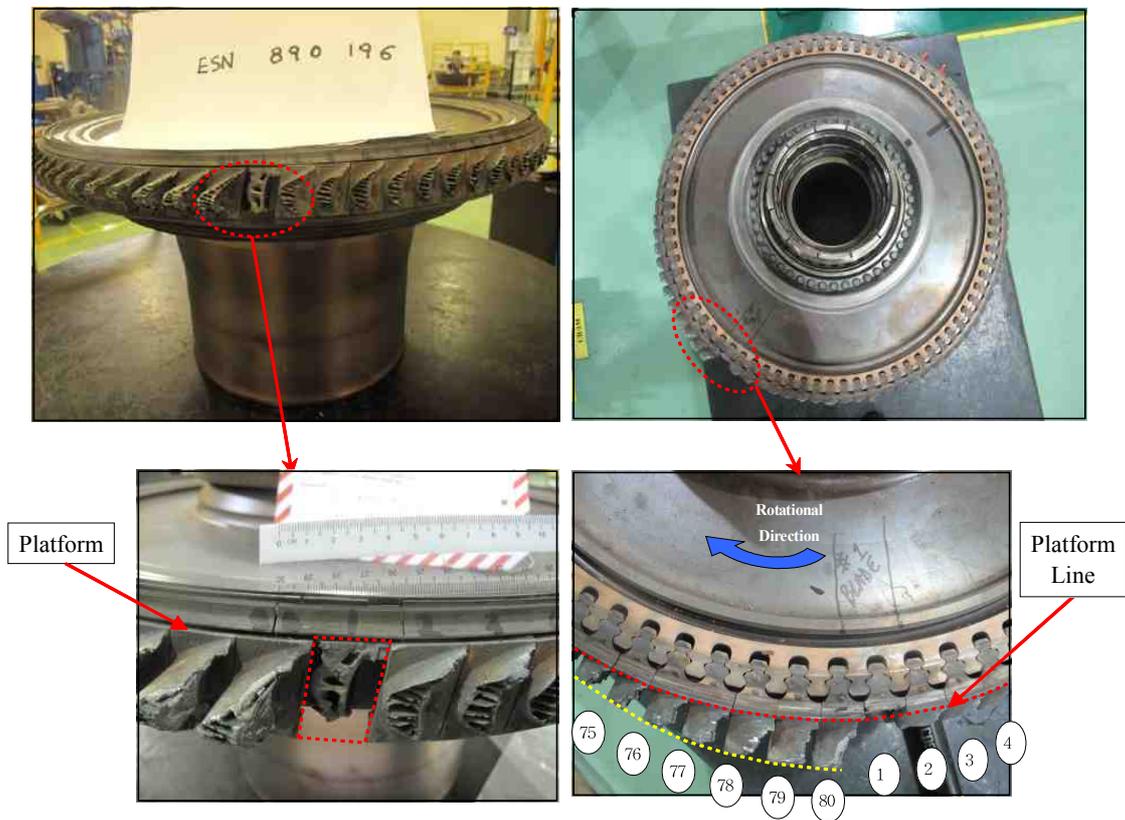
[Figure 5] HPT Rotor Disk and Blades

As shown in [Figure 5], HPT blades mostly had missing airfoils whose root sections only remained captured into the disk slots. One HPT blade (#1) was liberated under the platform, whereas the remaining 79 blades in the set had airfoil liberation above the platform.

When viewed from the rotational direction of the HPT rotor, #1 blade was the shortest of all, and the remaining blades were getting longer counterclockwise, with the last #80 blade being the longest. This indicates that #1 blade was initially liberated, and that the liberated fragments of #1 blade continued to impact neighboring blades by circumferentially rotating due to centrifugal force, thereby resulting in secondary damage.

Internal engine damage initiated from the HPT blades, some fragments of which were shot forward to the upstream engine modules, thereby resulting in the damage to the trailing edge of the NGVs. The blades of some HPC stages were curled at the tip of the airfoil, but the fan, booster, and combustion chamber were intact.

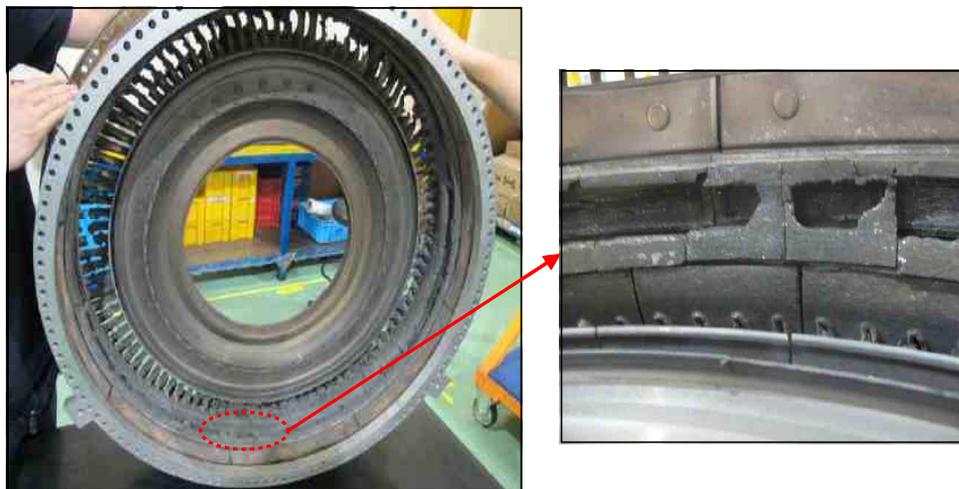
[Figure 6] HPT Shroud Assembly

As shown in [Figure 6], a total of 42 shroud segments attached to the HPT shroud assembly melted away or had large holes in all directions.

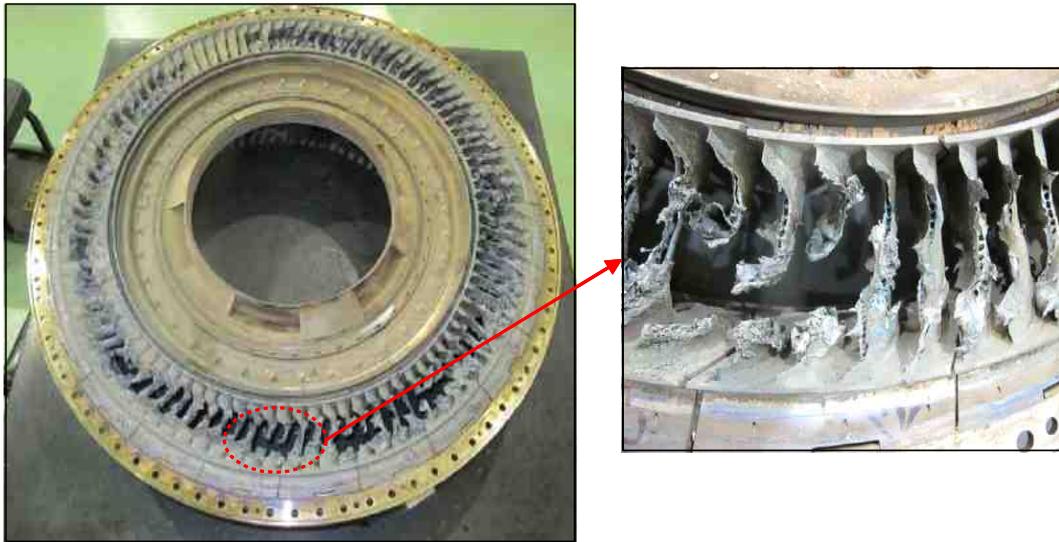
[Figure 7] LPT Stage 1 NGVs

As shown in [Figure 7], most airfoils of the LPT stage 1 NGVs were melted by high temperature.

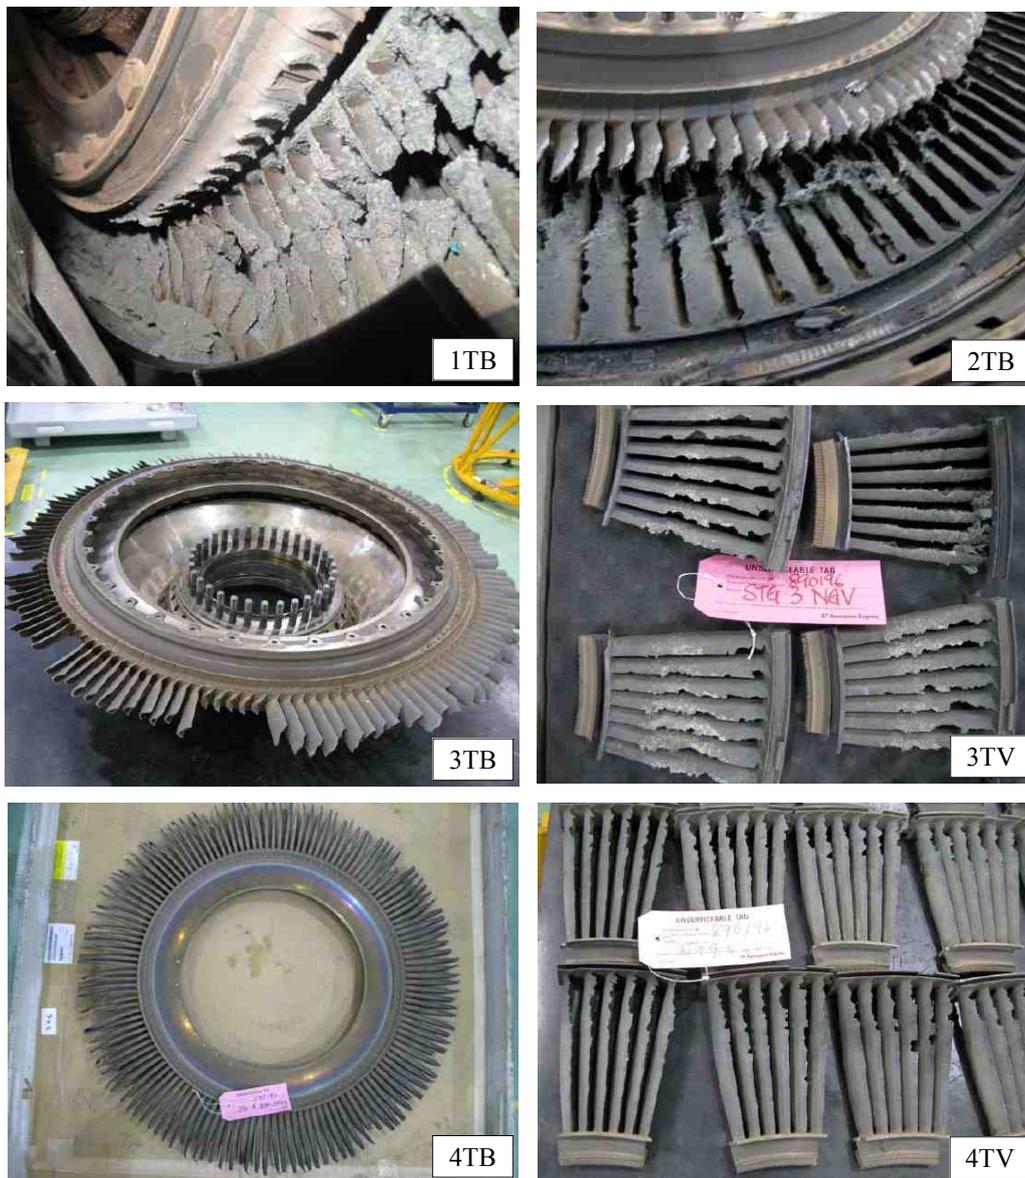
[Figure 8] Stage-by-stage Damage of the LPT Blades and Vanes

As shown in [Figure 8], all stages, 1 to 4, of the LPT sustained serious damage. Earlier stages were damaged much more than later ones. All airfoils of the LPT stage 1 blades were missing, and about 80% of the LPT stage 2 blade airfoils were liberated. The LPT stage 3 blades exhibited about 30 to 40% loss of the airfoils, some of which were missing right above the platform. About 10 to 20% of the LPT stage 4 blade airfoils were liberated along the outboard circumference.

7. All LPT blades and vanes from stages 1 to 4 were damaged by impact and high temperature, with relatively more damage in earlier stages.
8. Although the affected HPT #1 blade was once overhauled and has been

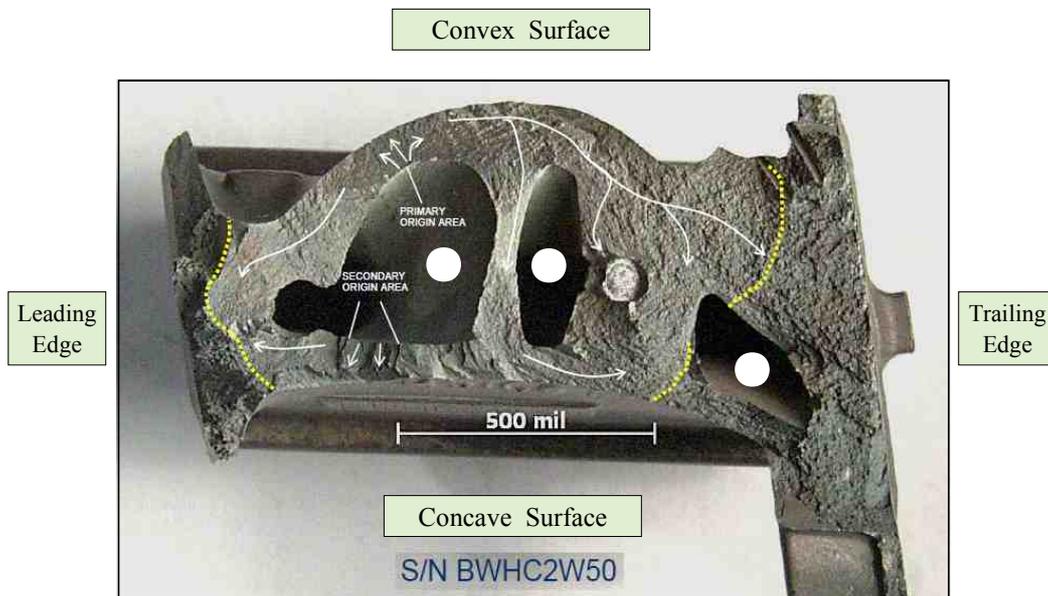
[Figure 9] HPT Blade Fracture Surface

Primary fatigue crack initiation of the HPT blade with S/N BWHC2W50 occurred from internal convex (CVX) surface located within cavity #1 shank transition zone.¹³⁾ Evidence of secondary fatigue crack initiation was also observed from internal concave (CCV) surface of cavity¹⁴⁾ #1 shank transition zone. As shown in [Figure 9], white arrows show the direction of the fatigue crack propagation. Yellow dotted lines show a transition from fatigue crack growth mode to tensile overload mode. This indicates the crack location at the time of liberation and the engine event.

used within the maximum permitted cycles recommended by the manufacturer, metallurgical inspection revealed that its fracture surface exhibited transition zone fatigue crack caused by long service hours.

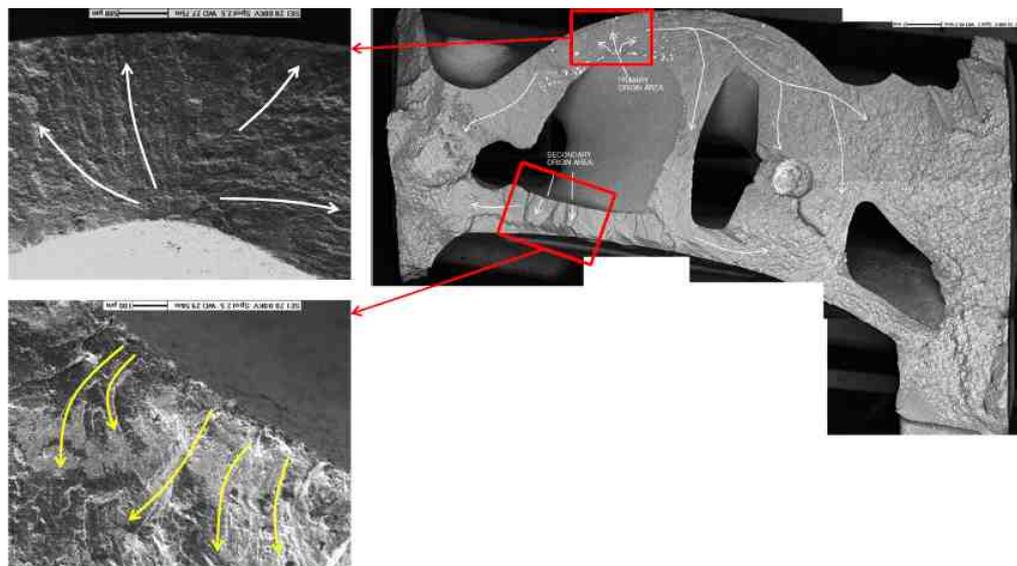
[Figure 10] HPT Blade Fracture Surface

As shown in [Figure 10], the fracture surface is heavily oxidized, but there is enough interpretable evidence to identify the primary crack origin area on the convex wall (white arrows). There is also evidence of a secondary crack origin area on the concave wall with multiple interacting initiation sites (yellow arrows).

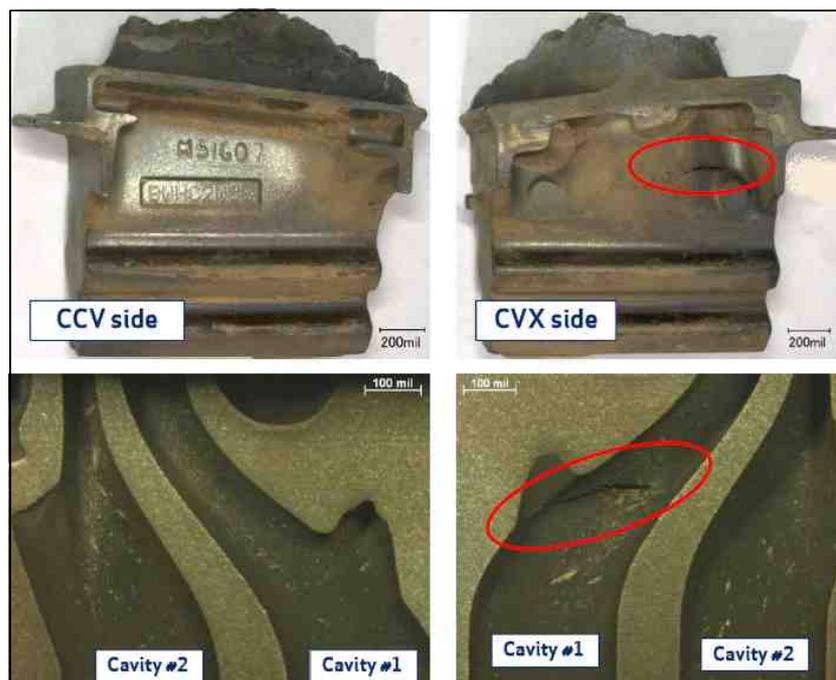
[Figure 11] Through Wall Transition Zone Crack

Visual inspection of the remaining 79 blades revealed seven blades with through wall transition zone cracks visible on the external convex wall. As shown in [Figure 11], these cracks were found only on the convex wall of cavity #1 on the leading edge of the blade, with no cracks on the concave wall of cavity #2 and #3. Also, all the blades with cracks had the same P/N, 1957M10P01.

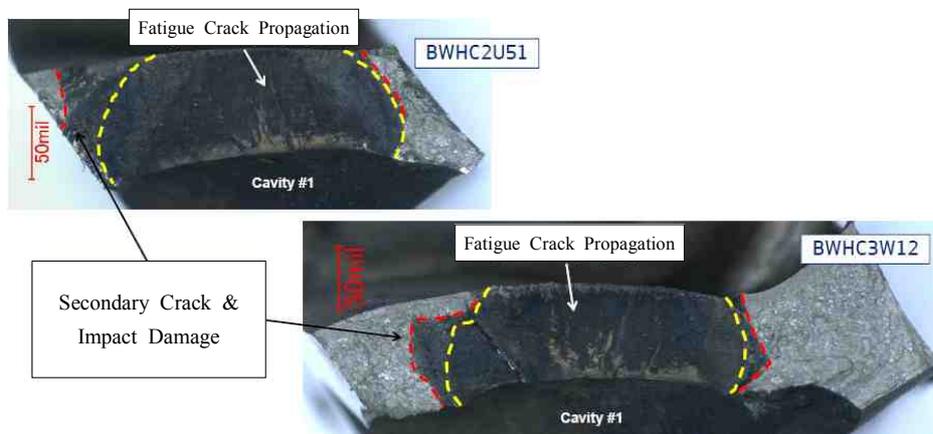
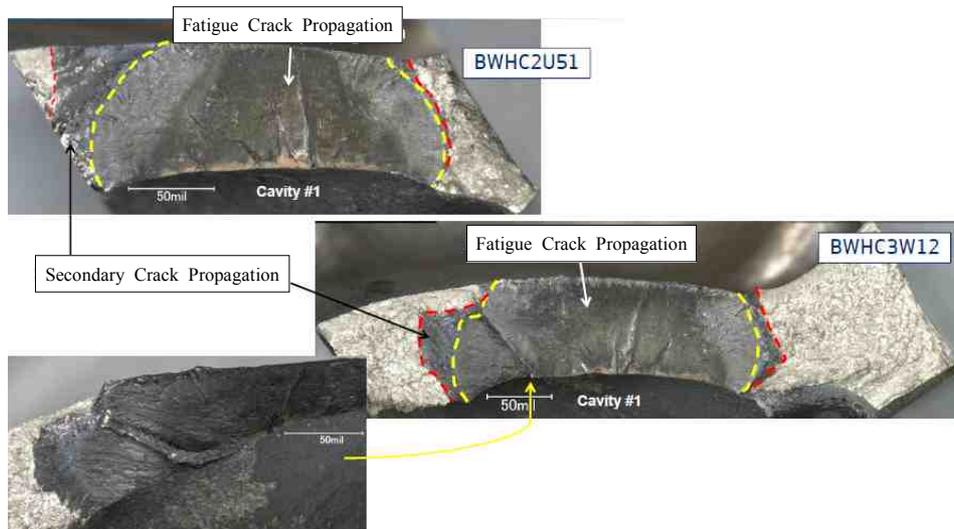
[Figure 12] and [Figure 13] show lab fractured through wall transition zone cracks of the two out of seven affected blades. [Figure 13] is a macro photo showing lab fractured convex through wall transition zone cracks of the blades after ultrasonic cleaning. Yellow dotted lines show the initial crack region where fatigue cracking initiated from the internal convex surface within cavity #1 and propagated. Red dotted lines exhibit the secondary crack region where cracking was induced by impact damage: tensile overload mode which occurred due to impact during the engine event.

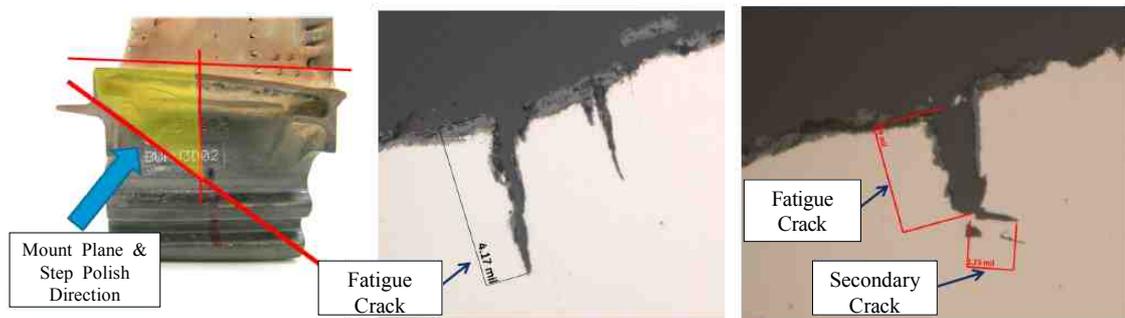
[Figure 14] Evaluation of TZ Cracks and Internal Coating Thickness

As shown in [Figure 14], the remaining 72 blades, except seven with through wall transition zone cracks, were all sectioned in the shank transition zone per the diagram shown and step polished four times in the upward direction for measuring transition zone crack depth and internal coating thickness. The secondary cracking induced by impact damage during the engine event was not included in the maximum fatigue crack depth measurement.

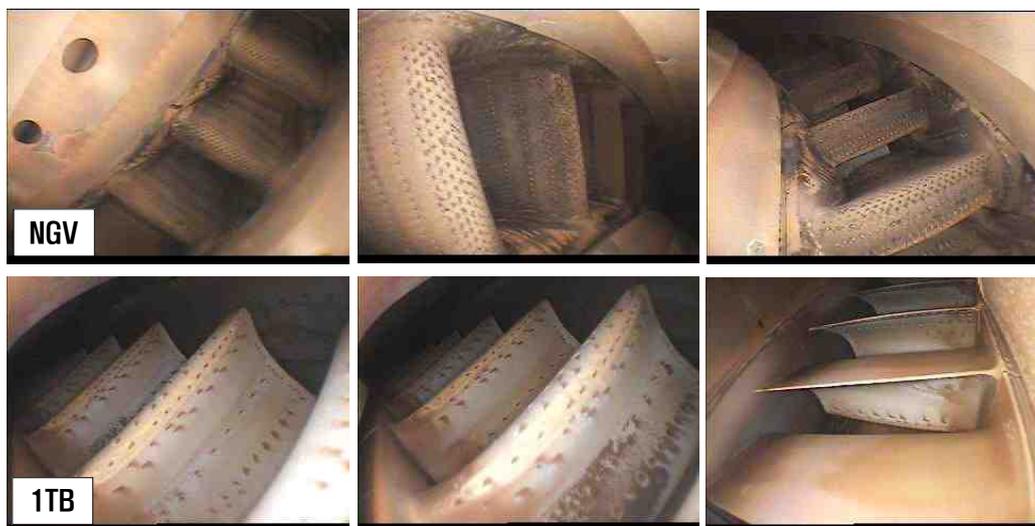
[Figure 15] Borescope Photos of HPT NGV (up) & Stage 1 Blades (down)

Eastar Jet regularly performed borescope inspection of the HPT blades for any defects. The condition of the HPT blades was to be inspected every 1,600 cycles according to the work sheet,¹⁶⁾ and the last inspection was performed on 8 July 2012, about three months before the event. As shown in [Figure 15], a work log written at that time showed that the HPT blades and NGVs were generally in good condition, with no signs of thermal damage or cracking.

1. In case the HPT blades with P/Ns 1957M10P01 and/or 1957M10P03 are installed on the CFM56-7B engine, seek measures, including borescope inspection at a shorter interval, to identify a defect in the blades beforehand and incorporate them in your maintenance program (ARAIB/AIR1206-1).

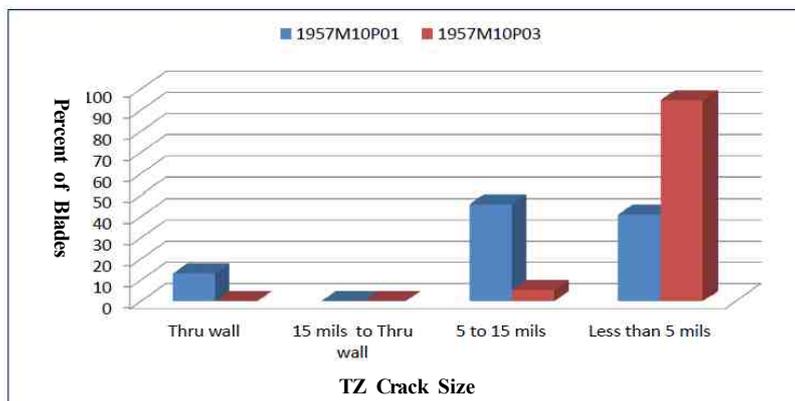
[Figure 16] TZ Crack Size

The HPT blades were all sectioned in the shank transition zone to measure the TZ crack depth, and the measurement data is presented in a graphical format by P/N as shown in [Figure 16]. The blades with P/N 1957M10P01 have more severe TZ cracks than those with P/N 1957M10P03. The latter were new when installed, accumulating 8,516 cycles since new, whereas the former were reused after the overhaul, accumulating 23,491 cycles, which indicates that, as cycles accumulate, occurrences of TZ cracks and their size increase.
