# **FOKKER F-28 MK 0100, XY-AGC** **ACCIDENT NEAR HEHO AIRPORT (VYHH)** **ON 25 DECEMBER 2012**

## **Executive Summary**

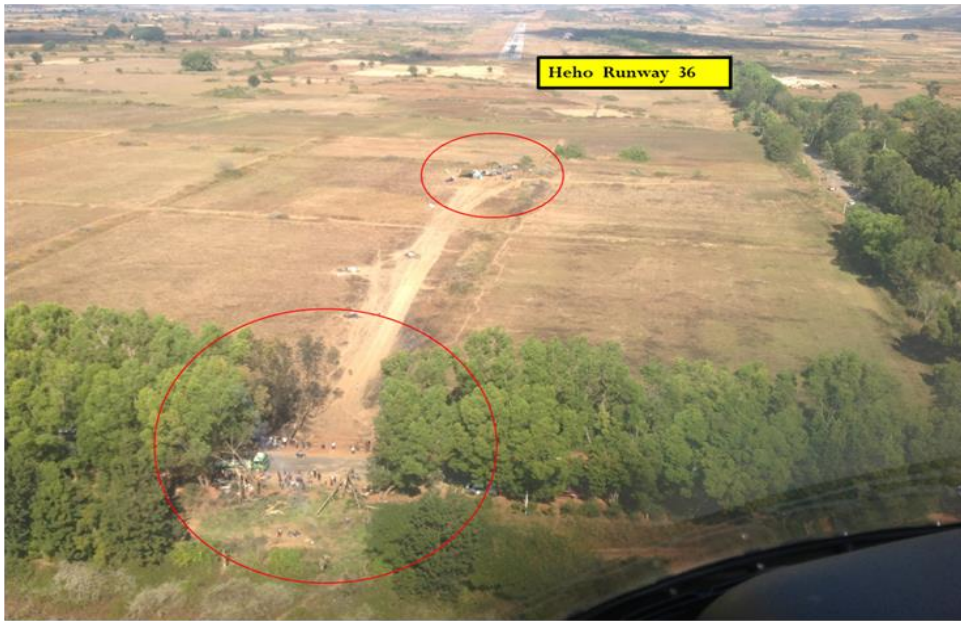
Figure 3: Accident site,

During the final inbound track at about 2.5 NM to the runway at 08:52:349, the EGPWS aural warning called out "500". The Pilot in command initiated "Alt hold" at about 0853, just before the EGPWS alert "100" "50" "40" "30" and the aircraft struck 66 KV power lines, trees, telephone cables, fence and collided with terrain short of the runway, coming to rest approximately 0.7 NM from the threshold. During the ground collision, both wings separated and a fire commenced almost immediately. An emergency evacuation was initiated by the cabin crews. One aircraft occupant and one motorcyclist on the ground were fatally injured, 70 of the occupants and one motorcyclist survived and the aircraft was destroyed by fire. (Figure 3).

The accident site was located in a paddy field about 0.7 nm from the threshold of Heho runway 36 at an elevation of 3934 ft. The initial strike with 66 KV electrical power lines was about 39ft. After aircraft struck the trees located both sides of road, left wing separated and fell on the road. For that moment a motor cycle with two motorcyclists, were passing on the road and were struck with aircraft debris and burned with aircraft drainage fuel. Right wings separated before the aircraft came to rest. The main fuselage, both engines and the landing gears remained together. The tail assembly had detached but remained connected to the fuselage by the flight control cables. The aircraft was subsequently destroyed by fire.

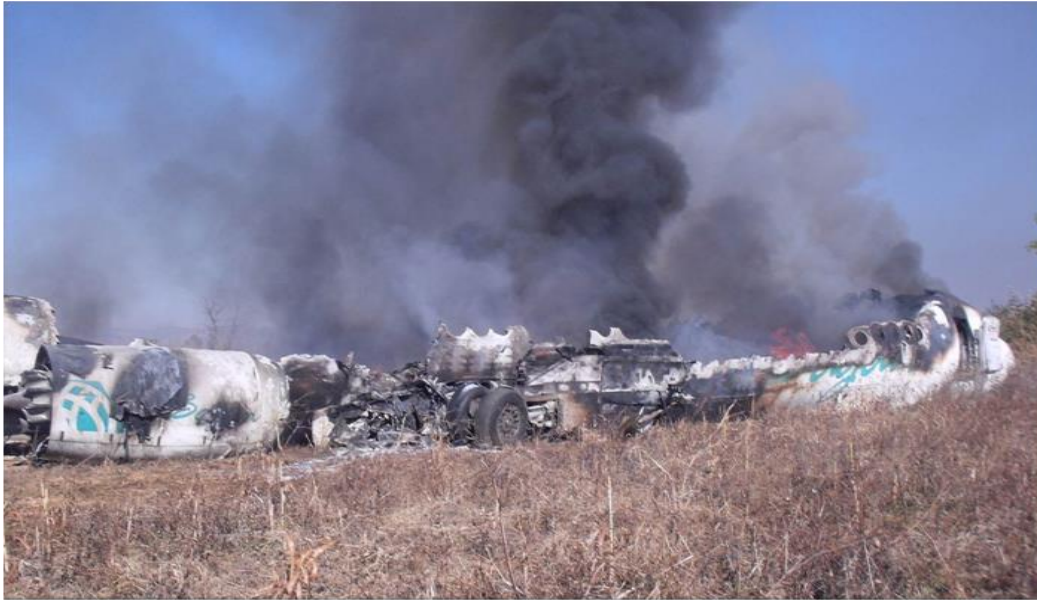
Figure 4: Damage to Aircraft

Both wings had separated before the aircraft came to rest. The main fuselage, both engines and the landing gear remained together. The tail assembly had detached but remained connected to the fuselage by the flight control cables. The remainder of the aircraft was subsequently destroyed by fire. (Figure 4).

- Both of the wings were broken off and separated from the aircraft fuselage .
- The landing gears was fully extended (down and locked).
- Flap position was fully extended (42°).
- Both forward doors were opened, the forward cabin left door slide activated and deployed. The service door slide on the right side was not deployed .
- Left side over wing exits were opened but right side over wing exists remained closed.
- Both engines were in tacted with fuselage and compressors can be freely rotated.
- All the instruments and avionics compartment were burnt .
- SSCVR was collected along the wreckage trail but SSFDR was collected at crash site after post-impact fire .
- The aircraft structure was totally destroyed by the post-impact fire .

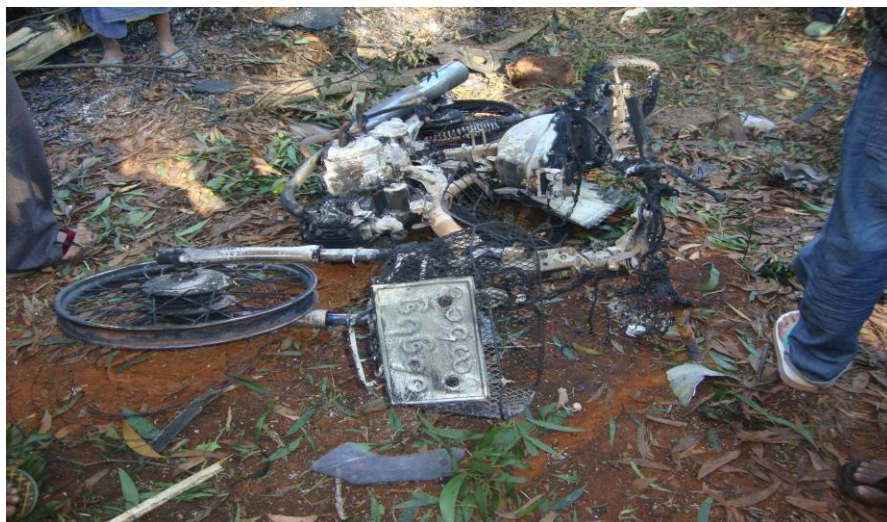
Figure 5: Damage to motorcycle

There was other damage to a 66 KV power lines, trees, 11 KV power lines, a telephone cables, a fence and a motorcycle. As the aircraft struck the trees, a motor cycle with two motorcyclists passing on the road, aircraft debris struck the motorcycle. The motorcycle was destroyed. (Figure 5).

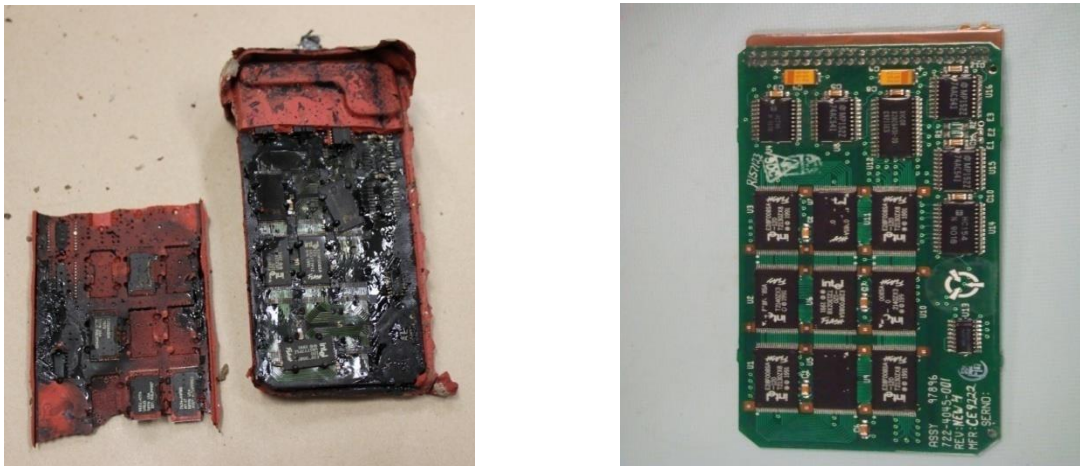
Figure 6: FDR memory module (accident module on left, normal module on right)

The SSUFDR's construction was outer steel housing, insulation liner, thermal block and memory board with 9 chips. The SSUFDR was severely burnt during the post-impact fire and significantly damage by fire. SSUFDR circuit board was removed at ATSB Lab. It is required special techniques to recover the recorded information. ATSB contacted to manufacture Honeywell and with the instruction of Honeywell carefully removed each chip from circuit board and downloading. A track plot of the flight is contained in figure and recorded information from the flight is included in ([Appendix-D](#)).

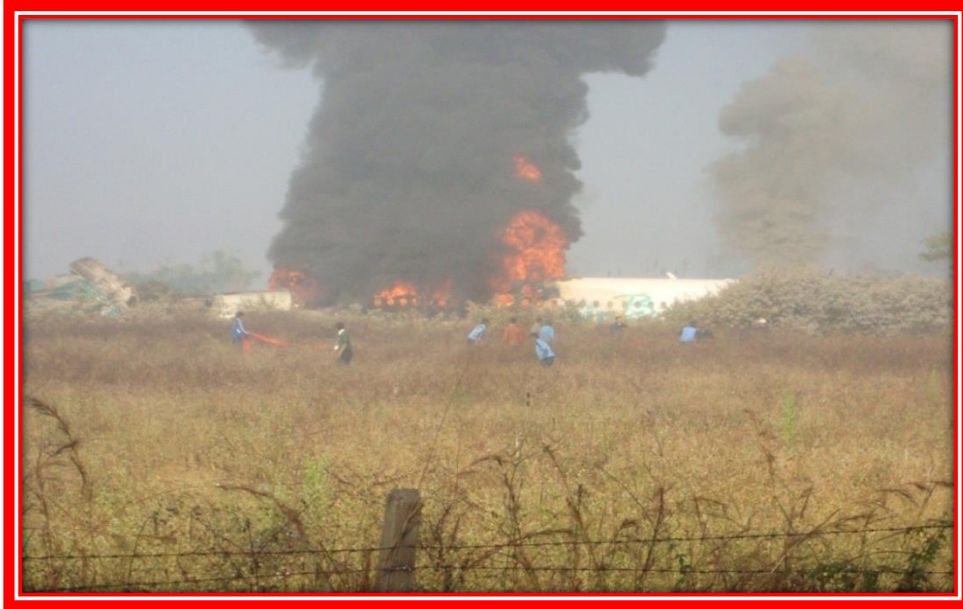
Figure 9: Fire Fighting

Both of the wings were broken off by the trees and the aircraft fuel tanks were disrupted during the impact sequence. The aircraft fire was initiated by electrical arcing and / or ignition of the residual fuel. There was no evidence of an in-flight fire (Figure 9).

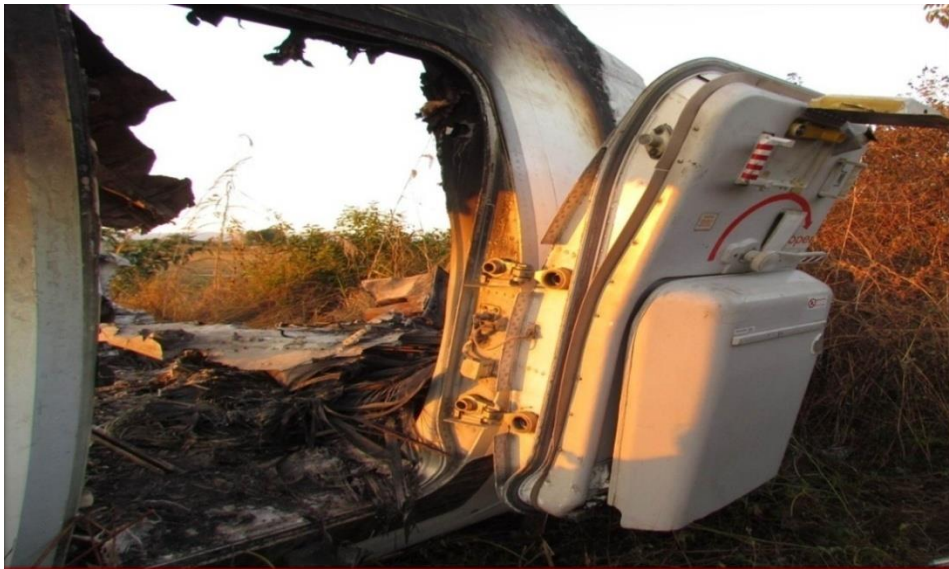
Figure 10: Forward cabin door (right side).

The forward cabin door left door slide activated and deployed but the cabin crew deactivated the service door slide on the right side, due to the close proximity of the ground and so it was not deployed (Figure 10).

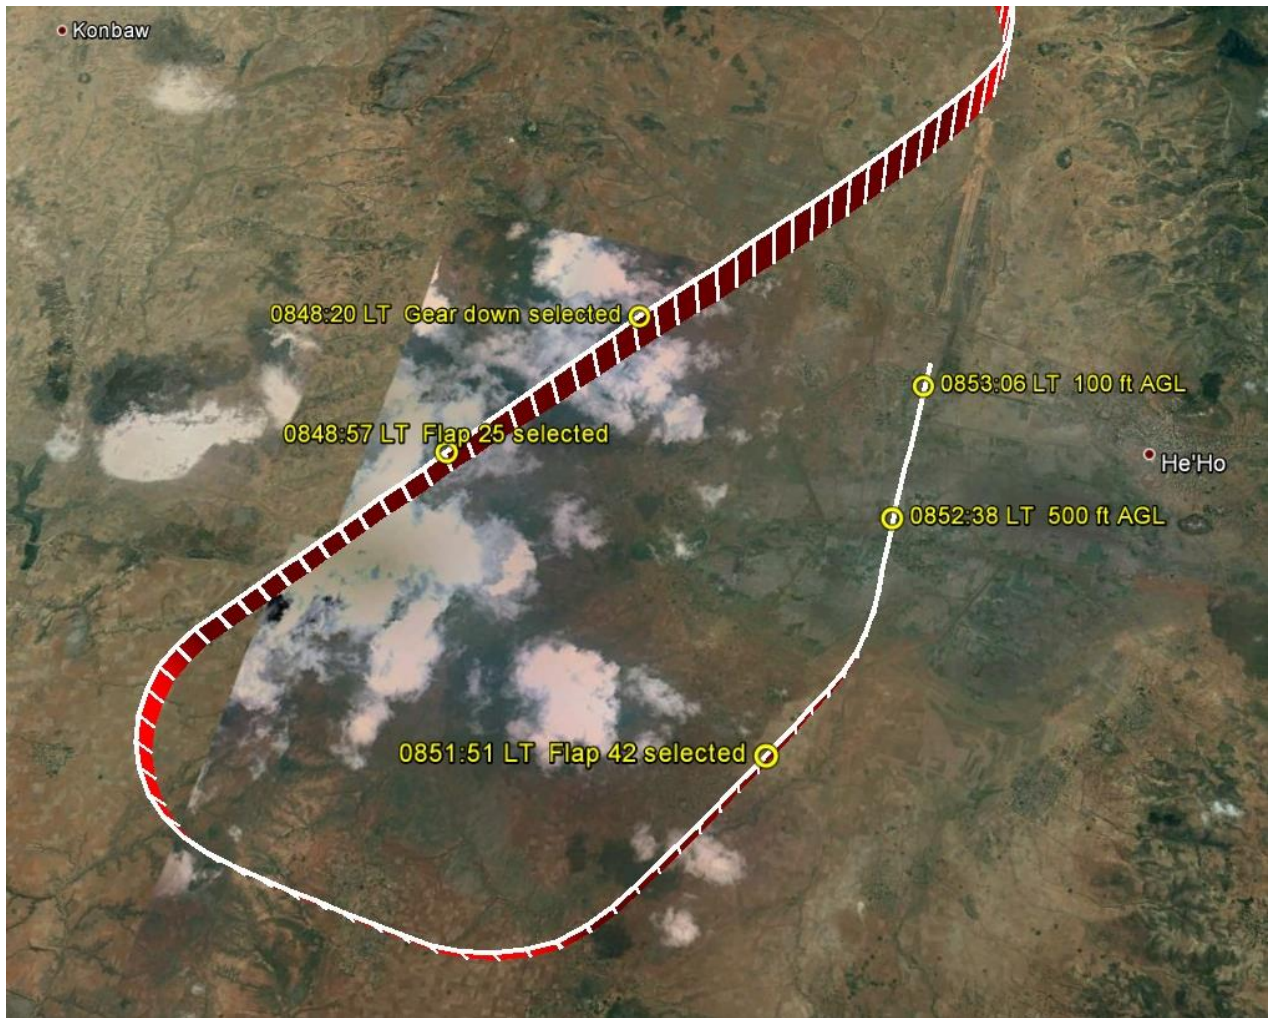
Figure 11: Vertical flight path Heho

FDR and CVR data showed the accident flight path to Heho airport. The layout of Heho airport was examined and geographic features was used to plots flight path. (Appendix-D)

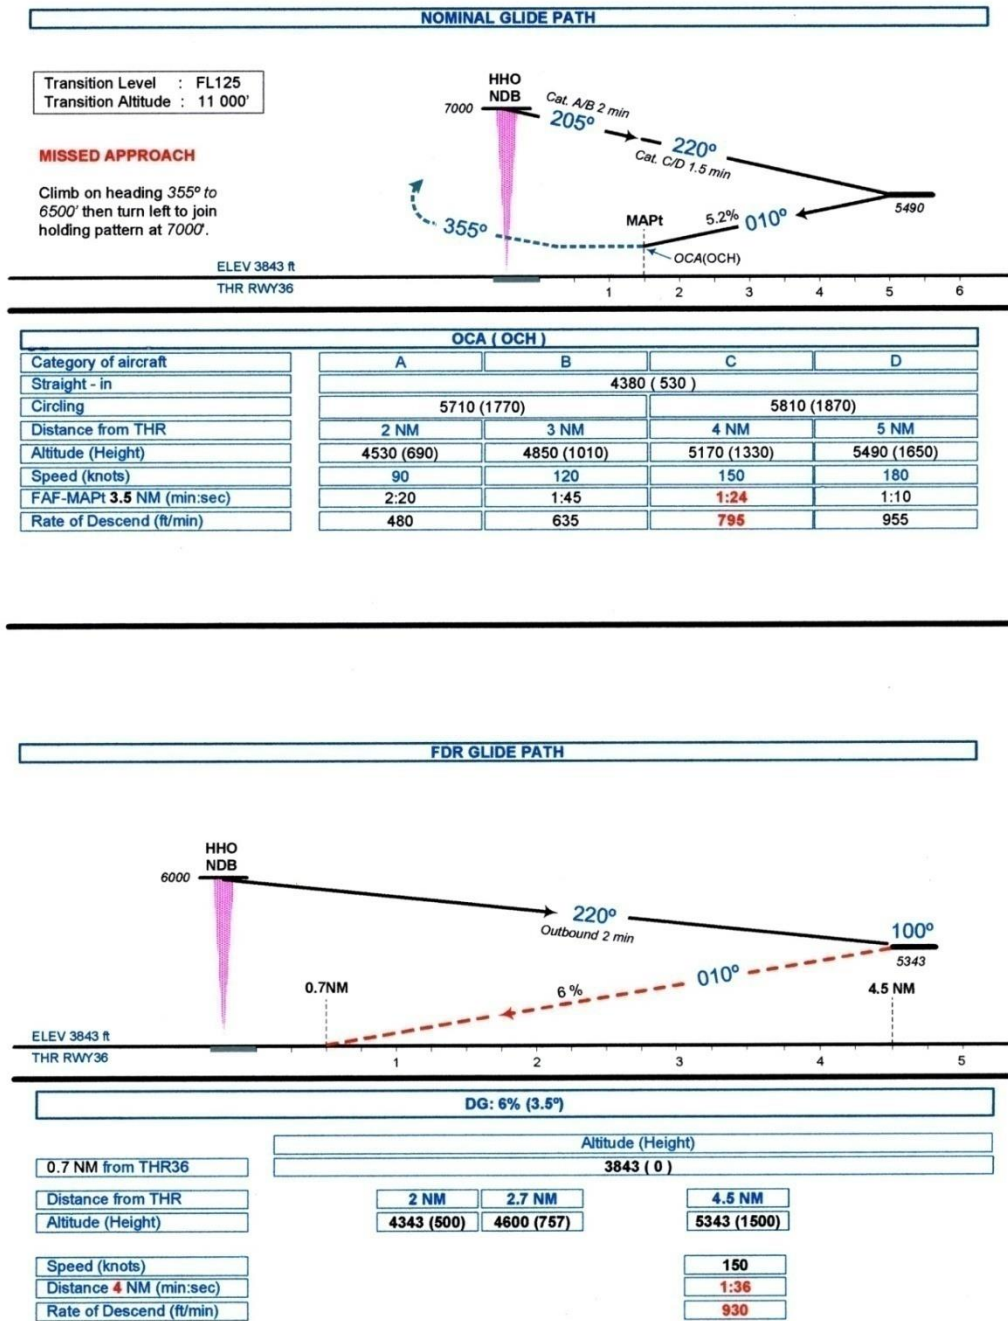
Figure 14: Normal Flight path & FDR Flight path

According to the CVR Transcript, R/A call out (500, 100, 50, 40, 30) aural activated and Terrain Clearance Floor (TCF) alert warning are not activated. Fokker 70/ 100, AMM 0100 Manual chapters-34,43,00 ZZ 2-810-E, Page-4 (Terrain Clearance Floor and Runway Field Clearance Floor) and Page-9 (Figure-34- 43 – 00 – 990- 040- E00, EGPWS Terrain Awareness Alerting) describe that, when the aircraft goes through a limit (boundary) of the alert envelope, the GPWS warning lights come on, the aural warning "TOO LOW TERRAIN" is given. In regard of the FDR results the aircraft was above the limit of the alert envelope before collision.
