Air Accident Investigation Unit Ireland

SYNOPTIC REPORT

ACCIDENT
FAIRCHILD - SA227AC Metro III, D-CAVA
Dublin Airport, Ireland (EIDW)
7 March 2013

AAIU Report No: 2013-010
State File No: IRL00913022
Report Format: Synoptic Report
Published: 9 July 2013

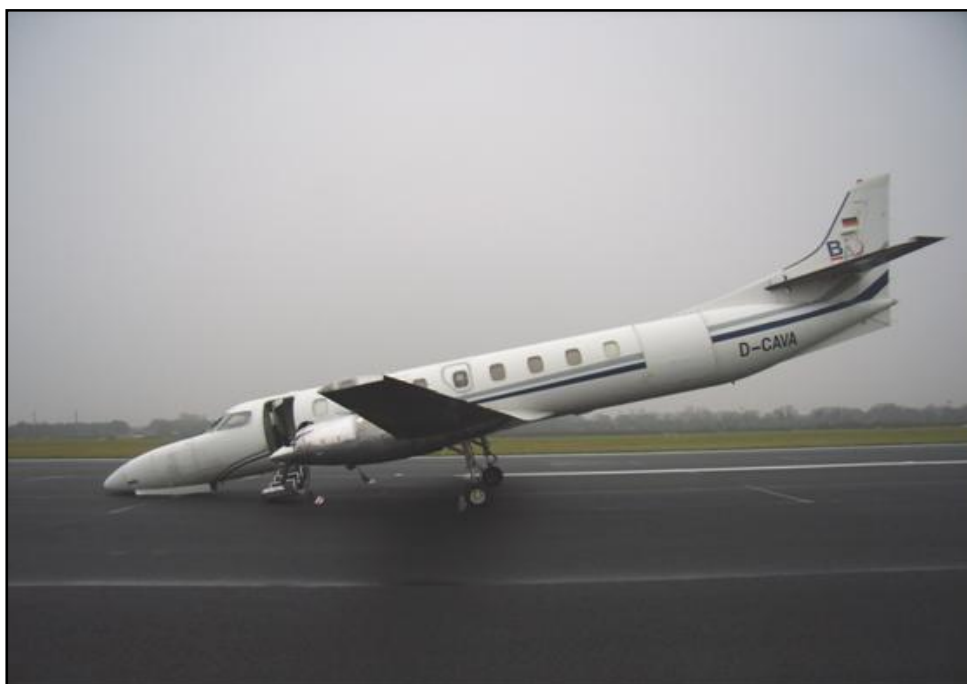
During the landing roll, the landing gear selector was inadvertently moved to the UP position. This mistake was immediately recognised and the selector was returned to the DOWN position but the nose-wheel, which had started to retract, continued retracting, resulting in substantial damage to the aircraft.

Photo No. 1: D-CAVA as it came to rest on RWY 10

3. The landing gear was selected to up momentarily during the landing roll.
4. The nose wheel retracted causing both propellers to strike the runway.
5. The aircraft came to rest blocking RWY 10.

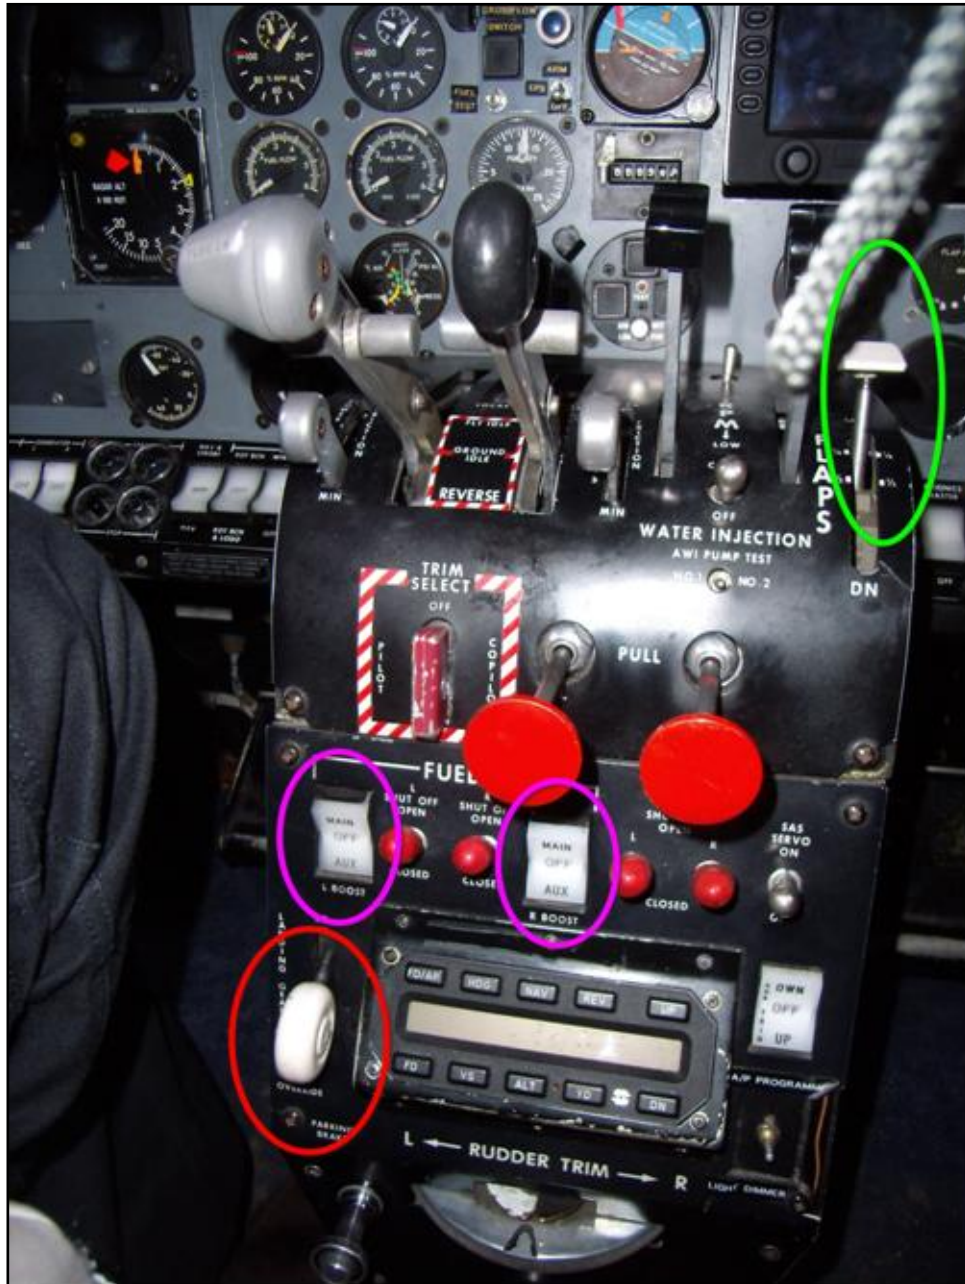
The Investigation considered the ergonomics and layout of the cockpit pedestal. **Photo No. 2** shows the pedestal with the landing gear selector (red), flap selector (green) and booster pump switches (purple) ringed. The Investigation noted that both selectors are lever actuated. The Investigation further noted that whilst the gear and flap selector knobs are coloured white, the knob geometry is different (circular for the landing gear, rectangular for the flap).

The Investigation observed that the selectors are not in close proximity being located on diagonally opposite corners of the pedestal. Consequently, the Investigation does not believe that there is any obvious visual mis-cueing or co-location of landing gear and flap selectors which may have prompted the mis-selection.

Photo No. 2: Positions of landing gear (red), flap (green) and booster pump (purple) selectors

The Investigation noted that the booster pump selectors are white coloured and located above the landing gear selector. The Flight Crew stated that booster pumps were one of the memory item checks to be completed prior to leaving the runway, so attention would have moved to that area of the pedestal. However, the nature of the selectors is different; the landing gear is a single lever whilst the booster pumps are selected via two separate 3-position switches. Consequently, the Investigation believes that, notwithstanding their close proximity on the cockpit pedestal, there is no obvious visual mis-cueing of landing gear and booster pump selectors which may have prompted the mis-selection.

10. The PF could not provide any explanation for his lapse in selecting the landing gear to UP.
11. Examination of the cockpit pedestal did not reveal any specific design concerns which may have contributed to the lapse.
