**AVIATION INVESTIGATION REPORT  
A13A0075**

**LOSS OF CONTROL AND COLLISION WITH WATER**

**GOVERNMENT OF NEWFOUNDLAND AND LABRADOR  
AIR SERVICES DIVISION  
CL-415, C-FIZU  
MOOSEHEAD LAKE, NEWFOUNDLAND AND LABRADOR  
03 JULY 2013**

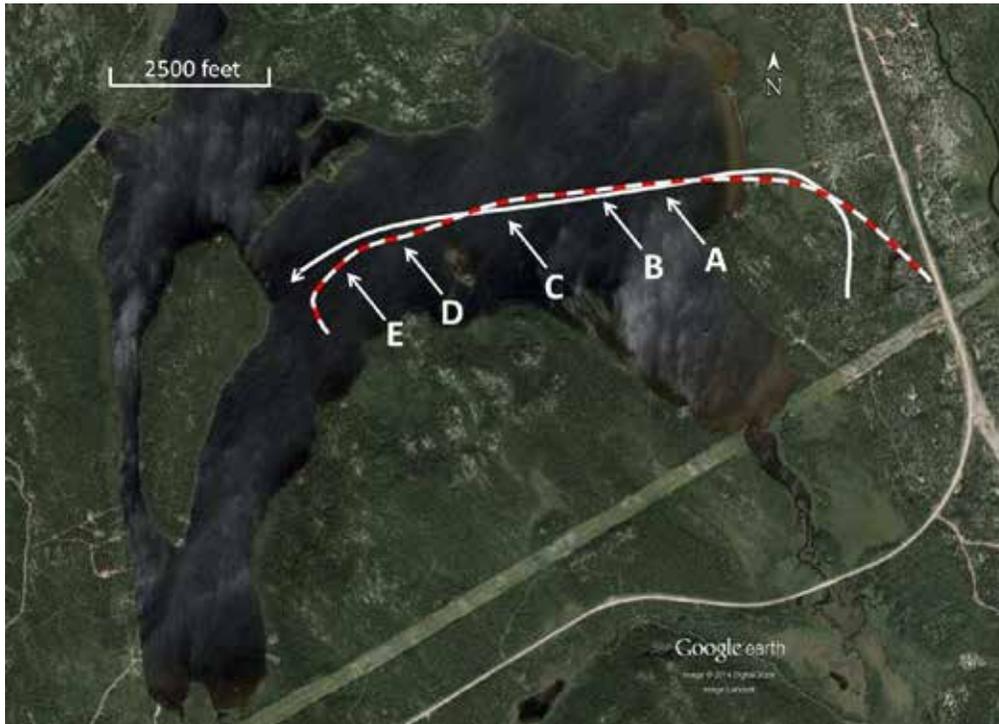
Figure 1. The track of a previous flight (solid line) and the track of the occurrence flight (dashed line)

About 4 minutes after take-off, the aircraft touched down about 1250 feet from the eastern shore of the lake (Figure 1), on a heading of 250° true (T). The PF then applied take-off power, and the PNF began adjusting the torque limit stops (herein referred to as soft stops). Throughout the scooping run, the PNF was focused on ensuring that the soft stops were set as per the PF’s instructions.

While adjusting the soft stops, the PNF noted that the water tanks were completely full, and advised the PF that the probes were still down and the PROBE AUTO/MANUAL switch was in the MANUAL selection. The PNF then manually selected the probes up. The probes retracted about 3490 feet after touchdown (point D).

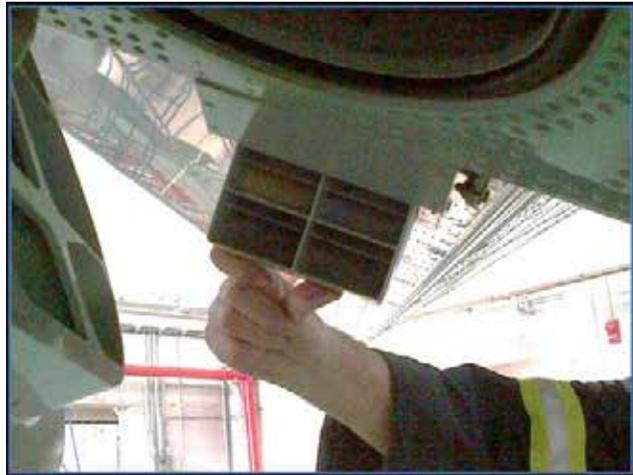
Photo 1. Water probe

About 1200 feet (11 seconds) later, the water probes<sup>2</sup> (Photo 1) would retract (point B), and liftoff would occur about 925 feet (10 seconds) after the probes had been retracted<sup>3</sup> (point C). All flights were made with the PROBES AUTO/MANUAL switch in the AUTO selection. The switch was left in this position at the end of these flights.

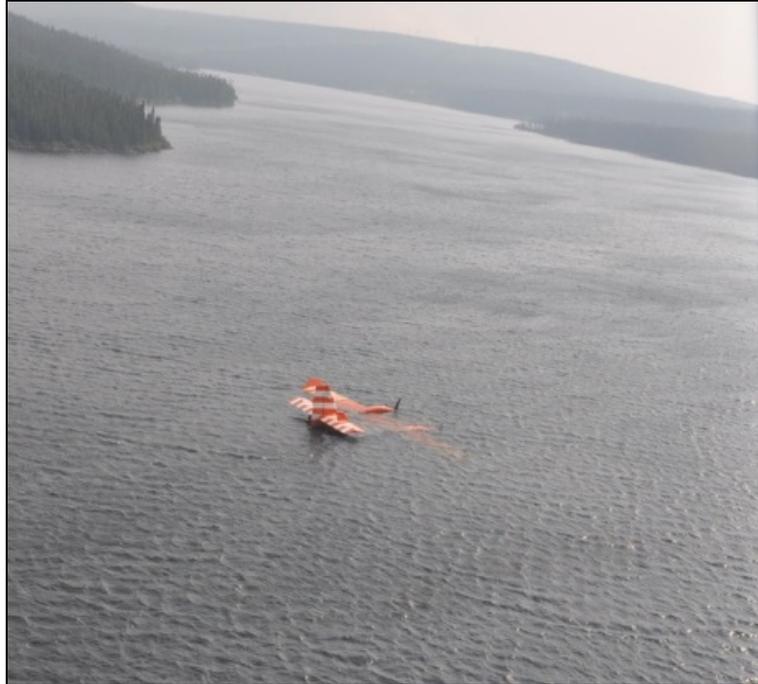
Photo 2. The occurrence aircraft (Source: Royal Newfoundland Constabulary)

The forward section of the hull collided with the water, causing the lower part of the forward fuselage to tear open. The right wing float collided with the water, causing complete separation of the right float and pylon. The aircraft came to rest upright, with the cockpit partially underwater (Photo 2). The flight crew briefly delayed their evacuation until the propellers had stopped rotating.

The PNF retrieved a life vest and evacuated the aircraft through the overhead escape hatch. Once on top of the aircraft, the PNF donned the life vest. The PF could not retrieve a life vest and exited the aircraft through the left-side sliding window.

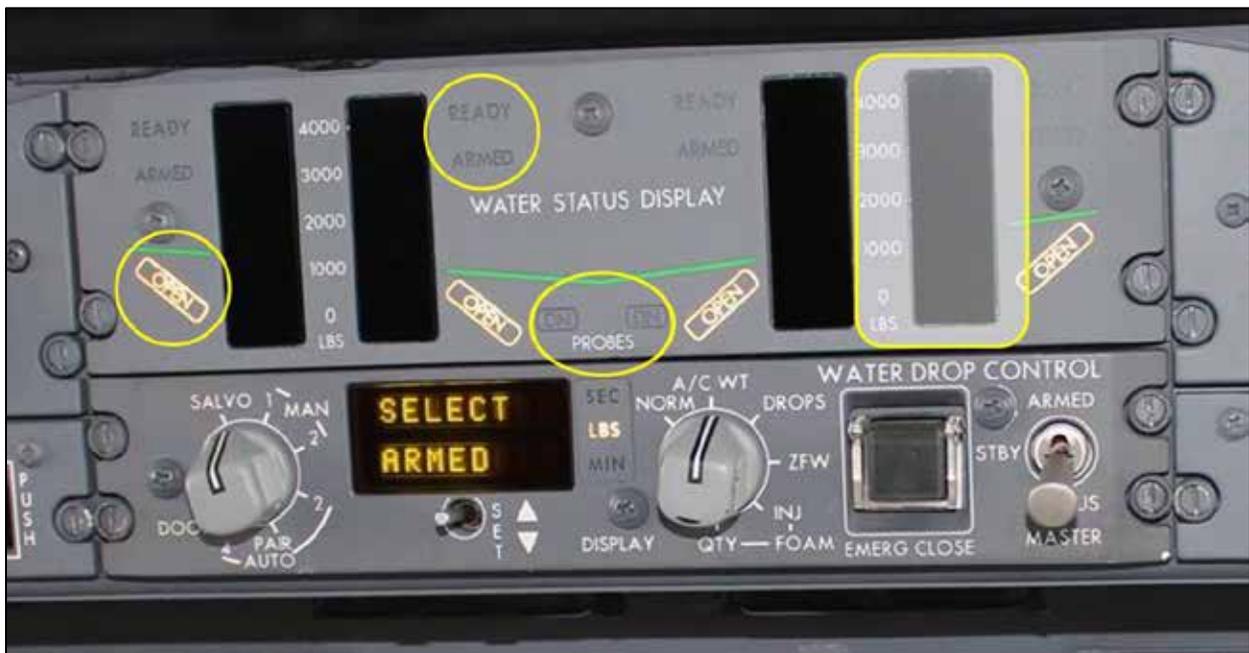
Photo 3. Water status display panel

The flight crew continued the take-off despite indication by the water status display panel that water quantity was in excess of that allowable for this take-off.

At the time of the occurrence, the aircraft had scooped full tanks of water, which resulted in the aircraft being about 3000 pounds over the maximum take-off weight.<sup>10</sup>

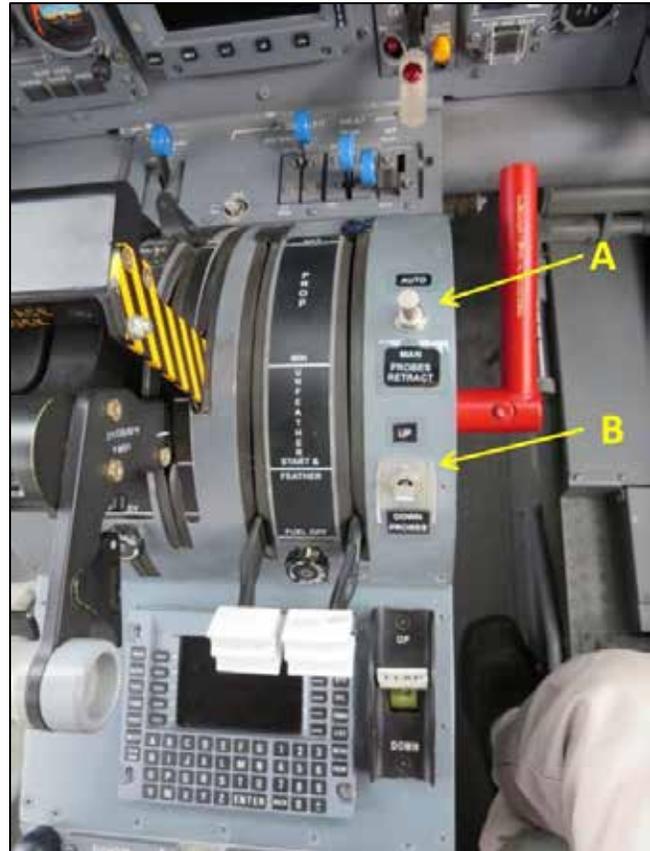
Photo 4. Centre pedestal and location of probe switches

The auto probe system includes the addition of a PROBES AUTO/MANUAL switch (Photo 4, item A) and relocation of the original PROBES UP/DOWN switch (item B). When the PROBES AUTO/MANUAL switch is in the AUTO position, the probes will automatically retract once the water level indicators reach the maximum quantity bug on the water status display panel. When this switch is in the MANUAL position, the flight crew must manually select the probes up using the PROBES UP/DOWN switch, when the water quantity has reached the predetermined level.

The PROBES AUTO/MANUAL switch is a 2-position toggle switch designed to lock in one position only. Bombardier used the lock position of the switch for the MANUAL selection. To move the switch from the MANUAL to the AUTO position, the switch lever must be lifted to overcome the locking mechanism. When the switch is in the AUTO position, the lever is not held in place by a locking mechanism.

TSB investigators examined an NGAS CL-415 and noted that the PROBES AUTO/MANUAL switch moved freely from the AUTO to MANUAL position, and could be made to do so by simply pulling the centre pedestal's cover rearward.

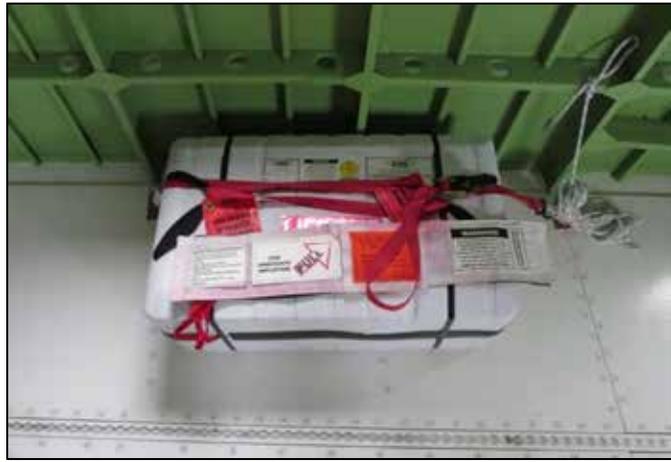
Photo 5. Life raft

The life raft was located in the rear of the fuselage, on the right side, opposite the rear cargo door (Photo 5). The raft was held in place by a ratcheting-type mechanism, which was not conducive for ease of removal. This mechanism had informally been identified by NGAS flight crew as a concern both in 2011 and again in 2012, at which time an alternate method of securing the raft in place was proposed. The ratcheting-type method of securing the life raft was still being used during the 2013 firefighting season.

The rear portion of the fuselage was partially submerged, and due to the difficulty gaining access to the life raft, the flight crew determined that it was unsafe to retrieve it.

- The life vests are now secured in the cockpit and cabin.
- The life raft is now installed in a manner that provides ease of removal.
- Storage cases and cargo straps are now used to secure cargo and loose items.
- Each aircraft is now equipped with a portable satellite telephone.
