Final report on aircraft accident

Case number: **M-01513/AIG-11**

Date: **5. August 2013**

Description: **The aircraft collided with the ground during a steep left turn**

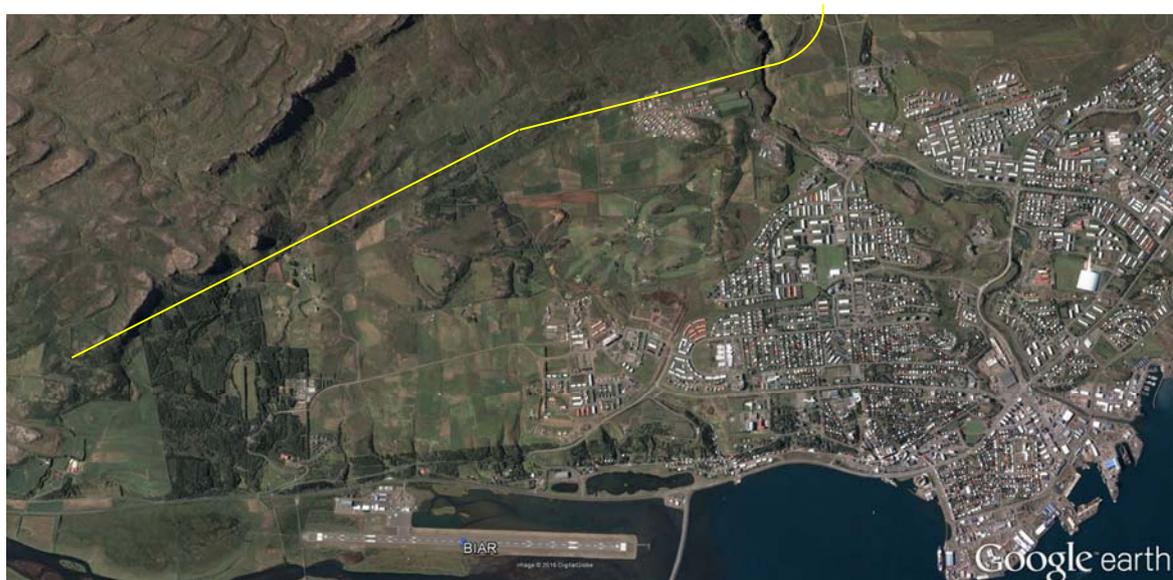
Figure 5: Approximate track of the aircraft after KN

aircraft after KN can be seen on Figure 5. Furthermore according to the co-pilot's statement, this phase of the flight was flown at 800'–1000'.

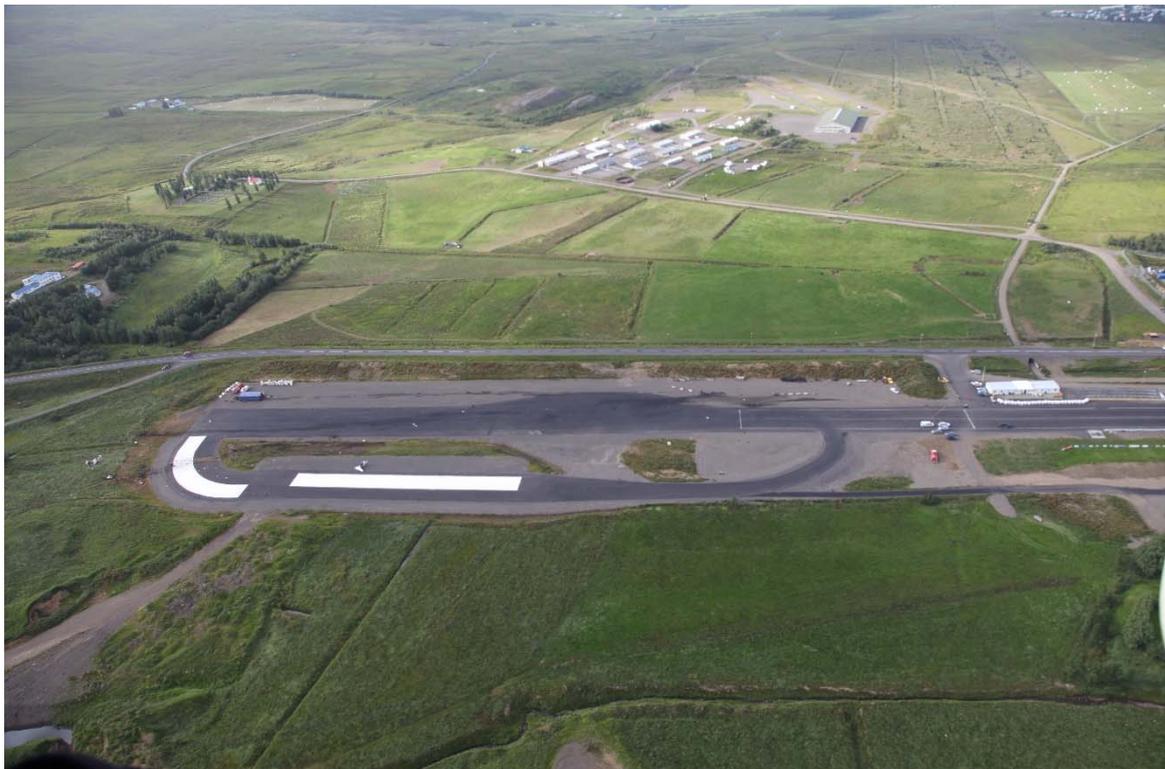
Indications of a post impact fire were found on the ground a few meters beyond the initial impact marks. Fuel was distributed over the racetrack and its surroundings, all along the accident site. Both engines were damaged, but still in a condition to be analysed. The tail and the fuselage did not catch fire. Both wings and other parts of the aircraft were severely damaged/burned.

Figure 7: Overview of the accident site, burn marks can be seen along the racetrack

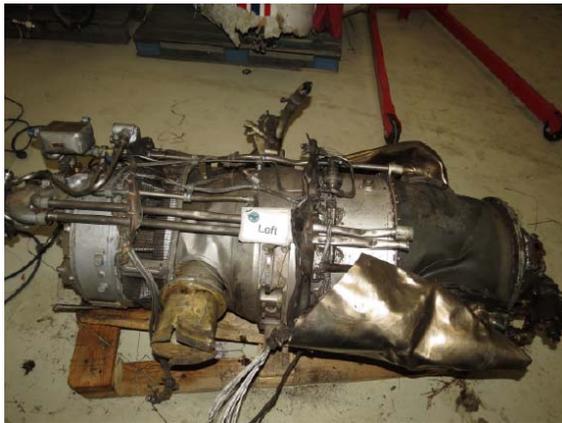
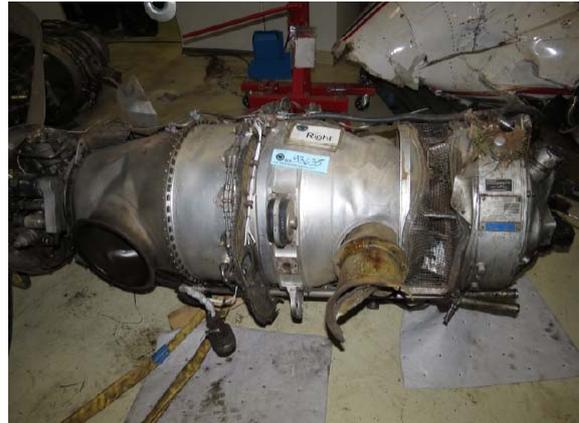
Both engines were severely damaged as result of the impact. When the engines were analysed, the left engine was found fractured at the front reduction gearbox housing. The propeller shaft was fractured just aft of the accessories drive gear. The fracture surface exhibited features characteristic of an overload. External tubes and linkages were either severed or crushed from the impact. The fuel pump/fuel control assembly was broken off the engine. The remainder of the left engine suffered limited structural damage. Rotating components, such as compressor rotors, turbine disks and blades showed circular rubbing and scoring damage from contact with adjacent stationary components. The right engine showed similar impact damage to external components. The engine exhibited limited structural deformation. Rotating components such as compressor and turbine assemblies exhibited rubbing and scoring damage indicative of rotation at impact.

The investigation of the engines did not reveal any evidence of pre-impact anomalies. Signatures found on the compressor and turbine sections of both engines were indicative of rotation under power at impact. The limited structural deformation observed on the engines prevented the assessment of the level of power the engines were producing at the time of impact.

The possibility of an un-commanded torque increase on one of the engines was investigated. Propeller blade angles, deformation and rotational signatures on both engines were compared and found to be very similar. This indicates that an un-commanded torque increase on either engine did not occur.

The engines are not considered a cause to the accident.

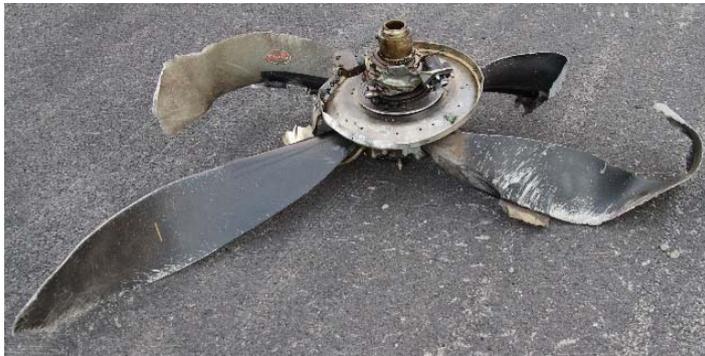
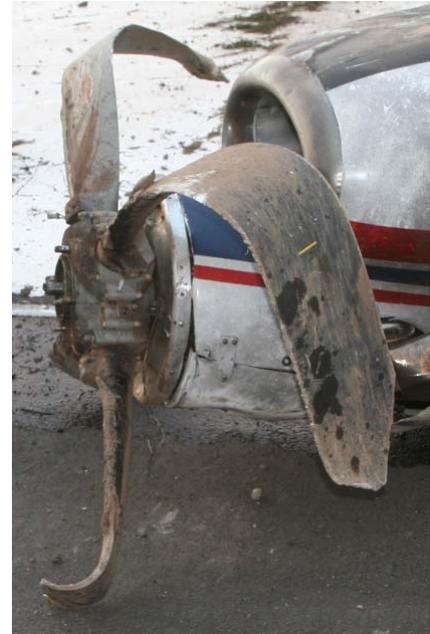
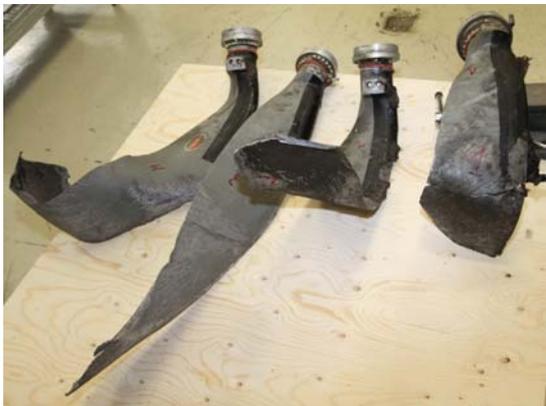
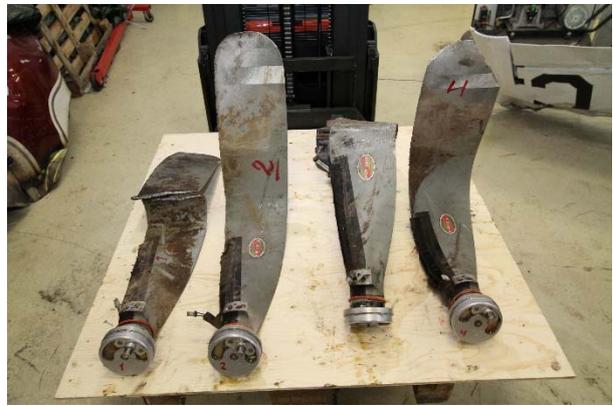
During the investigation process, a possible failure of the propellers was analysed, such as un-commanded feathering during the turn. The left propeller impacted before the right propeller, the propeller from left engine separated from the engine.

When analysing the propeller blades, the most damaged blade was found on the left propeller. All blades had moderate but distinct leading edge impact damage. All the blade tips were found fractured/torn, which is a strong indication of power and rotation during the impact.

In both of the propeller hubs, marks were found indicating that the propellers impacted under power. Both pitch change forks had damage on the aft tangs which supports a blade rotation from lower pitch towards higher pitch during the impact sequence.

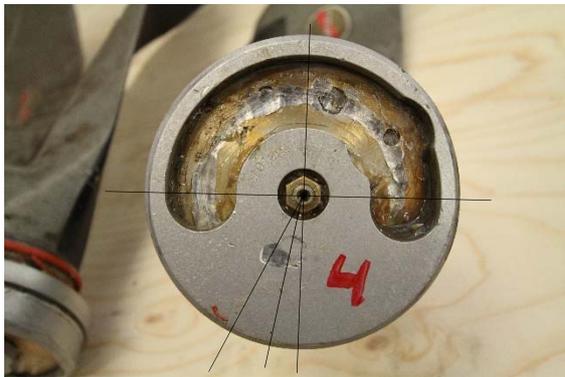
Figure 14: Propeller blade, left propeller

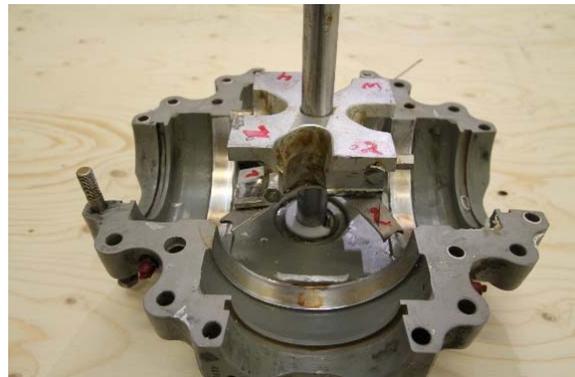
Figure 15: Left propeller hub opened

A fracture was found on the forward side of the bearing, which indicates that the impact forces occurred at a higher RPM setting. When analyzing the hub and the propeller blades no discrepancies that would prevent or degrade normal operation prior to impact were found.

No evidence was found that the propellers were in an abnormally high pitch or a feathered condition.

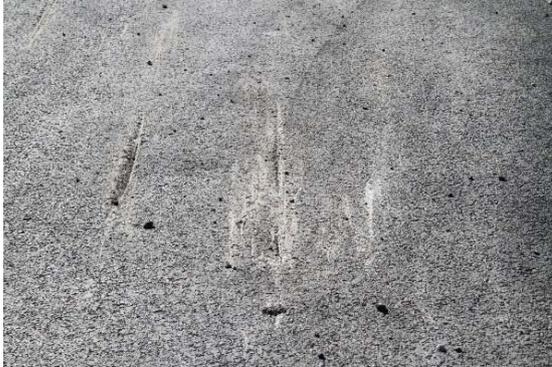
Figure 16: Propeller strike marks approx. 70 meters after initial impact

Based on the aircraft impact angle (left turn), the marks 70 m after the initial impact were made by the left propeller and the marks 170 m after initial impact were made by the right propeller.

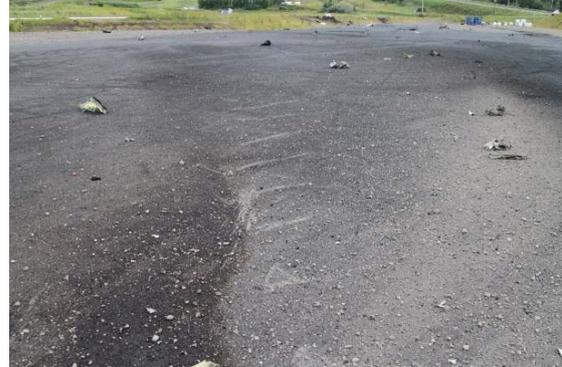
Figure 17: Propeller strike marks approx. 170 meters after initial impact

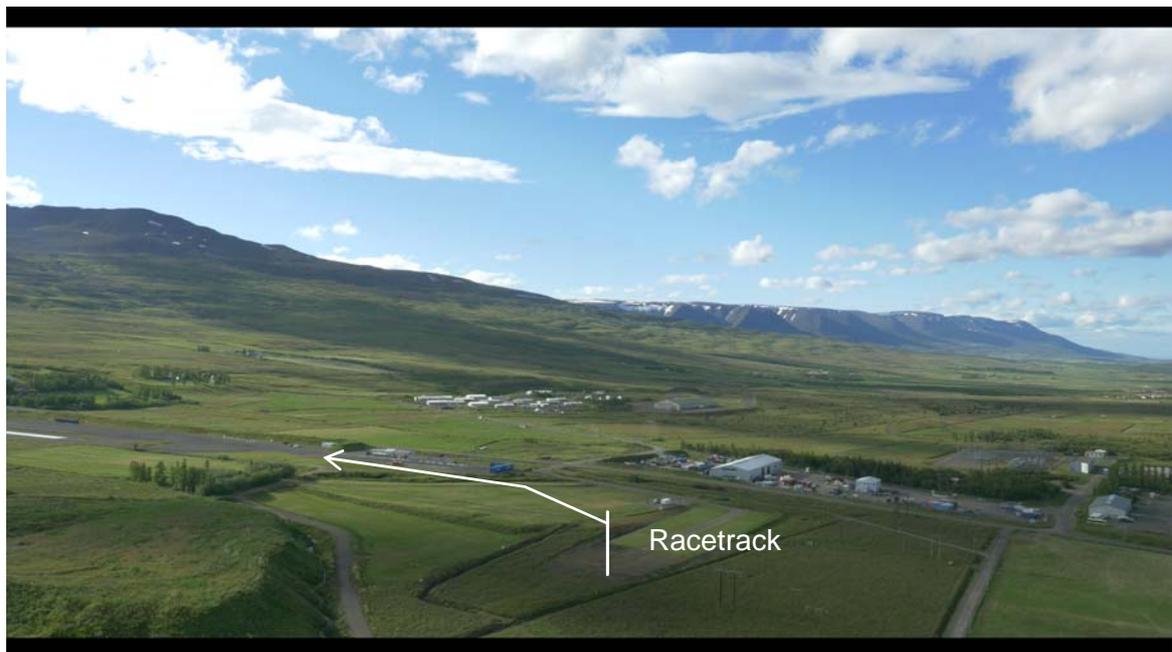
The racetrack is located in the foothills of a mountain, where the land slopes down against the flight path, i.e. after the left turn. Figure 30 is taken with a drone at the first calculated position from the video recordings and at the approximate altitude of the aircraft prior to the left turn. This figure therefore approximately portrays the view from the cockpit, prior to the accident.

Figure 30: View, approaching the accident site

The racetrack is similar in shape to a runway. However with the racetrack being narrower, shorter and sloping upwards, it might have provided the pilot with the visual illusion of the aircraft being at a greater altitude and distance from the racetrack.

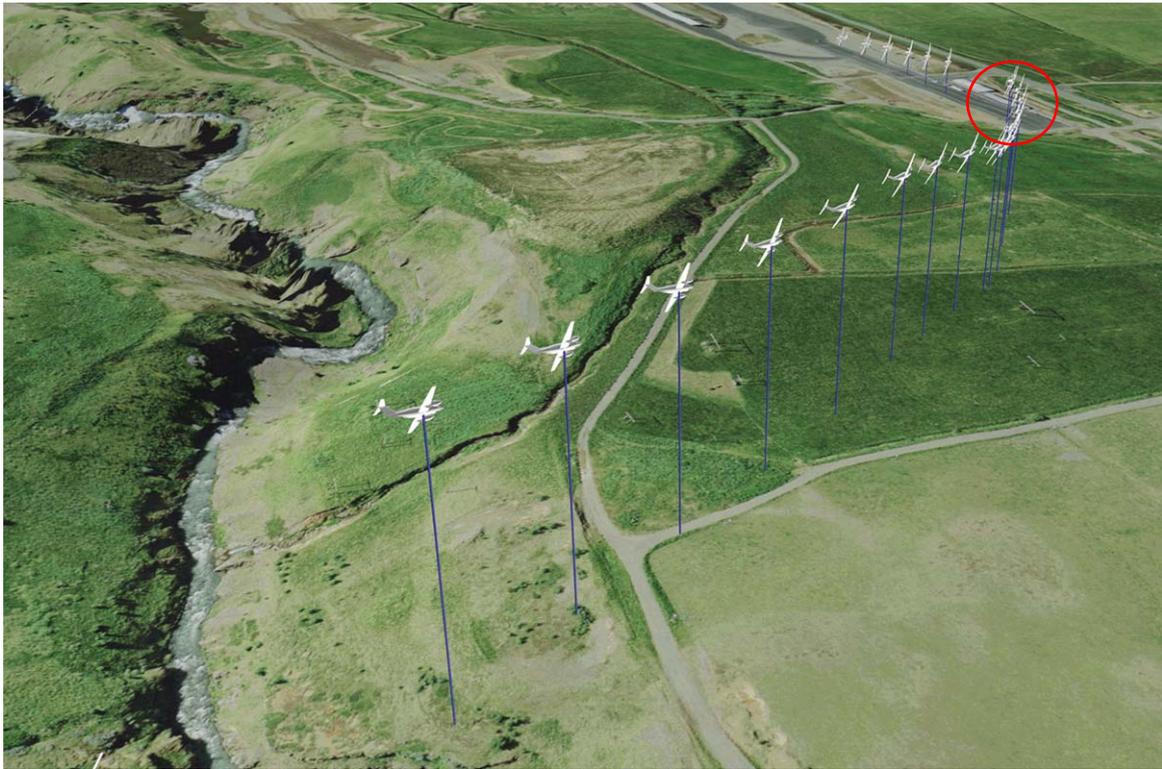
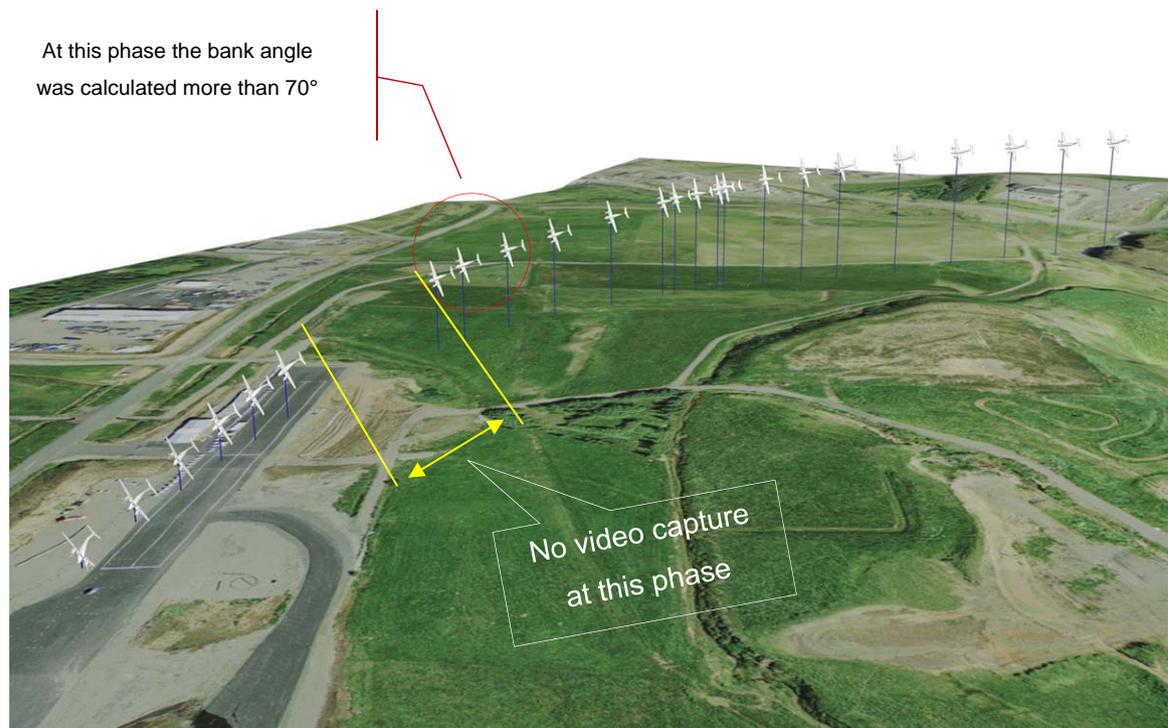
Using the analysis performed by TSB Canada, 22 out of 24 calculated points revealed that the bank angle in the turn was found to range from 60.4° to 72.9°¹⁴. When the aircraft is flown at a steeper bank angle than 60°, it is considered to be an acrobatic manoeuvre by the manufacturer.

Figure 31: Computer generated view of the aircraft flight path during left turn (seen from behind)

Figure 32: Computer generated view of the aircraft flight path during left turn (seen from front)
