FINAL REPORT

AIC 13-1007

AIRCRAFT ACCIDENT REPORT

Avions de Transport Régional ATR 42-320 freighter

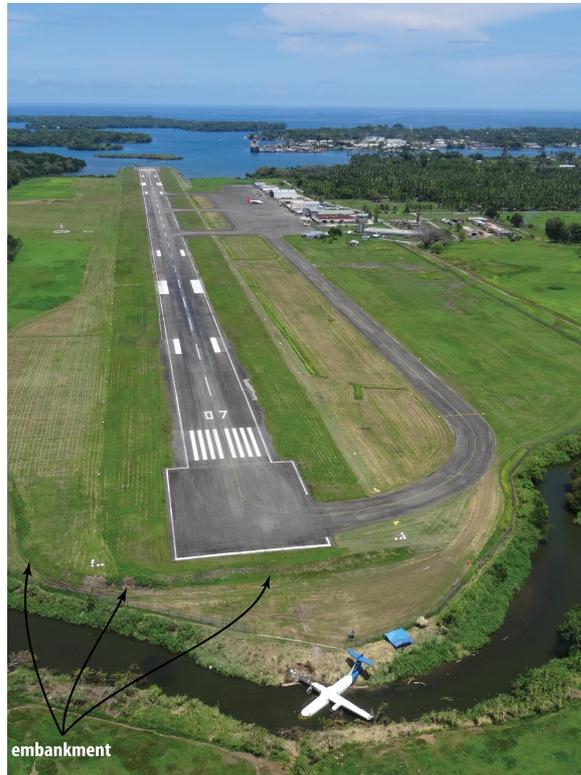
Figure 2: Aerial view of PXY and runway 07/25 at Madang

He subsequently reported that the controls felt very heavy in pitch and he could not pull the control column back in the normal manner. Flight data recorder (FDR) information indicated that approximately 2 sec later the PIC aborted the takeoff and selected full reverse thrust. He reported later that he had applied full braking. It was not possible to stop the aircraft before the end of the runway and it continued over the embankment at the end of the runway (Figure 2) and the right wing struck the perimeter fence (Figure 3).

This caused the aircraft to yaw to the right and it entered a creek beyond the perimeter fence at approximately 45 degrees to its direction of movement (Figures 2 to 4). The right outboard wing section caught fire and the flight crew escaped through the hatch in the cockpit roof.

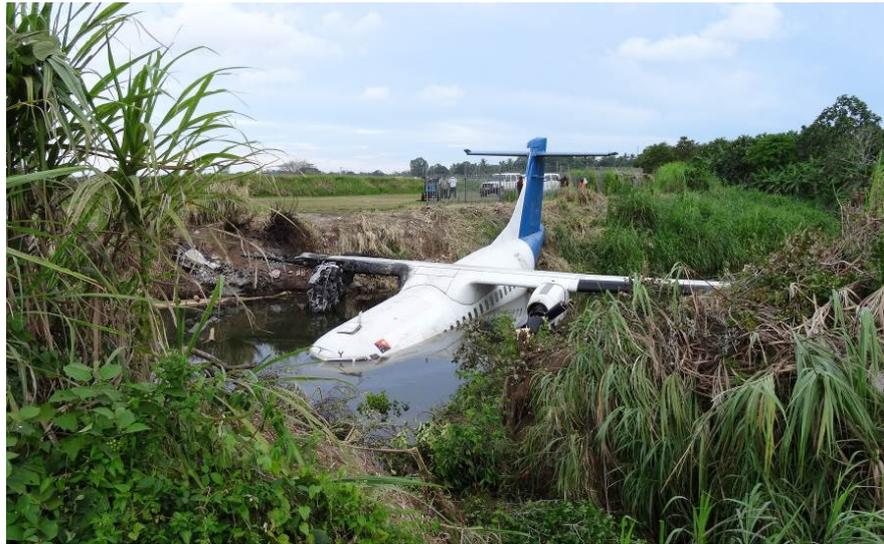
Figure 4: PXY where it came to rest in the creek

The aircraft was substantially damaged during the accident by the impact with embankment and the airport perimeter fence, the post-impact fire and partial immersion in salt water, and subsequently by the salvage operation during which it was lifted out of the creek and moved to a position on the airfield. The right outboard wing section was completely burnt, and the extensively damaged and burnt right engine fell off the wing into the water. Both propellers were torn from the engine shafts and destroyed by the impact forces.

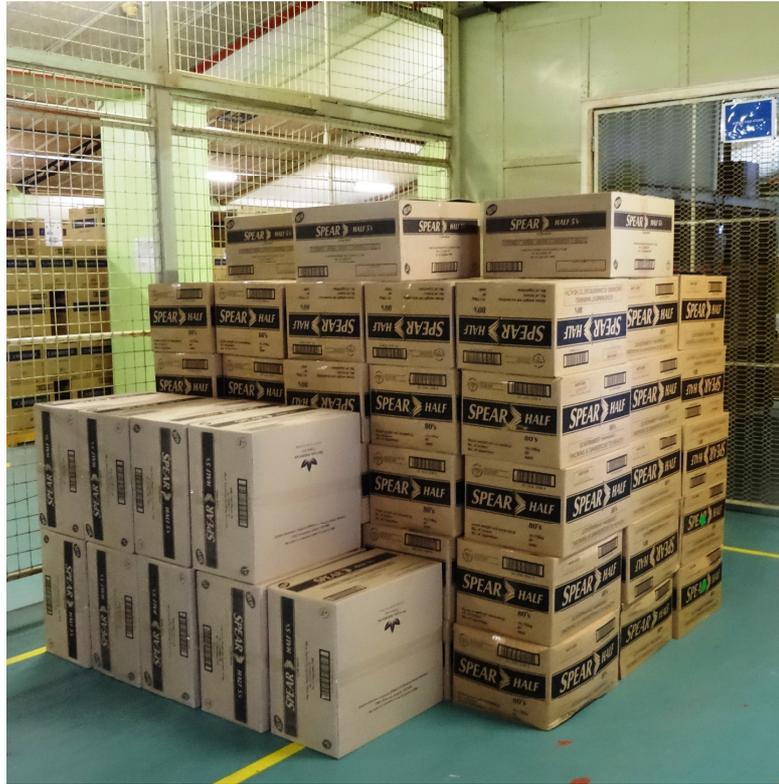
Figure 6: Reconstruction of the load in compartment 'A' according to the recollection of the client's staff member

When loaded on the aircraft, the 30 cartons requested by the PIC for cargo compartment 'A' would have only been two cartons high, by five cartons laterally across the compartment, by three cartons longitudinally along the compartment. The difference between the requested compartment load and the actual load should have been obvious.

The load in cargo compartment 'A' exceeded the maximum permissible compartment weight and therefore the maximum permissible structural load for compartment 'A' by 136 kg. The weight for cargo compartment 'A' as calculated by the pilots for the weight and balance of the aircraft should have been 350 kg. However, with 1,136 kg loaded in compartment 'A', the load in compartment 'A' exceeded the maximum permissible weight (for the required balance) by 786 kg.

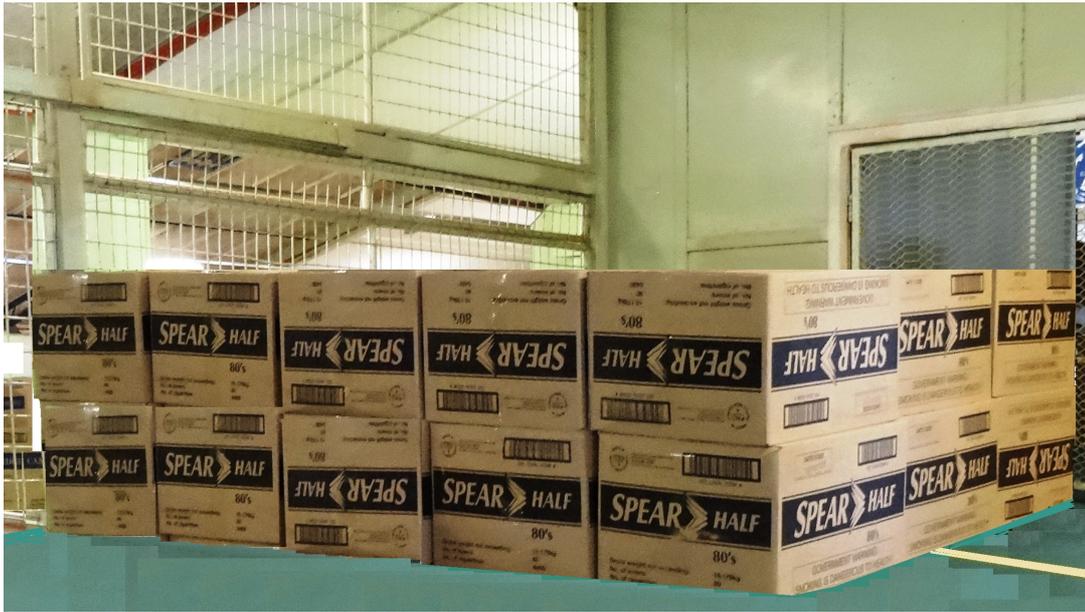
Figure 7: Reconstruction of the load for the 30 cartons as requested by the PIC

The maximum (permissible) all up weight was 16,900 kg. The Load Chart listed the MAUW accepted by the PIC as 16,606 kg; 254 kg below the permissible MAUW. However, the actual total cargo weight was 597 kg heavier than listed on the load sheet. Therefore, the aircraft was 343 kg heavier than the permissible MAUW.

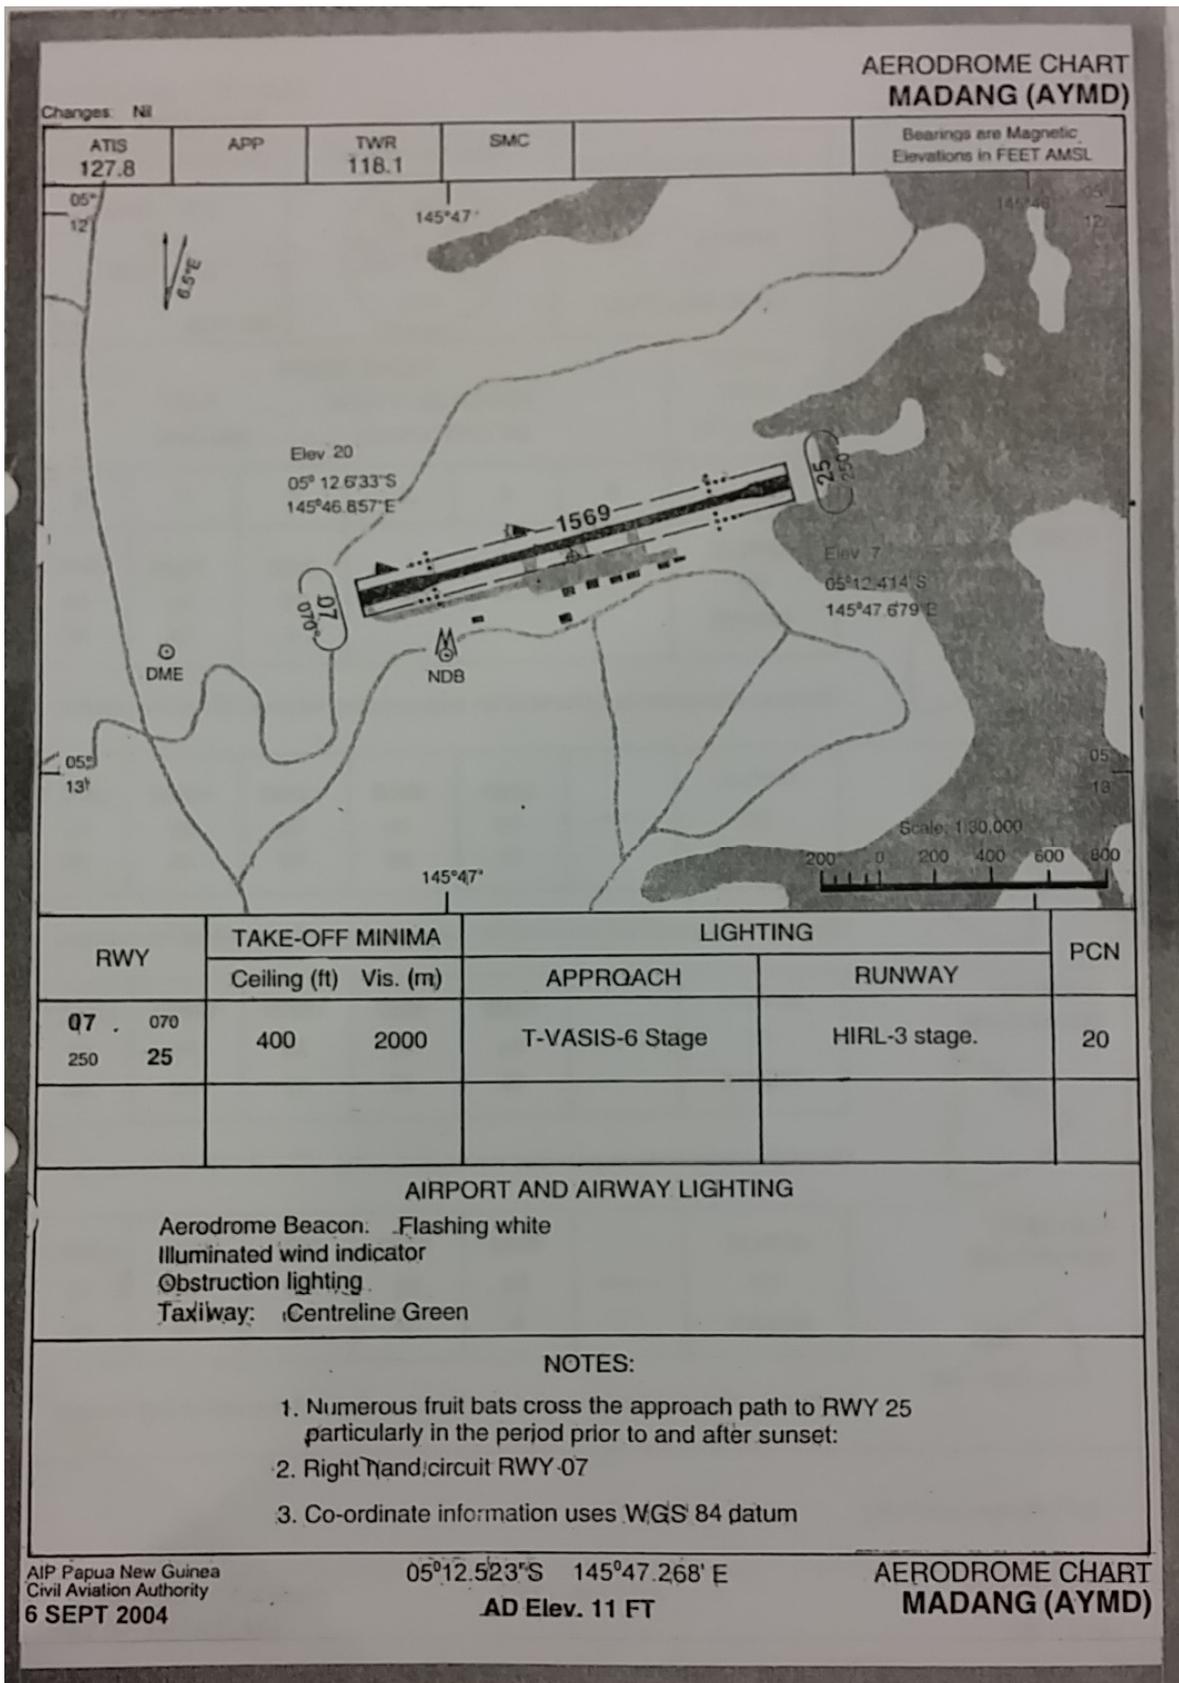
Figure 9: Madang aerodrome chart

In August 2015, the AIC was informed by CASA that it had not notified ICAO of the difference in its CAR's from the ICAO Annex 14 RESA Standard. However, during the ongoing investigation, which included a review of CASA and Air Services Limited publications, the AIC found that AIP, GEN 1.7-14 under the heading Annex 14 Aerodromes Chapter 3.4 states:

Papua New Guinea cannot implement RESA due to unavailability of an adequate area beyond the Stopway and runway lengths that are already too limited to accept further reduction by the implementing RESA. At the time of writing the CASA PNG has not notified the ICAO of the difference in its CAR's from the ICAO Annex 14 RESA Standard.

The Accident Investigation Commission recommends that the Civil Aviation Safety Authority (CASA) of PNG review the capacity for PNG airports to provide runway end safety areas (RESA) that meet the Standards prescribed in the International Civil Aviation Organization (ICAO) Annex 14 Volume 1.

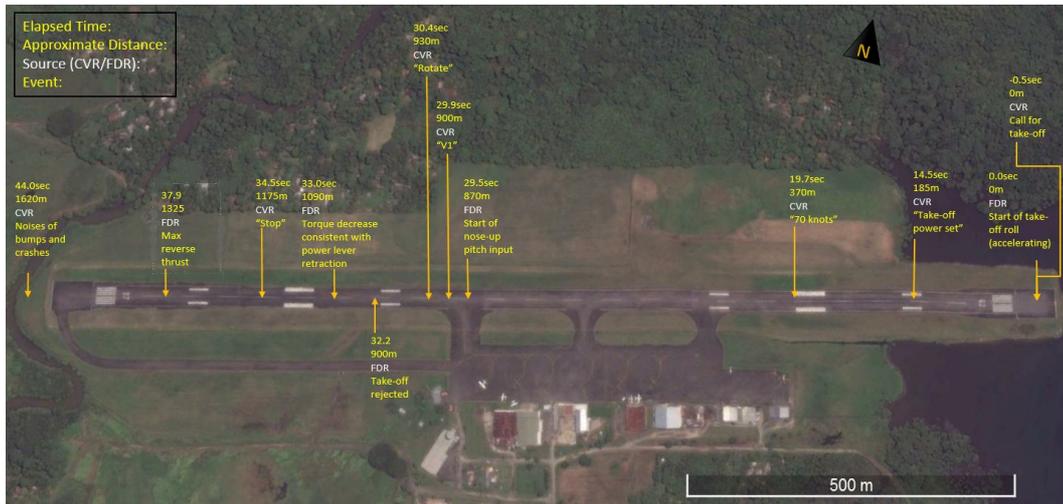
Figure 12: Madang runway with position of FDR and CVR recorded events
(See Appendix 1 for enlarged diagram for clarity)

From the FDR and CVR data/information the investigation determined that the copilot called V1 29.9 seconds after commencing the take-off roll when the aircraft had travelled 900 m. He called 'Rotate' 0.5 sec later when the aircraft had travelled a further 30 m. The aircraft speed was 112 kt and the aircraft had travelled 930 m from brakes release.

The FDR showed elevator deflection commanding a rotation had been initiated 29.5 sec after brakes release when the aircraft had travelled 870 m, but the aircraft did not respond. A torque decrease consistent with power levers being retarded was observed on the FDR data 33.0 sec after brakes release when the aircraft had travelled 1,090 m. The command 'stop' was heard on the CVR 34.5 sec when the aircraft had travelled 1,175 m after brakes release. The aircraft travelled 160 m between the Vr call position and the position on the runway when the power levers were retarded. The investigation determined that P2-PXY left the sealed runway end at a speed of 35 kt.
