# Air Accident Investigation Sector

-Final Report-

AAIS Case N°: AIFN/0011/2013

## Aircraft Contact with Jetblast Fence during Pushback

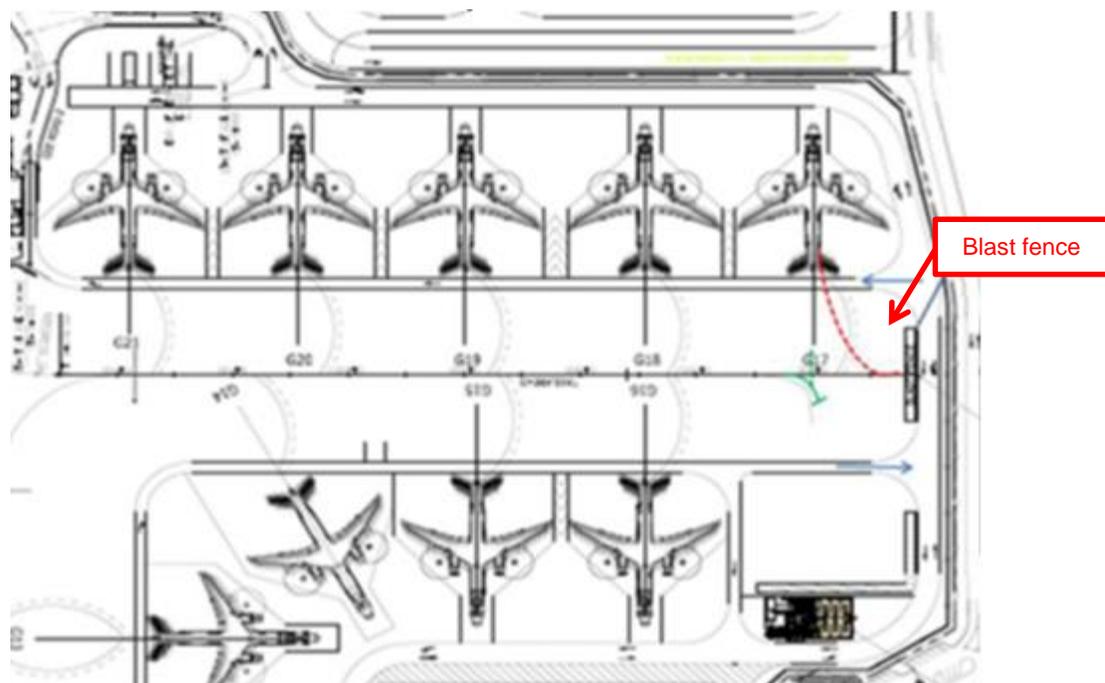
As the Aircraft continued to pushback and turn to the left, the aft fuselage contacted a jetblast fence and overrode it, and then the right hand horizontal stabilizer struck a light pole located on the far side of a service roadway, which ran behind the jetblast fence. Neither the PBO nor the HM were aware that the Aircraft had contacted the jetblast fence. After contacting the jetblast fence and the light pole, the Aircraft was then pulled forward and aligned with taxiway Juliet 5, at a point on the ramp approximately in line with Stand G20 (figure 1).

**Figure 1.** Configuration of the Golf Stands showing red, nose gear stop green, and the location of the jetblast fence

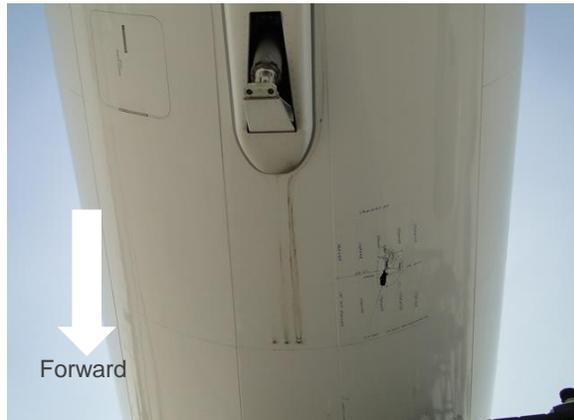
The Aircraft sustained damage to the aft fuselage in the region of frame station (STA) 2174 and stringers (STGR) 42R and 43R (figures 2, 3 and 4). Two static dischargers were dislodged from the starboard horizontal stabilizer (figure. 5).

Figure 2. Damage to aft fuselage

- 3.2.5 The Aircraft sustained damage to the aft fuselage and two static dischargers were dislodged from the right hand horizontal stabilizer as a result of contacting the jetblast fence and the light pole.

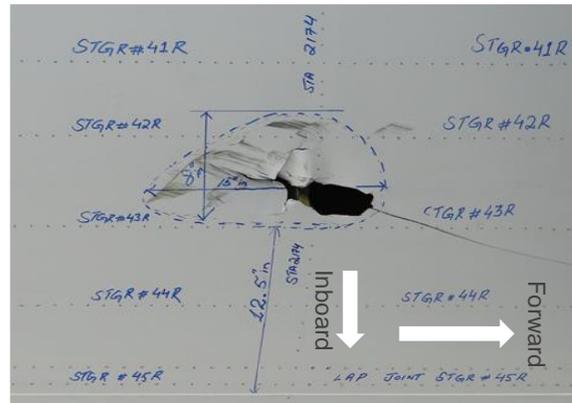
Figure 3. Detail and location of fuselage damage

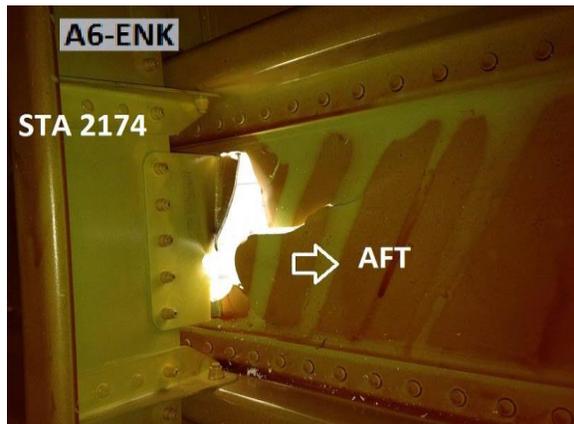
Figure 4. Internal view of fuselage damage

The contact of the aft fuselage with the jet blast fence resulted in the fuselage being punctured, and the dislodgment of a section of the upper vane of the jet blast fence. Following contact with the blast fence, the Aircraft overrode the blast fence and the right hand horizontal stabilizer contacted a light pole, which was located on the opposite side of the service road which ran behind the jet blast fence. This contact dislodged two horizontal stabilizer static discharge wicks and bent the light pole.

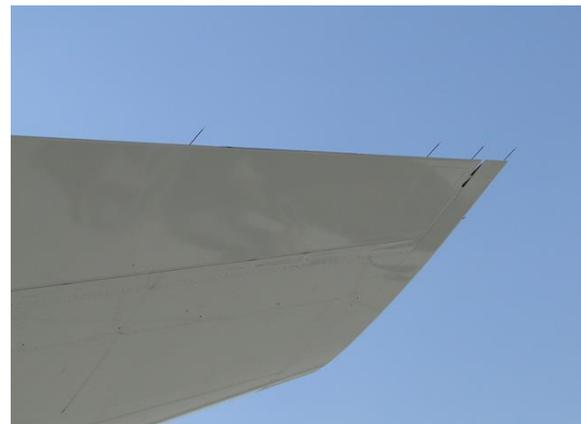
Figure 5. Two static dischargers missing from starboard horizontal stabilizer

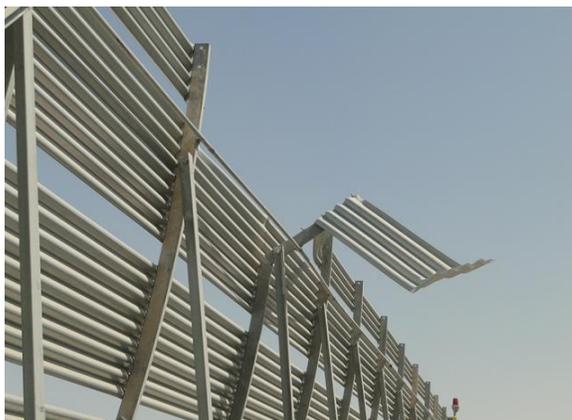
A section of the upper deflector vane of the jet blast fence was damaged (figure 6) and a light pole located on the opposite side of a service road that runs behind the jet blast fence was bent (figure 7).

Figure 6. Damage to blast fence

- 3.2.6 The jetblast fence sustained damage to a section of the uppermost deflector vane and the light pole was bent.
- 3.2.7 The Incident flight was the first pushback that the PBO had carried out from Stand G17, a stand where the use of a non-standard pushback procedure is required.

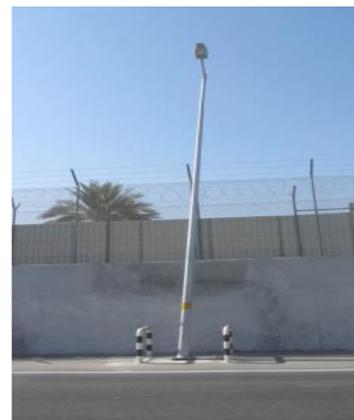
Figure 7. Service road light pole

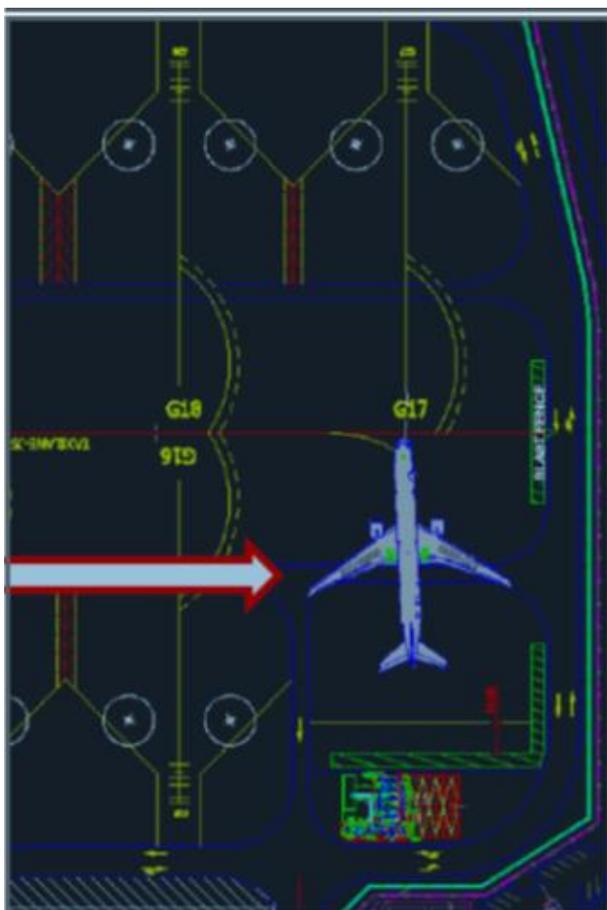
A recommendation of the joint hazard assessment conducted by the Operator's Engineering Department and the GHA Safety Department was to paint a dashed line, extending from the end of the Stand centerline, to a T stop mark. As per the procedure, the PBO was to

push the aircraft straight back along the stand centerline and then follow the painted dashed line (figures 9 and 10) leading to the white T stop mark. This information was omitted from the documented procedure.

**Figure 9.** Correct orientation of the aircraft at the end of the push off Stand G17. The fuselage aft of the wings overhangs the hatched area opposite Stand G17

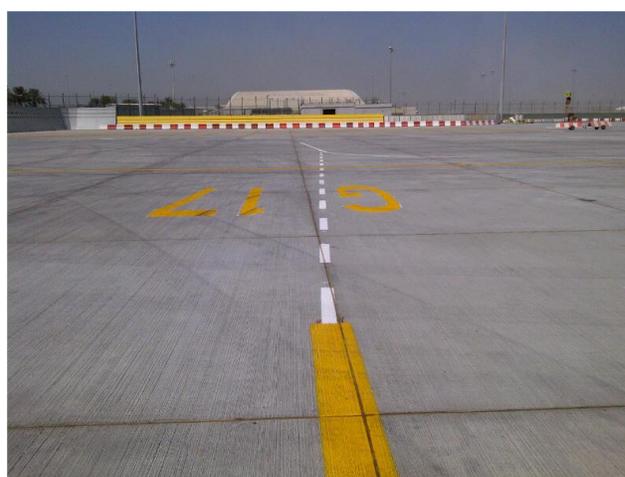
**Figure 10.** View of broken white pushback line extending from the G17 stand centerline to a T-stop mark. The jetblast fence is on the left hand side of the stand in this view

The procedure did not include any pictorial or visual aid to assist the PBO in the pushback from Stand G17. The markings that indicated the extended stand centerline, along which the Aircraft should have been pushed, were painted with a white broken line and terminated at a white T stop mark. There was no reference in the *ANN* to these markings.

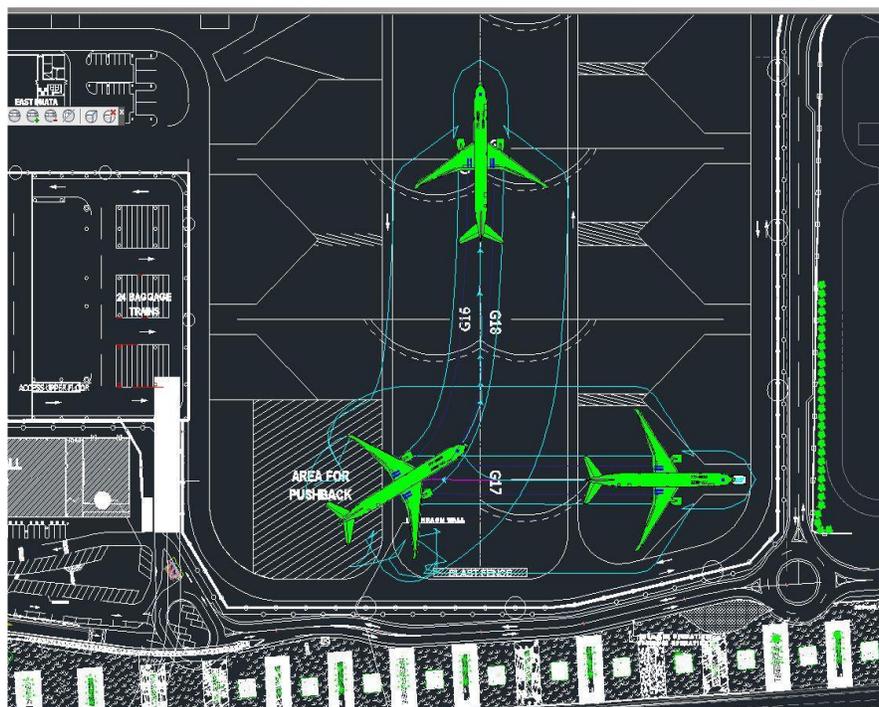
**Figure 11.** Approved pushback sequence off Stand G17 into the hatched area directly behind Stand G17, and then pull forward to the engine start line

The approved pushback procedure for Stand G17 required that the Aircraft be pushed back until the nose gear reached a painted white T-stop mark on the extended broken stand centerline (figures 10 and 11). The Aircraft was then to be pulled forward to the vicinity of taxiway Juliet 5.

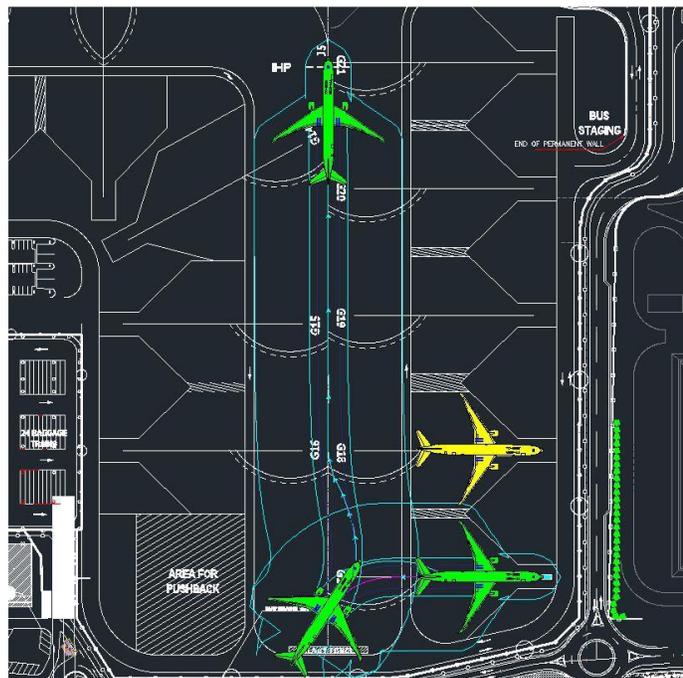
After contacting the jetblast fence and the light pole, the Aircraft was then pulled forward and aligned with taxiway Juliet 5 at a point on the ramp approximately in line with Stand G20. The HM left the tug cab to observe the engine starts. At this time, the dispatcher advised the HM that the Aircraft may have sustained damage during the pushback.

Figure 12. Actual pushback sequence of A6-ENK

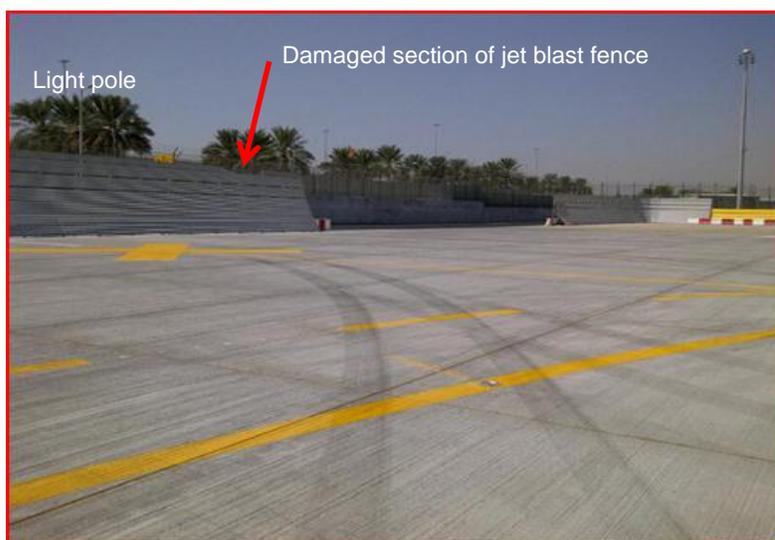
Seated in the tug cab, the PBOs' view of the aft fuselage and tail section was limited and the left turn directed the Aircraft towards the blast fence. This was evident from the main gear tire marks (figure 13), as all other pushbacks from Stand G17 had been straight back following the stand centerline.

Figure 13. A6-ENK main gear tire marks
