ACCIDENT

Aircraft Type and Registration:	Pilatus Britten-Norman BN2B-21 Islander, G-CIAS	
No & Type of Engines:	2 Lycoming IO-540-K1B5 piston engines	
Year of Manufacture:	1982 (Serial no: 2162)	
Date & Time (UTC):	3 November 2013 at 1908 hrs	
Location:	Near Devil's Hole, approximately 2.5 nm north of Jersey Airport, Channel Islands	
Type of Flight:	Private (charitable search and rescue)	
Persons on Board:	Crew - 1	Passengers - 4 ¹
Injuries:	Crew - None	Passengers - None
Nature of Damage:	Significant damage to wing, left main landing gear and forward fuselage; aircraft damaged beyond economic repair	
Commander's Licence:	Airline Transport Pilot's Licence	
Commander's Age:	65 years	
Commander's Flying Experience:	25,200 hours (of which 60 were on type) Last 90 days - 101 hours Last 28 days - 2 hours	
Information Source:	AAIB Field Investigation

Synopsis

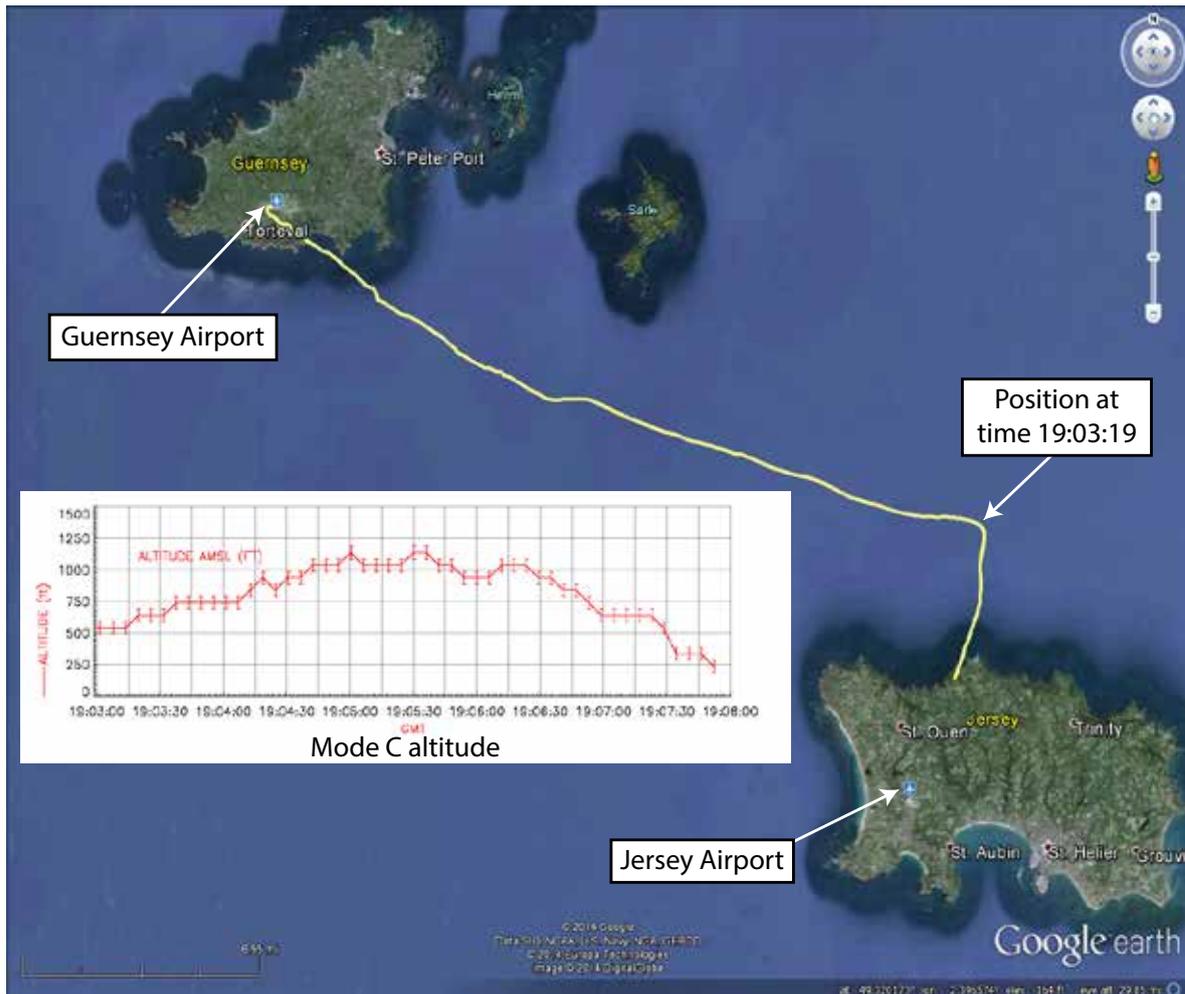
Figure 1

The aircraft position and Mode C altitude (± 50 ft) were recovered from radar recordings provided by Ports of Jersey Air Traffic Control (Figure 1). The first radar recording was at 18:51:42 hrs as G-CIAS departed Guernsey Airport. At 19:03:19 hrs G-CIAS was located just over 6.3 nm from Jersey Airport at approximately 500 ft amsl when it began a right-hand turn towards Jersey, climbing to approximately 1,100 ft amsl over the next 1 min 40 sec. At 19:05:36 hrs, when 1.2 nm from the coast, the altitude began to reduce until 19:07:52 hrs when the final radar return recorded the aircraft at a position approximately 200 ft from the first ground mark at the accident site.

G-CIAS radar position and Mode C altitude

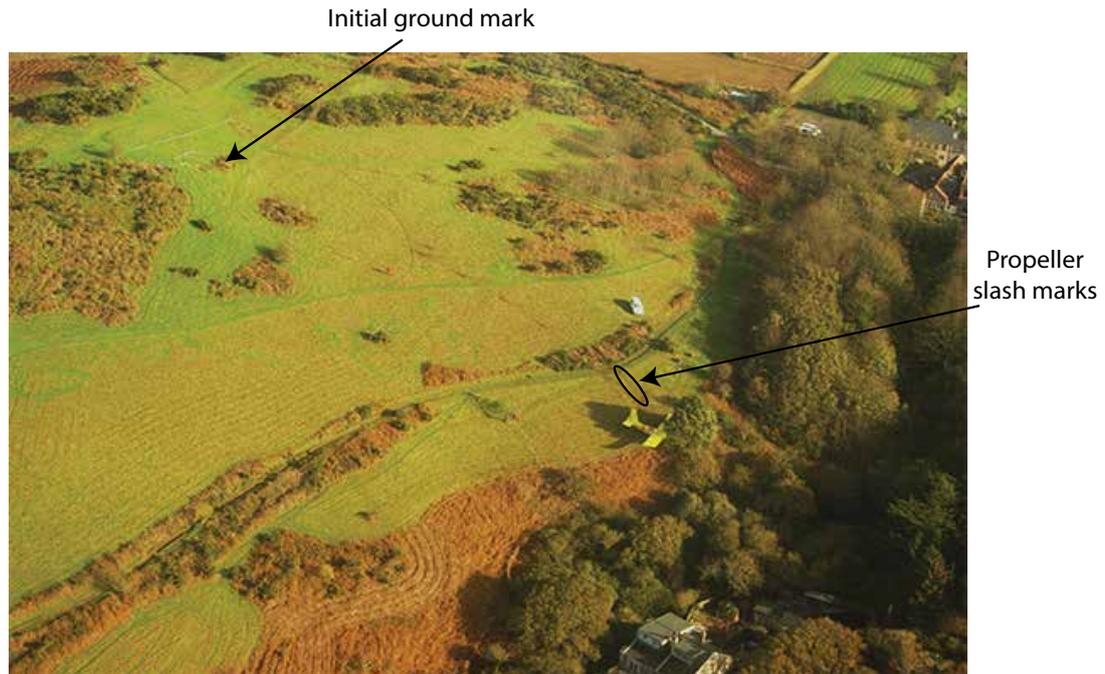
The nose of the aircraft had struck the base of a tree that marked the boundary of a sloping field. The damage was consistent with the nose striking the tree at a relatively low speed, probably around 10 kt. Figure 2 shows a general view of the wreckage site.

The left main gear leg had been distorted aft at its mounting in the wing. The propeller blades on the left engine showed signs of having been rotating whilst striking the ground but, due to the rearward deflection of the propeller blade tips, showed little signs of power. There was some rotational scoring on the spinner hub from a damaged piece of engine cowling. The propeller on the right engine had been feathered.

There were ground marks covering 140 m from the brow of the hill down to where the aircraft had come to rest that were made by the landing gear, and approximately 20 m from the aircraft there was a wider ground mark followed by a series of regularly-spaced slash marks. The left main gear had been distorted rearward and made the large ground mark, and the left propeller blades, which were rotating, caused the slash marks. It was estimated from the slash marks that the rotational speed of the left engine was well below 1,000 rpm.

General view of the wreckage site

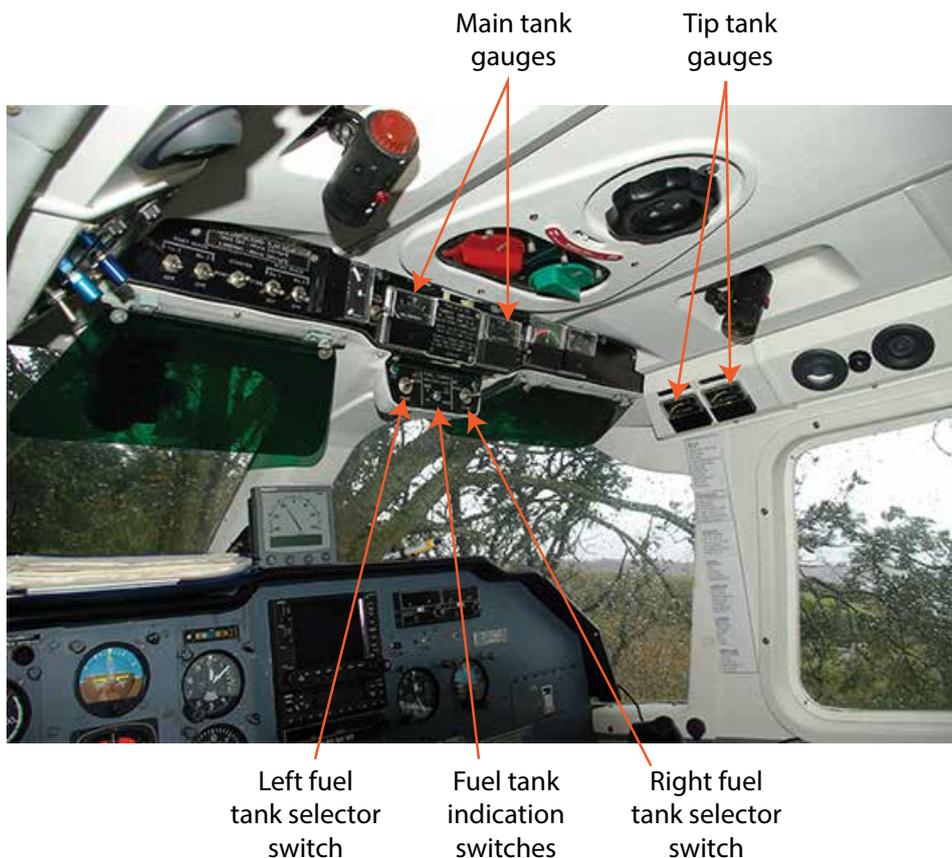
The fuel tank selector switches in the cockpit were both found in the 'tip tank' position. The fuel tank indication switches were both found in the position that would dim the tank selection indicator lights. Figure 3 shows the tank selector switches and gauges.

Image of the cockpit showing gauges and fuel tank switches

It was noted that the fuel selectors for the engines and main fuel tanks were prominent, and the main fuel tank quantity gauges were conveniently sited above the top of the centre windscreen pillar (Figure 3). However, the tip/main tank switches were much smaller and located away from the main fuel selectors, remote from the tip tank quantity gauges which were themselves on the right-hand passenger service unit, above the right-hand cockpit window.

The locations of the fuel controls and tank quantity gauges were examined. Although the main fuel selectors and main tank gauges were located centrally in the cockpit, the tip tank selector switches were smaller and not co-located with the respective quantity gauges. The dimming function of the tip tanks indicators further complicated the presentation of fuel supply information to the pilot. In the operation of G-CIAS, the typical search duration and main tank capacities, meant that the tip tanks were seldom used. These factors may have led to some complacency with regard to the configuration of the fuel system.
