FINAL REPORT

AIC 13-1008

**PAPUA NEW GUINEA
ACCIDENT INVESTIGATION COMMISSION
SHORT SUMMARY REPORT**

Engine failure involving a Cessna Aircraft Company C208B, P2-SAH

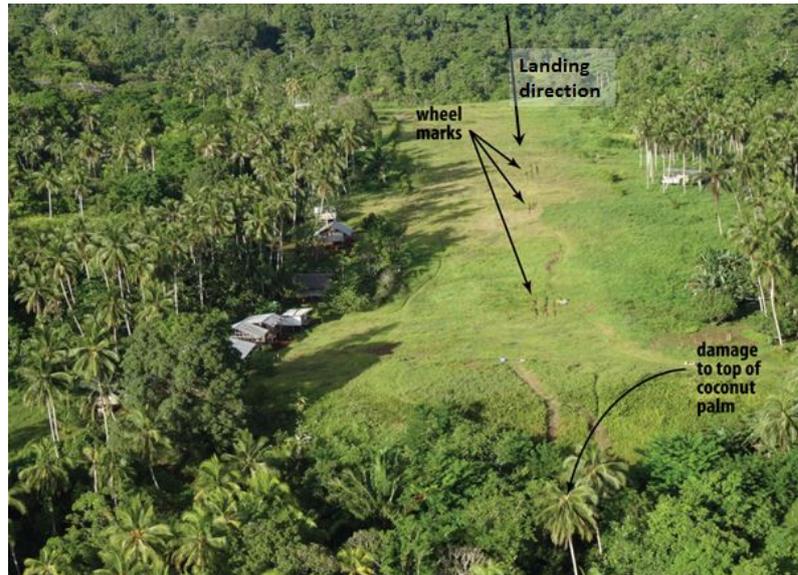
Figure 5: Ground witness marks on Kibeni airstrip

The disused 430 metre long Kibeni airstrip was overgrown with grass and weeds. It was about 60 ft above the river and 120 ft above mean sea level, with trees and other vegetation on the slope down to the river. The aircraft bounced three times and, because the aircraft's speed had not decayed sufficiently to stop in the available length, the pilot elected to pull back on the control column in order to clear the trees that were growing on the slope between the airstrip and the river. The aircraft became airborne, impacting the crown of a coconut palm (that was almost level with the airstrip) as it passed over the trees. The pilot banked the aircraft hard left in an attempt to land/ditch along the river and avoid trees on the opposite bank. He then pushed forward on the control column to avoid stalling⁶ the aircraft and levelled the wings before the aircraft impacted the water.

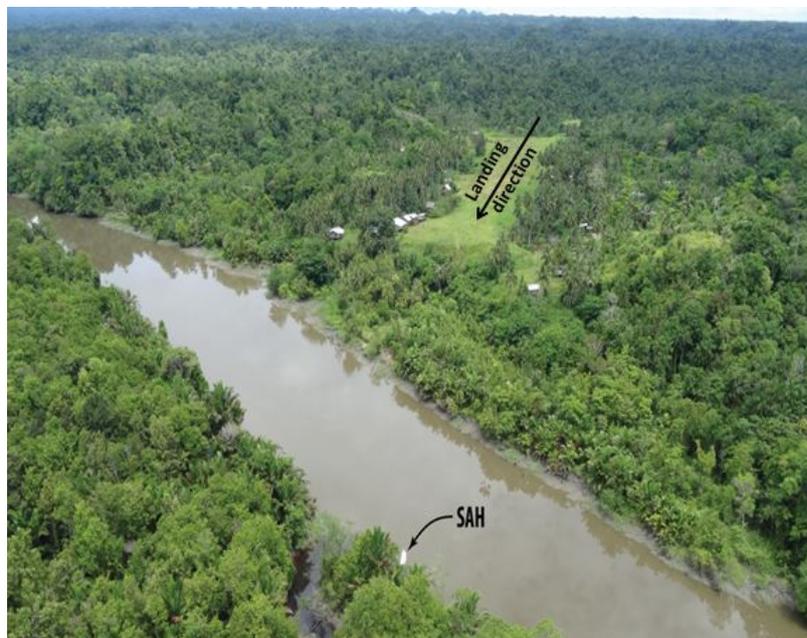
Figure 4: Kibeni village and airstrip by the Palbuna River. SAH wreckage in the foreground.

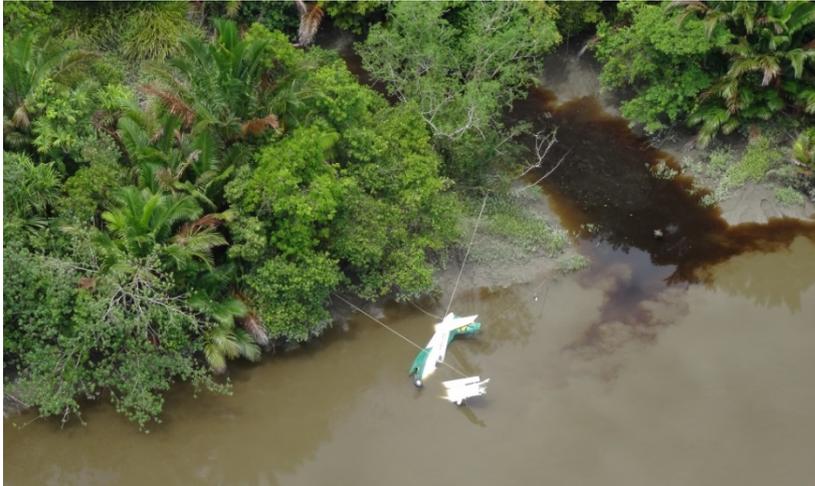
Figure 7: SAH in the river approximately 24 hours after the accident

The aircraft came to rest inverted with the cockpit and forward cabin submerged and immediately filled with water. After a short delay while he gained his bearings under water, the pilot was able to undo his harness and open the left cockpit door. He swam to the rear of the aircraft, opened the right rear cabin door, and helped the surviving passengers to safety on the river bank. He made several attempts to reach those still inside the aircraft. When he had determined there was nothing further he could do to reach them, he administered first aid to the survivors with materials from the aircraft's first aid kit. After approximately 20 minutes, villagers arrived in a canoe and transported the pilot and surviving passengers to Kibeni village across the river. About 90 minutes after the accident, rescuers airlifted the survivors by helicopter to Kopi, located 44 km north east of Kibeni.

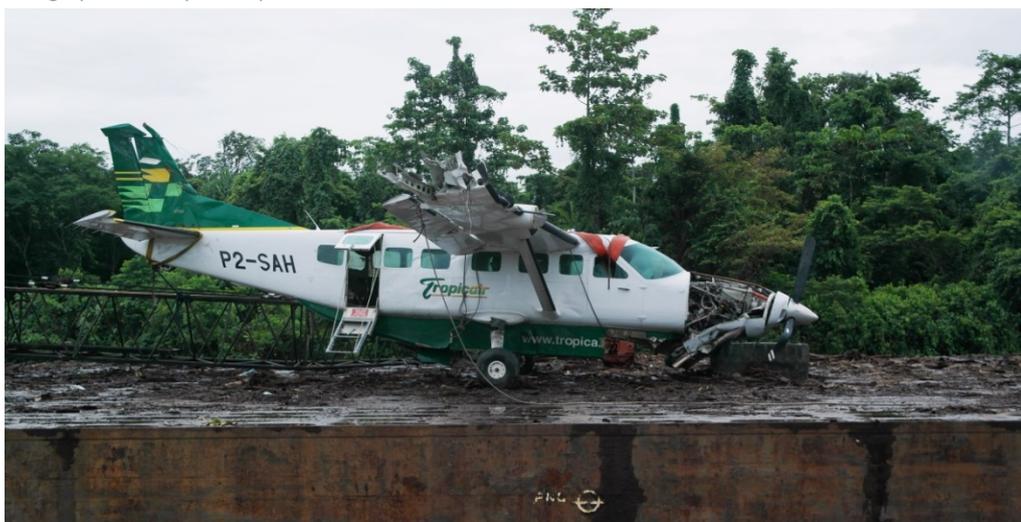
The aircraft was substantially damaged during the accident by impact forces and immersion in water. The left wing became completely detached during the impact sequence and, although the pilot reported that it floated back to the accident site on the incoming tide in the minutes after the impact, it could not be located by the AIC despite a search downstream by helicopter. During the evening of 27 November 2013, the aircraft wreckage was lifted onto a barge and transported to Panakawa (27 km south of Kamusi).

Figure 6: P2-SAH on the barge for transport to Panakawa

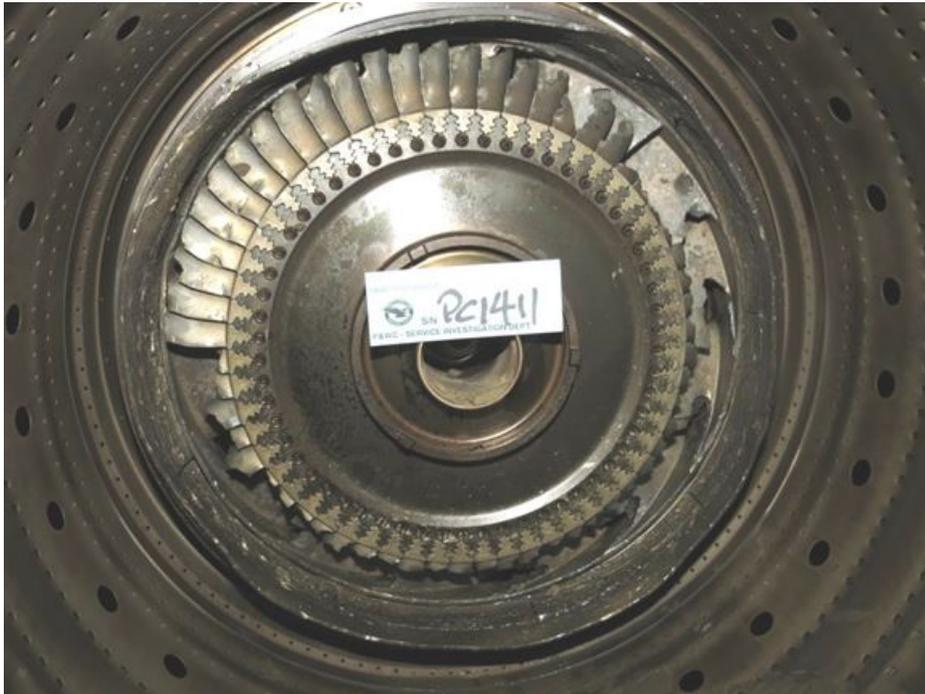
The Compressor Turbine (CT) blades were fractured within the airfoils at locations between the platform and approximately 2/3 of their height. The blades with the longest remaining airfoils were grouped together on the disk, resulting in significant unbalance of the assembly.

One CT blade was fractured in fatigue. The fatigue initiated from multiple origins near the trailing edge, pressure side of the blade. The crack then propagated 2/3 length chord wise towards the leading edge until final fracture in overload.

The engine power loss was caused by the fracture of one CT blade in fatigue, which resulted in secondary damage to the remainder of the CT blades and downstream components.

The fatigue originated from multiple origins on the pressure side of the blade trailing edge. The root cause for the fatigue initiation could not be determined with certainty.

Figure 8: CT disk and blades downstream side

The US Federal Aviation Administration issued Airworthiness Directive 2014-17-08 R1 Pratt & Whitney Canada Corp. effective 5 June 2015 stating:

This AD was prompted by several incidents of compressor turbine (CT) blade failure, causing power loss, and engine failure. We are issuing this AD to prevent failure of CT blades, which could lead to damage to the engine and damage to the airplane.

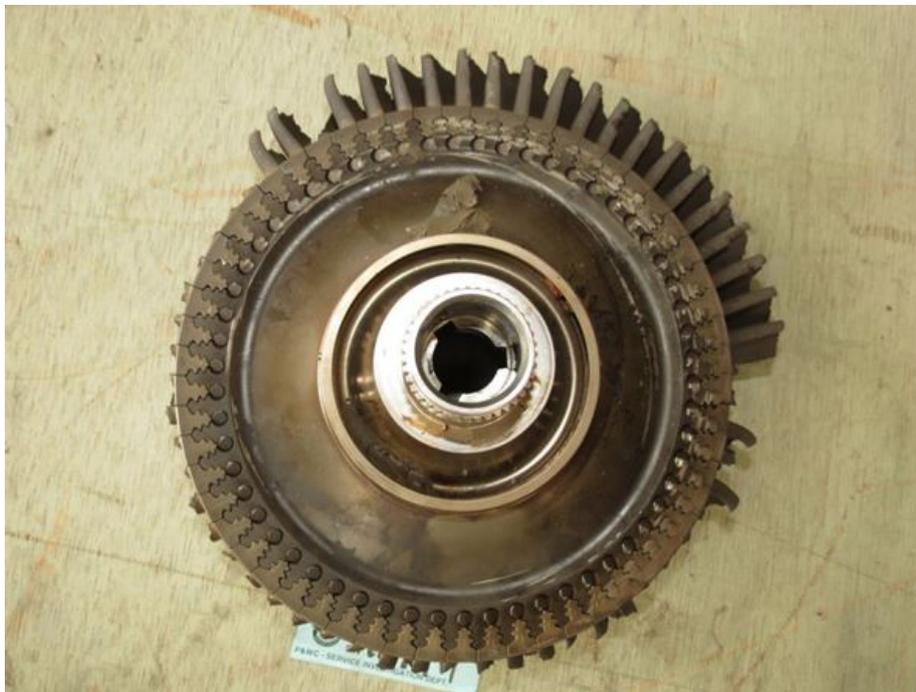
Figure 8: CT disk and blades upstream side
