**FINAL REPORT**  
**A-213/CENIPA/2013**

<b>OCCURRENCE:</b>	<b>ACCIDENT</b>
<b>AIRCRAFT:</b>	<b>PT-WMY</b>
<b>MODEL:</b>	<b>BN-2A-3</b>
<b>DATE:</b>	<b>04DEC2013</b>

This is the Final Report of the accident with the BN-2A-3 aircraft, registration PT-WMY, on 4 December 2013. The accident was classified as “undetermined”.

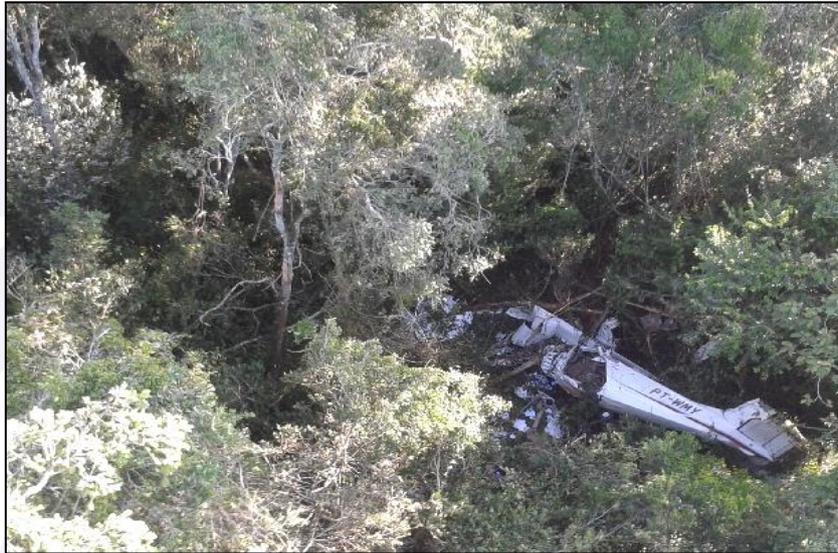
The impact with the ground occurred at a pitch-down angle of approximately 75°, with a heading of 090°, to the left of the direction of departure.

The distribution of the wreckage in the terrain was of a concentrated type. The front part of fuselage broke near the wing root, and was parallel to the plane of the wings.

The wings sustained deformation due to the frontal impact with ground. No fuel was found in the tanks since they are damaged. There were no signs of fuel leak in the area surrounding the wreckage.

The outer part of the left wing was severed upon colliding with a tree. The wing tip was located approximately 2 meters behind the central part of the wing.

The blades of the left engine propeller were at minimum pitch and had not sustained damage.

Figure 1 – The aircraft after the impact.

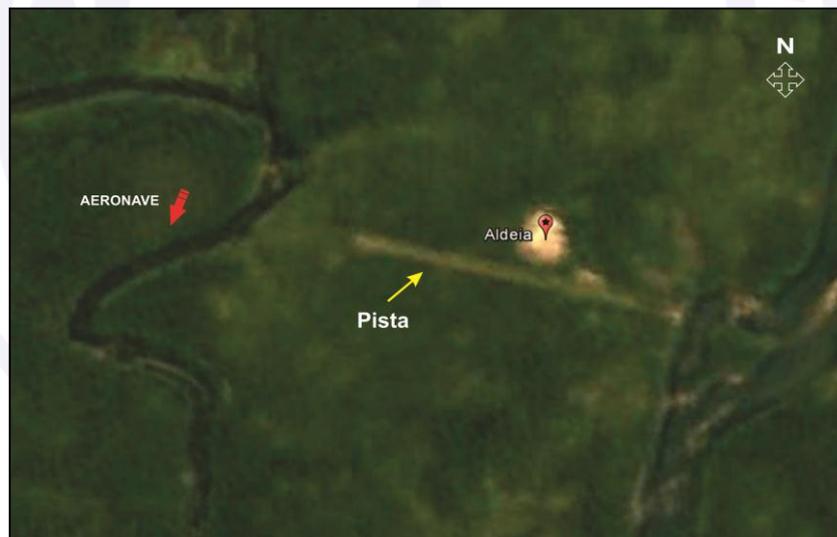
The accident occurred in a jungle area, at a distance of 1 km from the landing strip from which the aircraft had taken off.

Figure 2 – Location of the wreckage in relation to the landing strip.
