# **FINAL REPORT**

## **AIRBUS A380, REGISTRATION 9V-SKE DIVERSION TO BAKU, AZERBAIJAN**

**5 JANUARY 2014**

AIB/AAI/CAS.101

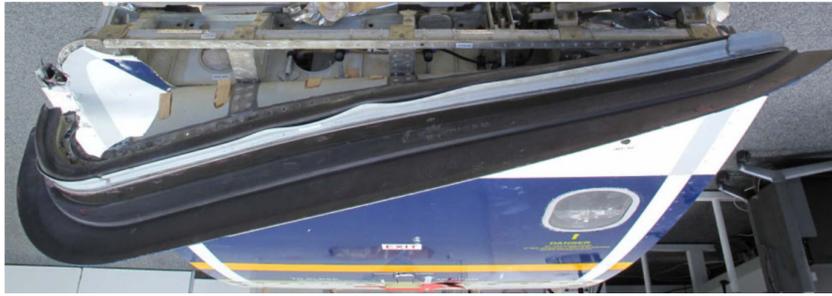
**Figure 3:** Door 3L (View from top)

- 1.2 **Injuries to persons**
- 1.2.1 There was no injury to any person.
- 1.3 **Damage to aircraft**
- 1.3.1 The skin of Door 3L was found torn and bent outwards at the top left hand corner of the door (**Figures 3 and 4**). As a result, the aircraft was unable to maintain pressurisation. The Door 3L window shade was found collapsed. (**Figure 5**).

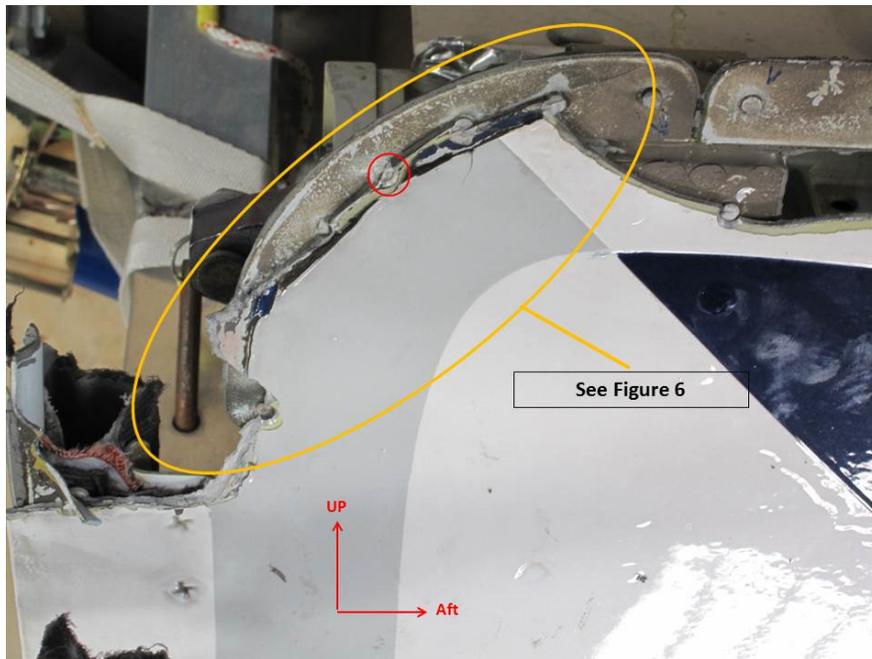
1.7.1.4 **Figure 5** shows the damage at the upper left corner of Door 3L in more detail.

**Figure 5:** Damage at Door 3L upper left corner

2.1.1 The root cause of the Door 3L failure was traced to a crack passing through a number of rivet holes on the door skin. The crack was probably induced by high cycle fatigue under varying amplitude loading caused by fluttering of the Batch 1 coverplate (CP) that was initially installed on the aircraft. The replacement of the Batch 1 CP by a stiffer Batch 3 CP could not prevent further propagation of the crack.

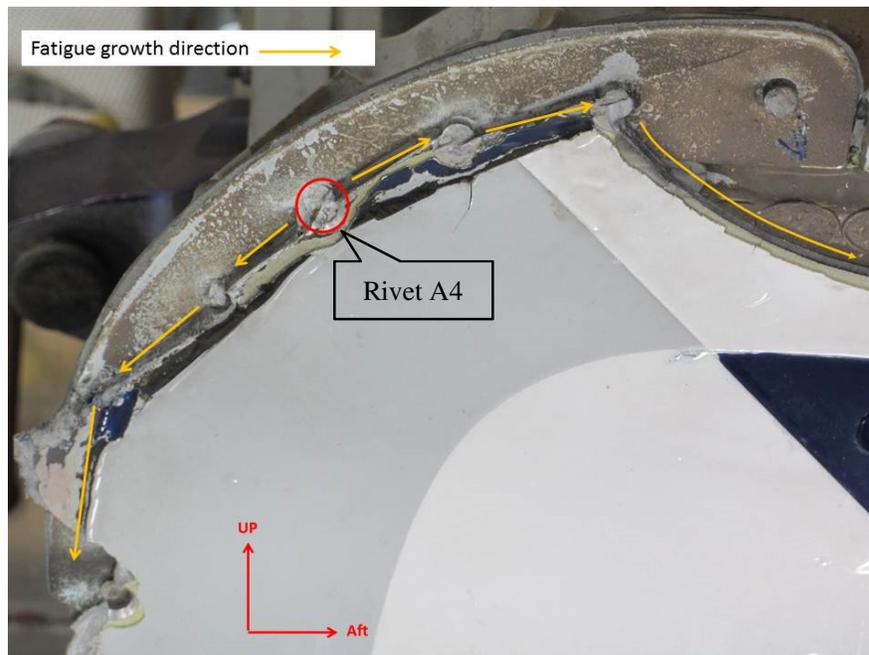
**Figure 6:** Crack growth direction indicated by arrows initiated from rivet highlighted in red

1.7.1.5 SEM examination of the cracked surface revealed predominantly fatigue induced fractures originating from some rivet holes (Figure 7). The crack is likely to have started at Rivet A4 and propagated away from Rivet A4 as shown in Figure 6. An analysis of the crack by the aircraft

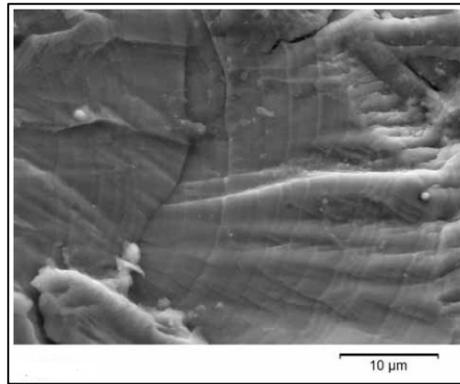
manufacturer suggests that the fractures were due to high cycle<sup>10</sup> fatigue failure under varying amplitude loading.

**Figure 7:** SEM image of fracture surface showing striation lines indicating fatigue failure

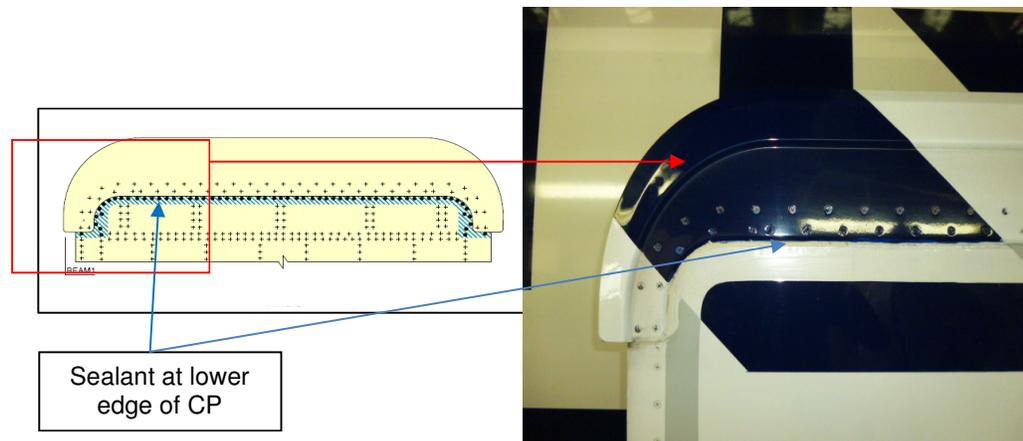
- 1.7.1.6 The row of affected rivets is located just below the bottom edge of the CP (**Figure 8**).

**Figure 8:** Location of affected row of rivets

2.2.2 When the CP is in place, the lower edge of the CP would almost cover the row of rivets in question (see Figure 8) and, as mentioned in paragraph 1.7.1.6, a fillet of sealant is applied to seal the lower edge of the CP. The sealant application job does not include an inspection of the row of rivets. Anyway, it is doubtful if maintenance personnel focusing on the sealant application job would notice any such missing rivet heads, especially if the cavity left by the missing rivet heads had been filled with sealant.

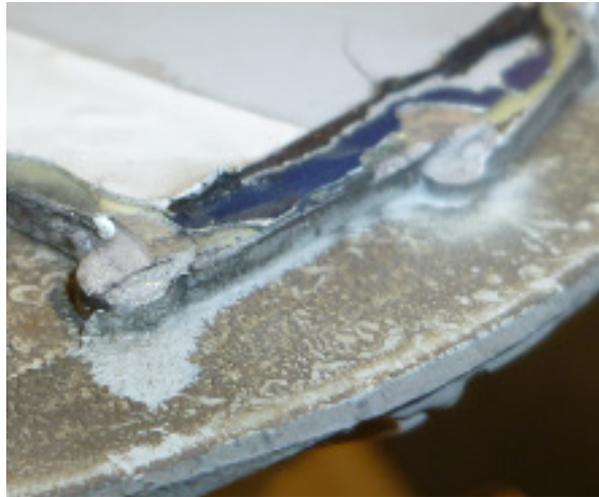
- 1.7.1.7 Some paint and sealant had seeped into the door skin cracks (**Figure 9**).

**Figure 9:** Paint seen under the door skin after seeping through existing door skin cracks

2.2.1 Traces of sealant and paint were found on the crack surfaces as well as on the countersunk surfaces of two of the rivet holes with missing rivet heads. This means the crack was already present in August 2012 during the CP replacement and subsequent painting work. The rivet heads could also have been missing by then.

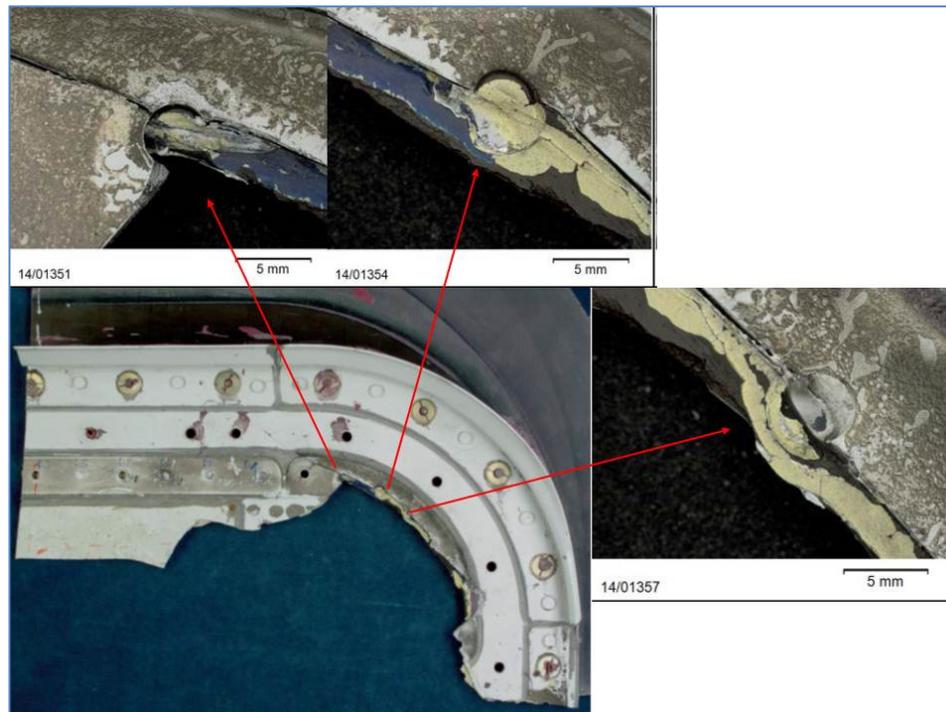
- 1.7.1.8 In addition, there were three missing rivet heads at the cracked area with paint and sealant found on two of the missing rivet heads' countersunk surface (**Figure 10**). Analysis of the paint revealed that the paint was PPG CA8000 (a top coat paint approved by the aircraft manufacturer).

**Figure 10:** Paint and sealant on countersunk surface of missing rivet holes

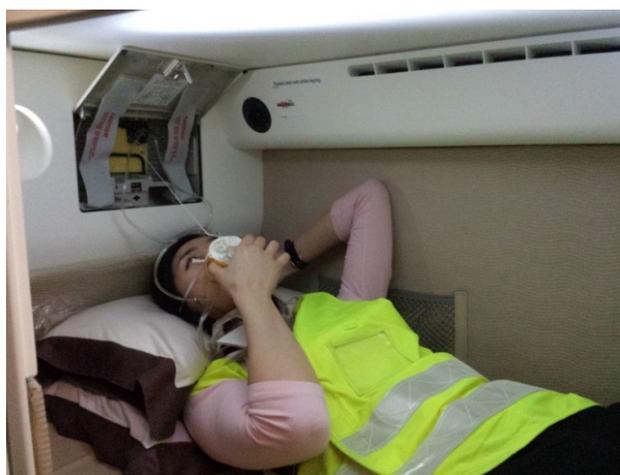
**Figure 13** - Crew rest bunk PSU

(b) The lanyard pins of seven of the 13 PSUs in the CCRC were not released and there was therefore no oxygen flow. The others were found with green band indicating that the oxygen flow was activated.

- 2.4.2 As for the PSUs for the bunks in the CCRC, it is to be noted that, in a lying position, the user of an oxygen mask would have to consciously pull on the mask in order to release the lanyard pin and activate the oxygen flow, in view of the user's close proximity to the PSU and the way the user would reach for the mask (see **Figure 13**).
