**Havarikommisjonen**  
Accident Investigation Board Denmark

# **BULLETIN**

**OY-JAI**

File number: HCLJ510-2014-257  
UTC date: 22-1-2014  
UTC time: 07:50  
Occurrence class: Accident  
Location: Copenhagen Airport, Roskilde (EKRK)  
Injury level: None

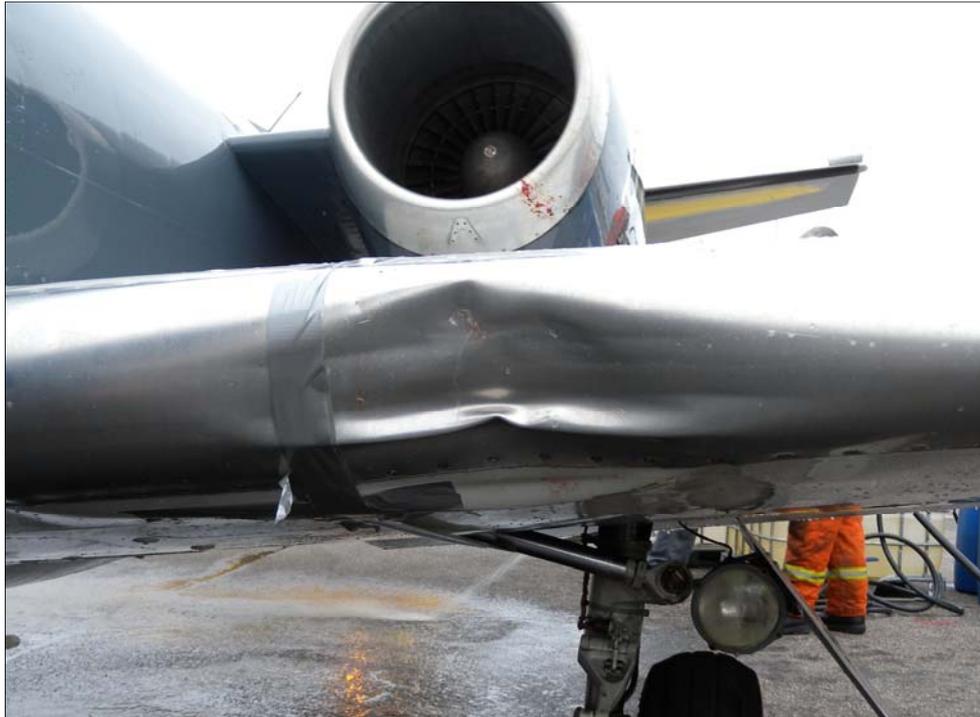
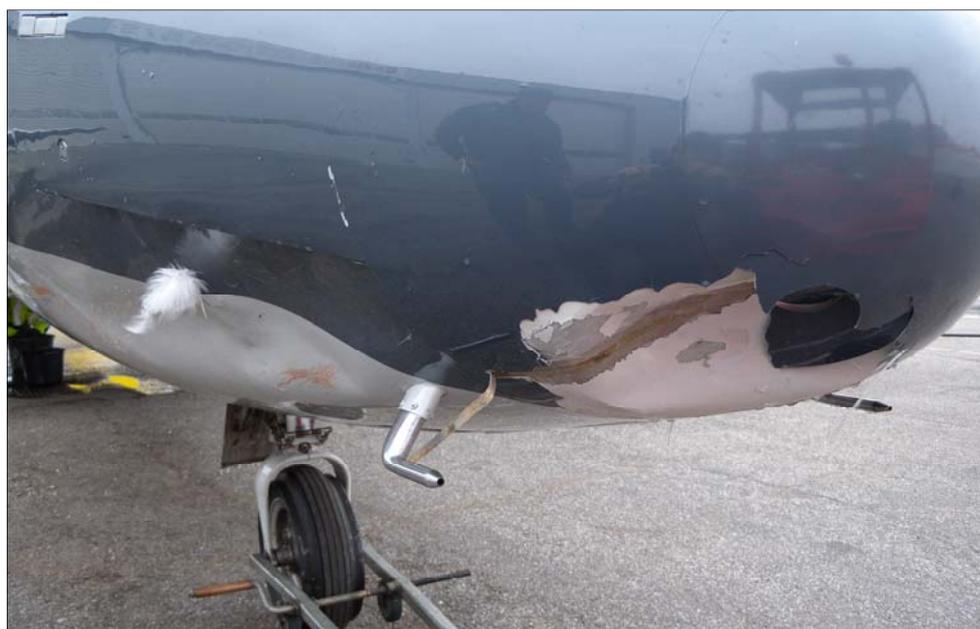
The aircraft had suffered several birdstrikes and was damaged on the left wing leading edge, lower forward part of the left wing and the lower right hand side of the nose radome.

In addition, there were remains of blood and tissue on the left engine inlet lip and in the aft part of the fan duct.

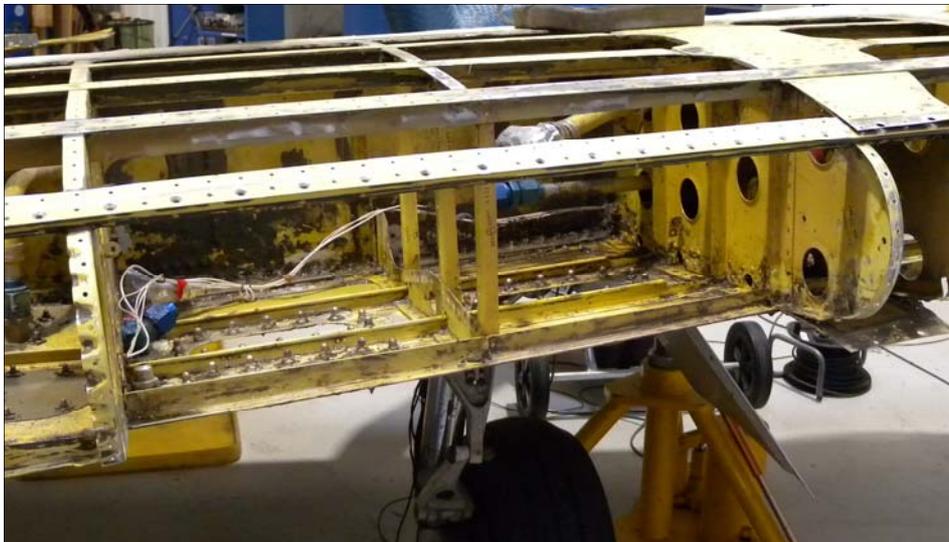
The skin and front stringers of the leading edge of the left wing was bended. Structural damage had opened the wing tank, allowing the fuel to leak.

The main spar of the wing was undamaged.

The above picture shows the wing integral fuel tank. The front bottom stringer was removed for replacement and the skin on the lower part of the wing has been repaired.

The left wing integral fuel tank structure was damaged resulting in a fuel leak.

On-site, an intermittent repair was performed and the aircraft was towed to a maintenance facility in order to carry out sufficient drainage of fuel.
