PRELIMINARY
KNKT.14.02.04.04

Aircraft Accident Investigation Report

**PT. Lion Mentari Air (Lion Air)
Boeing 737 – 900ER; PK-LFH
Juanda Airport, East Java
Republic of Indonesia
01 February 2014**

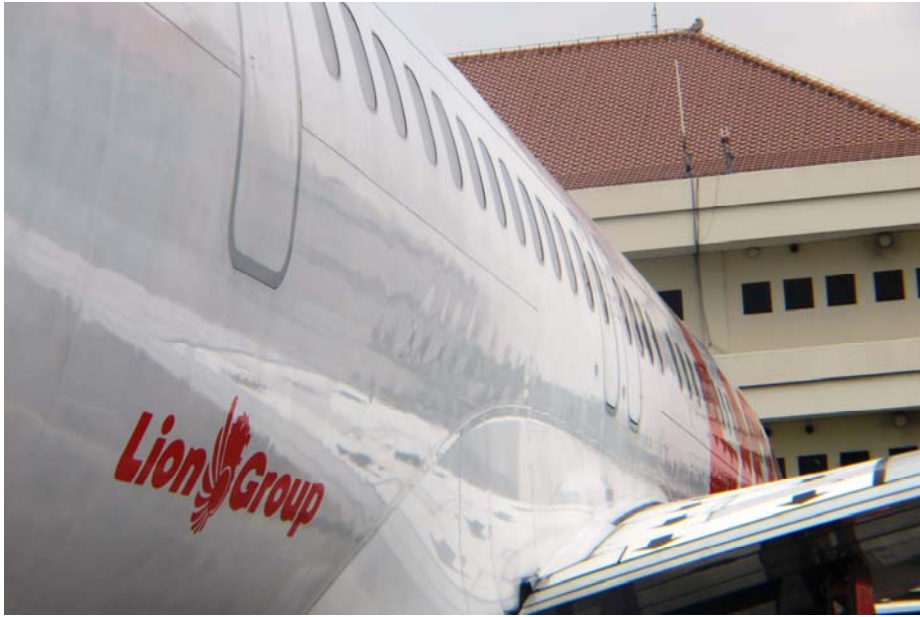
The aircraft was substantially damaged, with the following condition; the nose wheel hub broken, one main tire flat and tail skid damage, left lower fuselage Section 43 Sta 500G - Sta 500H Stringer 21L wrinkle and right middle to upper fuselage from Section 43 - Section 46 wrinkle.

Figure 2. The right aircraft skin wrinkle

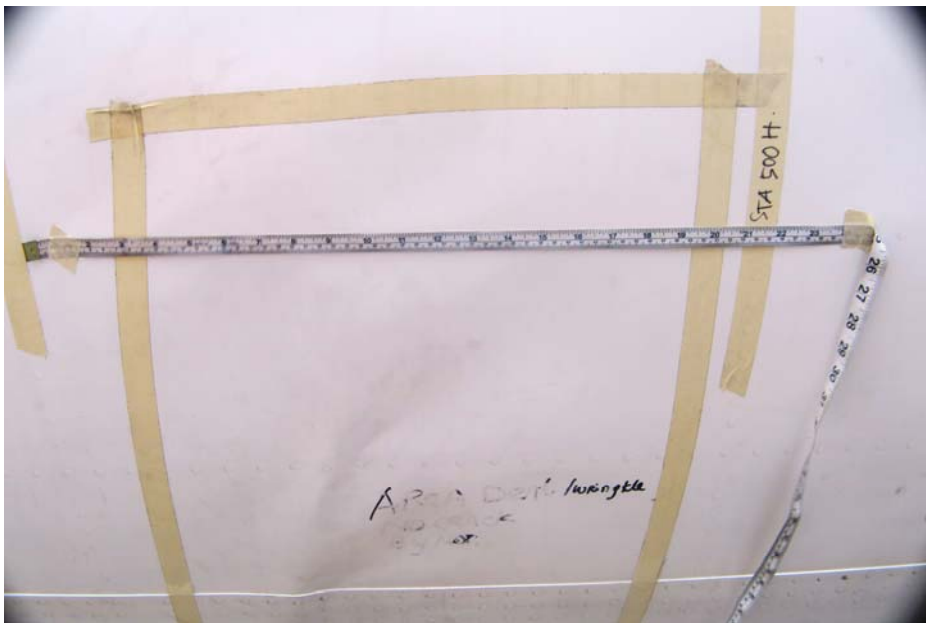
Figure 3. The aircraft skin wrinkle

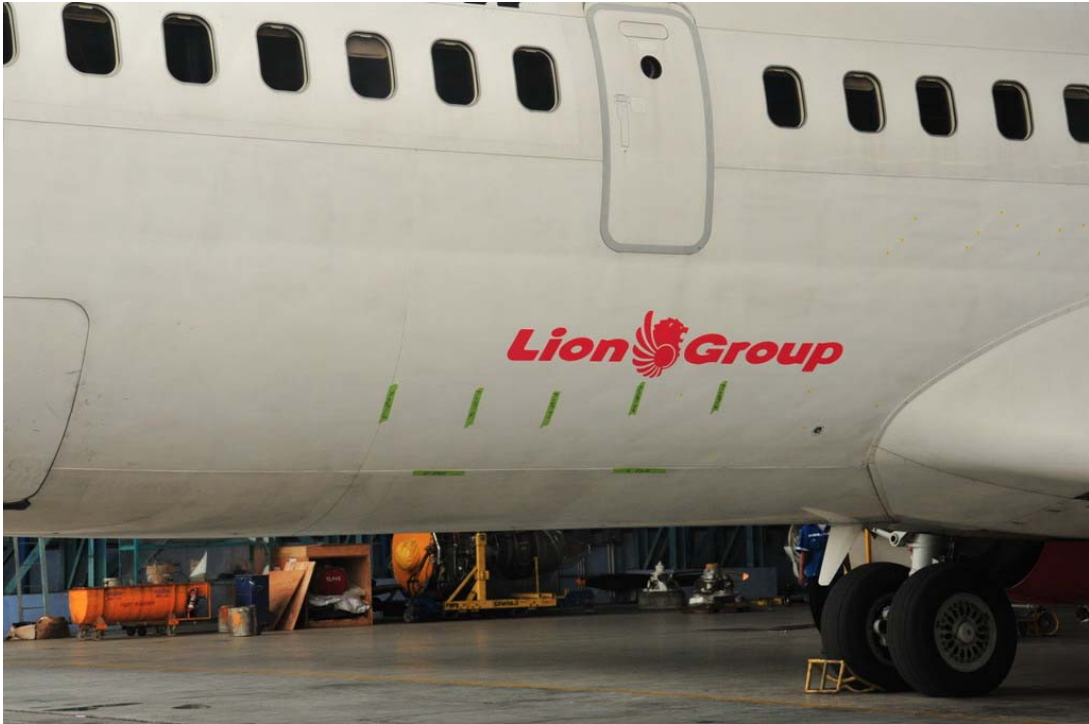
Figure 4. The Left aircraft skin wrinkle

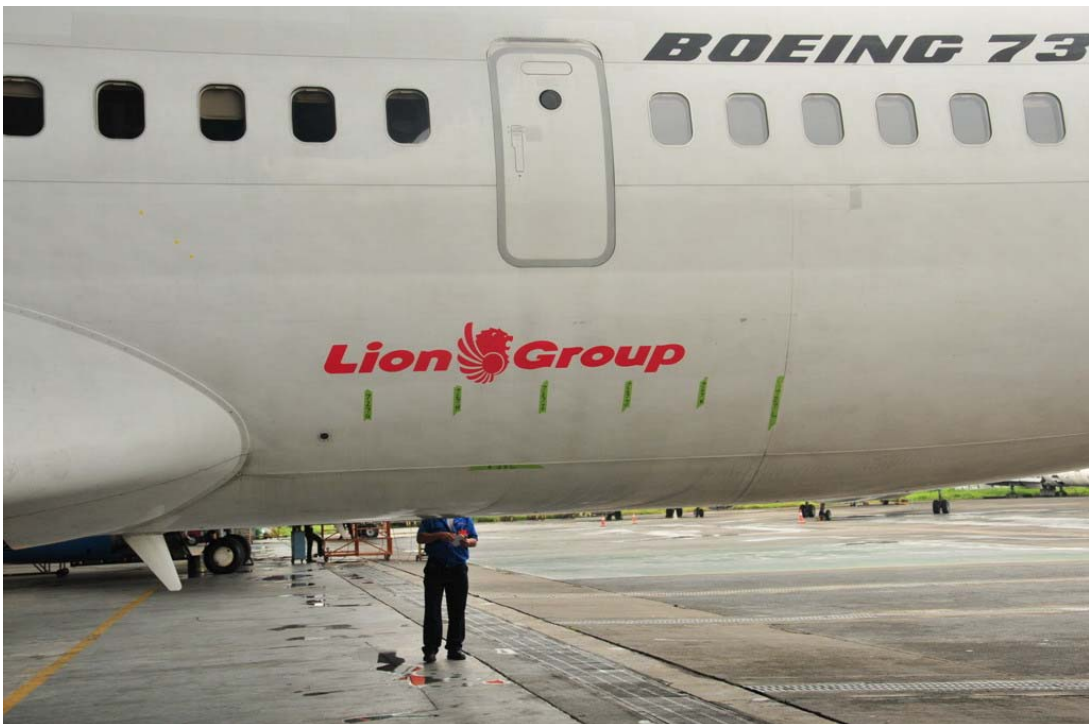
Figure 5. The right aircraft skin wrinkle

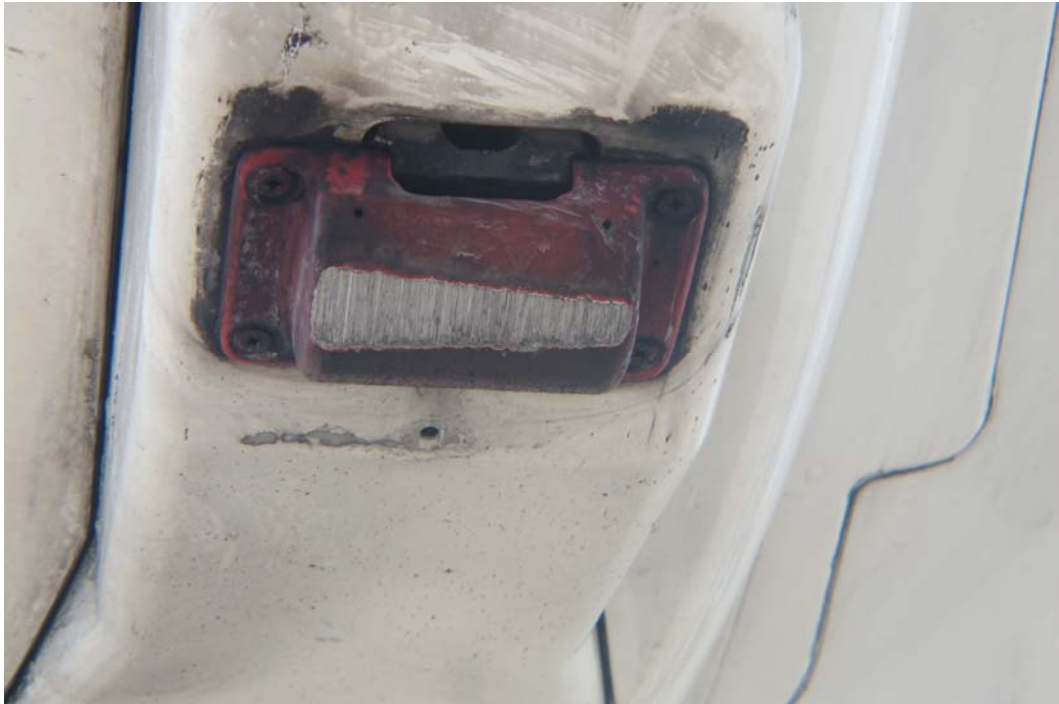
Figure 6: Tail skid indicator
