<b>AIRCRAFT ACCIDENT REPORT AND EXECUTIVE SUMMARY</b>
---

Reference:	CA18/2/3/9291	
<b>Aircraft Registration</b>	ZS-EPZ	<b>Date of Accident</b>	10 February 2014		<b>Time of Accident</b>	1030Z
<b>Type of Aircraft</b>	Cessna Caravan C208B (Aeroplane)		<b>Type of Operation</b>	Commercial		
<b>Pilot-in-command Licence Type</b>	Commercial		<b>Age</b>	25	<b>Licence Valid</b>	Yes
<b>Pilot-in-command Flying Experience</b>	Total Flying Hours	1 859.5		<b>Hours on Type</b>	431.6	
<b>First Officer's Licence Type</b>	Commercial		<b>Age</b>	23	<b>Licence Valid</b>	Yes
<b>First Officer's Flying Experience</b>	Total Flying Hours	412.6		<b>Hours on Type</b>	4.3	
<b>Last point of departure</b>	MalaMala aerodrome (FAMD): Mpumalanga province.					
<b>Next point of intended landing</b>	O R Tambo international airport (FAOR): Gauteng province.					
<b>Location of the accident site with reference to easily defined geographical points (GPS readings if possible)</b>						
On the taxi way leading to runway 16 threshold at GPS co-ordinates determined to be South 24° 48.732' East 31°32.359' at an elevation of 1 100 feet above mean sea level (AMSL).

<b>AIRCRAFT ACCIDENT REPORT</b>
---------------------------

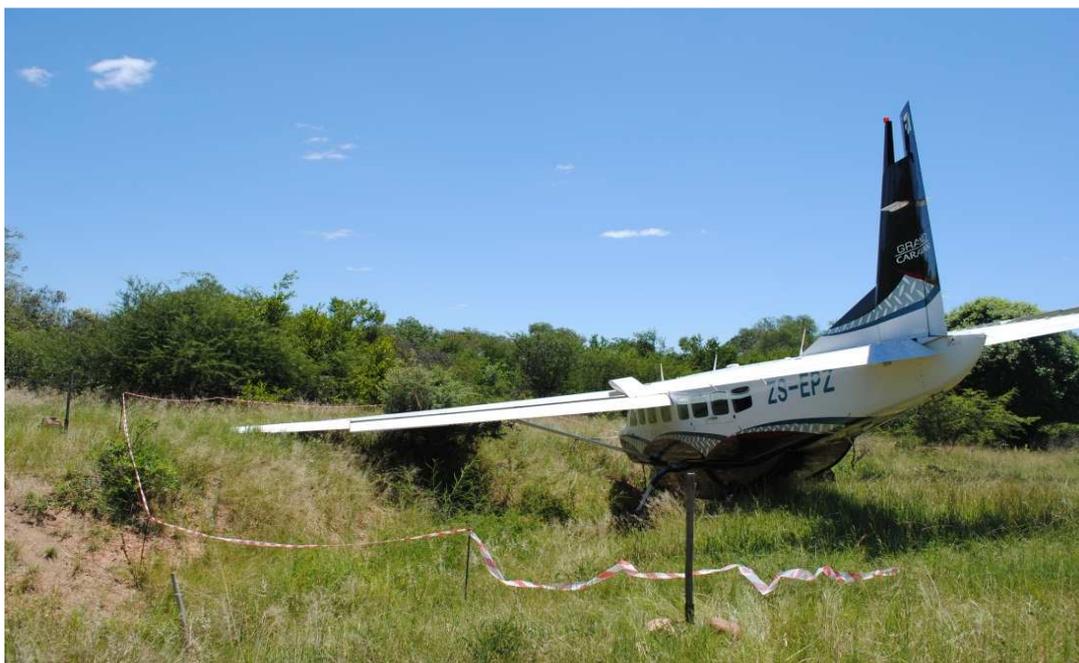
1.3.1 The aircraft was substantially damaged during the accident sequence.

Figure 2: The aircraft as found at the accident site.

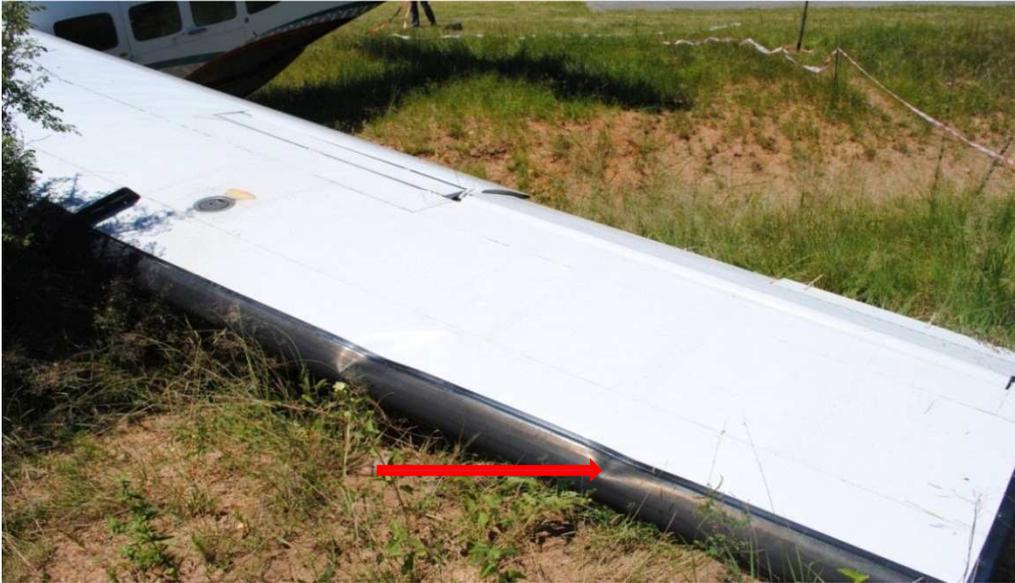
1.12.1 The aircraft ended in a ditch located on the left hand side parallel to the taxi way while taxiing towards runway 16. The aircraft's four bladed propeller struck the embankment and came to a complete stop simultaneously. The aircraft ultimately slid towards the left hand side and came to rest on the left wing. The entire fuselage remained intact except damages to the propeller, the left hand side leading edge/de-icing boot, the left hand wing under skin, the pitot tube and the engine due to sudden stoppage.

Figure 5: The left wing showing damage on the leading edge de-icing boot.

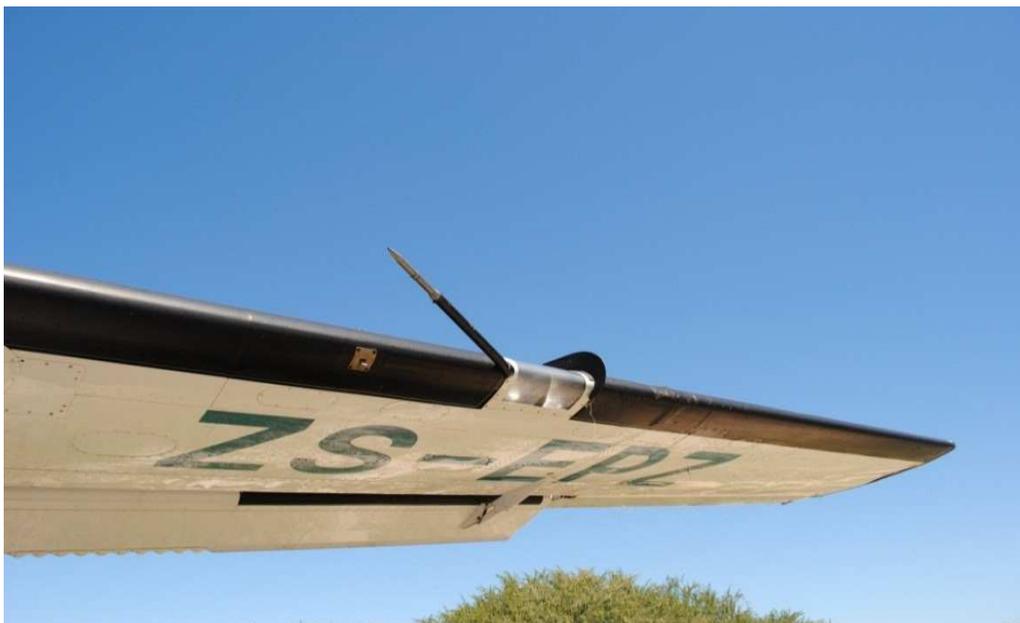
Figure 6: Damaged pitot-tube.

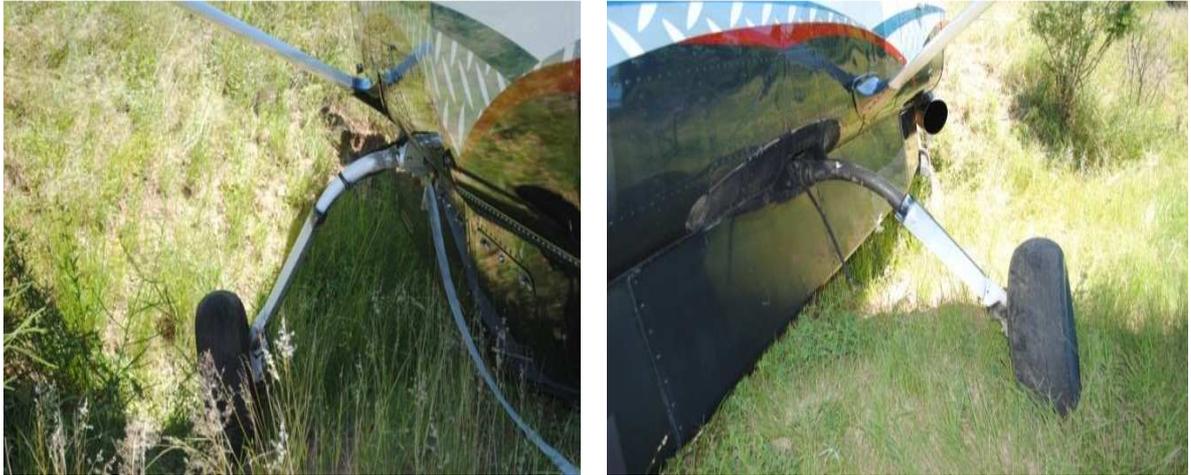
1.16.2 The hydraulic brake fluid ,MIL H5606 reservoir was checked for security and proper level and was found to be in accordance with the manufacturer's specifications. The master brake cylinders, brake discs, brake assemblies and hydraulic lines were subjected to visual inspection and no abnormalities were found. Both landing gear upper fairings were removed with the intention to attach a rope in order to pull the aircraft out of the ditch with the assistance of a truck. Below are pictures of the landing gear with evidence of upper fairings removed and the aircraft as it was pulled out of the ditch by means of a truck.

**Figure 8 and 9: Right and left.**

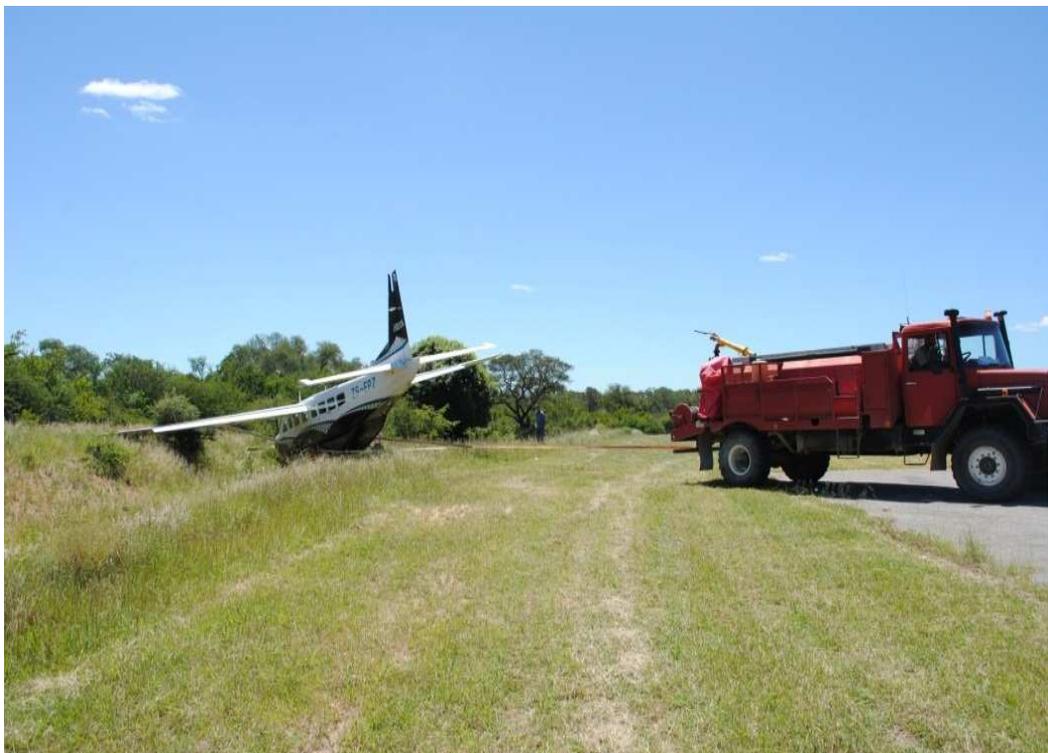
**Figure 10: The aircraft as it was pulled out of the ditch.**

1.16.3 The aircraft was successfully pulled out of the ditch and subjected to brake system examination in the presence of the operator's representative and was found to have sufficient pressure and fully functional. The parking brake was also examined by applying foot pressure at the top of the brake pedal, thus closing the parking valve by locking the hydraulic pressure and was also working in accordance with the manufacturer's specification. The operator's representative confirmed the condition of the rudder/brake system and the PF remarks to the investigators and answers provided to the passengers were proved to be incorrect and was eliminated. Below is a Cessna Caravan C208B cockpit.
