In-flight upset, inadvertent pitch disconnect, and continued operation with serious damage involving ATR 72 aircraft, VH-FVR

47 km WSW Sydney Airport, New South Wales | 20 February 2014

ATSB Transport Safety Report
Aviation Occurrence Investigation
AO-2014-032
Final – 24 May 2019

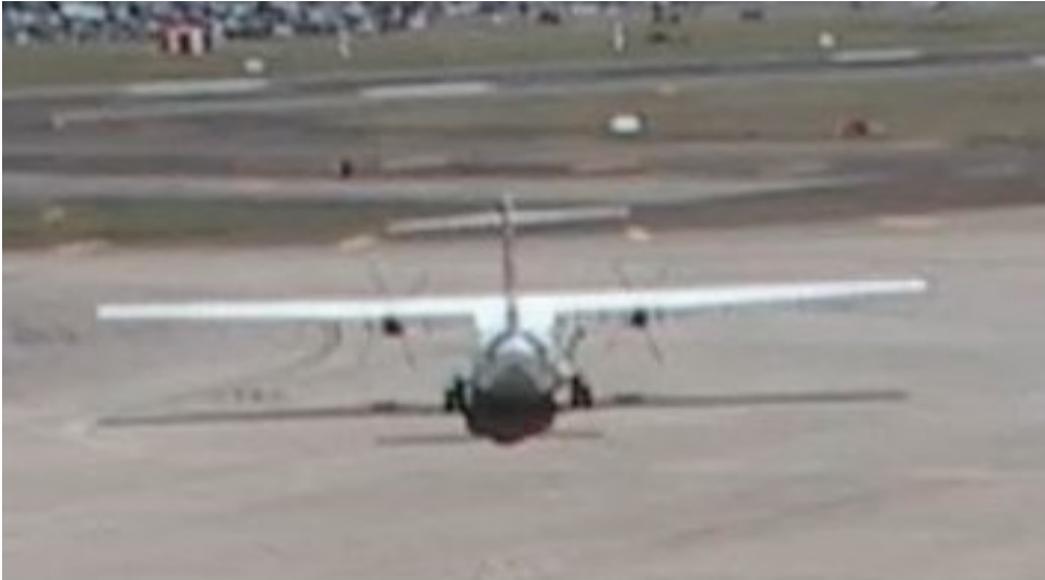
VH-FVR under tow following completion of post-occurrence maintenance. The angle of the horizontal stabiliser relative to the angle of the wings indicates substantial structural deformation.

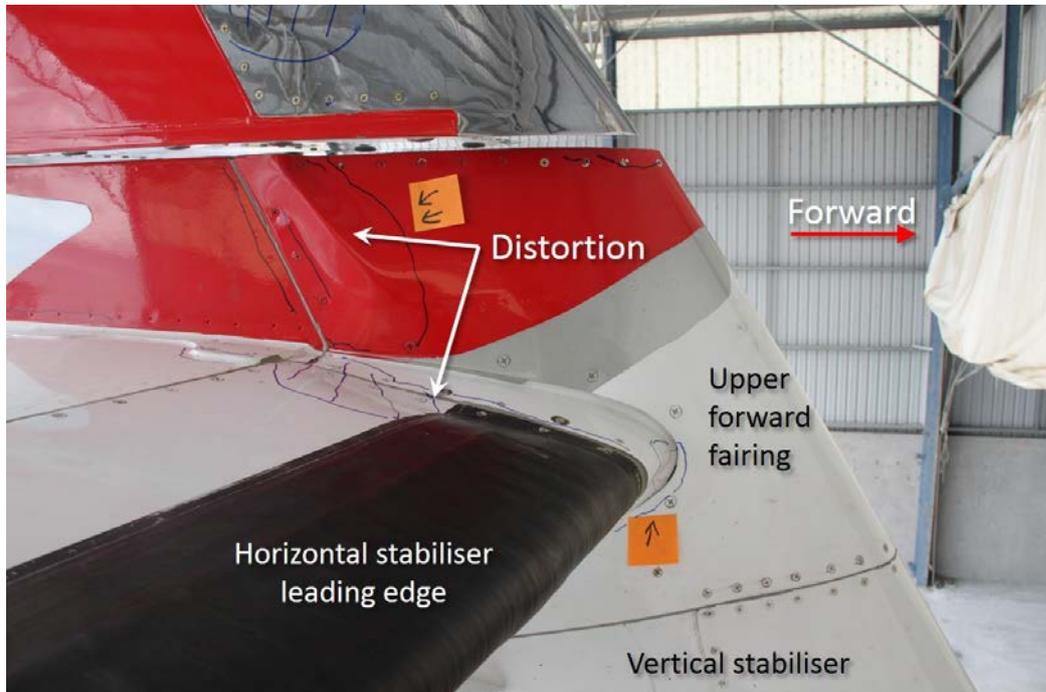
During the next 5 days the aircraft was operated on 13 flights and was subject to routine walk-around visual inspections by flight crew and engineers. No one identified any anomalies until flight crew observed some damage after a suspected bird strike. The aircraft was grounded and subjected to extensive maintenance that included replacement of the horizontal and vertical stabilisers.

Upper tailplane of VH-FVR showing damage to horizontal and vertical stabilisers that was evident when the damage was identified 5 days and 13 flights after the in-flight upset/pitch disconnect and associated maintenance

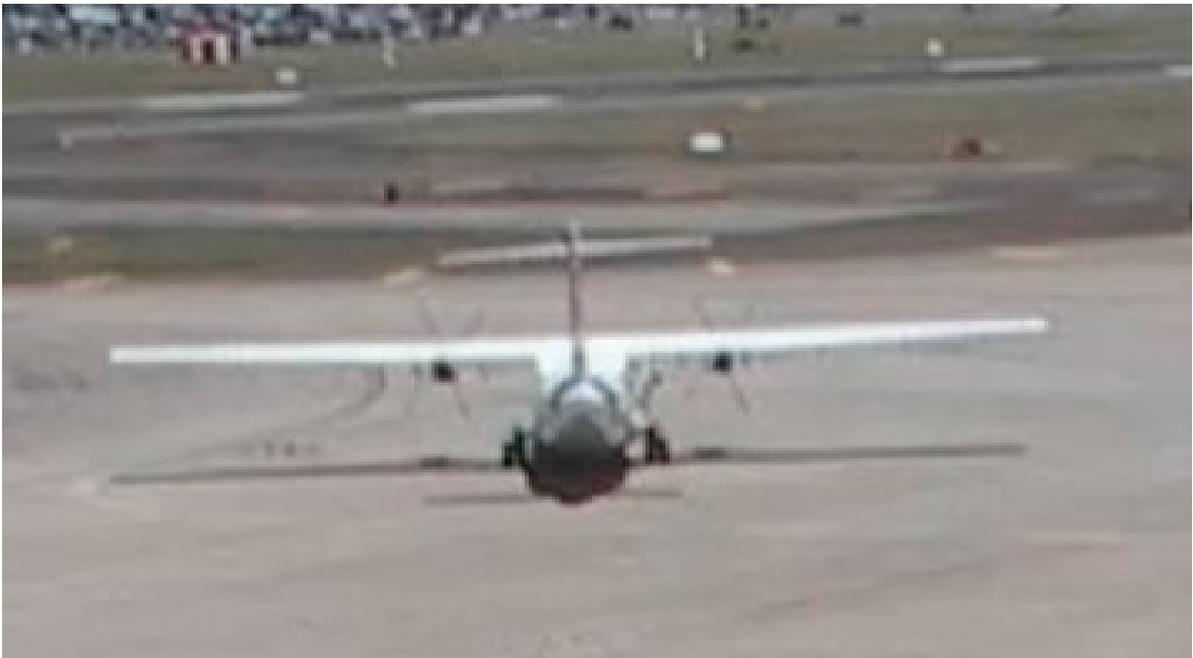
Figure 4: Aircraft being towed away from remote bay at 1215 on 21 February 2018 (still image copied from closed circuit TV footage). Note the angle of the horizontal stabiliser relative to the angle of the wings.

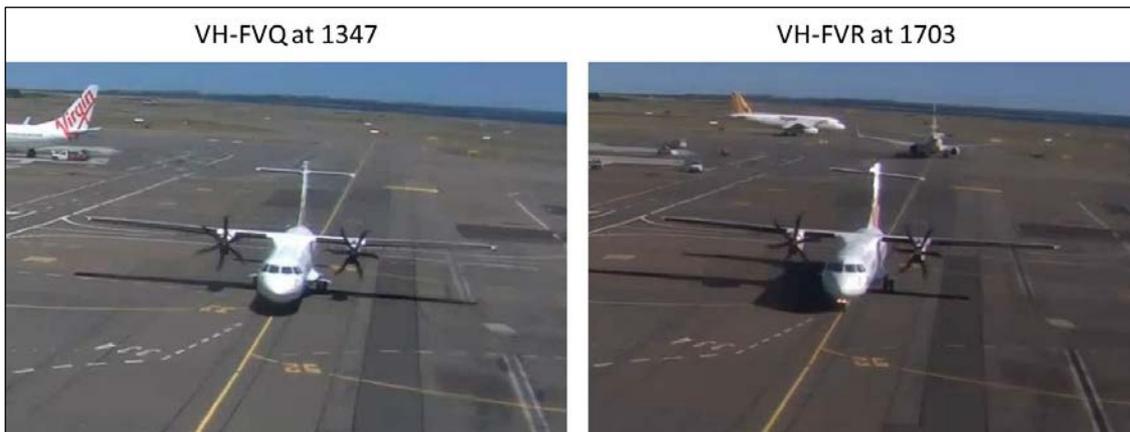
Figure 5: Images from Sydney Airport CCTV footage showing the deformation to the horizontal stabiliser of VH-FVR (right) as compared to an undamaged ATR 72, VH-FVQ (left).

The image was taken as the aircraft taxied to the bay on 20 February 2014. Note that the left tip of the horizontal stabiliser VH-FVR is visibly lower than the right when compared to the angle of the wing.

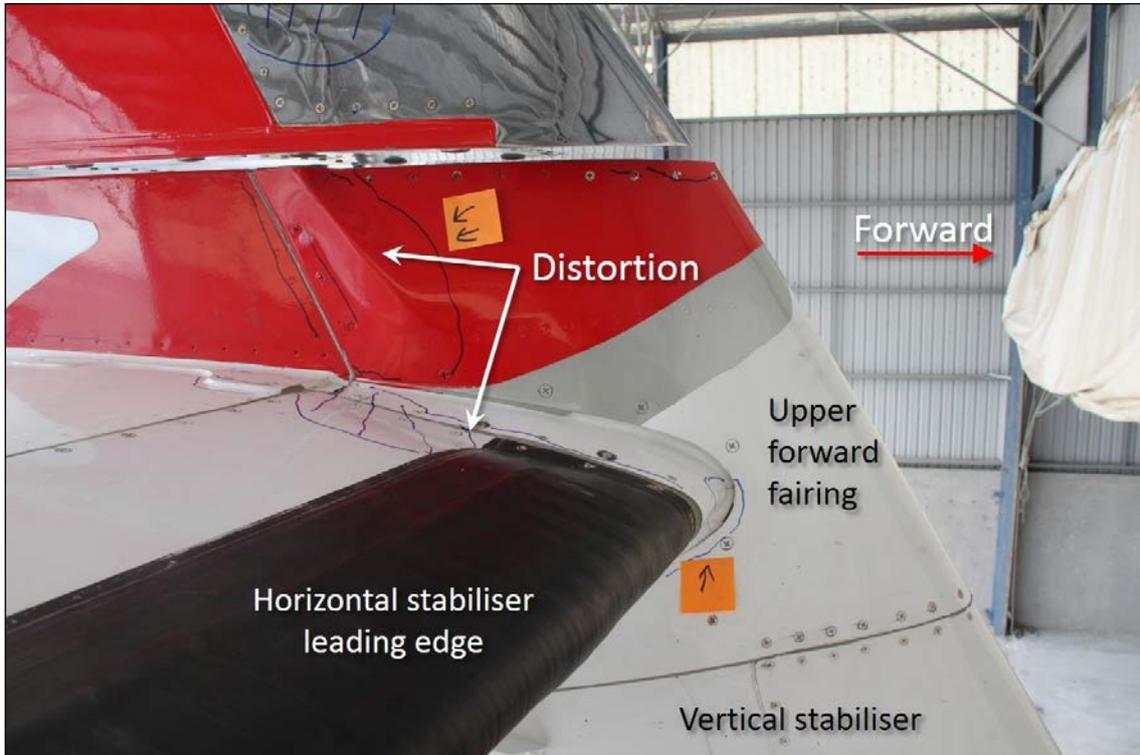
Figure 6: Distortion in the upper forward fairing right side horizontal stabiliser leading edge prior to removal of any fairings or access panels.

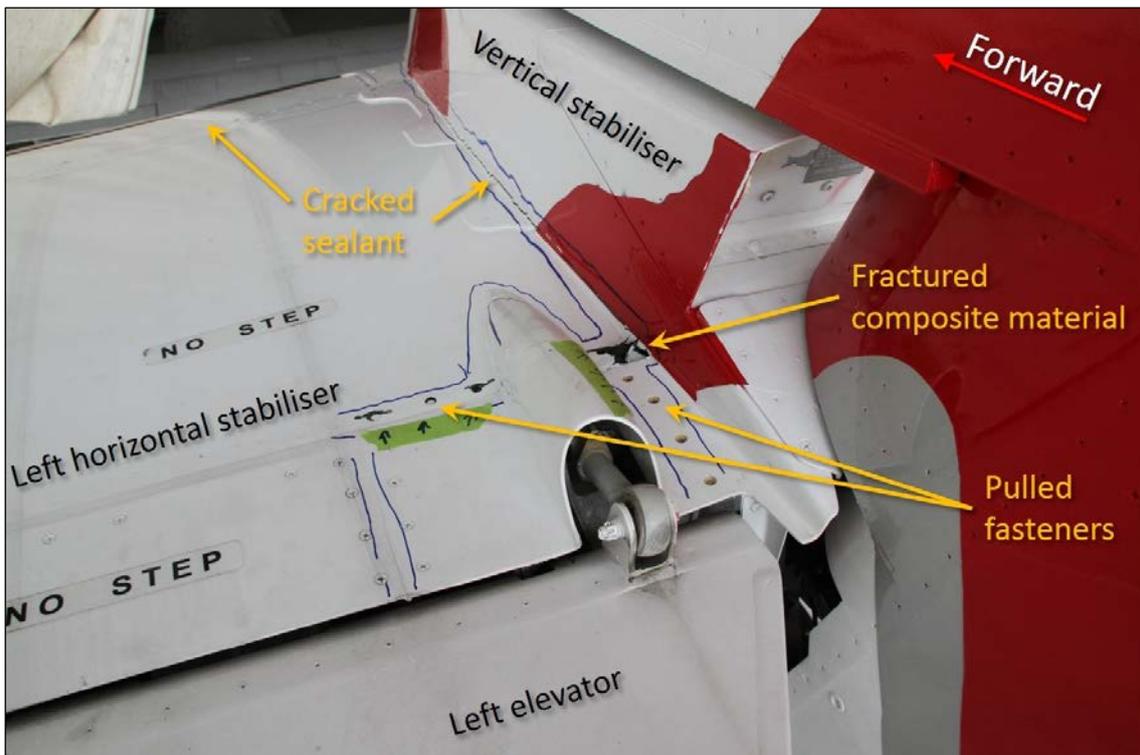
Figure 7: Damage visible on the upper left side of the horizontal stabiliser included cracked sealant, fractured and exposed composite material, and fasteners pulled through the composite material

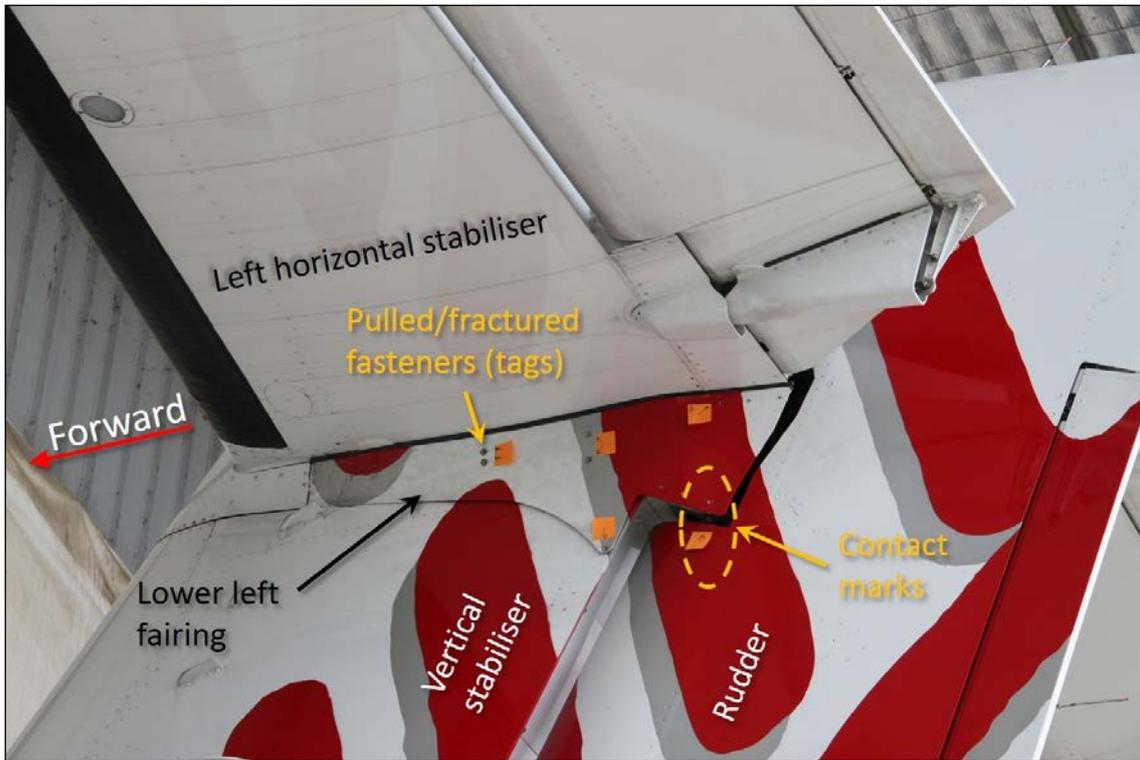
Figure 8: Damage visible on the lower left side of the horizontal stabiliser included fasteners pulled through the lower left fairing, fractured fasteners for securing the fairing and contact marks between the fairing and the rudder.

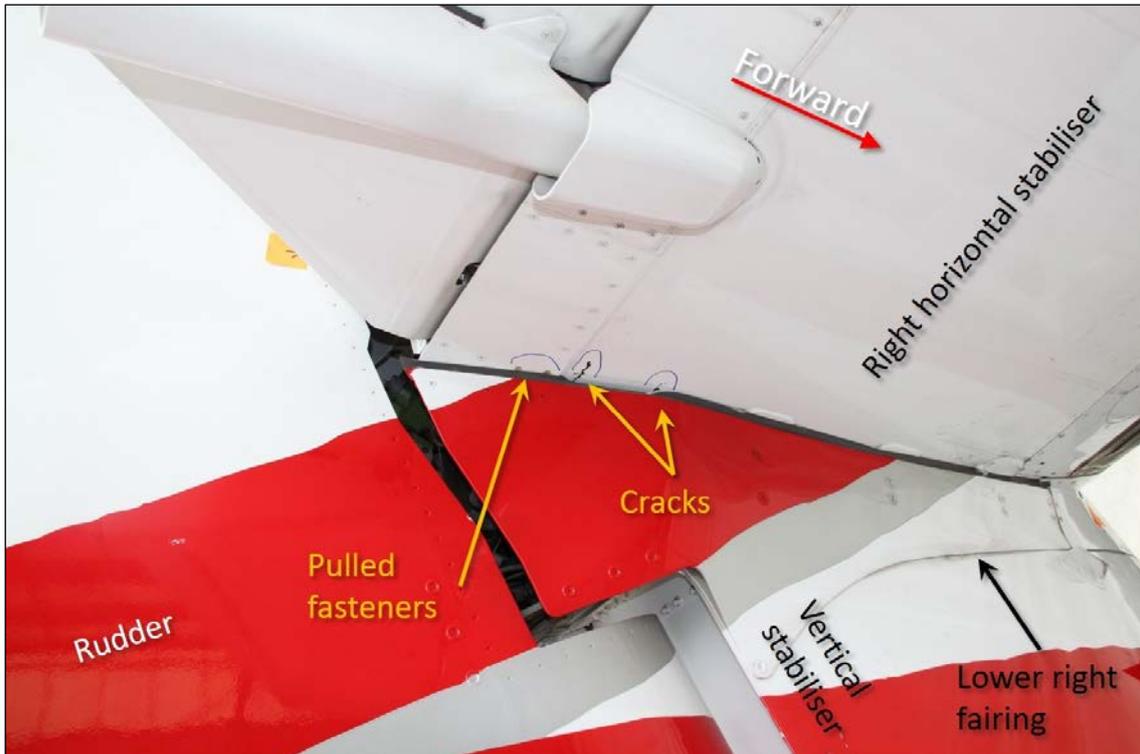
Figure 9: Damage visible on the lower right side of the horizontal stabiliser included fasteners pulled through the lower skin and cracks in the lower skin panel.

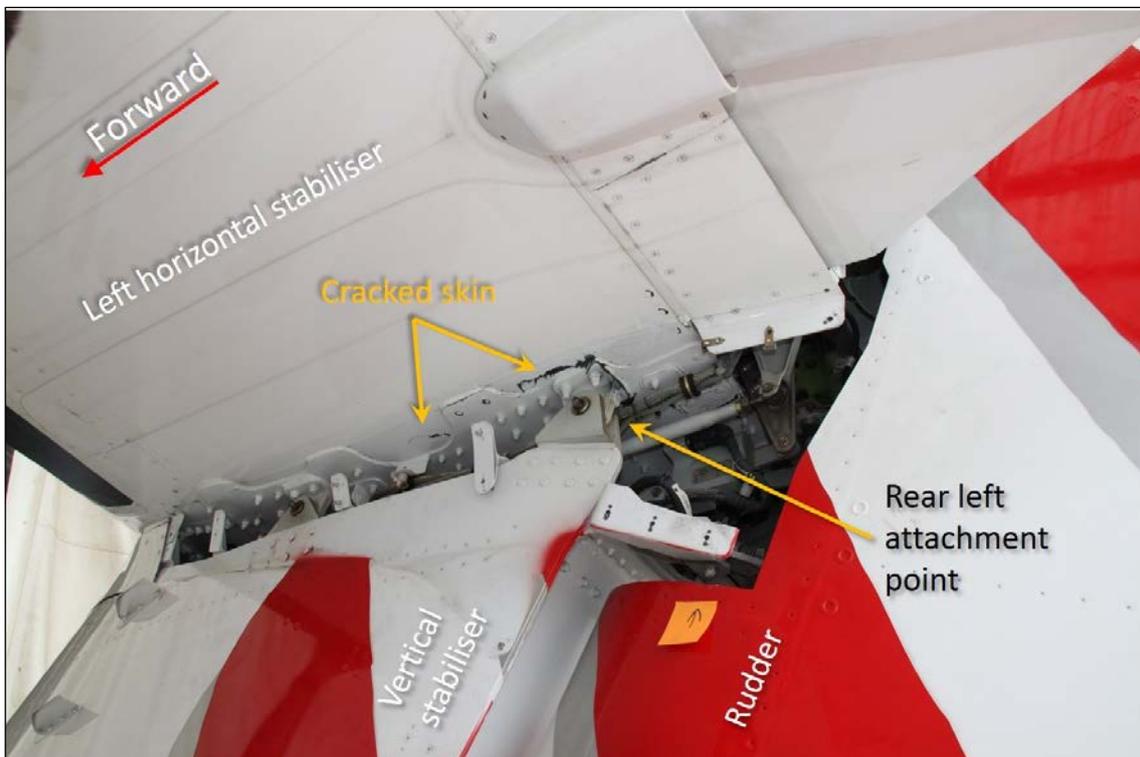
Figure 10: Horizontal-to-vertical stabiliser attachment with the lower left fairing removed showing the cracking in the skin panel adjacent to the attachment fitting.

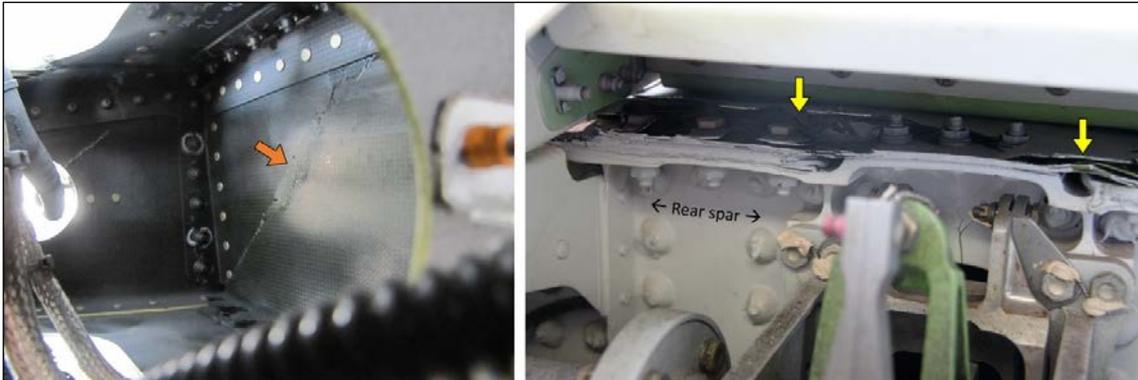
Figure 11: Crack in the horizontal stabiliser front spar (left) identified by orange arrow. Cracking and delamination in the composite skin at the rear spar (right) identified by yellow arrows.

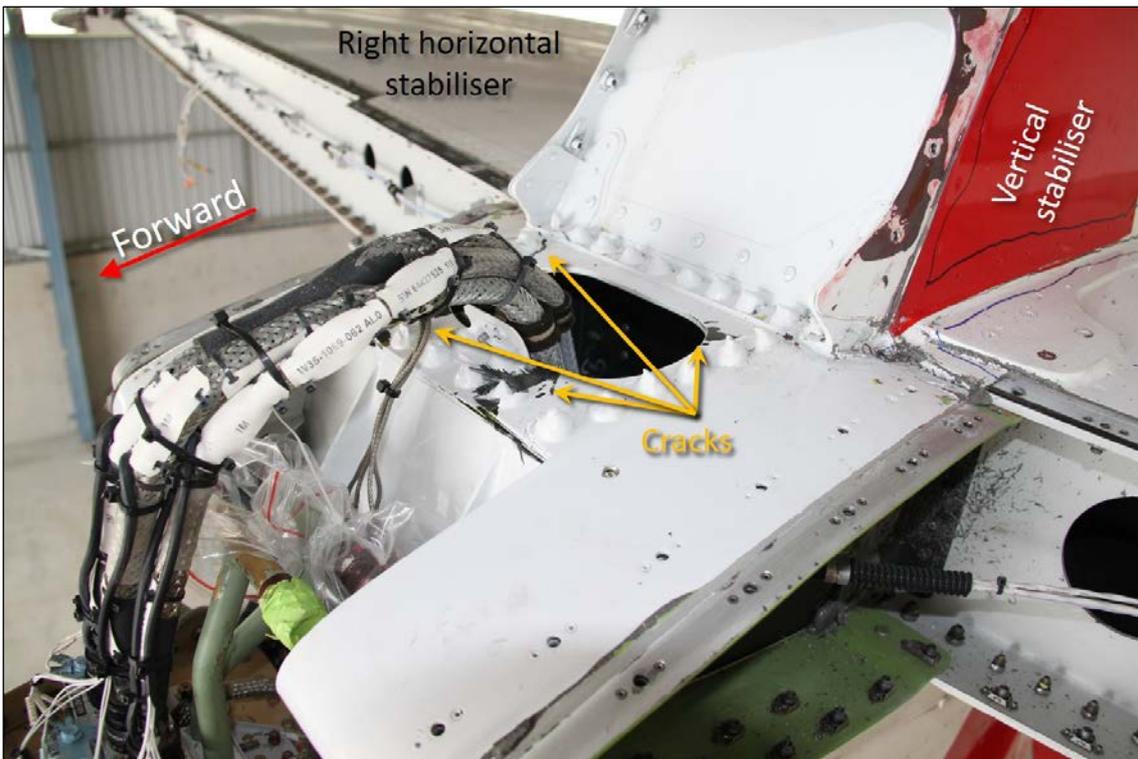
Figure 12: Damage in the centre leading edge section above the forward attachment points, included cracking and delamination in all corners of the cut-out and cracks in the ribs (not shown) and deformation of the material around the attachment points (not shown).

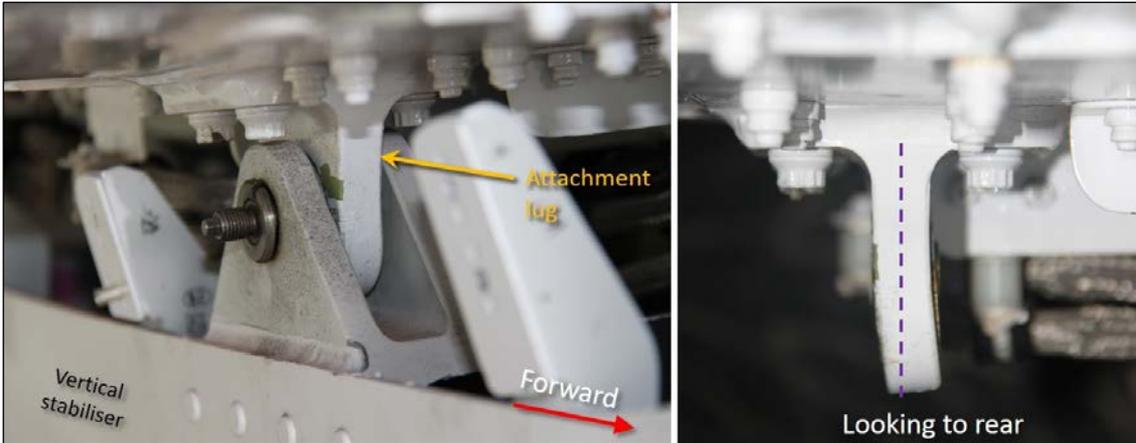
Figure 13: Mid-right attachment lug. Left image shows the lug while connected to the vertical stabiliser. Cracks and missing white paint (green patch) were indications of distress. Right image shows the lug following removal of the horizontal stabiliser.

The purple dashed line has been added as a visual reference to highlight the bending in the lug. The damage to the mid-left lug was similar.
