ACCIDENT

Aircraft Type and Registration:	BD-700-1A10 Global 6000, EC-LTF	
No & Type of Engines:	2 Rolls Royce BR710A2-20 turbofan engines	
Year of Manufacture:	2011	
Date & Time (UTC):	6 March 2014 at 1858 hrs	
Location:	Prestwick Airport, Scotland	
Type of Flight:	Commercial Air Transport (Passenger)	
Persons on Board:	Crew - 4	Passengers - 2
Injuries:	Crew - None	Passengers - None
Nature of Damage:	Damage to right wingtip, aileron, flap track fairing and slat	
Commander's Licence:	Airline Transport Pilot's Licence	
Commander's Age:	46	
Commander's Flying Experience:	8,000 hours (of which 1,400 were on type) Last 90 days - 30 hours (all on type) Last 28 days - 20 hours (all on type)	
Information Source:	AAIB Field Investigation

Synopsis

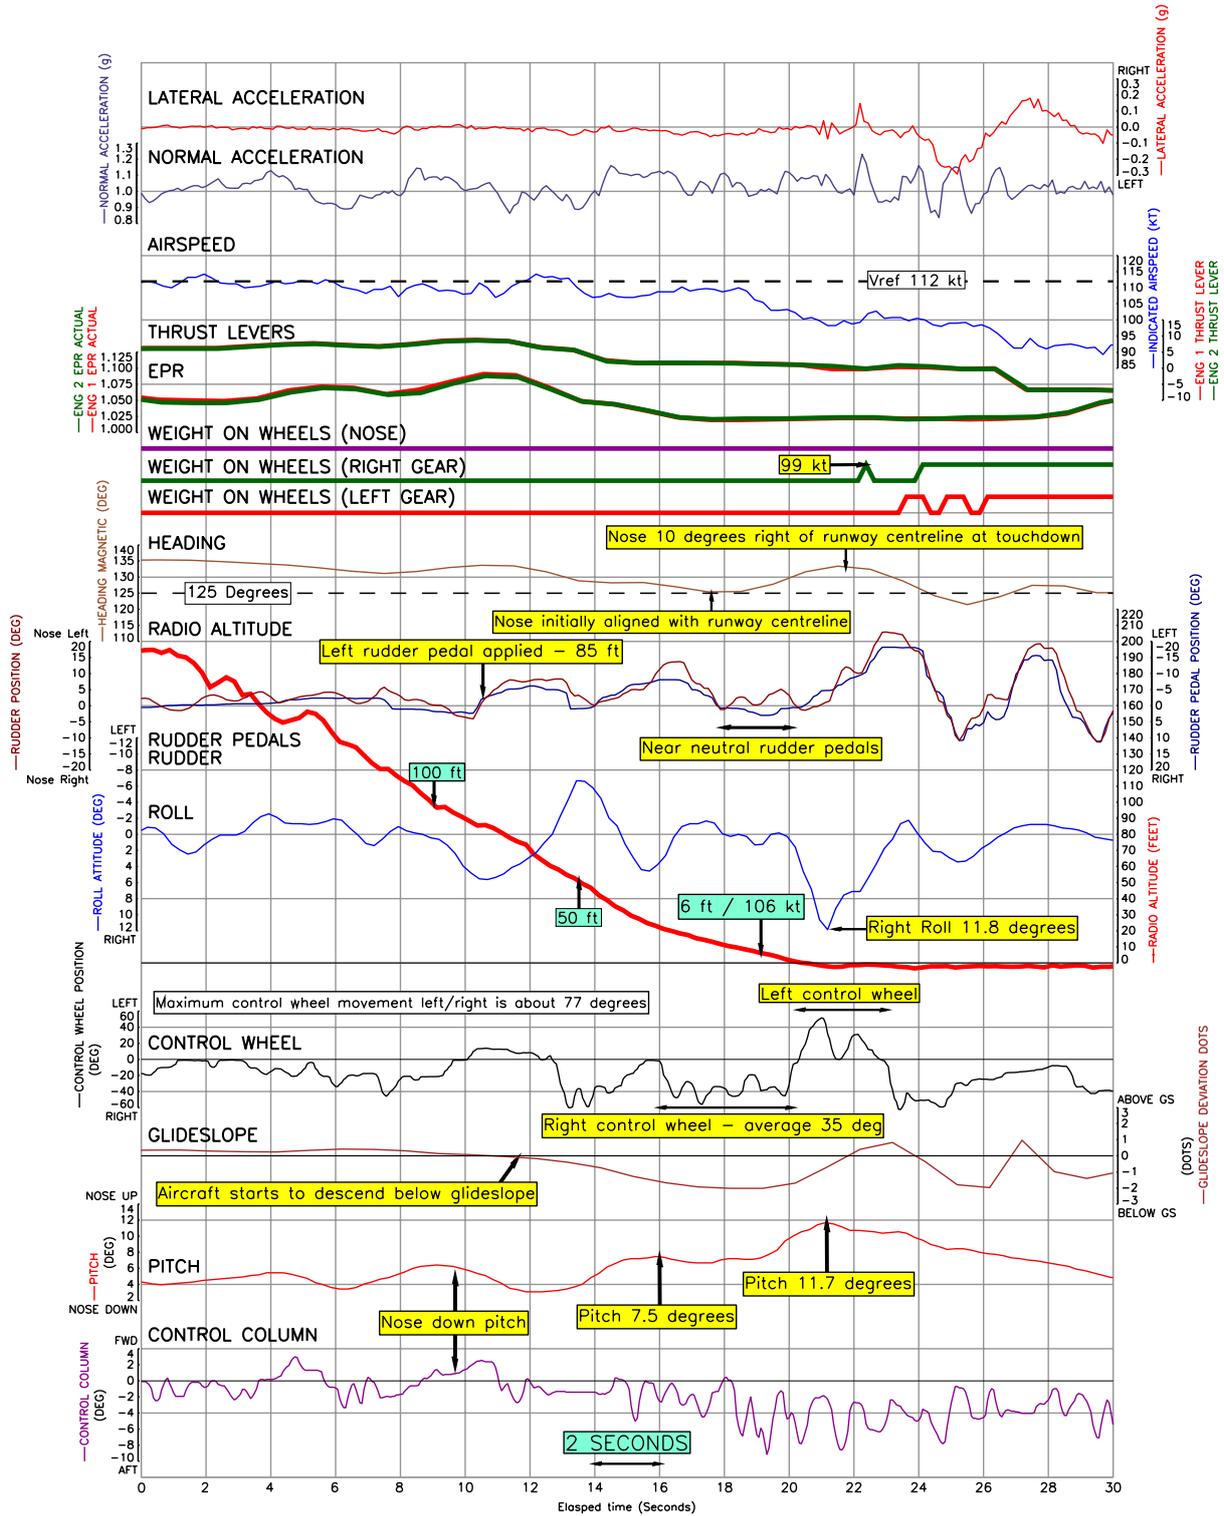
Figure 1

At approximately 100 ft agl a nose-down control column input caused the rate of descent to increase and the aircraft deviated below the glideslope. A right wing-down attitude began to develop and, at 85 ft agl, when the aircraft was about 330 m from the displaced threshold, left rudder was applied. In response the aircraft's nose started to align towards the runway centreline and the aircraft rolled quickly left. The commander reacted to what he believed to be a gust of wind by making a control wheel input to the right. He briefly centred the rudder pedals before re-applying left rudder. At the same time, passing 50 ft agl, he commenced a flare by pitching to about 7.5° nose-up. The wings were then held in a near level attitude which required an average control wheel input of 35° to the right but with the rudder pedals almost neutral. This attitude was maintained for approximately 4 seconds and the nose of the aircraft began to yaw to the right. At 6 ft agl, the airspeed had decayed to 106 KIAS (V_{REF} minus 6 KIAS).

The commander increased the flare by pitching the nose quickly from about 7.5° to about 11.7°. The aircraft then started to roll right rapidly, so the commander reacted by moving the control wheel to about 50° to the left but the aircraft continued rolling right, reaching 11.8° before responding. In this nose-high attitude, the right wing contacted the runway, although the crew were unaware of the wing strike. Shortly afterwards the right main gear compressed with the right wing 7° down, at an airspeed of 99 KIAS (V_{REF} minus 13 KIAS). The aircraft then rolled left before rolling right again and landed left of centreline with about 3.5° right wing down.

FDR Salient parameters of the approach starting at 200 ft agl

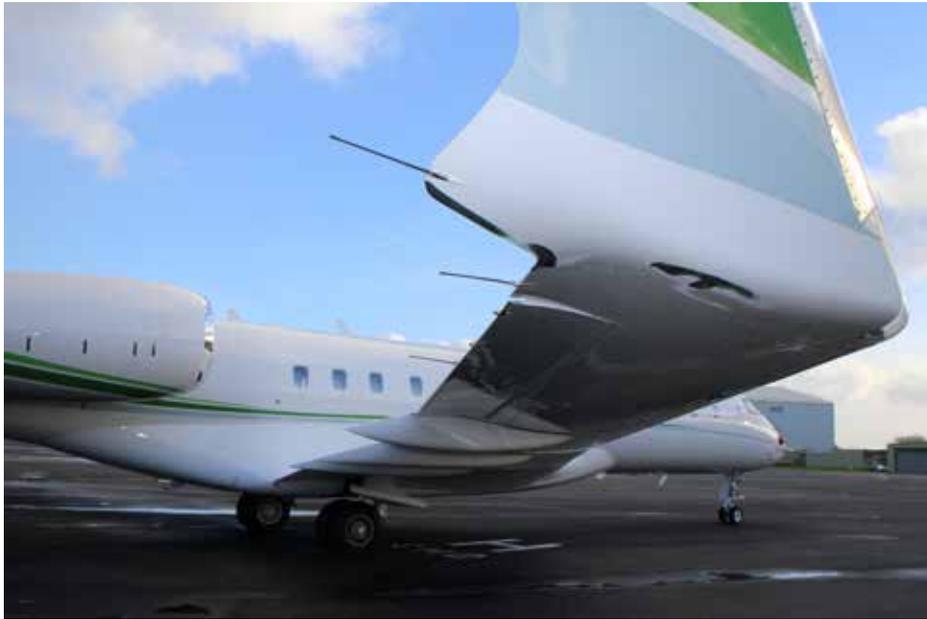
Figure 2
Damage to EC-LTF

During the accident the aircraft suffered damage consistent with the right wing touching the runway surface at various points across its structure. The composite wingtip had been abraded in three positions, the heaviest contact having worn through the skin exposing the aluminium wing structure beneath. The damage to the rear of the wingtip extended onto the corner of the wing trailing edge. As the flaps and slats had been extended at touch down, the corner of the leading edge slat had been planed flat, as had the rear tip of the outboard flap track fairing. There was also damage to the outboard trailing edge of the aileron and static wick mounts, along with the loss of the two furthest outboard static

wicks fitted to the aileron. No pre-impact technical issues were identified that may have affected the aircraft's handling.

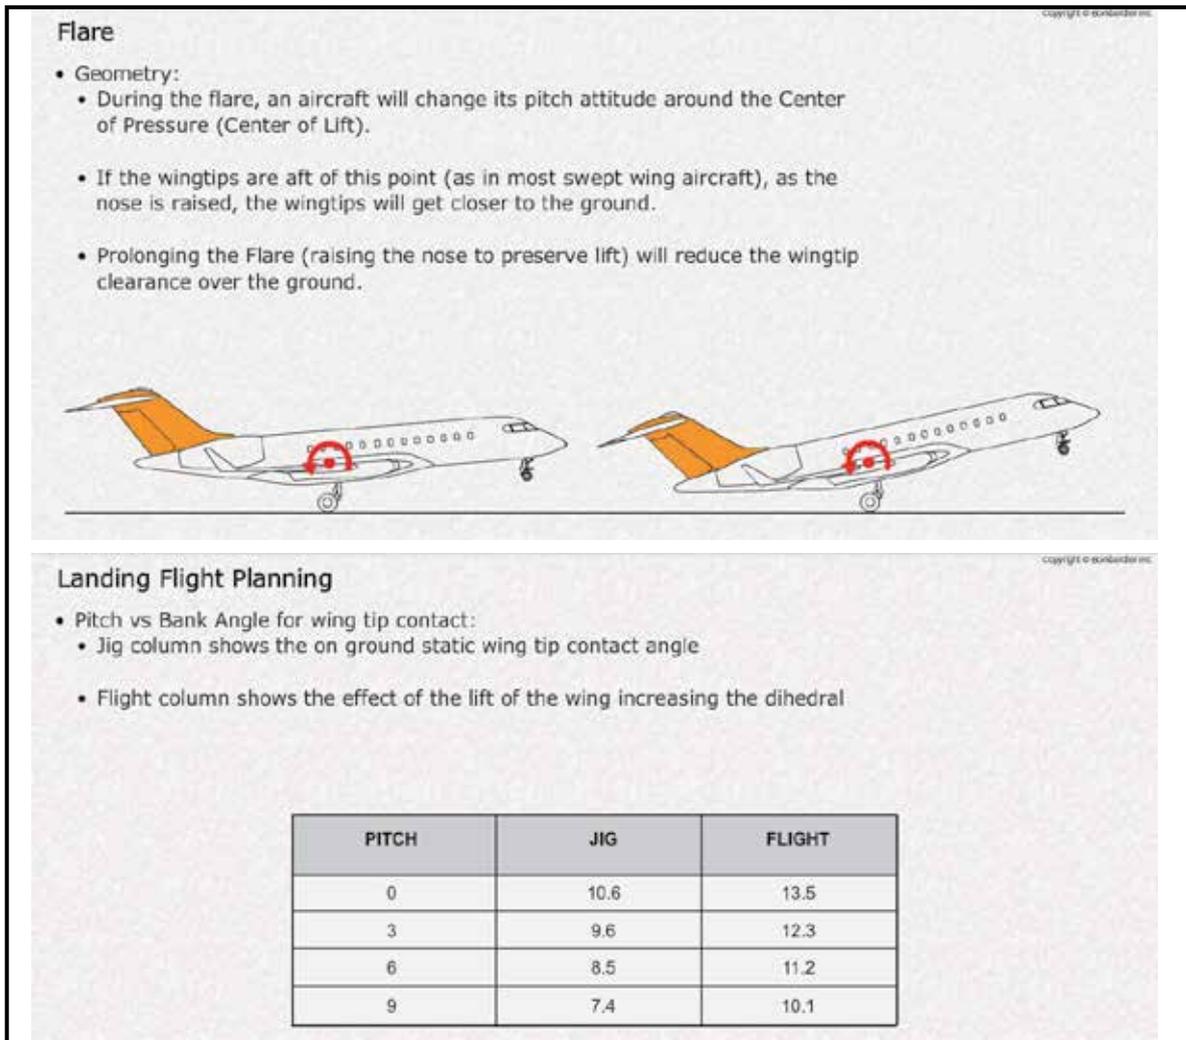
Figure 3

Manufacturer's slides showing effect of pitch on wingtip clearance

The high nose-up attitude, during a prolonged flare, increased the likelihood of a wingtip strike. This was explained in the manufacturer's e-learning module, the ORM and the FCOM of other Global variants. This information was not included in the FCOM for the Global 6000 or in the OM.

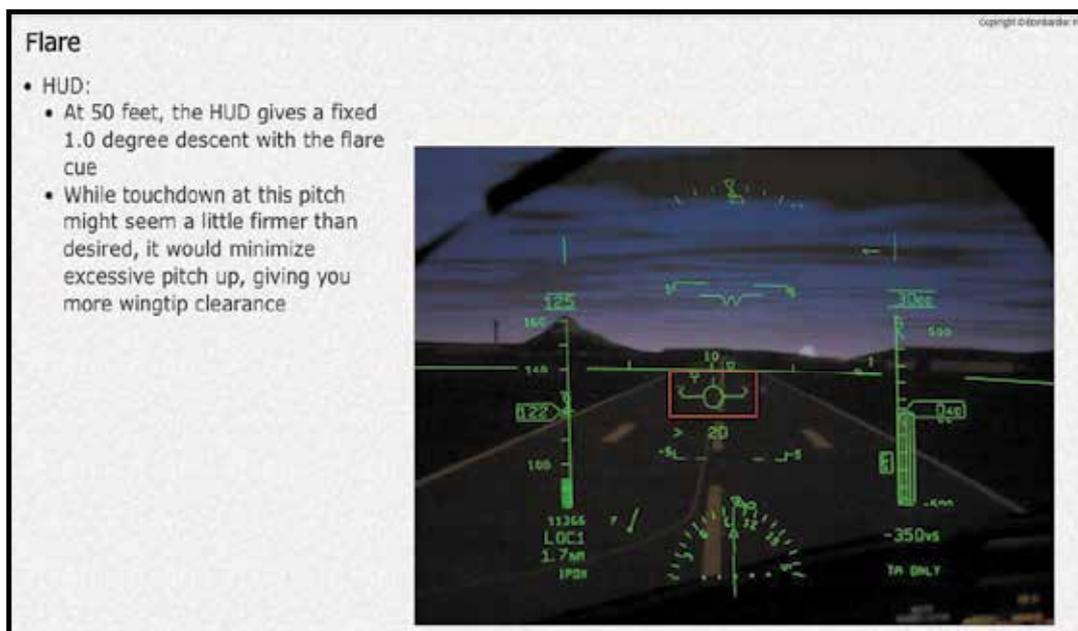
A further slide in the material (Figure 4) discussed use of the HUD during a crosswind landing. It mentioned that a flare cue would appear on the screen at 50 ft agl and if this was followed the aircraft would fly a 1° descent path to touchdown. This would lead to a firm touchdown but would protect against a wing strike. The picture in Figure 4 illustrates how the green symbology of the HUD overlays the external vista at night. The red rectangle is not part of the display but is presented on the picture to highlight the flightpath vector with flare cue symbols above each wingtip. When the flare cue appears the pilot is expected to initiate the flare manoeuvre.

Manufacturer's slide indicating HUD guidance during landing flare
