National Transportation Safety Board Aviation Accident Final Report

Location:	Philadelphia, PA	Accident Number:	DCA14MA081
Date & Time:	03/13/2014, 1822 EDT	Registration:	N113UW
Aircraft:	AIRBUS A320 - 214	Aircraft Damage:	Substantial
Defining Event:	Landing gear collapse	Injuries:	154 None
Flight Conducted Under:	Part 121: Air Carrier - Scheduled

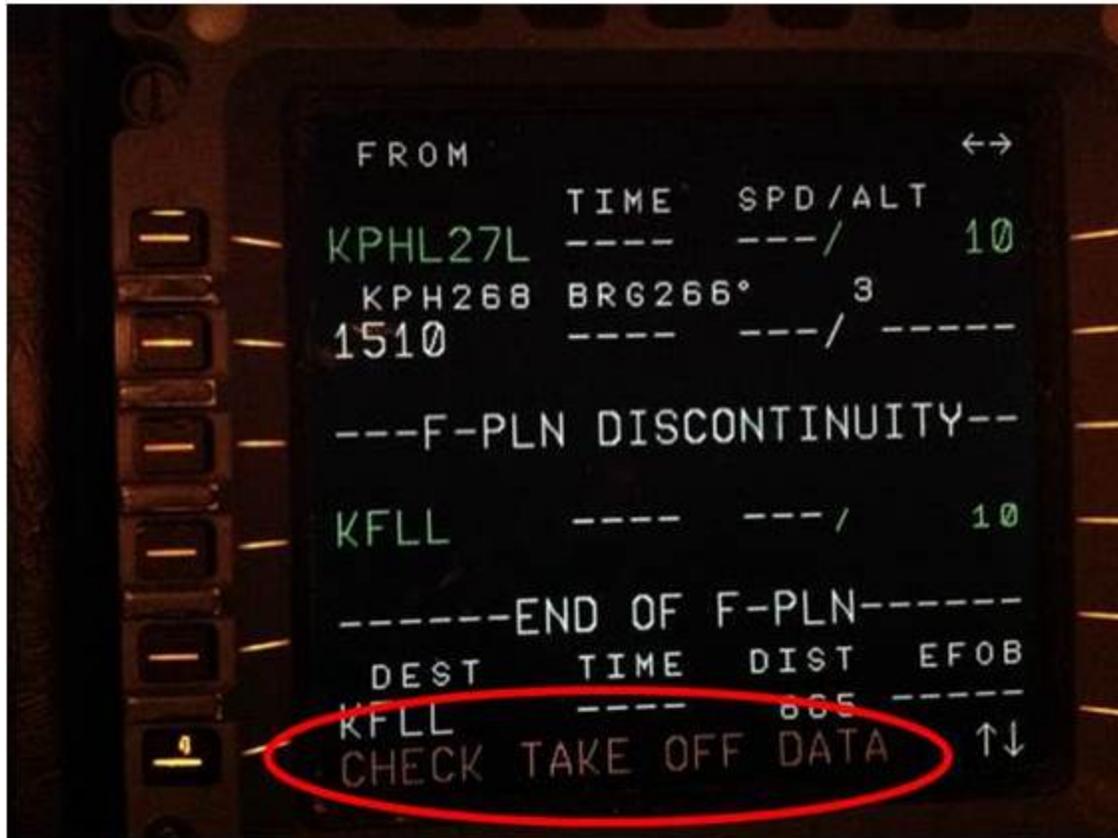
Figure 3. MCDU flight plan page after runway change (27R to 27L), with MCDU message (indicated).

entered in the FMC. There was no aural alert when the "CHECK TAKE OFF DATA" message came up. She further said if she had realized that at the point they had that message, she would have told the captain they needed a few minutes.

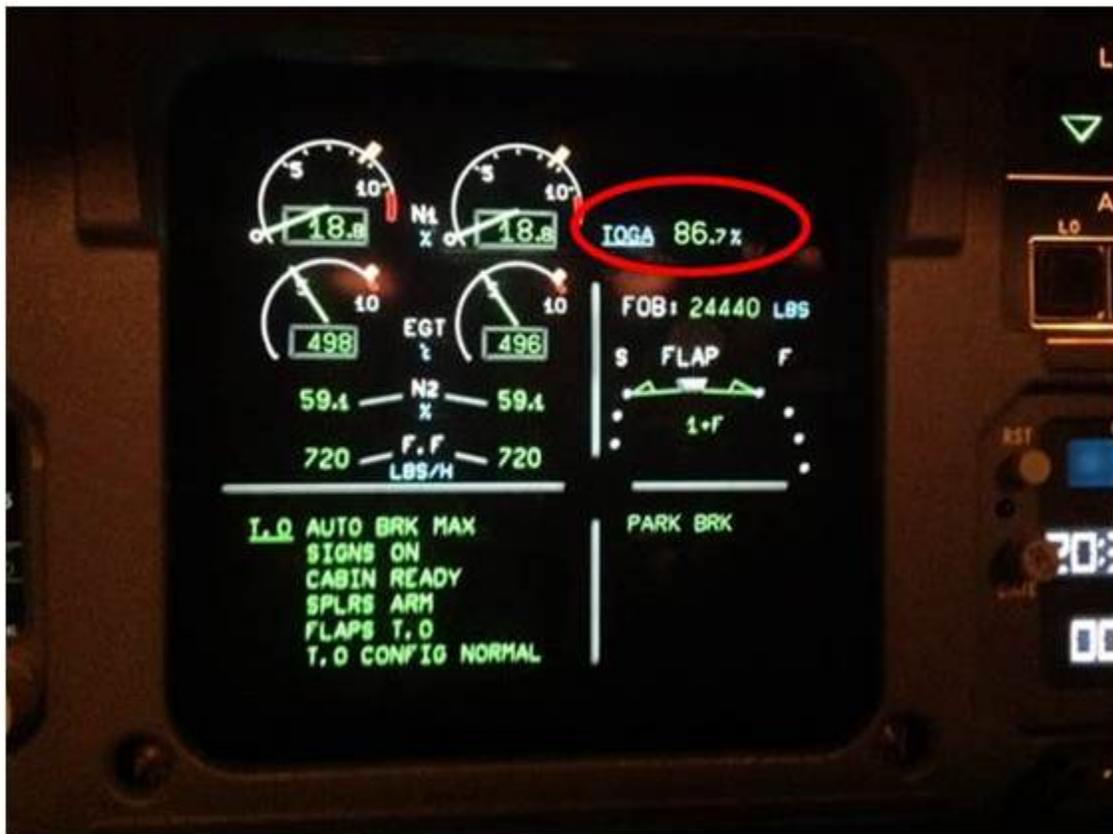
During the March 26, 2014, testing in an A320 simulator at the US Airways training facility in Charlotte, North Carolina, NTSB investigators conducted a runway change in the MCDU from runway 27R to 27L without entering the new takeoff V-speeds or a FLEX temperature and documented the MCDU screen, the PFD, and the ECAM. Following the runway change in the MCDU, the "CHECK TAKE OFF DATA" message was visible in the MCDU scratchpad and the upper ECAM indicated a TO/GA target power setting since no FLEX temperature was entered (see figures 3 and 4).

Figure 4. Upper ECAM without FLEX temperature inserted in MCDU (TO/GA indicated).

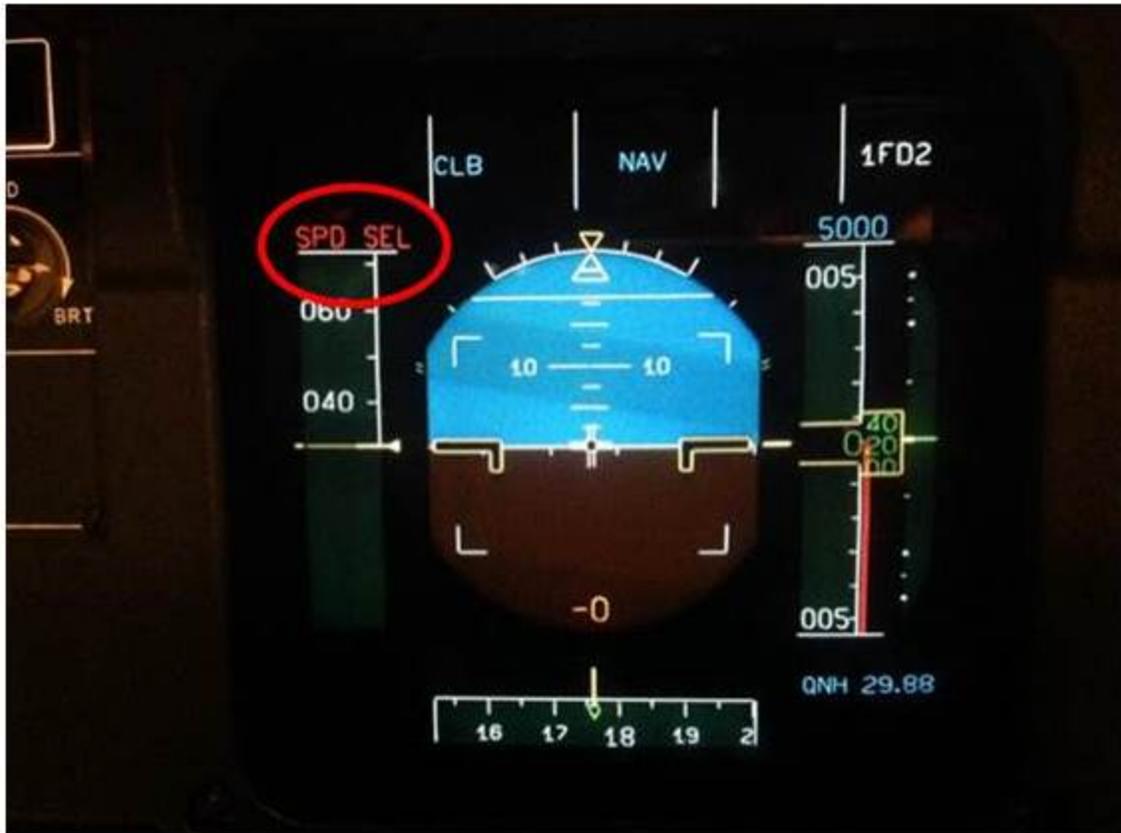
As shown in figure 5, a red "SPD SEL" appeared at the top of the speed tape when there were no V-speeds indicated on the PFD speed tape.

Figure 5. PFD after runway change with no V-speeds inserted in MCDU and SPD SEL on speed tape (indicated).

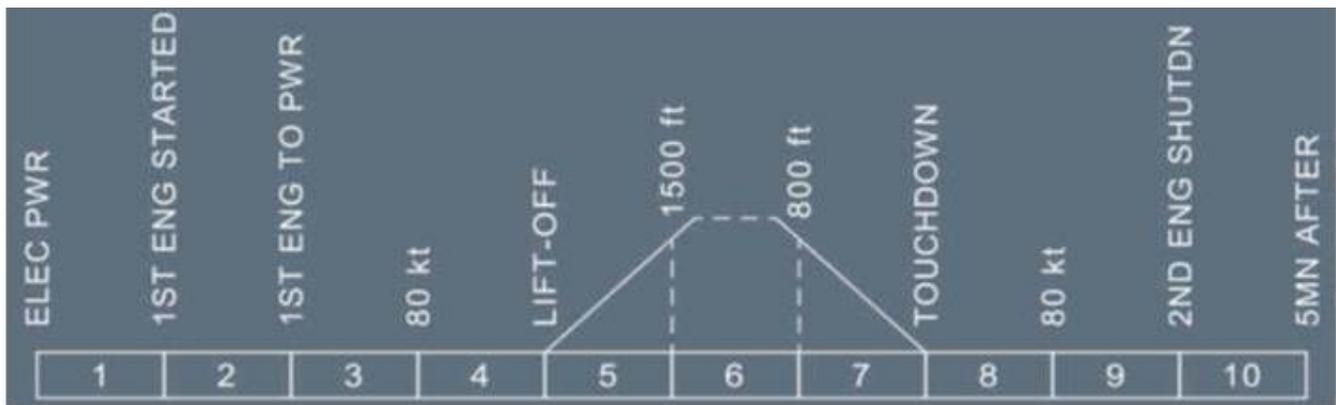
If the takeoff is initiated with an abnormal thrust setting, during the acceleration phase FWC remains in flight phase 2 and does not enter into flight phase 3 because of low TLA. When over 80 KIAS, the FWC leaves the flight phase 2 for speed above the defined threshold and computes the flight phase 8 corresponding to a landing roll (see figure 6).

Figure 6. Chart of flight phase segments.

The RETARD callout is therefore triggered at around 80 KIAS. Airbus stated that, in this scenario, the RETARD callout is not associated with Master Caution or Master Warning lights, and the RETARD callout experienced during the takeoff roll is linked to a divergence between the FWC computation and the aircraft's flight phase, due to the throttles position not being set in the TO POWER condition (TO/GA or FLX/MCT TLA positions). Airbus stated that this FWC behavior is due to the TLA configuration combined with the flex temperature not being entered in the FMS.
