# Air Accident Investigation Sector

### - Summary Report -

AAIS Case N°: AIFN/0005/2014

# Uncommanded Engine In-flight Shutdown

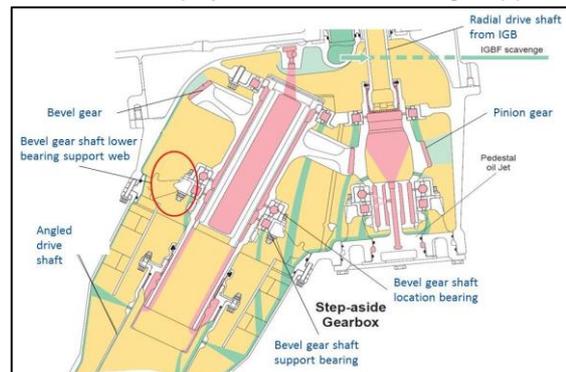
In June 2013, during a shop visit for the removal of the high pressure turbine (HPT) disc due to time expiry, the SAGB bearing support

**Figure 2.** Schematic of step aside gearbox (SAGB) was found damaged and it was replaced.

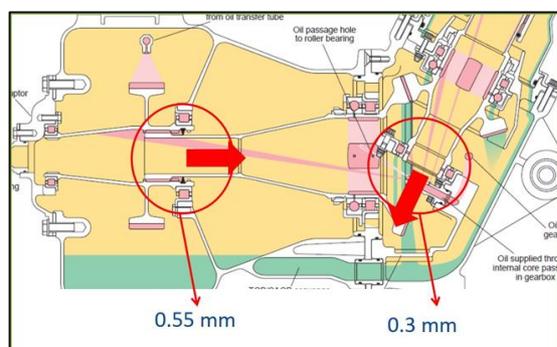
Figure 3. TGB showing bearing displacement

Minor displacement noted in two bearing locations within the TGB. This was considered to be non-contributory to the event. (Figure 3).

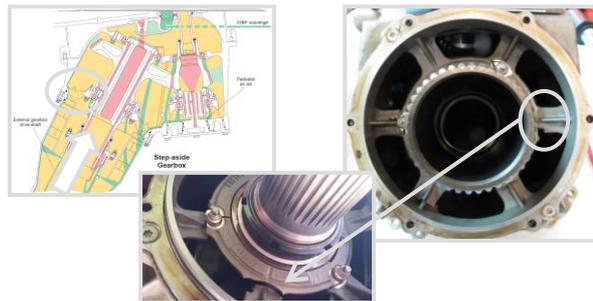
Figure 4. SAGB Bevel bearing support web

The preliminary inspection revealed fractures of the cast webs of the SAGB driven bevel bearing support.

engine was examined by Avio and Rolls-Royce in the Rolls-Royce laboratory. These examinations identified that crack had initiated from stress concentration features resulting from the wear step generated on the lower bearing support. Examination of the fracture surface in the scanning electron microscope (SEM) identified characteristic of propagation under a high cycle fatigue mechanism.

Analysis of the bolted joint at the interface of the bearing with the lower bearing support found that the original, specified bolt torque did not produce a sufficient clamping load to prevent relative movement between the components during engine running. This was identified as the primary root cause.

- The bolt torque is increased from 8.8 Nm-10.8 Nm. (78 lbf.in-96 lbf.in) to 11.5 Nm. (100 lbf.in) in-line with Rolls-Royce recommendations.
- The SAGB manufacturer amended accomplishment instructions to incorporate best practice for flange bolt torque tightening in-line with Rolls-Royce recommendations.

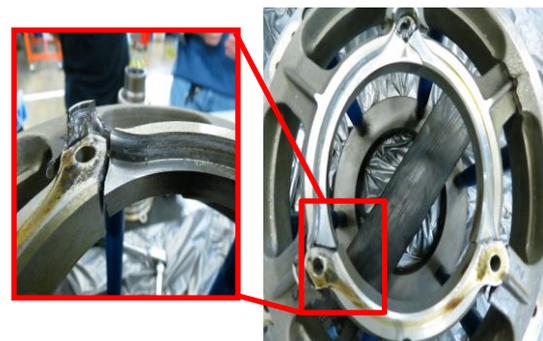
Figure 5. SAGB support web cracks (close-up) was retrieved from the oil pump inlet screen

Figure 5 illustrates a closer view of the cracked webs which indicates the bolted webs cracked (two cracks adjacent to the bolt holes and one crack through bolt hole) and the arcs between bolt positions worn to different extents. The Incident SAGB was removed and sent to the manufacturer for a detailed inspection.

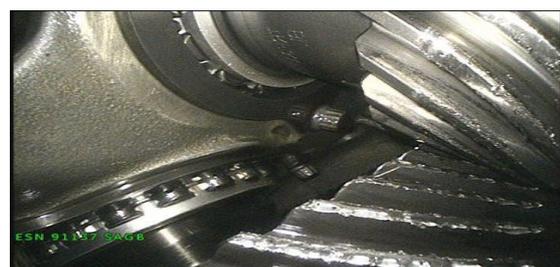
Figure 6. Damaged bevel gear

The borescope inspection revealed damage and displacement of the driven bevel gear (figure 6). A significant amount of debris

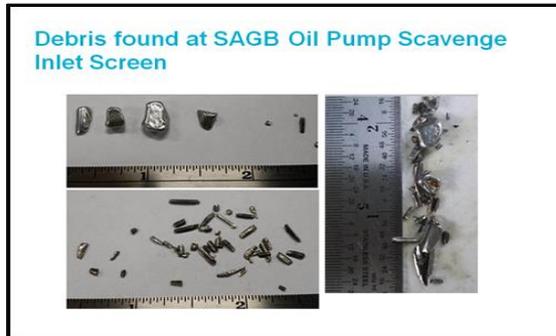
Figure 7. Debris from oil pump screen

(figure 7) and sent for further analysis. The gear material was Pyrowear 53 and the bearing support webs material was Al-Si Alloy. However, no bearing material was present.

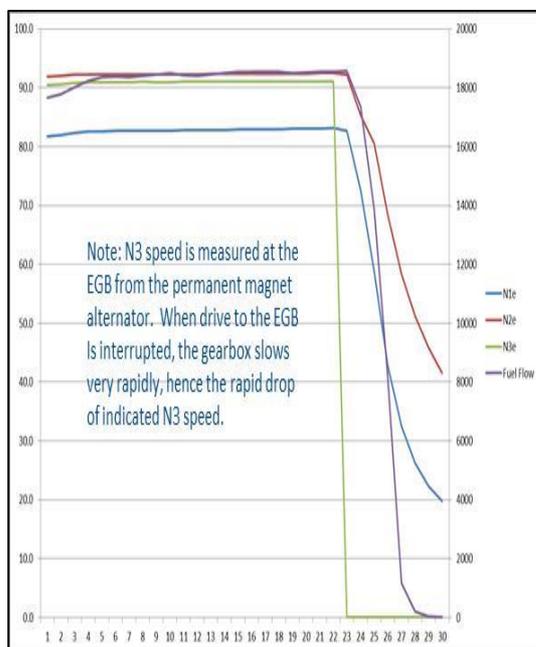
Figure 8. The effects of the HP spool disconnection

As mentioned earlier (in Engine Description); disconnection of the drive between the EGB and the IGB during engine operation would lead to loss of drive to the engine oil and fuel pump causing an engine shutdown. The IGB is driven by the HP spool of the engine.

Figure 8 shows the effect of the Engine speeds, N1/N2/N3, and fuel flow following the disconnection.
