Serious Incident
- Final Report -
AAIS Case N° AIFN/0010/2014

Aircraft Attempted Takeoff from Taxiway

Operator: Bahria
Type: Hawker Beechcraft 400XP
Registration: AP-RBA
Location: Al Maktoum International Airport, Dubai
State of Occurrence: The United Arab Emirates
Date of Occurrence: 23 May 2014

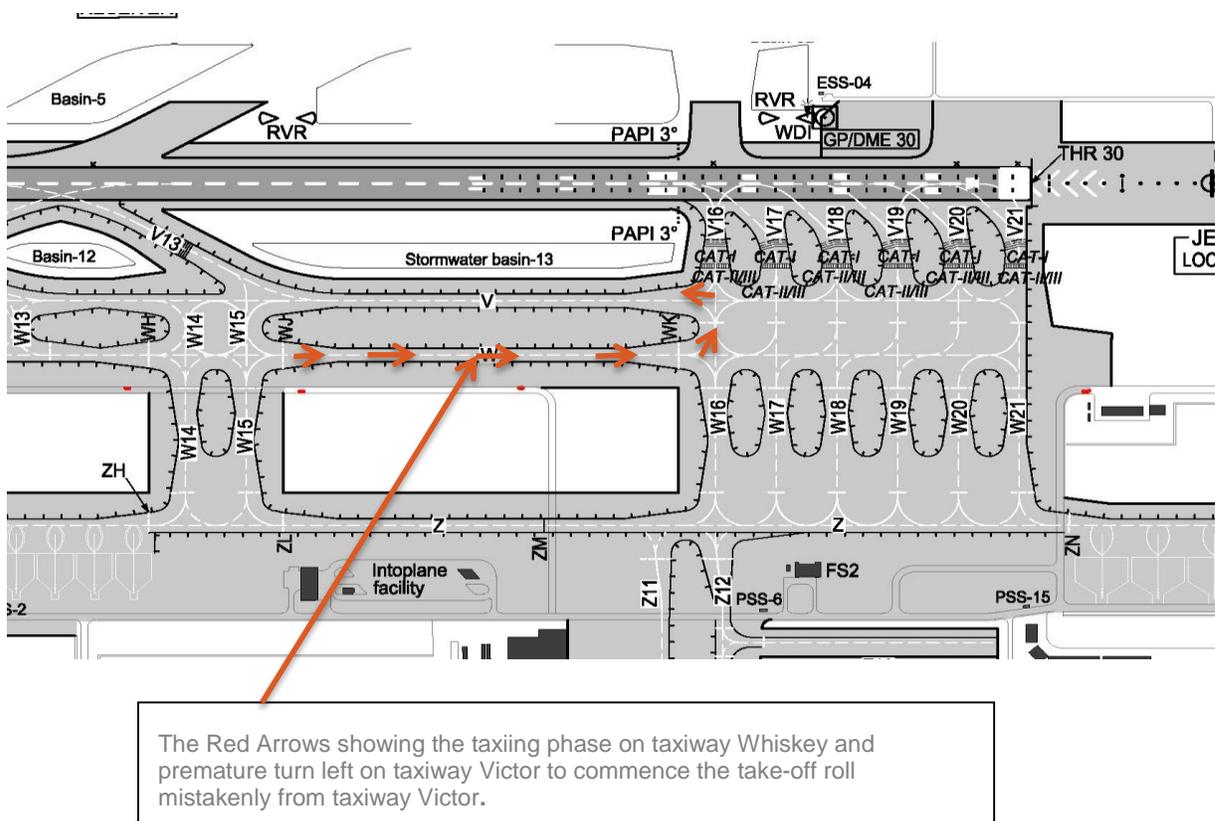
Figure 01. Airport layout

As the Aircraft approached the end of taxiway Whisky, it turned left at junction Whisky 16, and then, mistakenly, made a premature left turn and lined up on taxiway Victor instead of continuing straight ahead on taxiway Whisky 16 to Runway 30 (See Figure 01, airport layout).

As the Aircraft approached the end of taxiway Whisky it turned left via junction Whisky16, and then mistakenly made another left turn and lined up on taxiway Victor instead of continuing straight on Whisky16 to Victor 16, crossing taxiway Victor, and then turning left to enter runway 30.

This premature left turn and line up on taxiway Victor was not observed by ATC until the aircraft commenced the takeoff roll.

The Investigation visually checked the ground markings and signs along the taxi route taken by the Aircraft. All taxiway and runway markings and signs complied with ICAO requirements. The Investigation also confirmed that the taxiway markings and signs provided

good visual guidance to pilots as they taxied via Whisky16 to Victor 16, crossing taxiway Victor and then turning left to enter runway 30.

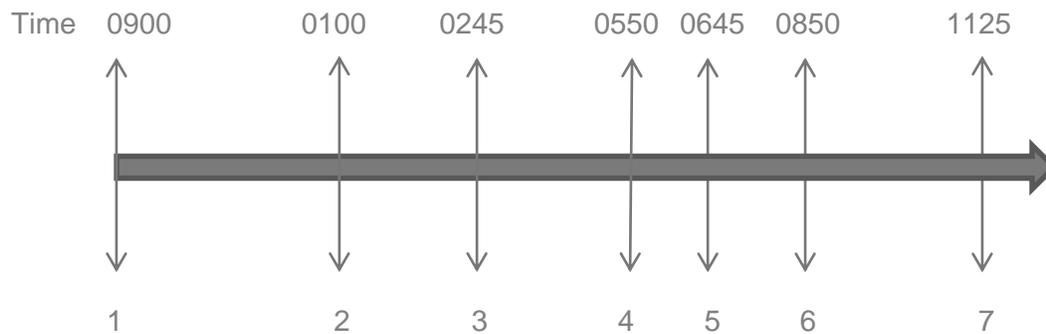
The flight crew started their duty time at approximately 0100 UTC. They flew two sectors before the Incident flight. Their duty time duration was 10 hours 25 minutes, including the additional waiting time for refueling at Al Maktoum Airport, as is shown below:

1. End of duty time on the day before the incident day, (16 hours rest).
2. Start duty time in the day of incident
3. Takeoff from Islamabad
4. Landed Karachi
5. Takeoff from Karachi
6. Landed Al Maktoum
7. Incident takeoff

The cumulative effect of awakening in the early morning, operating two sectors before the Incident flight during a time when the crew's Circadian rhythm was low, and then managing the problems during the delay, while exposed to elevated temperatures and high humidity, caused the crew to become tired and degraded their situational awareness.
