**KOMITE NASIONAL KESELAMATAN TRANSPORTASI
REPUBLIC OF INDONESIA**

Aircraft Accident Investigation Report

Wings Abadi Airlines

ATR 72-212A (600 version); PK-WGK

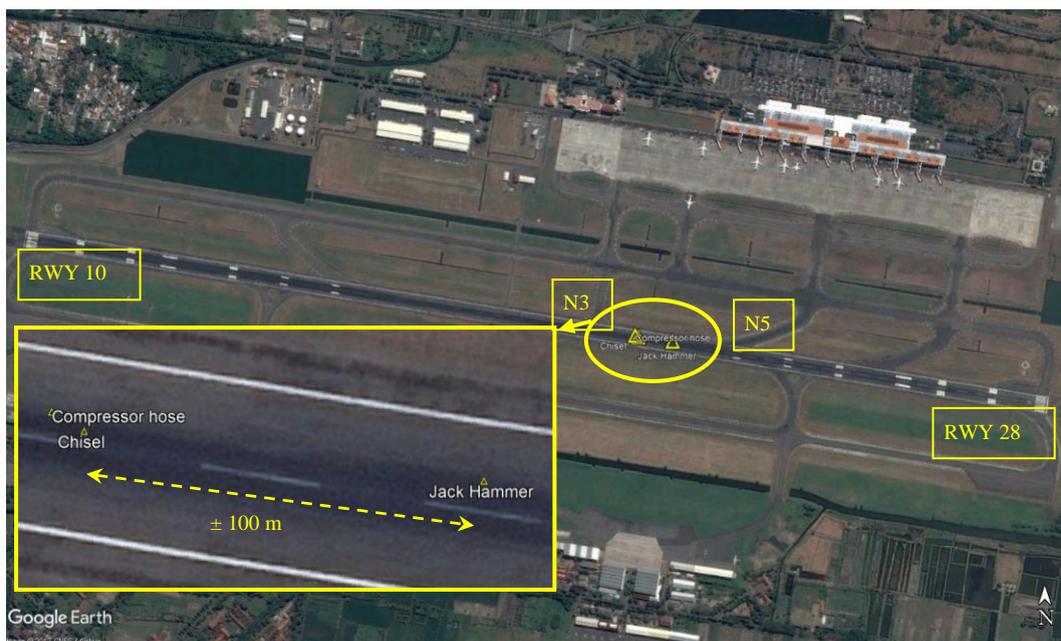
Figure 1: Estimated location of the objects on the runway

The estimated location of the compressor hose, chisel and jack hammer on the runway is shown in the figure below.

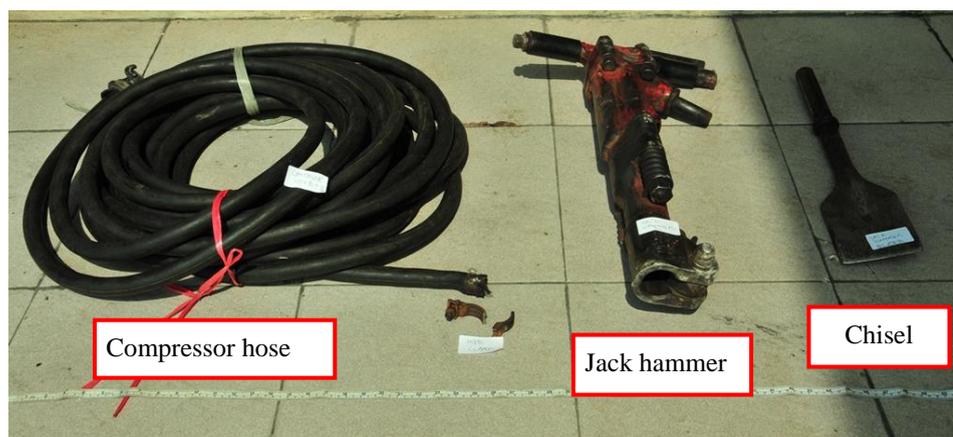
Figure 2: Objects found on the runway

At 0623 LT, the controller decided to close the runway operation and instructed the ARFF personnel to enter and inspect the runway. The ARFF personnel found compressor hose (about 10 meters long), jack hammer (about 60 cm long) and chisel (about 4.5 kg) on the runway.

15. ARFF personnel entered the runway and found objects around the runway centerline on the intersection with taxiway N5. The objects consisted of compressor hose (about 10 meters long), jack hammer (about 60 cm long) and chisel (about 4.5 kg).

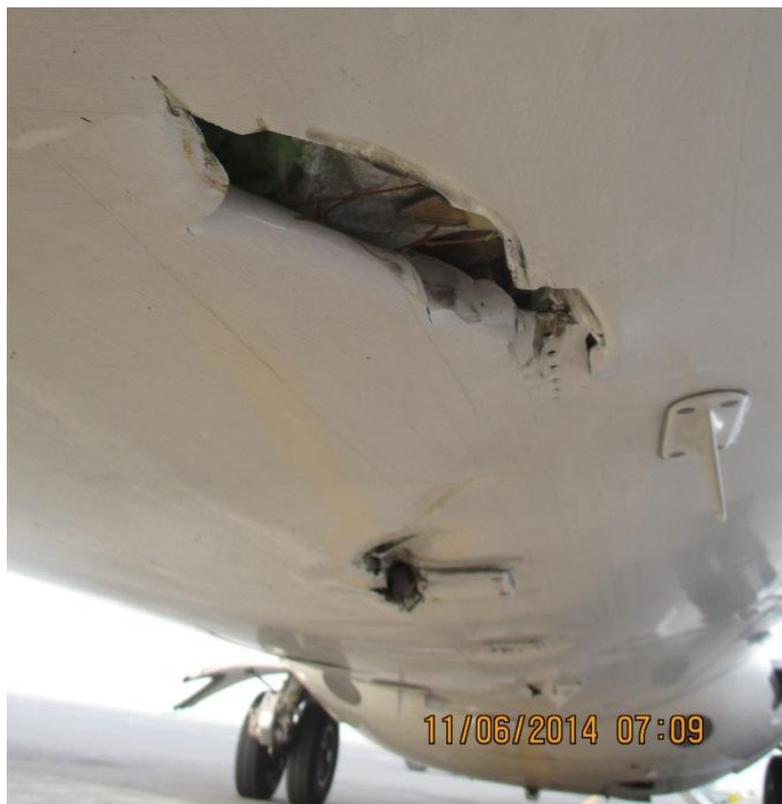
Figure 3: Damages found on the lower fuselage

After the IW 1861 aircraft parked on the apron, the aircraft engineer performed walk around inspection and found eight holes at the aircraft lower fuselage between the nose wheel and the main wheel bay. The aircraft grounded for further inspection and repair. No one injured in this accident.

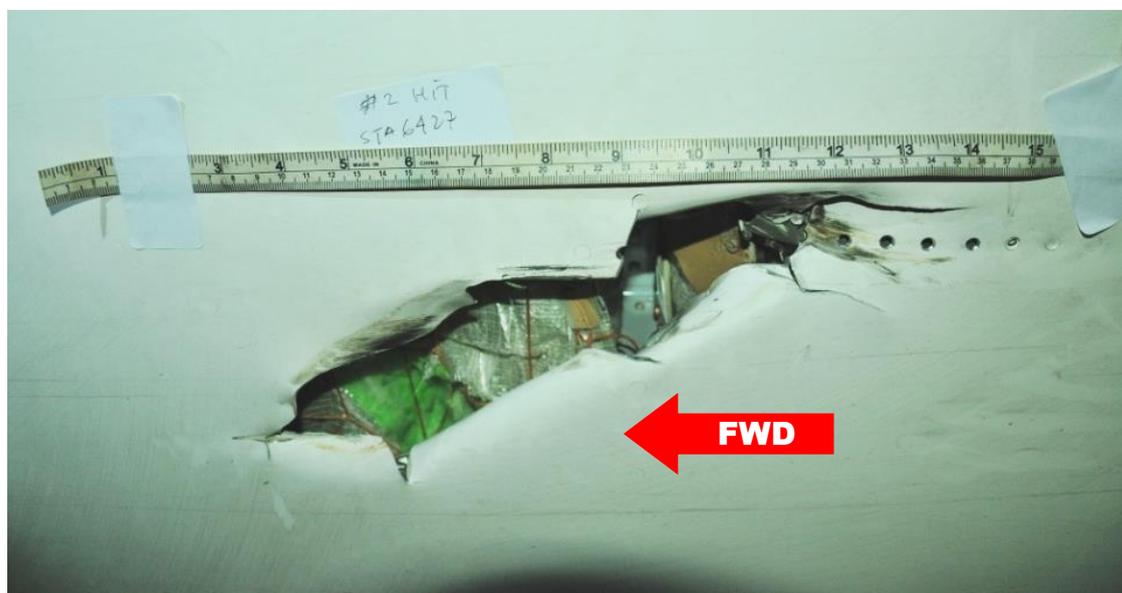
Figure 4: The hole on STA 6427

1. at body station (STA)⁴ 6427, a hole with dimension of 33 cm x 15 cm,
2. at STA 6888, a hole with dimension of 44 cm x 19 cm,
3. at STA 7684, a hole with dimension of 29 cm x 15 cm,
4. at STA 9020, a hole with dimension of 49 cm x 15 cm,
5. at STA 10604, a hole with dimension of 53 cm x 22 cm,
6. at STA 12268, a hole with dimension of 26 cm x 14 cm, honeycomb panel and gondola support structure damage,
7. at STA 13322, a hole with dimension of 30 cm x 40 cm, honeycomb panel, gondola support structure, refrigeration condenser and pipe damage,
8. at STA 15589, a hole with dimension of 34 cm x 50 cm, honeycomb panel and wheel well structure damage.
