ACCIDENT

Aircraft Type and Registration:	1) Boeing 737-8AS, EI-ENL 2) Boeing 737-8AS, EI-DLJ
No & Type of Engines:	1) 2 CFM56-7B turbofan engines 2) 2 CFM56-7B26 turbofan engines
Year of Manufacture:	1) 2011 (Serial no: 35037) 2) 2005 (Serial no: 34177)
Date & Time (UTC):	28 June 2014 at 0546 hrs
Location:	London Stansted Airport
Type of Flight:	1) Commercial Air Transport (Passenger) 2) Commercial Air Transport (Passenger)
Persons on Board:	1) Crew - 6 Passengers - 161 2) Crew - 6 Passengers - 178
Injuries:	1) Crew - None Passengers - None 2) Crew - None Passengers - None
Nature of Damage:	1) Right winglet detached 2) Right tailplane damaged and severe damage to APU installation
Commander's Licence:	1) Airline Transport Pilot's Licence 2) Airline Transport Pilot's Licence
Commander's Age:	1) 39 years 2) 49 years
Commander's Flying Experience:	1) 12,200 hours (of which 6,200 were on type) Last 90 days - 264 hours Last 28 days - 80 hours 2) 16,408 hours (of which 12,857 were on type) Last 90 days - 232 hours Last 28 days - 62 hours

Information Source:	AAIB Field Investigation

The right winglet of a taxiing Boeing 737-8AS detached when it collided with the tail of another Boeing 7

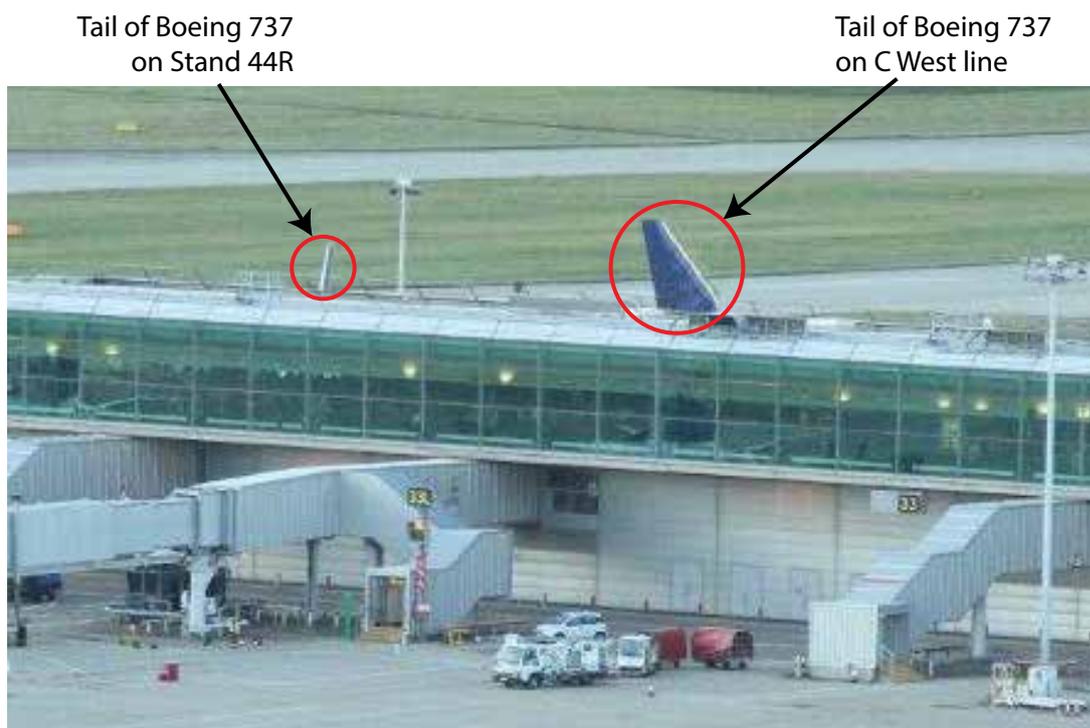
Figure 2

A pier obscured the controller's view of Stands 43 and 44 and only the fins of aircraft on the 'C West' line could be seen from the Visual Control Room (VCR) (Figure 2). The crew of EI-ENL saw a B737 on Stand 44R as they turned onto the 'C West' line but they did not appreciate that it was commencing pushback. After completing the turn, the co-pilot looked to his right and realised that the tail cone of the other B737, was now moving towards him. He told the commander to stop and the commander started to turn left, away from the conflict, and to apply the brakes. Three and a half seconds after the co-pilot started speaking, the winglet of EI-ENL impacted the leading edge of the right horizontal stabiliser on EI-DLJ. The winglet was forced under the tail cone of EI-DLJ where it penetrated the APU bay and fragmented. The pilots of EI-ENL felt the aircraft "touch" before they brought it to a halt a few metres further on.

A view from the VCR looking towards Stands 43 and 44 with a Boeing 737 parked on Stand 44R and another taxiing along the 'C West' line

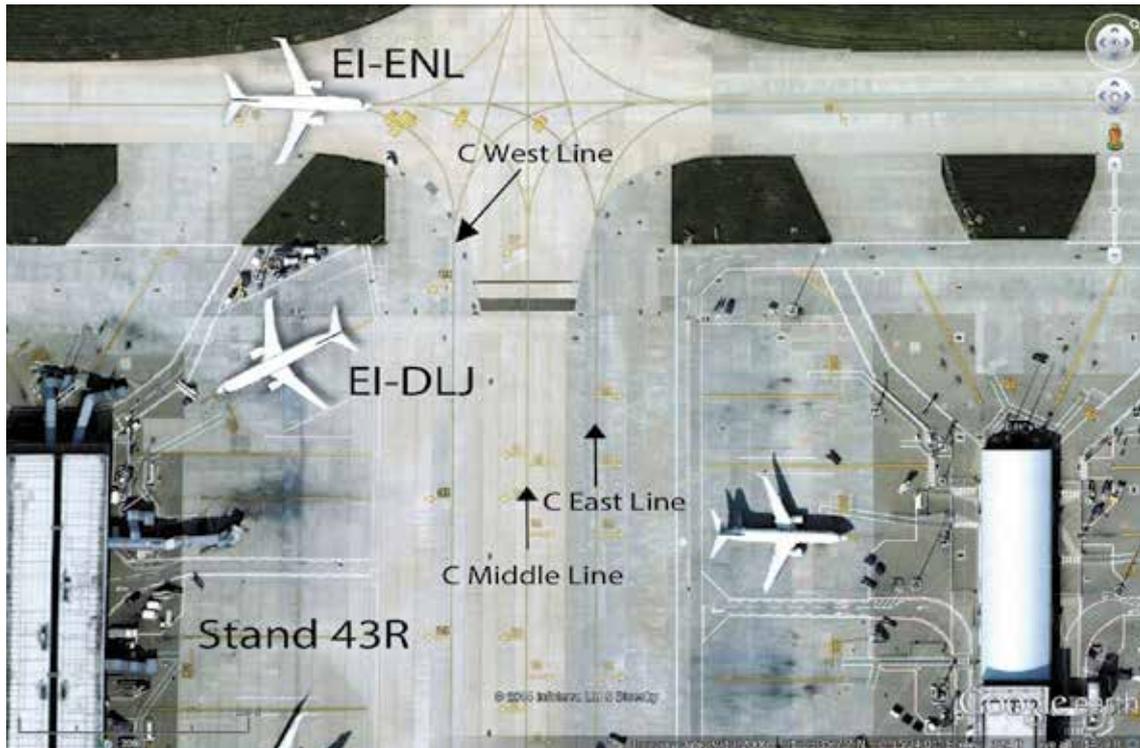
Relative position of EI-ENL when EI-DLJ push back commenced (composite image)

¹⁴ See Figure 3 to view the angular difference between the lead-in line for Stand 44R and the 'C West' line.

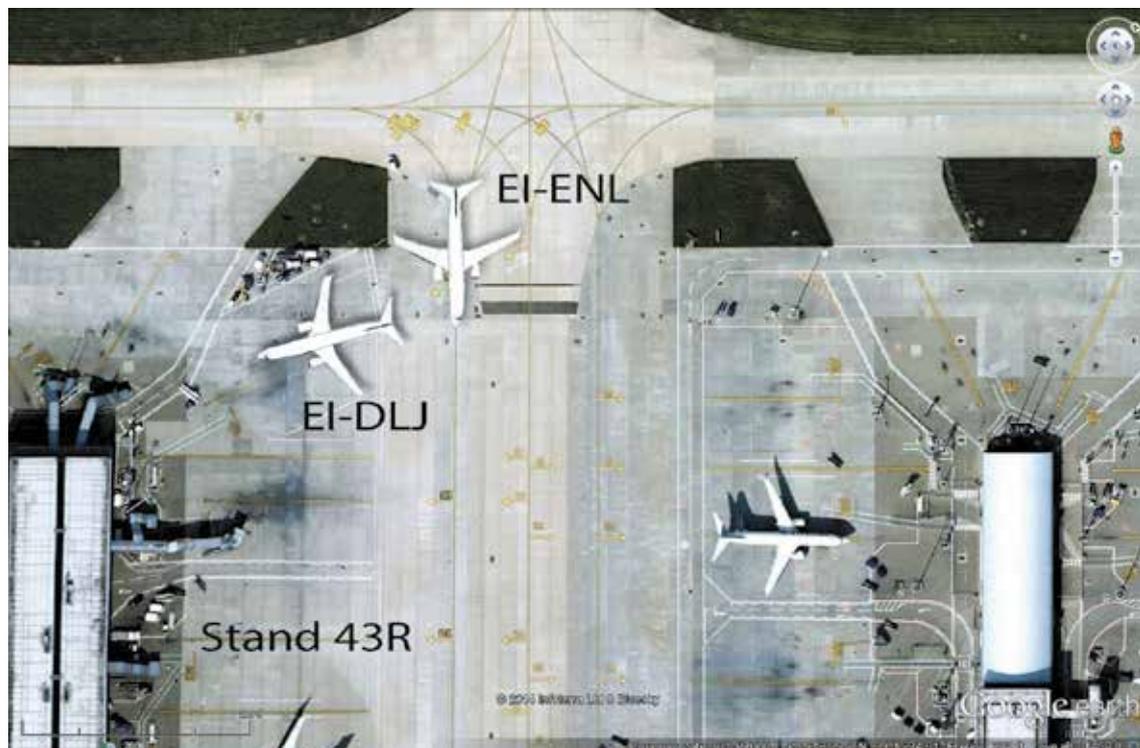
Figure 4

Position of EI-ENL when co-pilot observed EI-DLJ moving (composite image)

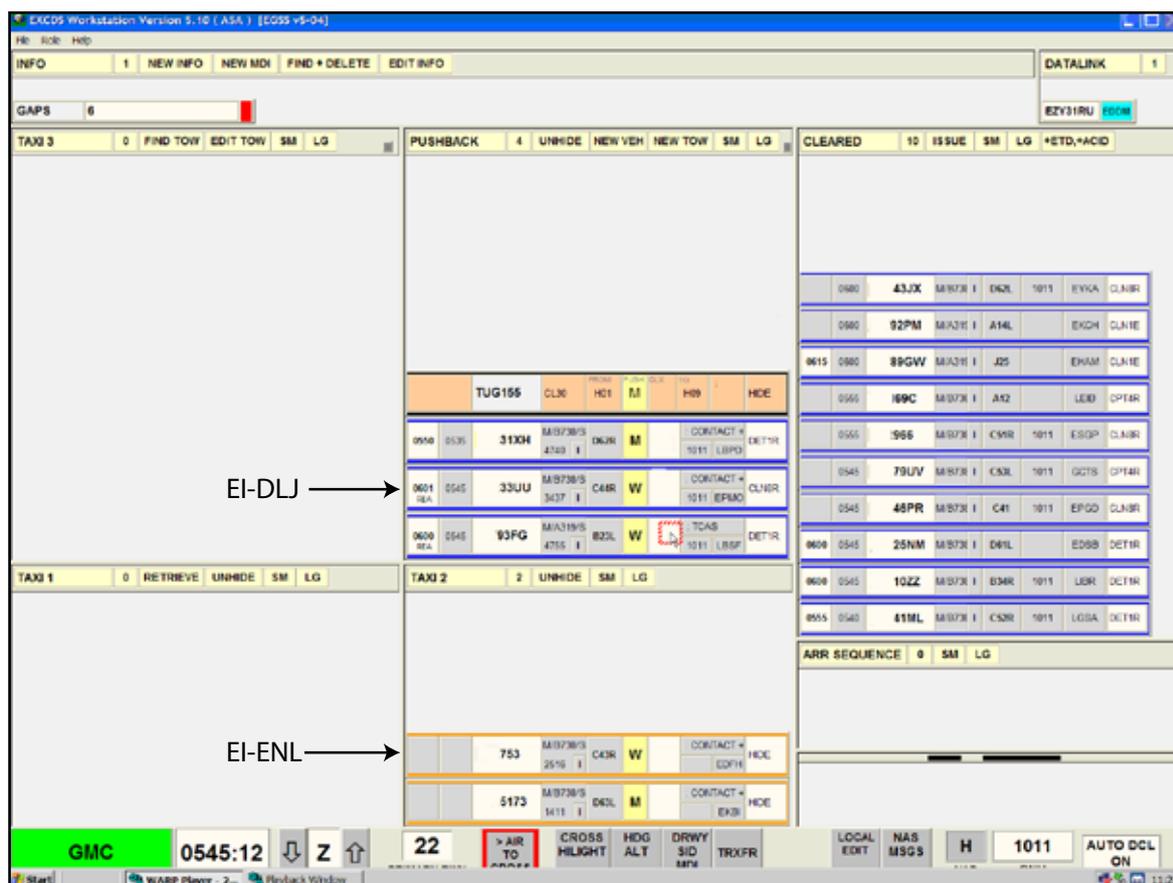
The left EFPS screen just before the collision (operators' identifiers removed)

The controller's situational awareness relies on his integration of information gained by looking outside, by monitoring the A-SMGCS and by checking the EFPS. Figure 7 shows that as EI-ENL taxied in, its strip appeared along with that of one other aircraft in the 'Taxi 2'¹² bay of the left hand screen. The data on the strip included the radio callsign, the allocated stand (C43R) and a 'W' for the 'C West' line. Before EI-DLJ requested push and start, there were several progress strips in the 'Cleared' bay but only three other strips in the 'Pushback' bay. It was these three strips along with the two strips in the 'Taxi 2' bay that needed to be checked before EI-DLJ was given instructions. The right EFPS screen (not illustrated) showed the scheduled departures that had not yet been given a departure clearance. There was a steady stream of departure clearances to be given over the radio; the controller's workload was therefore almost continuous.

The report produced by NATS Stansted recommended that development of EFPS should be explored, to find out if it could highlight when more than one aircraft has been given an instruction to use the same cul-de-sac taxi line. This idea has since been incorporated into a nationwide project to evaluate surface management tools at UK airports. NATS is reviewing available technology, and methods for monitoring and checking the instructions given by Ground controllers, with the aim of quickly resolving any errors that are made. The project encompasses the control of aircraft pushbacks and the extra difficulties that exist when there is no headset communication between the flight crew and the ground team. Consideration is being given to the concept of having “Standard Pushback” procedures for each stand and to the idea of passing radio instructions for pushback directly to the tug driver. The project aims to identify an enhanced surface management tool which will provide conflict resolution and for this to be trialled at a major UK airport.
