**FINAL
AIRCRAFT ACCIDENT REPORT
19 APRIL 2016**

**AIRBUS 330 9M-MUC
HITS LAMP POST DURING TAXI AT ASTANA
ASTANA INTERNATIONAL AIRPORT
29 JUNE 2014**

ACCIDENT REPORT NO.: 07/2014

OPERATOR : MALAYSIA AIRLINES
AIRCRAFT TYPE : AIRBUS 330
NATIONALITY : MALAYSIAN
REGISTRATION : 9M-MUC
**PLACE OF ACCIDENT : ASTANA INTERNATIONAL AIRPORT
KAZAKHTAN**
DATE AND TIME : 29 JUNE 2014 AT 1046 HOURS LOCAL TIME

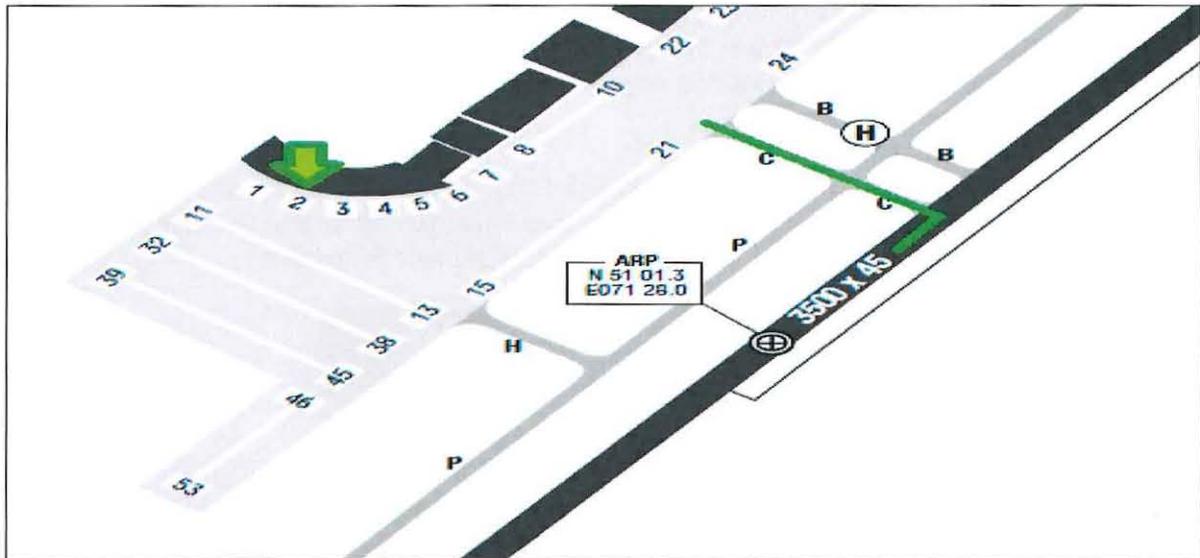
Figure 1: Section of Lido AGC of Astana Airport 24 April 2014

Note: LIDO Airport Ground Chart (AGC) did not depict the outer and inner lines on the apron.

- 4.1 It is recommended that the LIDO chart provider to amend the TSE AGC chart to reflect the restriction on the taxiway.
- 4.2 It is recommended that the Kazakhstan Authority is to update the Astana International Airport AIP with the relevant taxiways and routings.

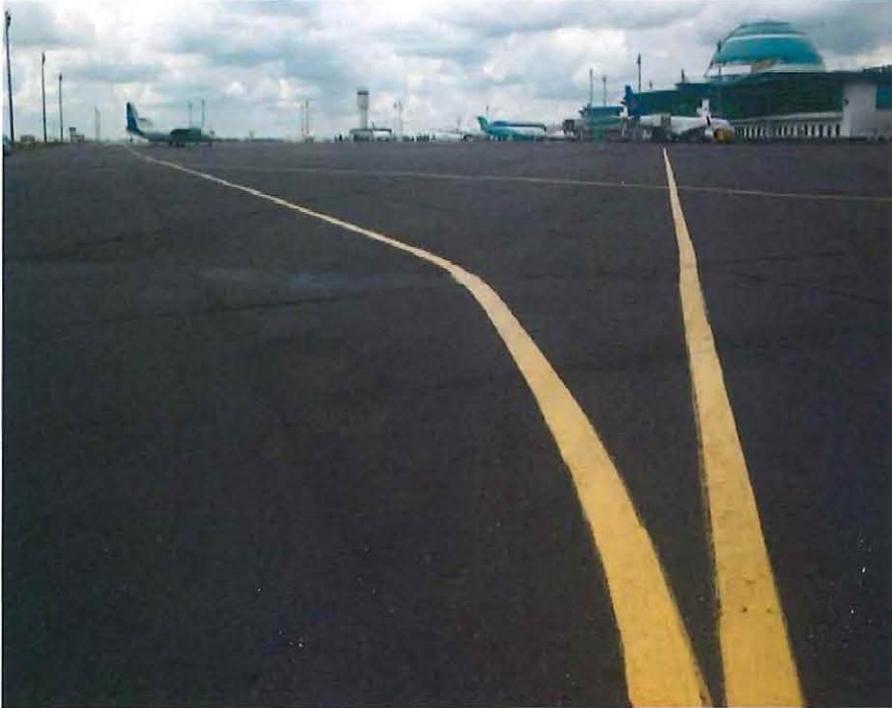
- 1.1.4 Upon entering the Apron area, the crew observed that there were 2 separate taxi lanes adjoining Taxiway 'C'; one leading towards the main terminal and the other towards the opens bays across the terminal. These taxi lanes were not given any specific designation (name), either on the ground or on the airport charts that were provided. (see Figure 3).

Figure 3: Ground level view of taxiways branching out and inner

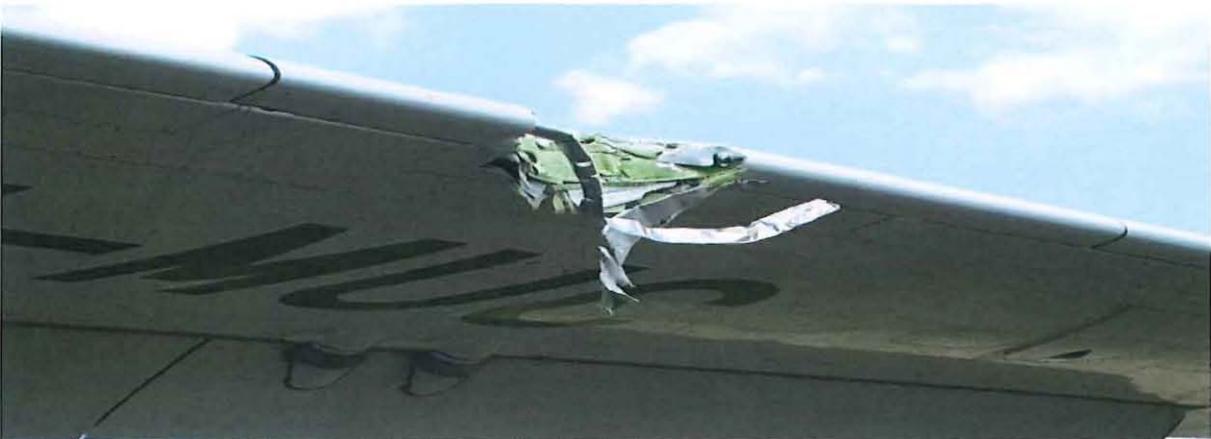
9M-MUC Number 6 slats damage

Figure 4: Left Wing No. 6 Slat Damage

Aircraft left wing came into contact with the light pole approximately 7.3 meters from the left wingtip. The aircraft continued forward approximately another 7 meters before coming to a stop.

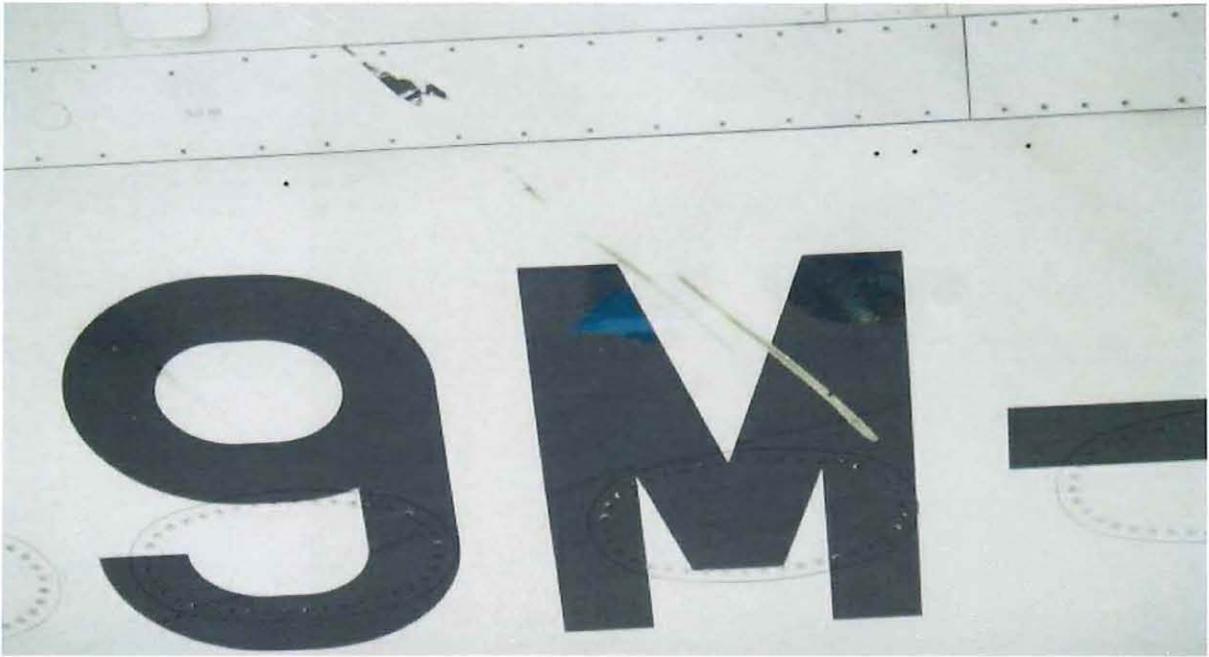
1.3.1.2 Left underwing scratched by 2nd post (CCTV post)

Figure 5: Scratch marks on underside of left wing

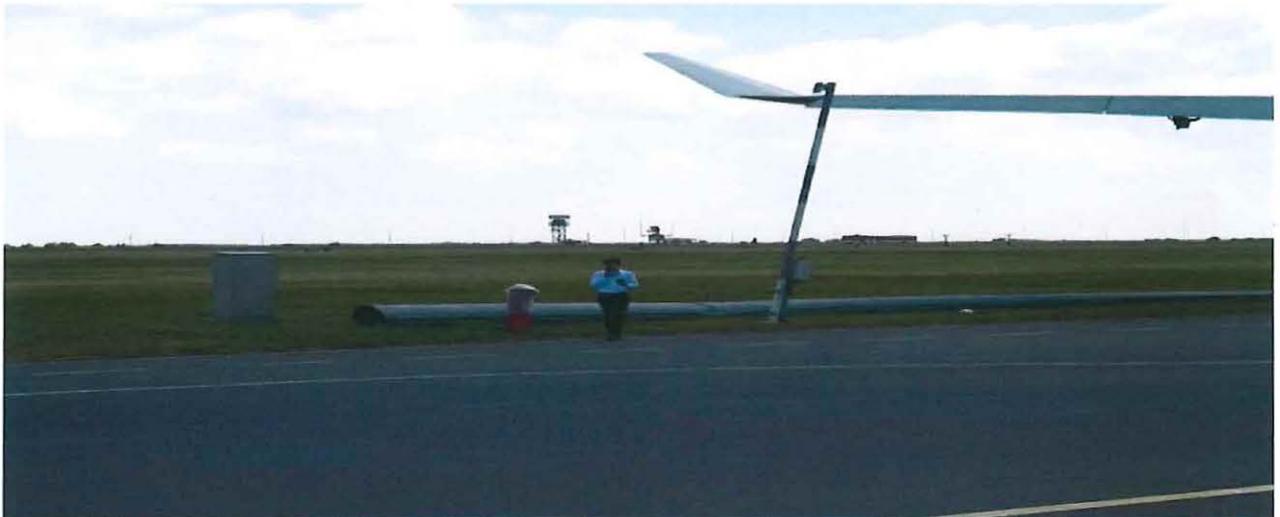
1.4.1. Light Pole is being knocked down

1.4.2. CCTV knocked off 2nd shorter pole

Figure 6: Light pole lying on floor and CCTV pole slanted

The light pole is located 4.2 meters from the edge of the taxiway. The CCTV pole is located 5 meters after the light pole.

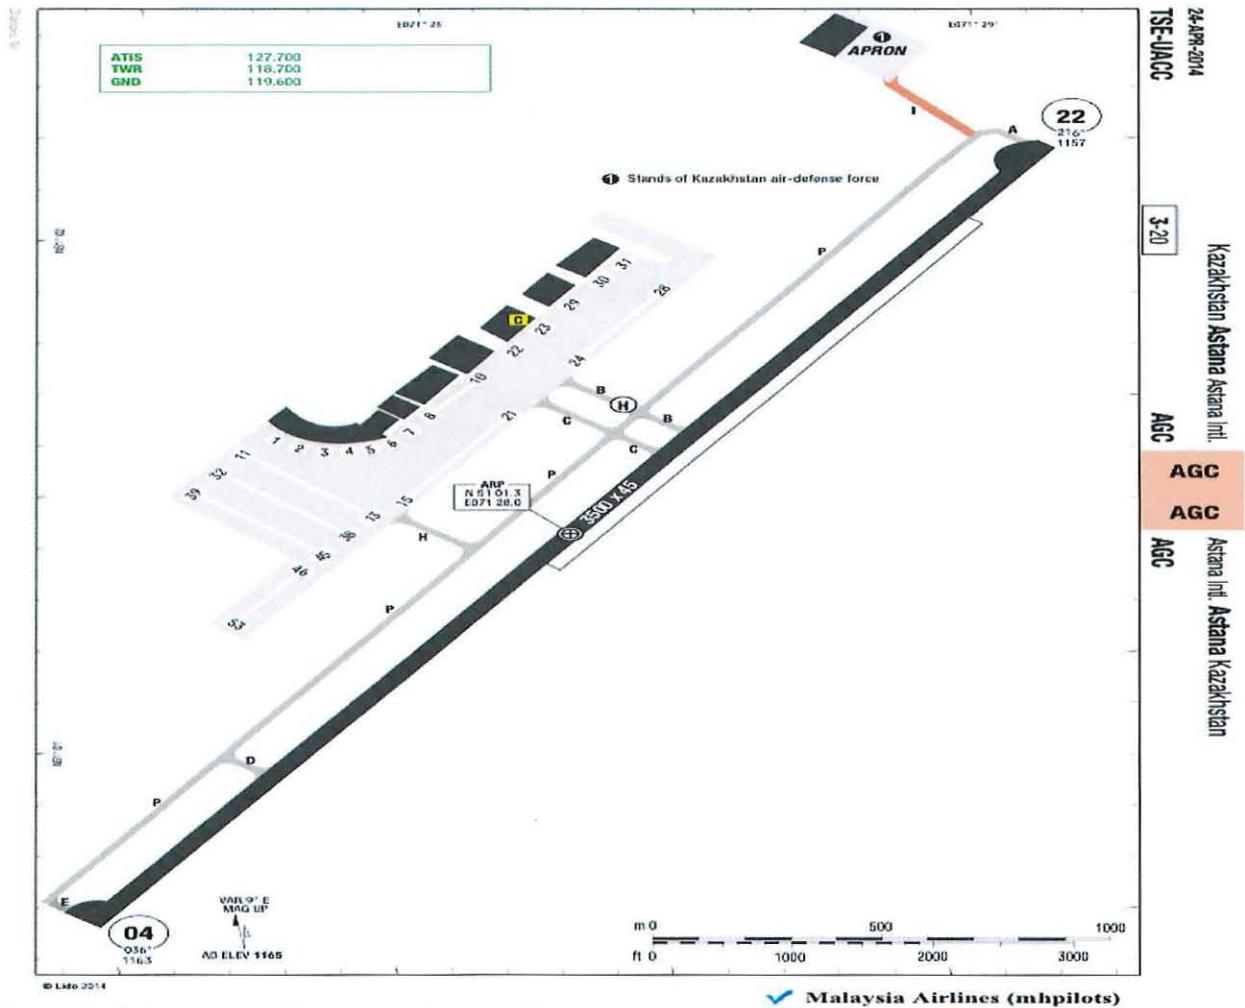
Figure 9: Astana Aerodrome Ground Chart 24 Apr 2014

- 1.10.1 The Aeronautical Information Publication (AIP) and aerodrome chart for Astana International Airport did not depict sufficient information when compared to the actual layout of the airport.

- 1.10.2 Based on the satellite image, the intersection between Taxiway 'C' and 'P' has no shoulder on the runway side and does not allow turning onto Taxiway 'P' when vacating the runway. LIDO chart however indicates that the taxiway shoulders are avail at this intersection and the prohibition of turns from Taxiway C towards Taxiway P is not highlighted.

- 1.10.3 As Taxiway 'C' joins the apron, there are multiple branches of taxiways that were not depicted on the charts. These taxiways are not named or labelled on the charts and on the ground. There is also no information provided with regards to taxiway limitations on the apron area.

- 4.3 It is recommended that the Kazakhstan Authority is to look at naming the various taxiways.
- 4.4 It is recommended that Malaysia Airlines is to update the information in the route manual to reflect the restriction on the apron taxiways.

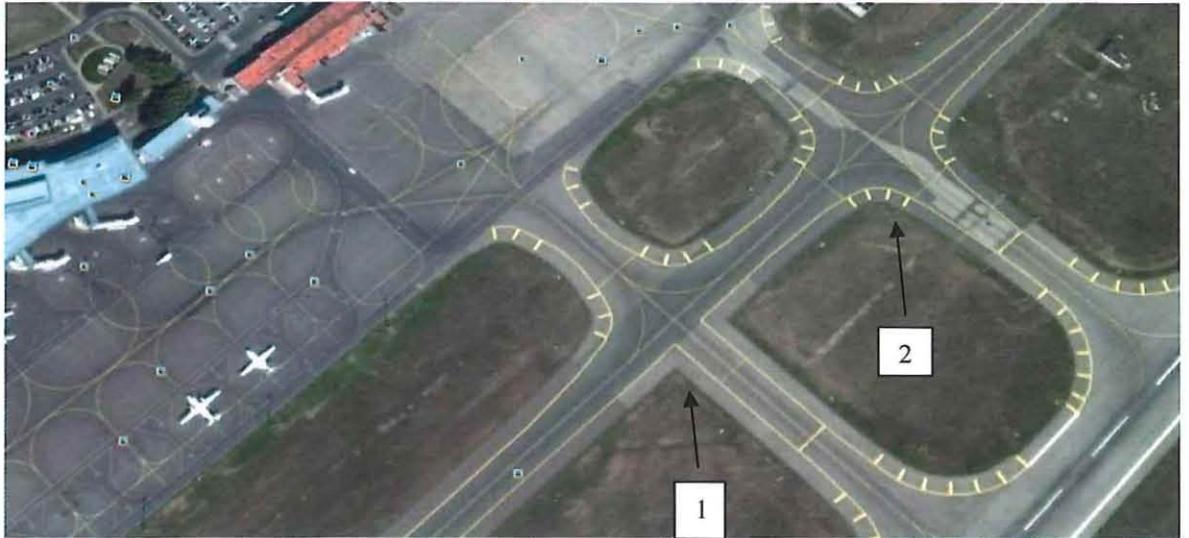
- 2.1.7 Reference to Figure 10 below, (box 1), there are no taxiway lines for turns onto Taxiway 'P' at the intersection of Taxiway 'C' and Taxiway 'P' on the side closest to the runway. The taxiway markings also do not allow left turn into Taxiway 'P'. This means that all aircraft vacating the runway using Taxiway 'C' will have to route via the apron. Aircraft vacating using Taxiway 'B' has the option of either turning left on

Taxiway 'P' or continuing via the apron. (Box 2). This information is not shown on the LIDO AGC chart that was developed based on information from AIP for Astana International Airport.

Figure 10: Google Earth picture of taxiway B and C with taxi markings sourced on 30 June 2014
