ACCIDENT

Aircraft Type and Registration:	Jetstream 3102 31, G-GAVA
No & Type of Engines:	2 Garrett Airesearch TPE331-10UGR-516H turboprop engines
Year of Manufacture:	1987 (Serial no: 785)
Date & Time (UTC):	15 August 2014 at 1836 hrs
Location:	Doncaster Sheffield Airport, Yorkshire
Type of Flight:	Commercial Air Transport (Passenger)
Persons on Board:	Crew - 2 Passengers - 1
Injuries:	Crew - None Passengers - None
Nature of Damage:	Left main landing gear, left propeller, fuselage and wing
Commander's Licence:	Airline Transport Pilot's Licence
Commander's Age:	54 years
Commander's Flying Experience:	8,740 hours (of which 3,263 were on type) Last 90 days - 147 hours Last 28 days - 60 hours
Information Source:	AAIB Field Investigation

Synopsis

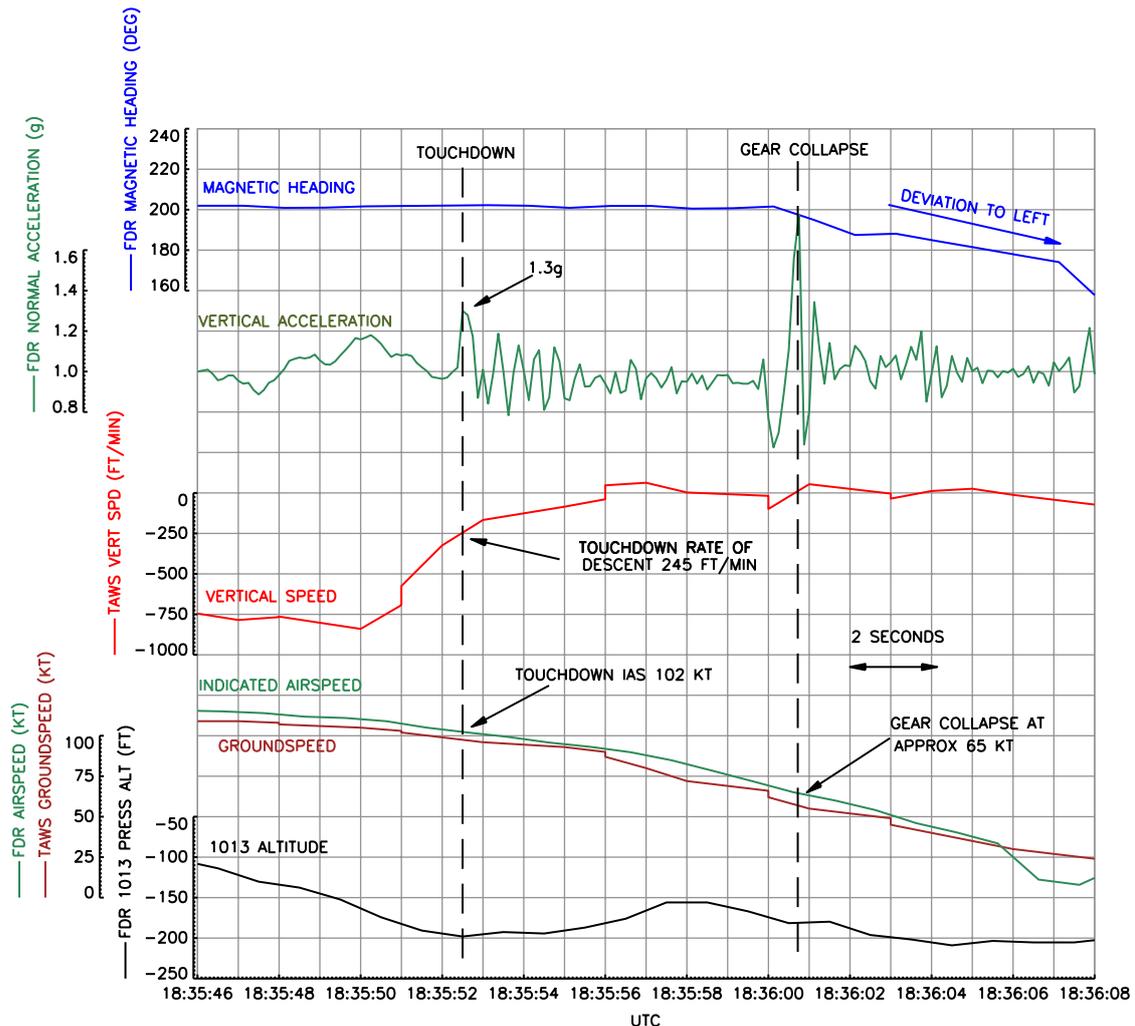
Figure 2

The aircraft touched down at 1835:52 hrs at an IAS of 102 kt and normal acceleration of 1.3g (Figure 2). Recorded rate of descent was approximately 245 ft/min (4 ft/sec) which was within the touchdown landing gear load limit which is defined as a rate of descent of 10 ft/sec at a maximum landing weight of 14,900 lb (6,758 kg).

While decelerating through a groundspeed of 65 kt, a normal acceleration spike was recorded, indicating the point at which the left main landing gear failed.

Flight data recorded during the landing

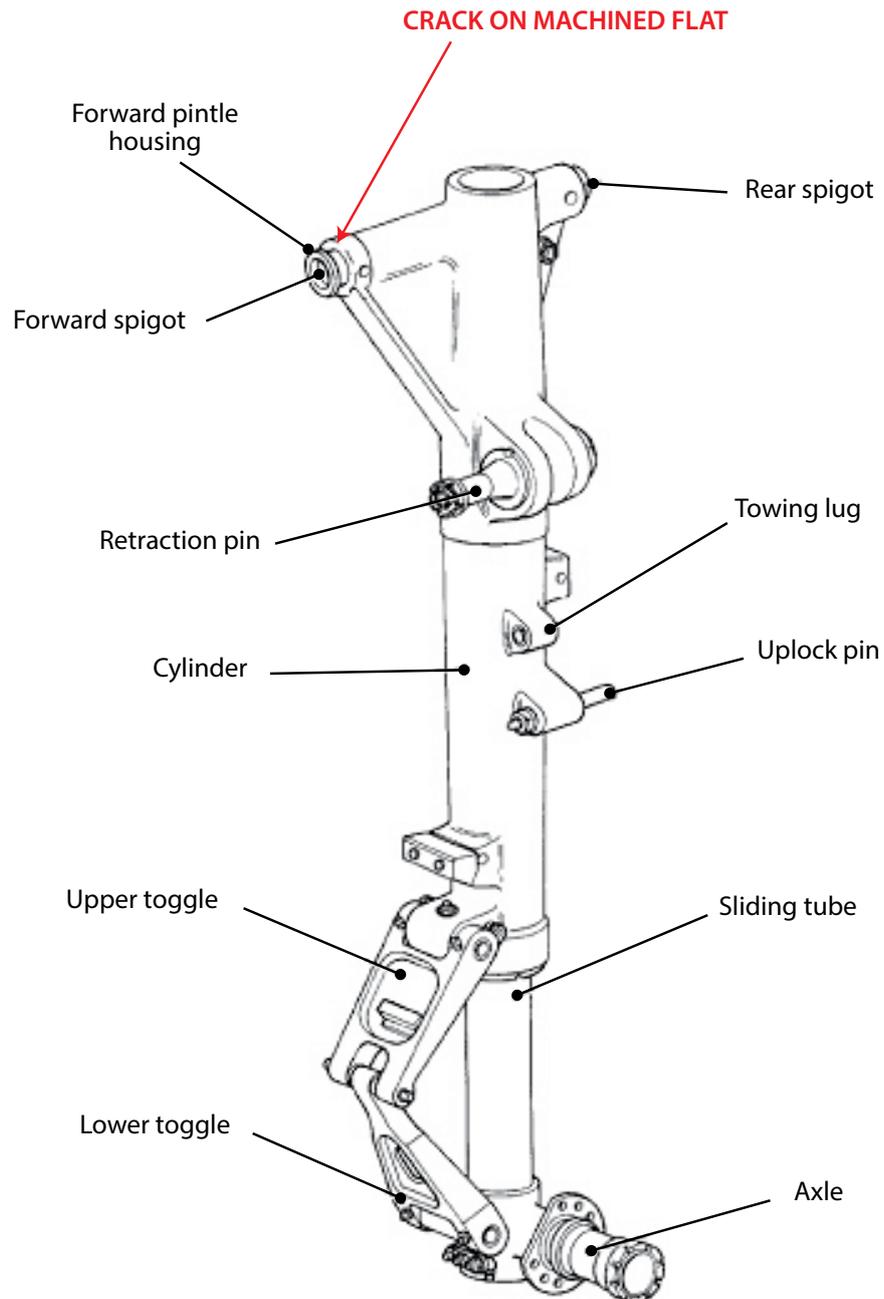
Figure 4
Jetstream 31 main landing gear leg

The Jetstream 31 main landing gear leg consists of a cylinder, manufactured from DTD 5094 aluminium alloy, and an inner sliding tube on which the single wheel and brake assembly are mounted. The landing gear cylinder is attached to the airframe by a yoke which fits onto steel spigots, which are bolted through the pintle housings. The upper surfaces on the forward and rear pintle housings are machined flat to introduce a weak link which will fail, allowing the landing gear to detach from the airframe without damaging the fuel tanks, if it is subjected to a force outside its design limits. During the accident, the forward pintle housing failed along the machined flat (Figure 4).

The DTD 5094 landing gear cylinder is known to be susceptible to stress corrosion cracking (SCC) and similar landing gear failures have occurred on other Jetstream 31 aircraft. In particular, SCC has occurred in the forward pintle housing as a result of the forward face rotating against the spigot bearing during extension and retraction of the landing gear. The resulting abrasion causes degradation of the protective surface treatment, the consequent formation of corrosion pits and, ultimately, cracking. The Jetstream 32 main landing gear cylinder and later versions of the Jetstream 31 main landing gear cylinder are manufactured from L161 alloy and are not susceptible to SCC.

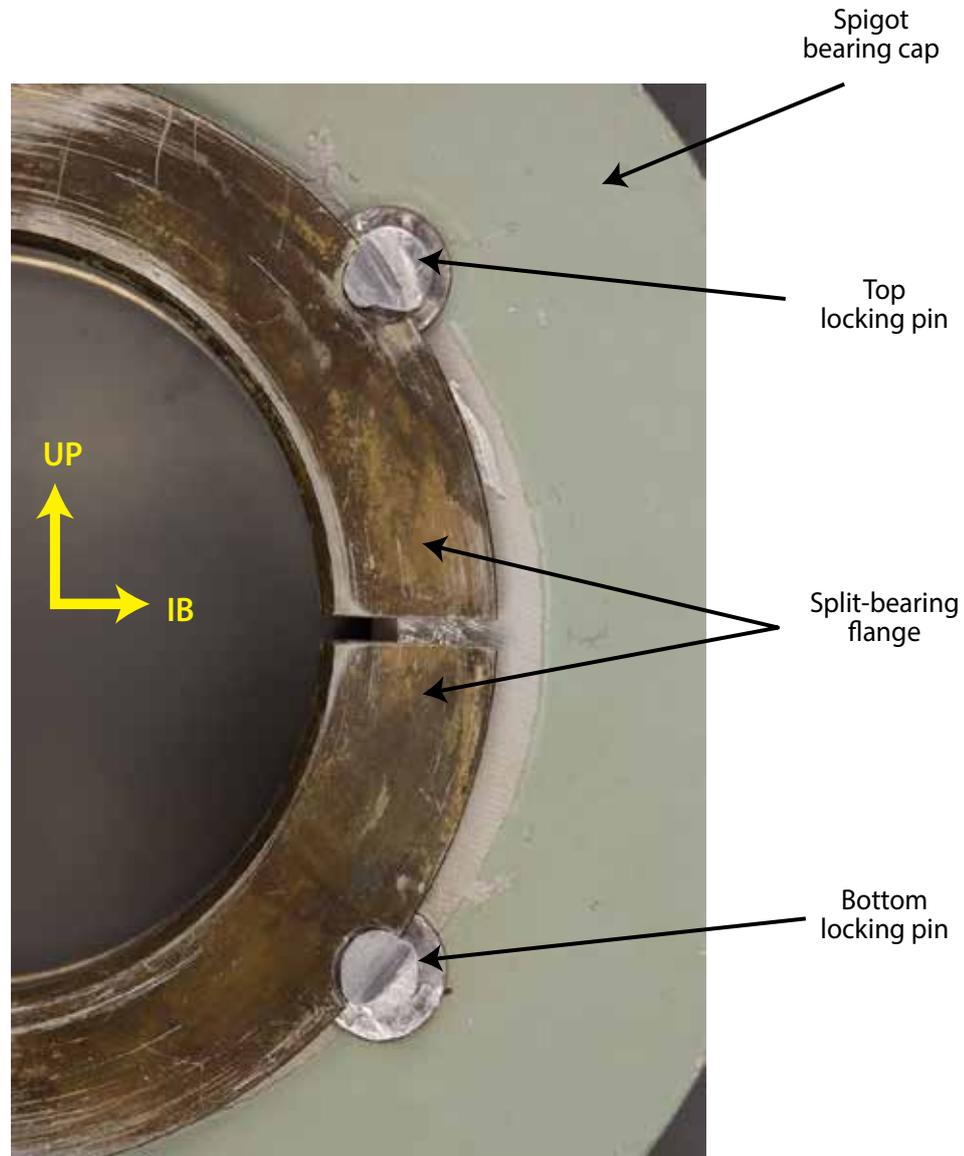
Figure 7

The washer tab was distorted and rotational wear marks were evident on the forward face of the washer, around the inboard edge. This wear is consistent with contact between the washer and the bearing locking pins in the spigot bearing cap. Substantial wear was evident on the bearing locking pins, including a distinctive notch on each pin, created by the outer edge of the washer (Figure 7). The top and bottom pins protruded 1.95 mm

and 2.03mm respectively, from the surface of the spigot bearing cap. The bearing flange measured 1.64 mm thick.

Left landing gear, wear on bearing locking pins

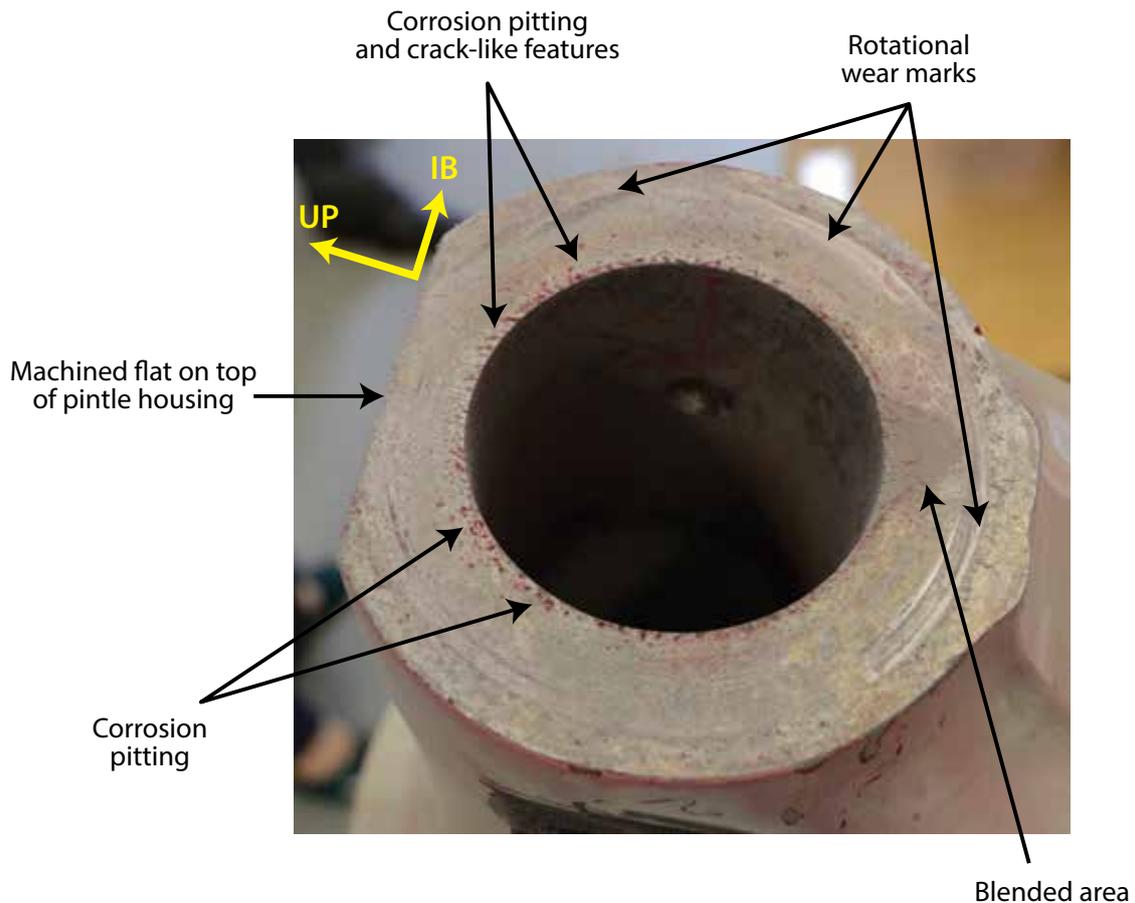
Figure 8

The special washer had rotated such that its tab had passed the inboard corner of the machined flat on the pintle housing. Correctly cured gasket material was evident on the machined flat, under the footprint of the washer tab, but the gasket was absent from the forward face of the pintle housing, except for one small fragment. This fragment had collected in a small depression on the surface, which had the appearance of a blend, possibly indicating the site of a previous repair on the cylinder, although no such repair was referenced in the component records. Rotational wear patterns and witness marks on the forward face of the pintle housing and both faces of the washer, and wear on the bearing locking pins were very similar to those on the left landing gear and indicated that the washer had rotated up to 53° from its normal position.

There was extensive corrosion pitting on the forward face of the pintle housing, most prevalent around the bore, with crack-like features appearing to emanate from the corrosion pits. A HFEC inspection using the technique called up in SB 32-A-JA851226, Revision 6 and SB 32-19 Revision 6, identified defect indications which exceeded the maximum permissible limit. A dye-penetrant inspection was conducted to highlight these defects; the results are shown in Figure 8. The damage was determined to be outside permissible repair limits and the right landing gear cylinder was deemed to be 'scrapped'.

Right landing gear, forward face of pintle housing after dye penetrant examination
