**AVIATION INVESTIGATION REPORT
A14Q0148**

RUNWAY EXCURSION

**AIR LABRADOR LIMITED
DE HAVILLAND DHC-6-300, C-GKSN
LA TABATIÈRE, QUEBEC
28 SEPTEMBER 2014**

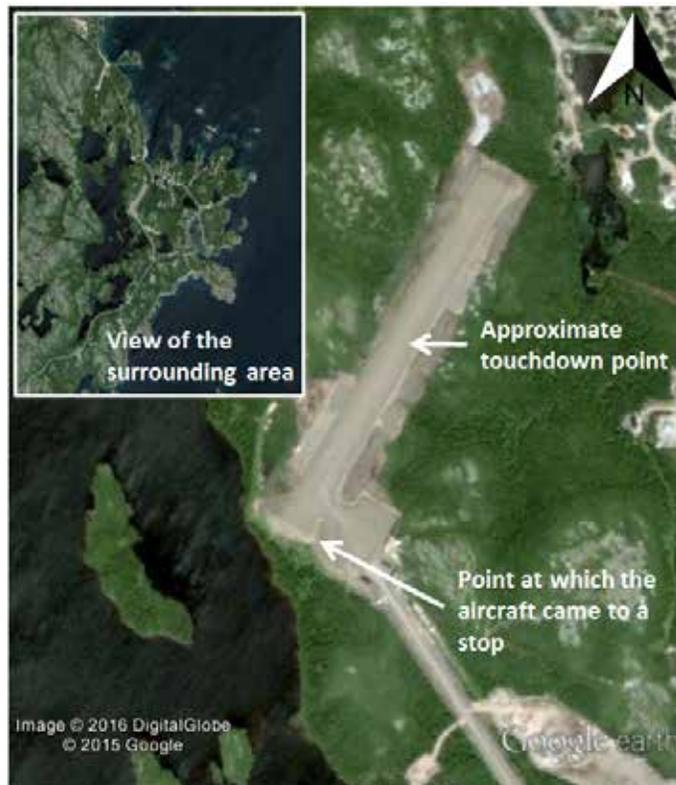
At 1512:32, after floating for 6.3 seconds, the aircraft touched down about 750 feet from the threshold of Runway 23, which is 1649 feet long (Figure 1).

Figure 1. Satellite image of La Tabatière aerodrome showing touchdown and stopping points (Source: Google Earth, with TSB annotations)

During the turn, a tire hit a runway edge light, and the right propeller struck a runway identification sign before the aircraft came to a stop (Figure 1). Debris from the sign penetrated the fuselage just aft of the right cockpit door. As the aircraft was skidding, it came within 3 feet of sliding off the taxiway surface and going down a significant drop.

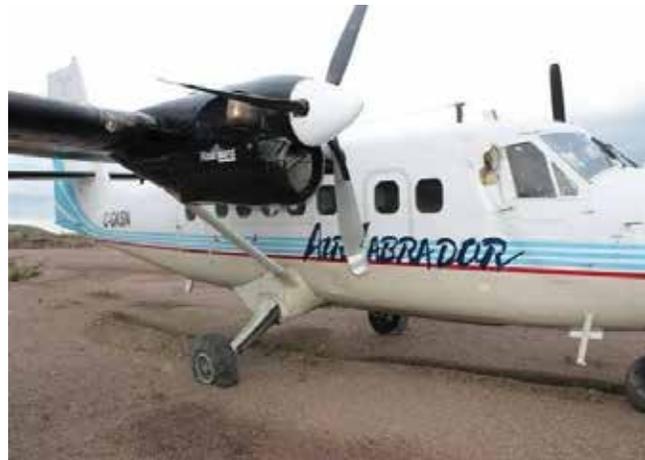
The nose wheel was destroyed, and the right main wheel sustained substantial damage when the nose and right tires separated from their wheel beads.

The right propeller, right engine, and right nacelle structure sustained substantial damage when the propeller struck the runway identification sign.

Debris thrown against the right side of the aircraft punctured the fuselage skin immediately behind the right flight compartment door and caused structural deformation that prevented the door from opening (Photo 1). The aircraft was substantially damaged.

Photo 1. The occurrence aircraft, after coming to rest beside the taxiway (Source: Randy Jones)

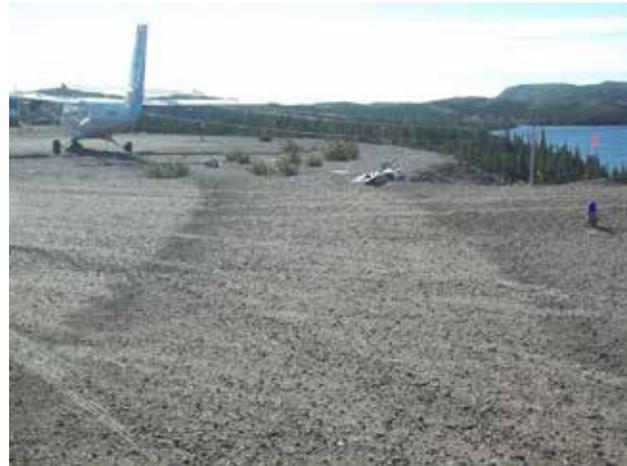
CTU5 airport is for VFR use only. It has 1 gravel runway (05/23) which is 1649 feet long by 82 feet wide (Appendix A). The runway has 100-foot extensions at both ends. Beyond these extensions there are substantial drops of about 90 feet in elevation (Photo 2).

Photo 2. The occurrence aircraft beside the taxiway near the west end of Runway 23, showing terrain features (Source: Air Labrador)
