Air Accident Investigation Unit Ireland

SYNOPTIC REPORT

ACCIDENT
Boeing, 737-8AS, EI-EMH/EI-EKK
LINK 2, Dublin Airport, Ireland

7 October 2014

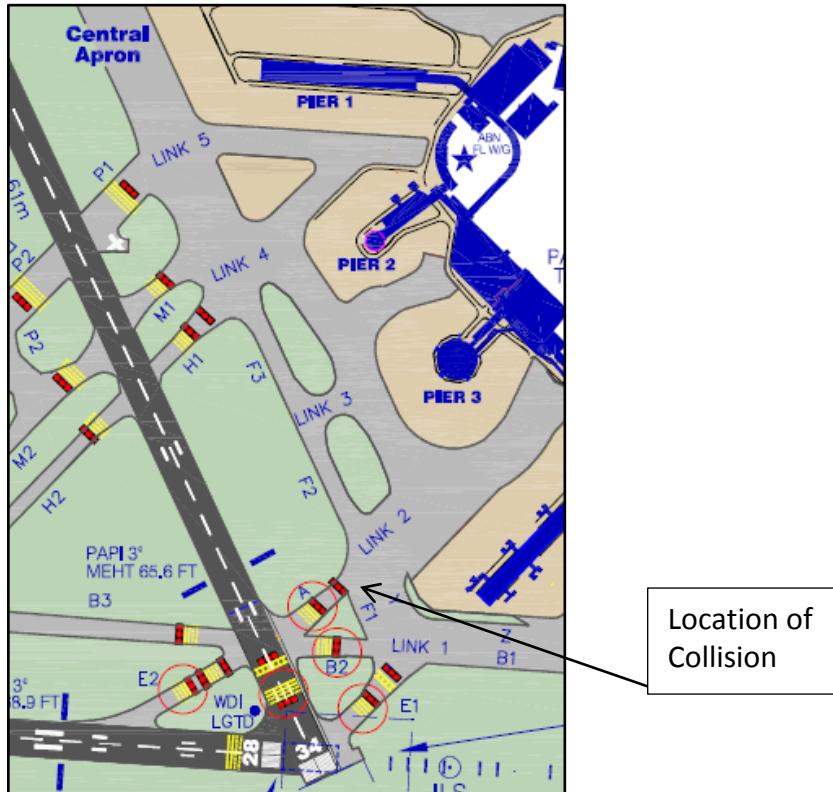
Graphic No. 1: Close-up of Aerodrome chart/Collision area

The second aircraft (EI-EMH), with a planned destination of Edinburgh (EGPH), was following behind EI-EKK in sequence but was due to depart from RWY 34. EI-EMH had been cleared to taxi, LINK 5 onto the Foxtrots and TWY A to hold short RWY 34. When the aircraft was approaching LINK 2, the SMC advised EI-EMH to continue onto TWY A, hold short RWY 34, and monitor TWR 118.6 MHz. As EI-EMH turned right onto LINK 2 and taxied towards TWY A, the tip of the port side winglet struck the outer portion of the starboard elevator of the stationary aircraft, EI-EKK.

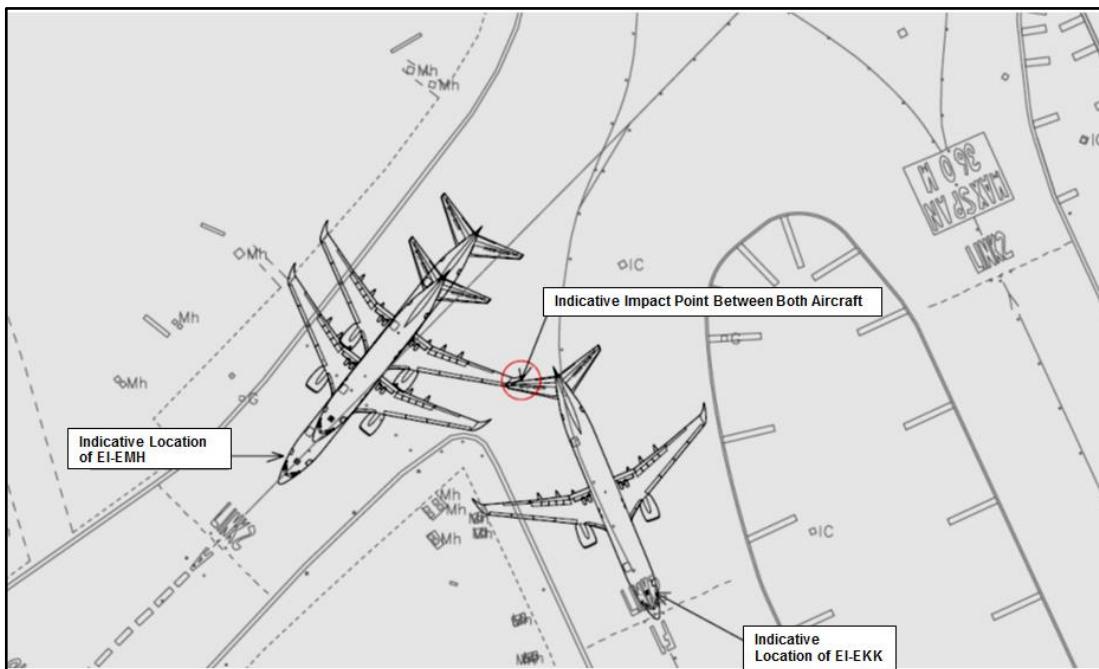
Graphic No. 2: Approximate position of both aircraft at impact
and the final parked position of EI-EMH

Two Inspectors of Air Accidents arrived on site approximately one hour after the occurrence. The first aircraft, EI-EKK, was found in its original parked position with its nose tip just over the demarcation line between LINK 2 and TWY F1 and with the nose wheels slightly left of the taxiway centreline. The main undercarriage wheels were predominantly to the left side of the taxiway centreline as the aircraft tracked to complete the turn onto the centreline. The rearmost section of the starboard elevator was in line with the southern edge of TWY A/LINK 2 (**Graphic No. 2**).

The second aircraft, EI-EMH, stopped a short distance (approximately five metres) from its first point of contact with EI-EKK, approximately 15 metres (m) short of the demarcation line between LINK 2 and TWY A. The nose wheels were slightly right of the taxiway centreline and the main undercarriage wheels were predominately to the right side of the taxiway centreline as the aircraft tracked to complete the turn onto the centreline. **Graphic No. 2** depicts, for indicative purposes only, the approximate positions of both aircraft at the time of impact and the final parked position of EI-EMH following impact.

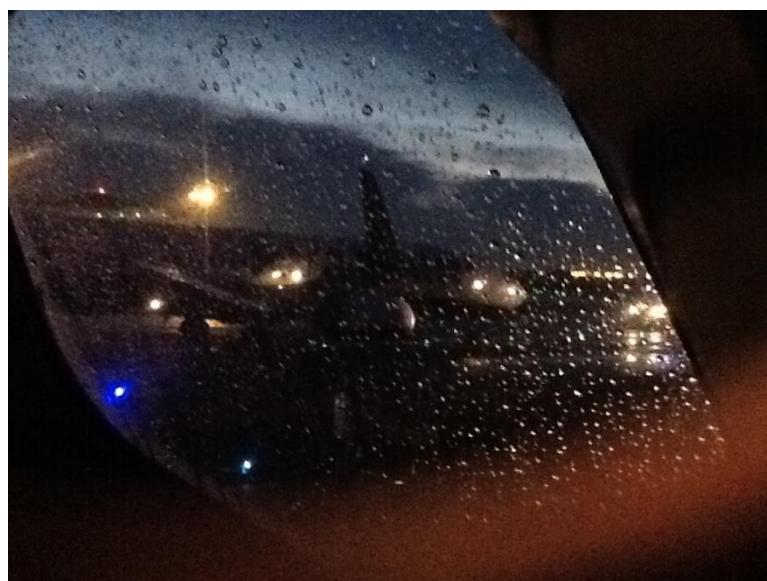
Photo No. 1: Post collision view of EI-EKK from side cockpit window of EI-EMH

Shortly after the occurrence, the Commander of EI-EMH took a photograph of EI-EKK from his rear portside cockpit window and on request the Commander provided the photograph to the Investigation (**Photo No. 1**). This photograph shows EI-EKK in the foreground. The side cockpit window is covered in rain drops and diffused ramp lighting can be seen in the background. Light conditions are early morning darkness. However, it was not raining at the time of the collision.

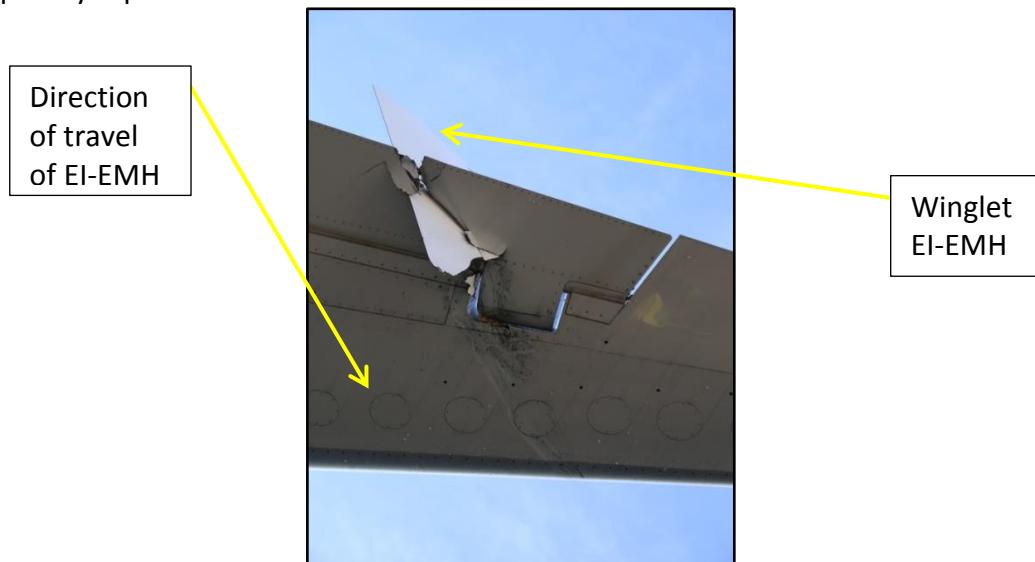
Photo No. 2: Tip of winglet embedded in elevator of EI-EKK and associated scuff marks

The tip section of the port side winglet of EI-EMH struck the outer portion of the starboard elevator of EI-EKK and then sheared from the main part of the winglet as the aircraft continued forward. The underside of the elevator and horizontal stabilizer on EI-EKK suffered scuffing and scrape marks as a result of the stub of the winglet remaining in contact with the aircraft structure as it passed underneath and across the elevator and horizontal stabiliser (**Photo No. 2**). Both the winglet and elevator were extensively damaged and subsequently replaced.

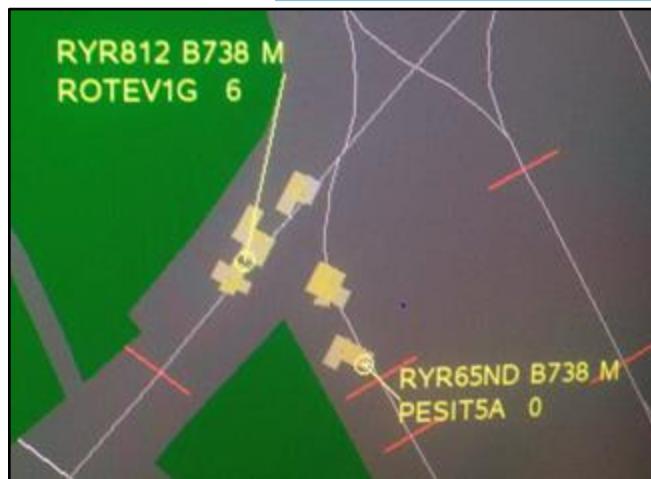
Graphic No. 3: ASMGCS return at point of contact

A review of a series of ASMGCS recordings identified that it was not uncommon for aircraft to stop on the demarcation line LINK 2/F1 when queuing aircraft were ahead on LINK 1/E1.

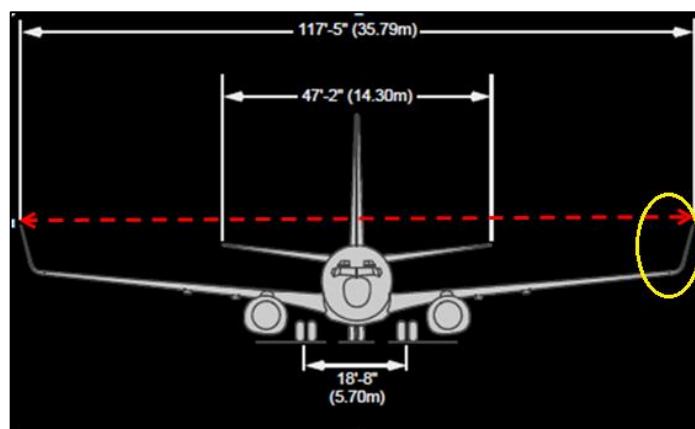
Graphic No. 9: Winglet extending above the height of the aircraft's horizontal stabiliser

The increase in height is significant as it extends above the height of the aircraft's horizontal stabiliser (**Graphic No. 9**). Prior to the introduction of winglets, wingtips would have had sufficient vertical clearance to pass underneath the horizontal stabilizer of the same aircraft type.

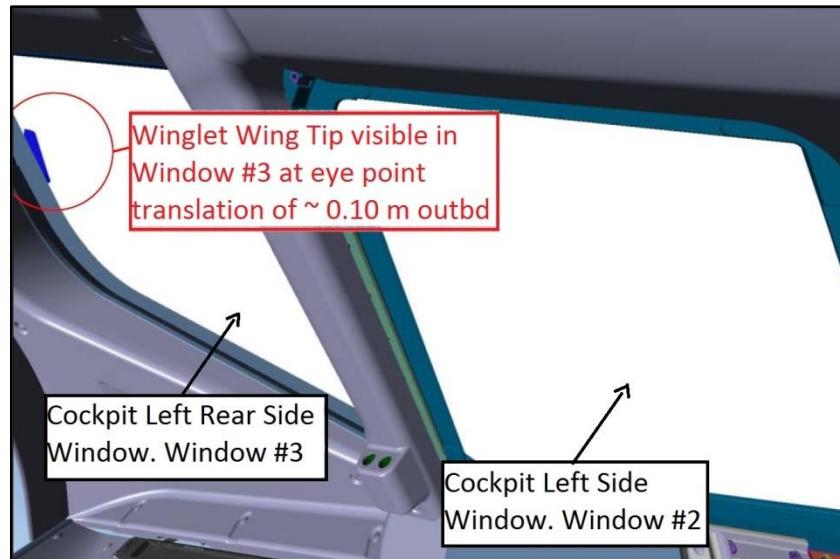
Graphic No. 12: Approximate visibility of winglet wingtip through window No. 3 - 0.10 m outboard of the normal seating position (Boeing Proprietary Copyright © Boeing - Reprinted with permission of The Boeing Company)

The aircraft Manufacturer was asked by the Investigation to analyse how much of the winglet was visible from the seating position of the Commander (left-hand seat). The Manufacturer provided a graphic, which is reproduced in **Graphic No. 12**.

This approximation shows that the left winglet of the B737-800 is just visible from the seated position in the pilot's seat, when the viewer's head is turned and moved 0.10 m outboard to the left.

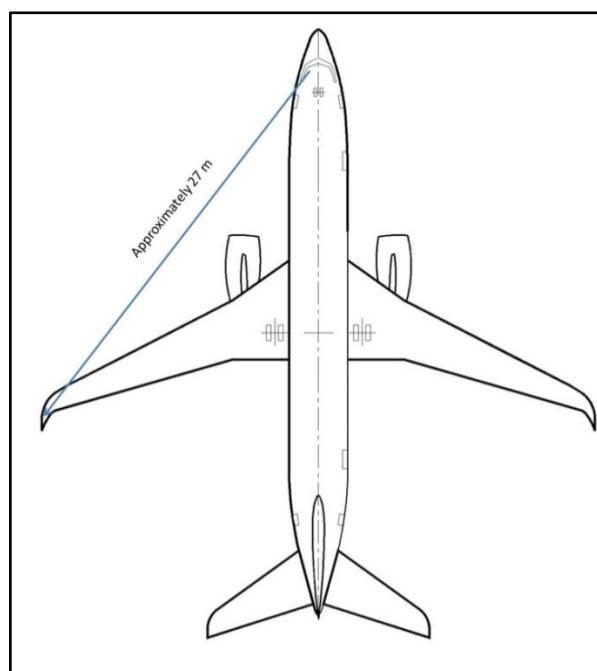
Graphic No. 13: Line of sight distance between cockpit and winglet

The Investigation also carried out its own examination of the view of the wingtip from the Commander's seat. The direct line of sight distance from the Commanders normal seating position to the winglet was approximately 27 m (**Graphic No. 13**).

It was noted that in order to obtain a view of the complete winglet, a pilot would need to move their head closer to the No. 2 window, and then look back through the No. 3 window. This is not a natural seating position, and takes the pilot's visual attention away from the straight ahead view. The Investigation further noted that the thickness and depth of the pillar dividing the No. 2 and No. 3 window interfered with the view.
