**Final Investigation Report on Serious Incident to**  
**M/s Jet Airways (India) Ltd. B-737-800 Aircraft**  
**VT-JGE on 14-01-2015 at Kolkata Airport**

**COMMITTEE OF INQUIRY VT-JGE**

**FINAL INVESTIGATION REPORT ON SERIOUS INCIDENT TO  
M/s JET AIRWAYS (INDIA) LTD. BOEING B 737-800 AIRCRAFT  
VT-JGE AT KOLKATTA AIRPORT ON 14-01-2015**

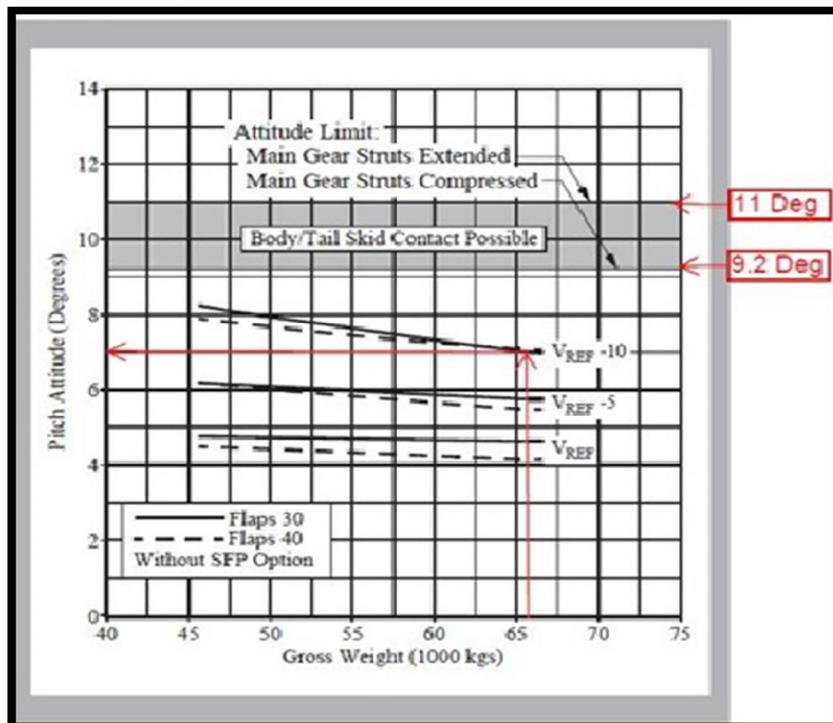
Speed at touchdown was 138kts which was 10kts below selected Vref (148kts). With the lower speed the aft body clearance is reduced thereby increasing the risk of tail strike as shown in the diagram below.

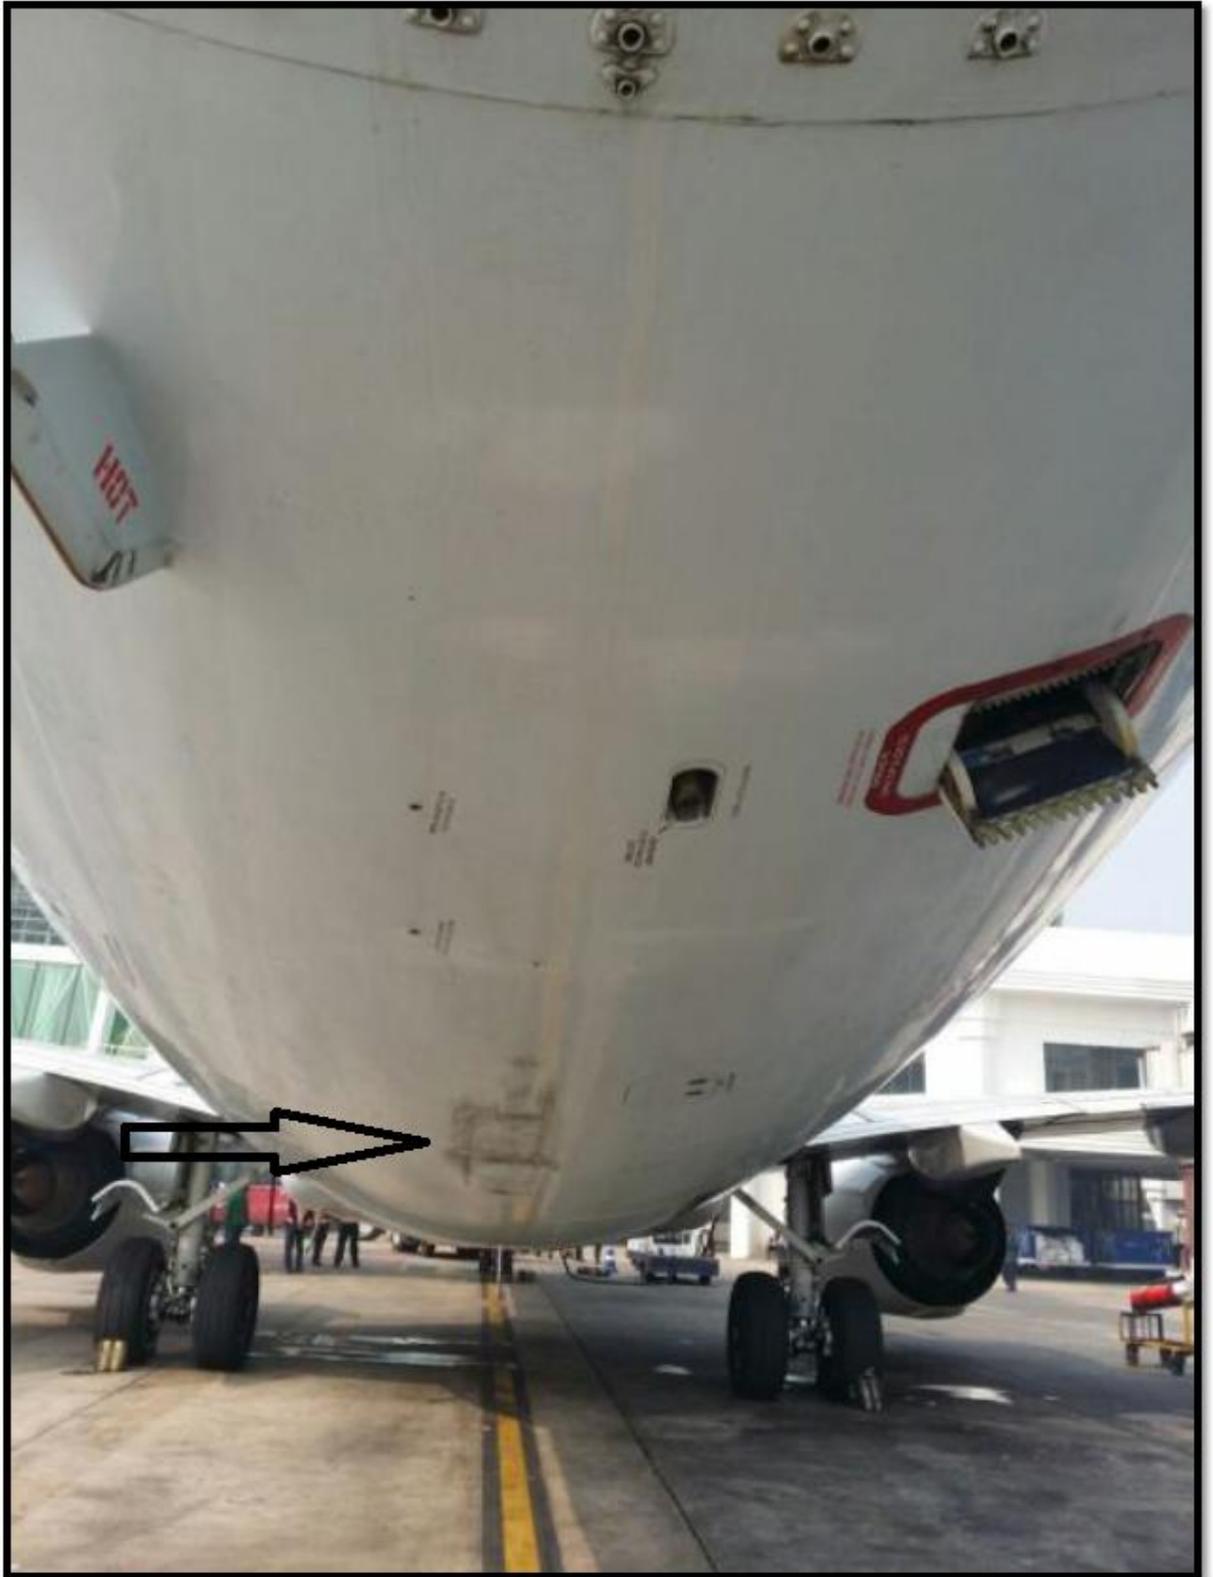
- 1) Tail skid shoe rubbed but four dimples visible. Tail skid green decal was slightly visible
- 2) Rubbed mark of approx. 70" long found on fuselage bottom side between STA 867 & STA 967 and between Stringer 27 L & 27 R.
- 3) Rubbed mark at Frame 1016 (from 18" forward FR1016 to 18" aft of FR 1016).
- 4) Paint peeled off and 2 deep longitudinal gauges of approximately 9" length ahead of FR 1016.
- 5) Tail Skid Cartridge core assembly damaged (shortened by 0.5").
- 6) 07 Rivets sheared off at STA 967 and between Stringer 27L & 27 R.
- 7) Shear Tie at STN 887 cracked between Stringer 27L & 27 R
- 8) Stringer clip at STA 907 and STA 887 at Stringer 27L bend.
- 9) Deep Gauges of Length 44.5" between STA 867 and STA 927 Stringer 27 L & 27 R.
- 10) Bulge of fuselage skin of 3.5" aft edge of frame STA 867 between Stringer 27 L & 27 R.

Damage to Belly of aircraft

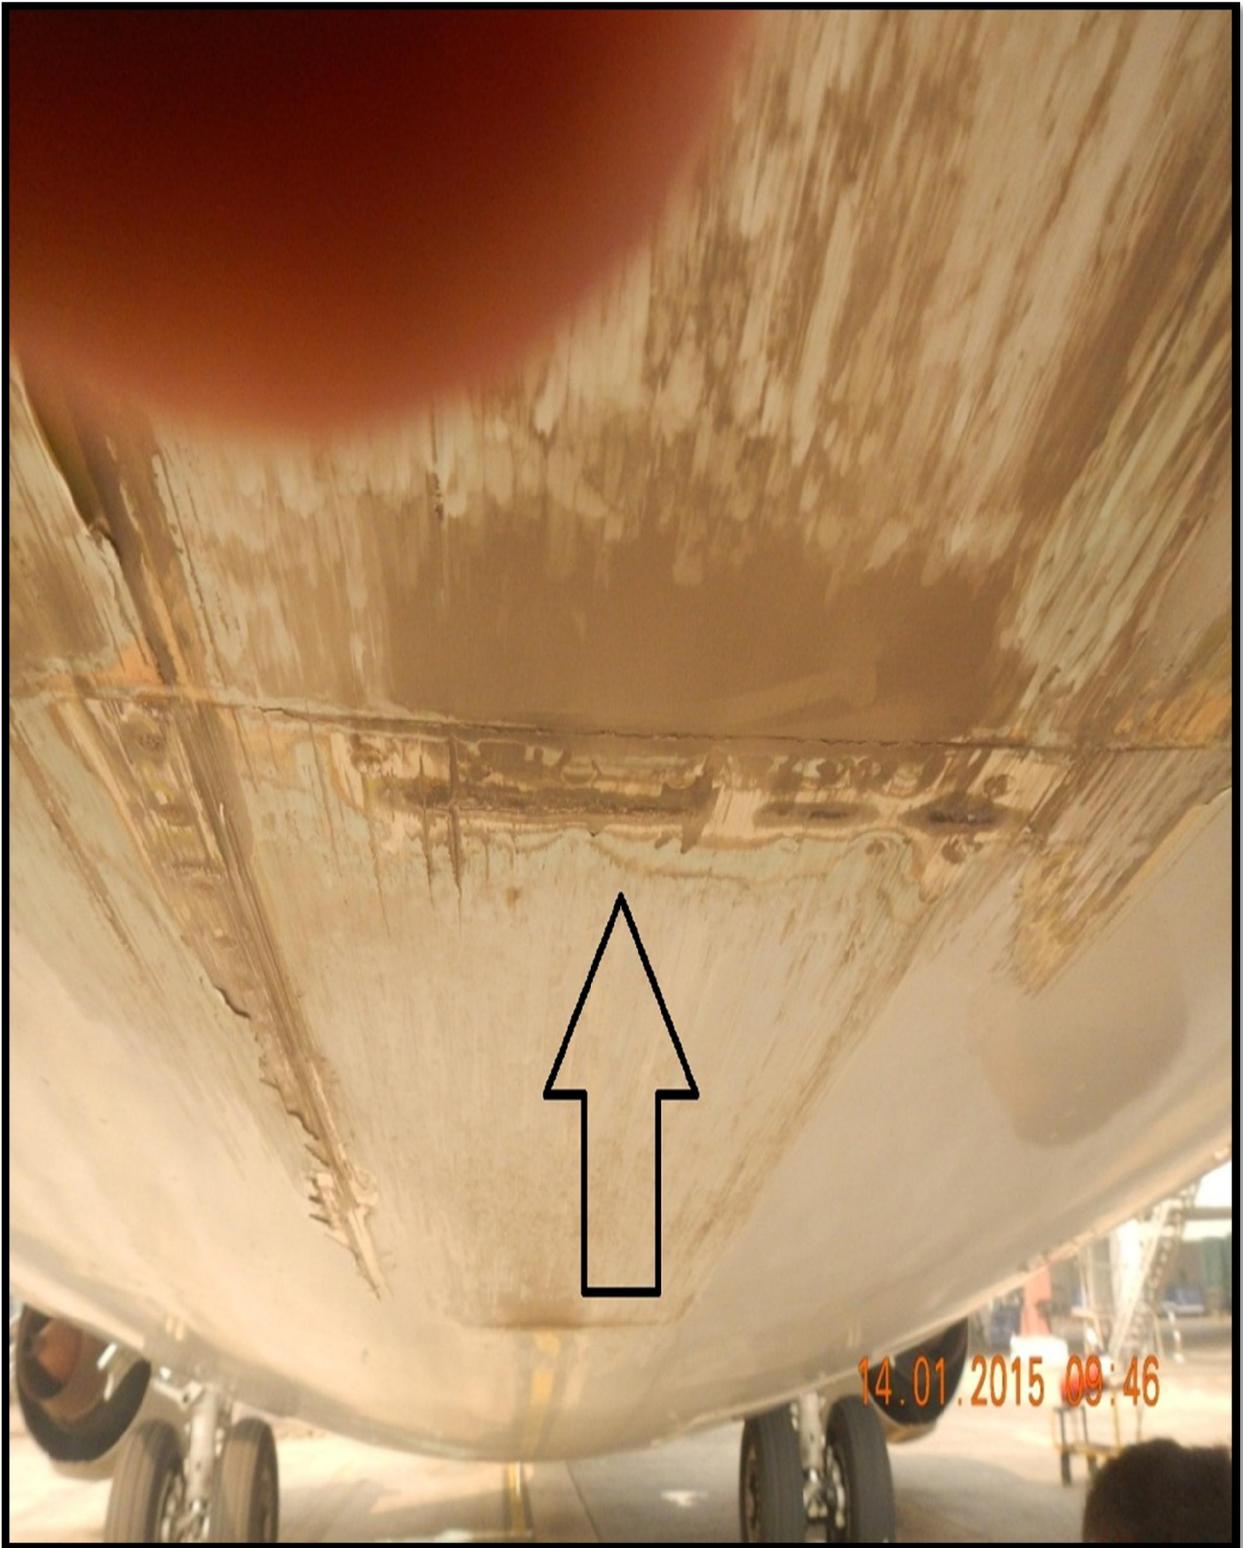
**Damage to Belly of aircraft**

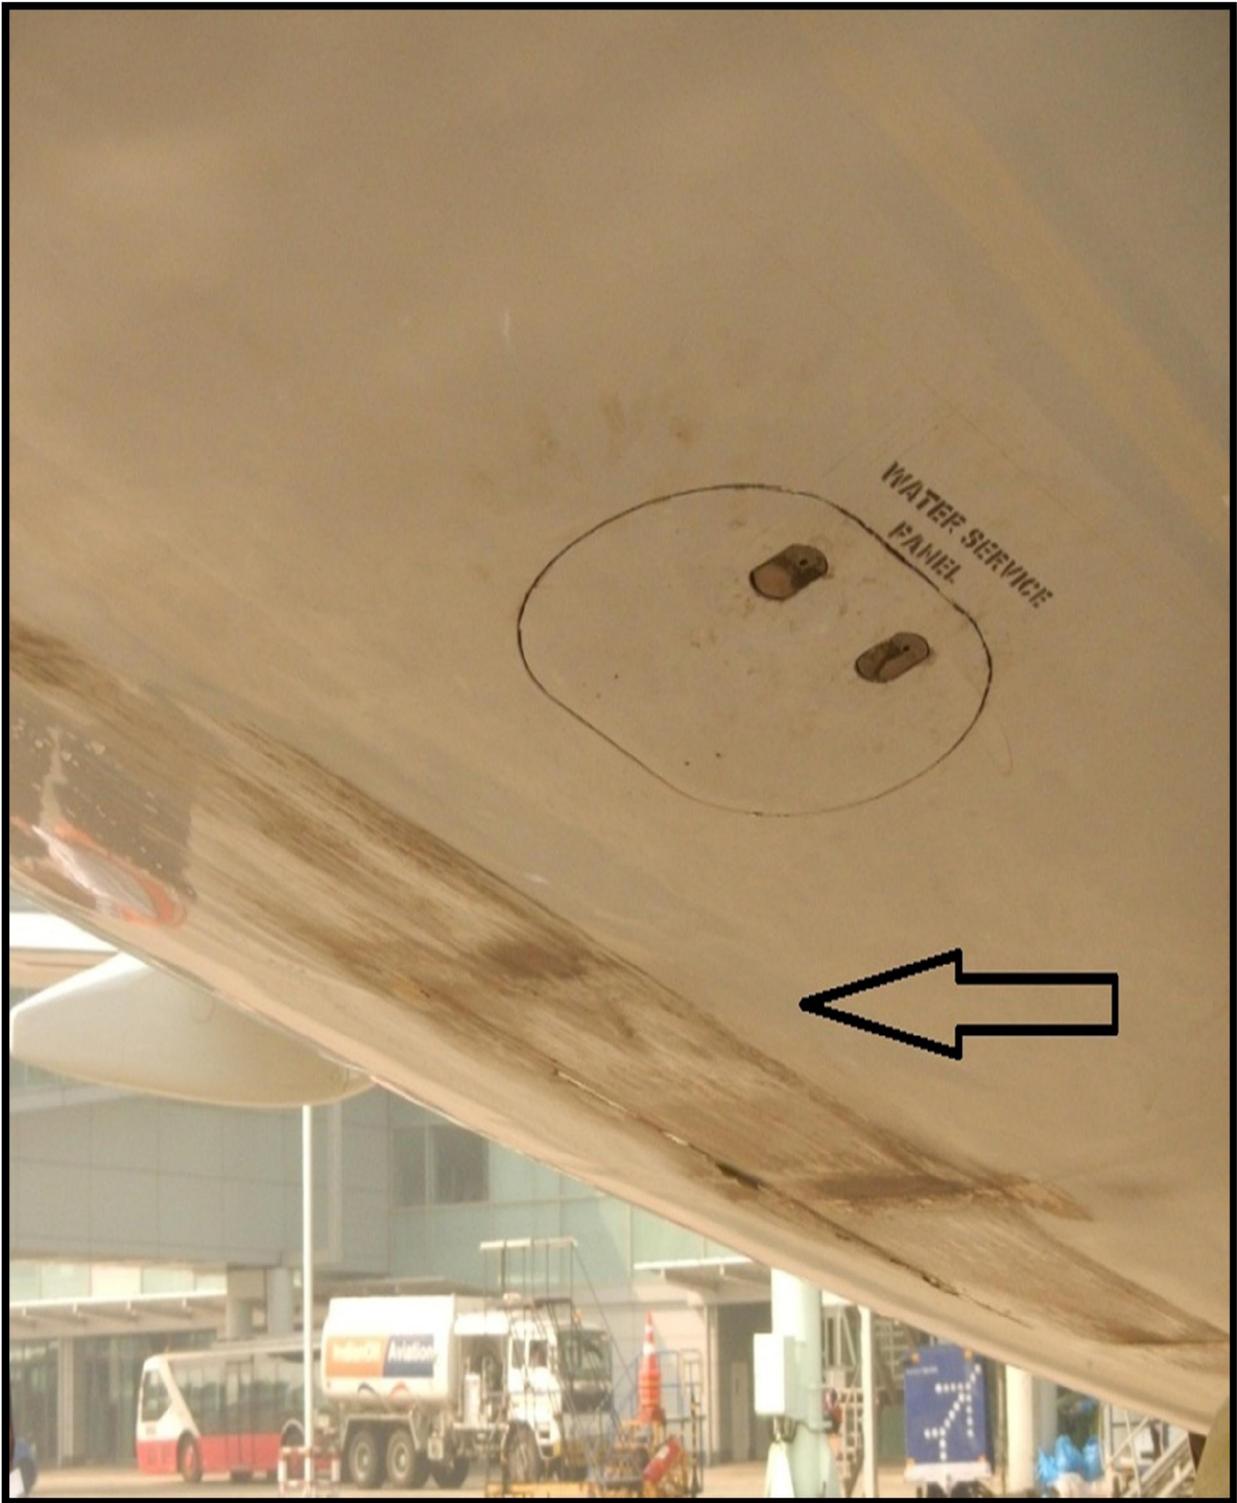
**Damage to Belly of aircraft**

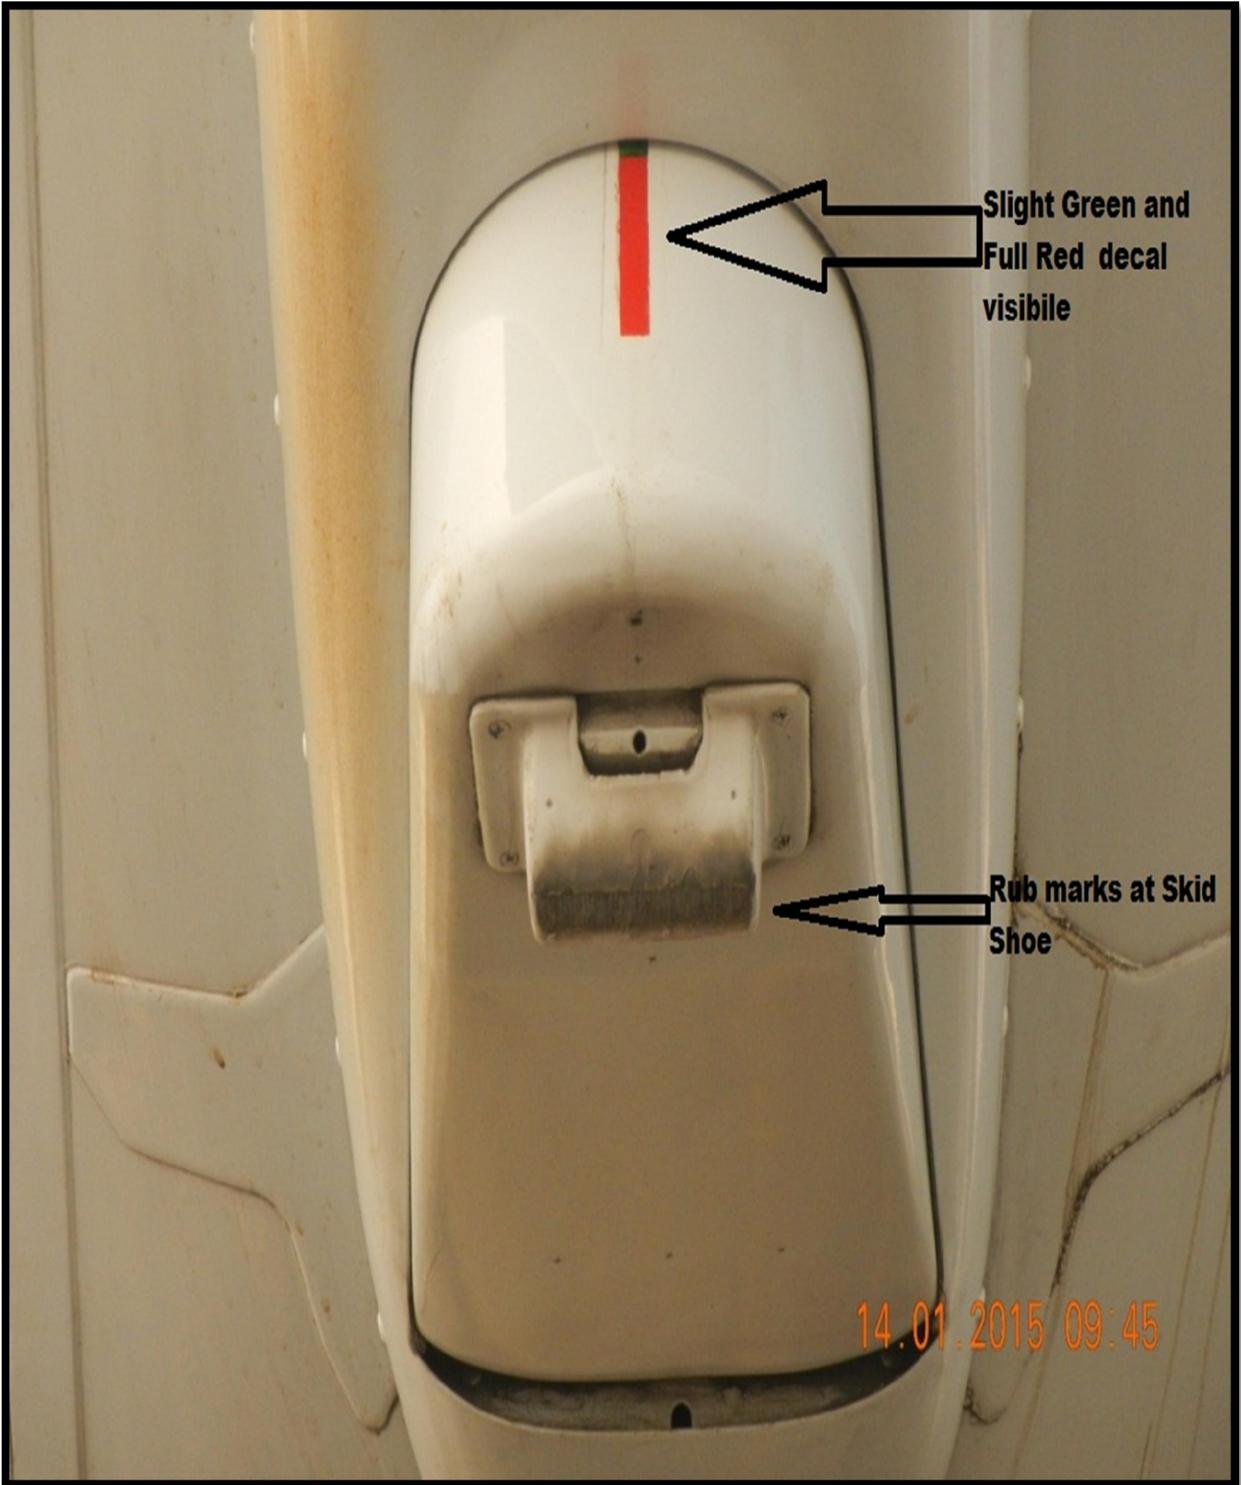
Damage to Tail Sid Shoe and decal markings

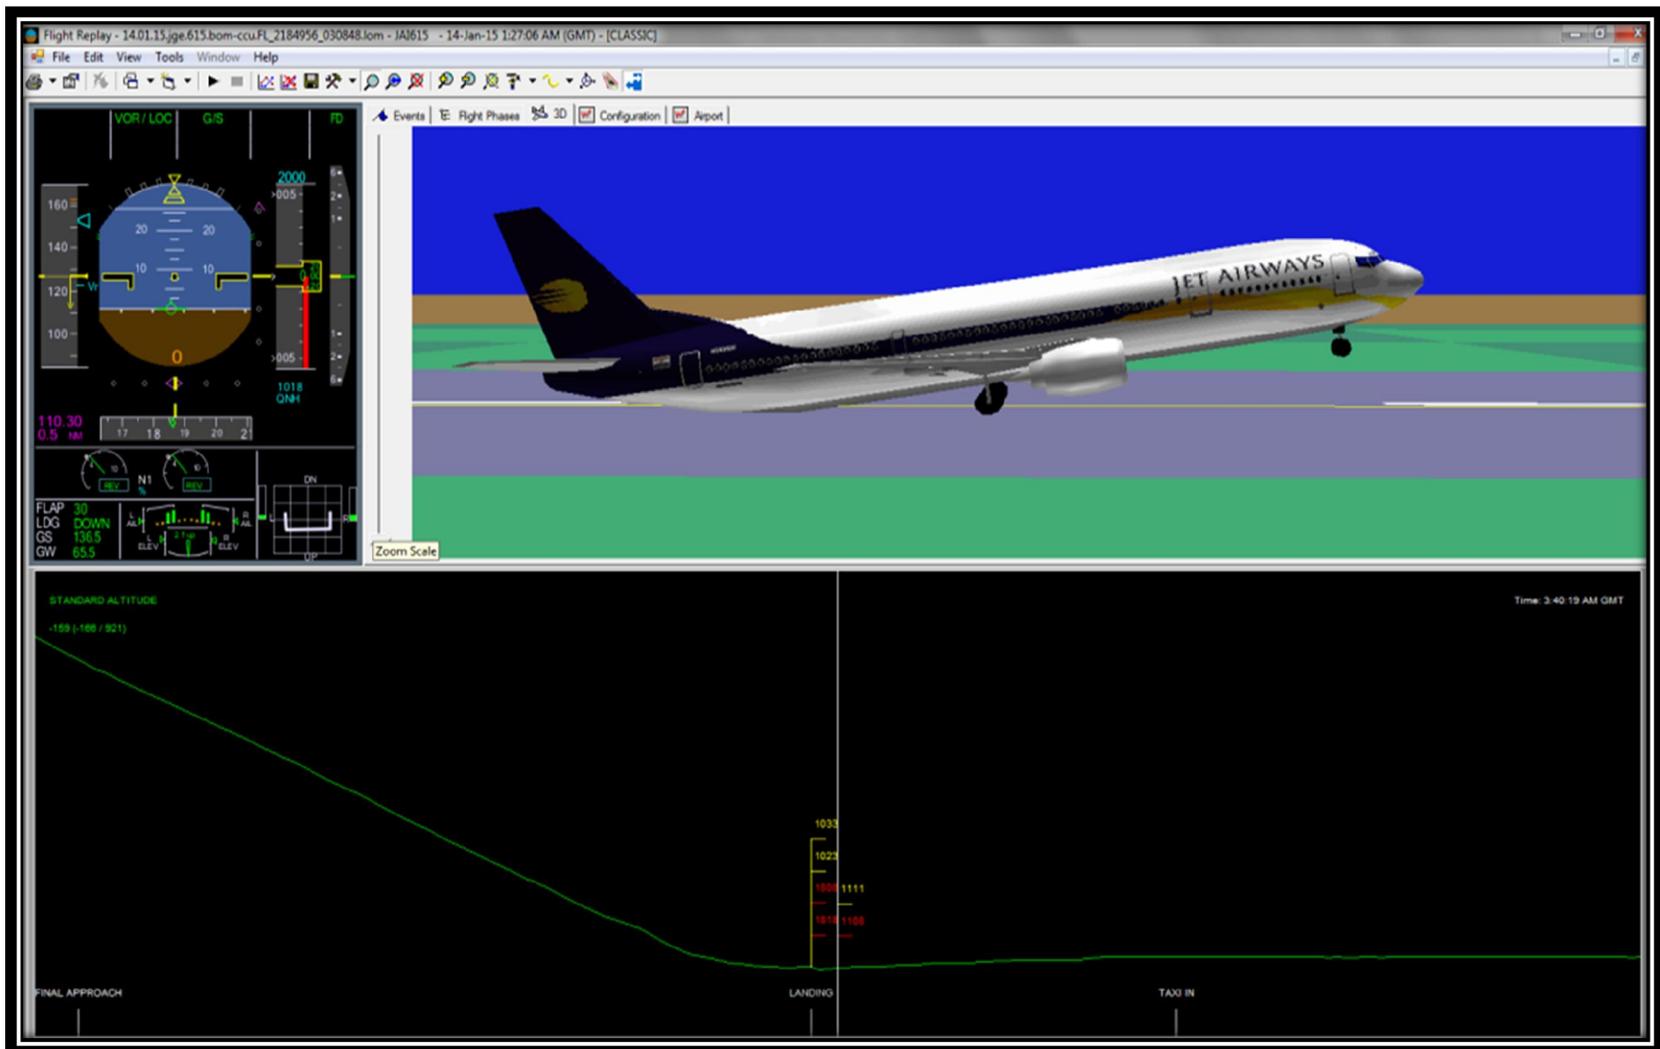
Screen shot Image of VT-JGE landing using Airfare Software
