ACCIDENT

| Aircraft Type and Registration: | BAe 146-200, G-RAJJ |
| Location: | Guernsey Airport, Channel Islands |
| Information Source: | AAIB Field Investigation |

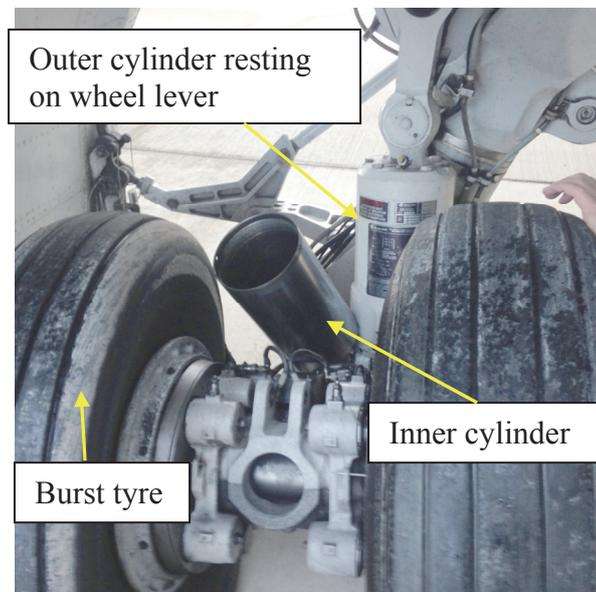
Figure 6
Left main landing gear

Following the accident the shock absorber inner cylinder was found to have separated from the outer cylinder, Figure 6. The top surface of the wheel lever had sustained damage as a result of contact with the outer cylinder. The inner cylinder had made contact with the No 1 brake pack Green hydraulic system quick release pipe, causing it to detach from its connecting union. The operator's engineers later established that the Green hydraulic system had only lost one litre of fluid.

The inner cylinder also rubbed against the inner sidewall of the outer tyre (No 1 mainwheel), which had punctured and deflated. The frame, which runs down the centre of the lower fuselage between the main landing gear bays, had been damaged. Tyre marks indicate that the No 2 mainwheel caused this damage during the retraction sequence. The sheared bolt head attached to a long section of locking wire recovered from the runway was identified as being from one of the shock absorber diaphragm locking bolts. There was no damage to the bottom of the wheel lever.

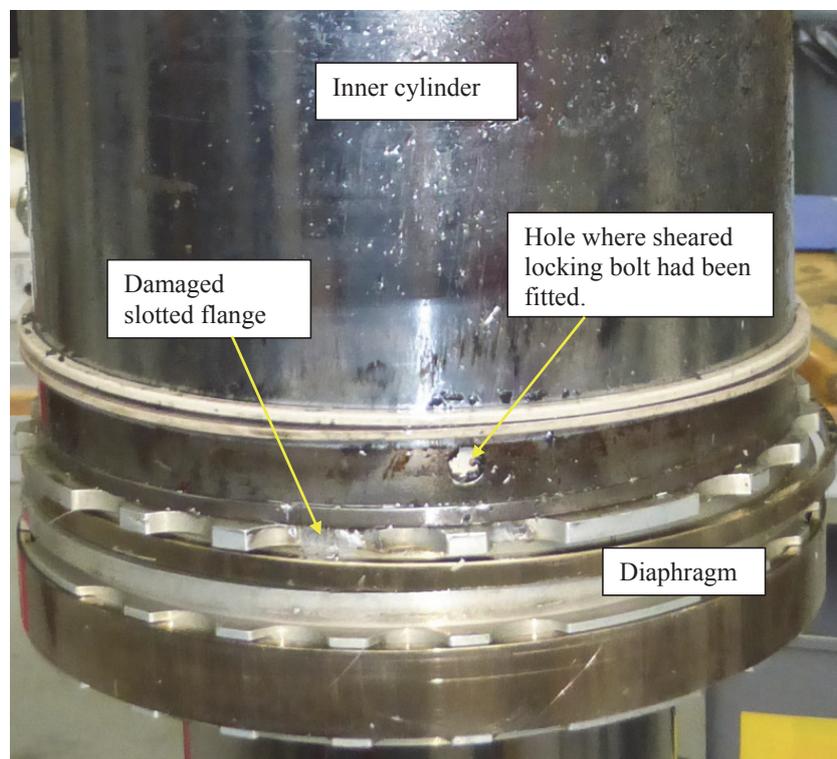
Figure 7
Inner cylinder and diaphragm

- The threads on the inner cylinder (steel) were found to be intact, whereas the threads on the diaphragm (aluminium alloy) had sheared in a direction consistent with a compressive load forcing the diaphragm and inner cylinder together.

- The locking bolt fracture surfaces only showed evidence of fracture due to shear overload. These bolts had failed in a direction consistent with a tensile load forcing the diaphragm and inner cylinder to separate.

- One of the slotted flanges had broken away from the diaphragm. It was concluded from the damage to the flange that the sheared diaphragm locking bolt head had become trapped between the flange and the outer cylinder bore causing the flange to break, Figure 7.

- Mechanical damage on the diaphragm, shim, recoil ring and outer cylinder, was assessed as having been caused by the bolt head, which suggests that the locking bolts had sheared some cycles before separation of the shock absorber.
