INVESTIGATION OF RUNWAY EXCURSION ACCIDENT OF TURKISH AIRLINES TC-JOC, A330-303, AT TIA, KATHMANDU, NEPAL ON 4th MARCH 2015

**Accident investigation commission (TC-JOC, A330-303)
2015**

Date: 2015/10/06 (2072/6/19)

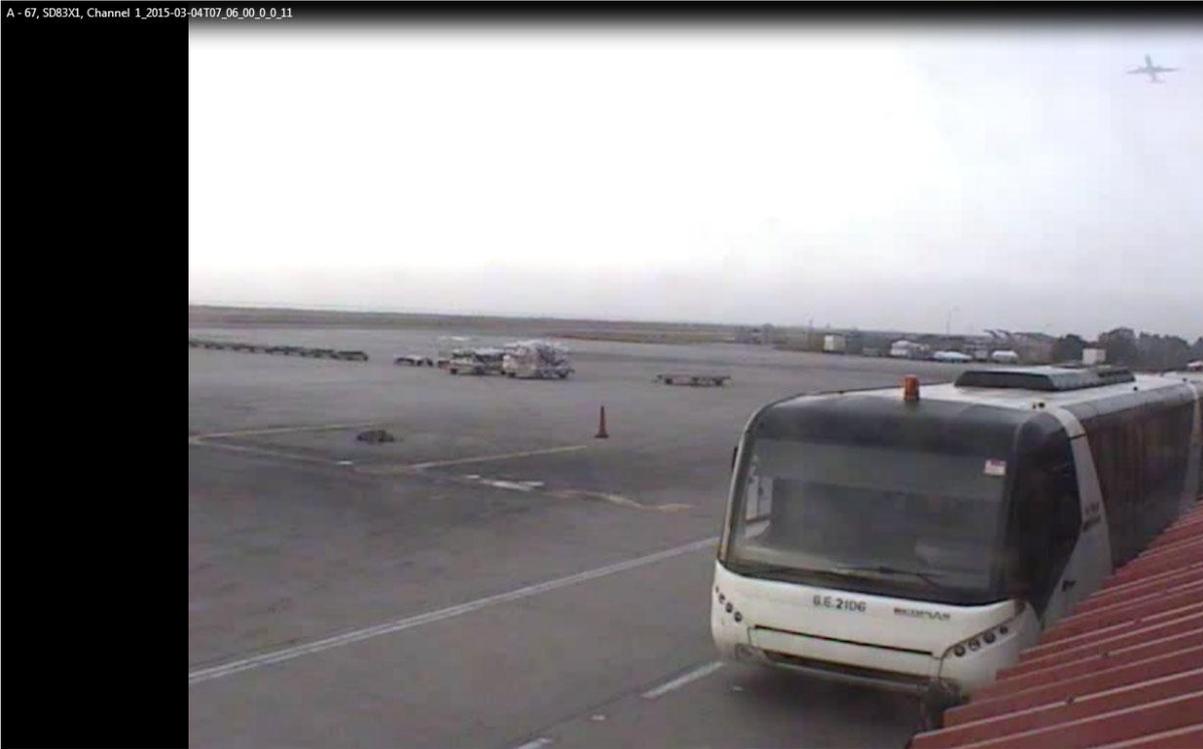
Picture by CCTV Footage camera A-67 Sd83X1 channel at 01:22 Hrs,
First Go around

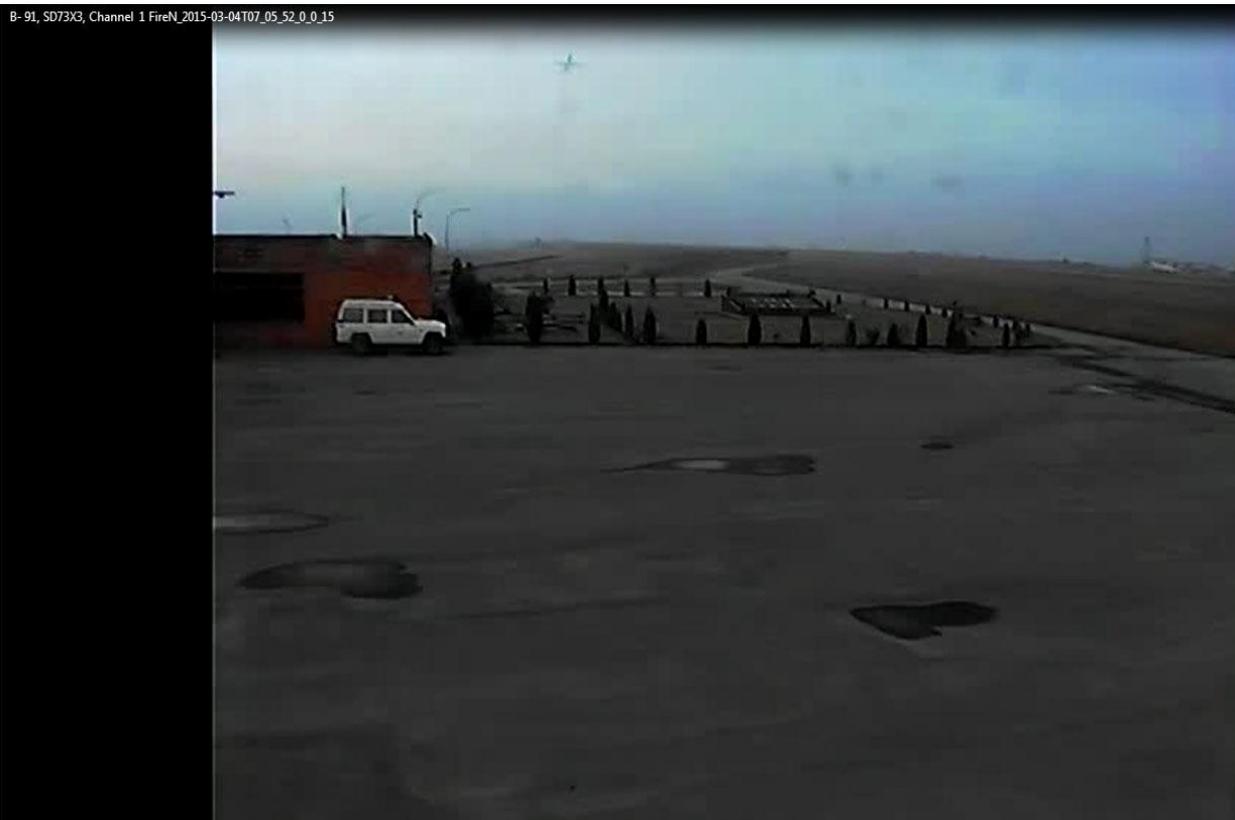
Picture by CCTV Footage B-91. SD73X3 Channel 1 Fire N at 01:21 Hours
First Go around

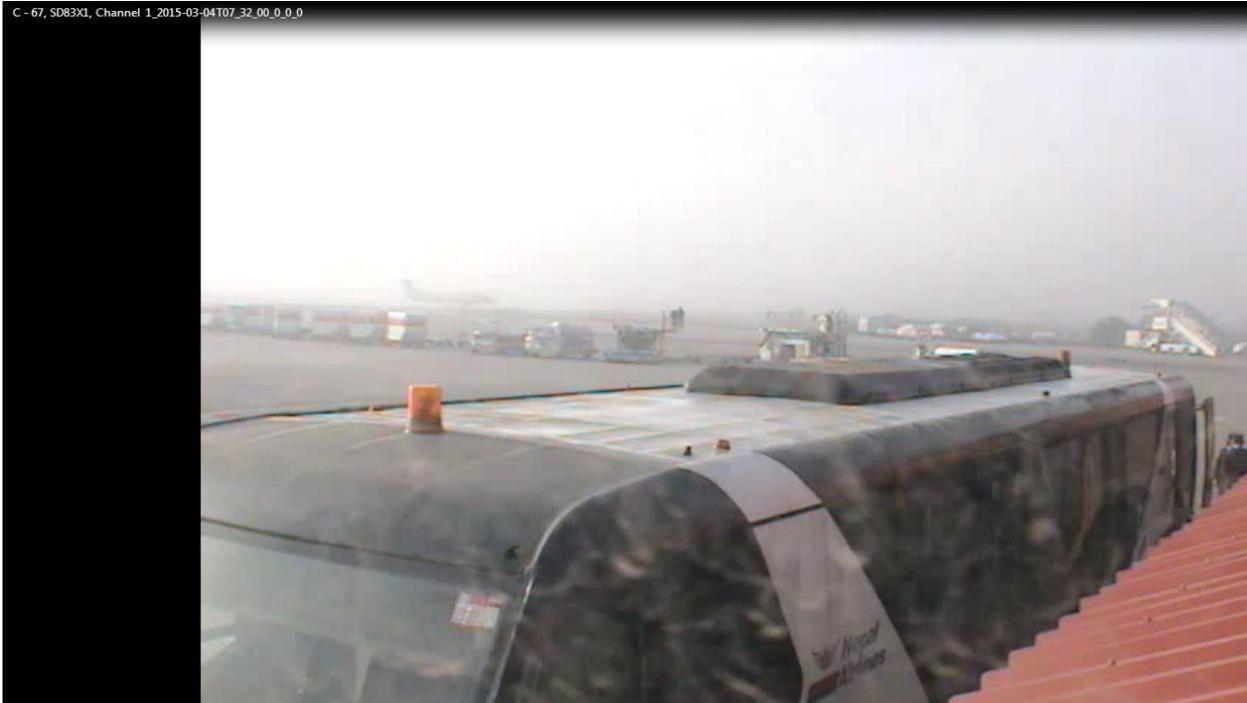
Picture by CCTV Footage C-67,Sd83X1 Channel 1 at 01:56 Hours,
Seen one Domestic Aircraft Taxiing

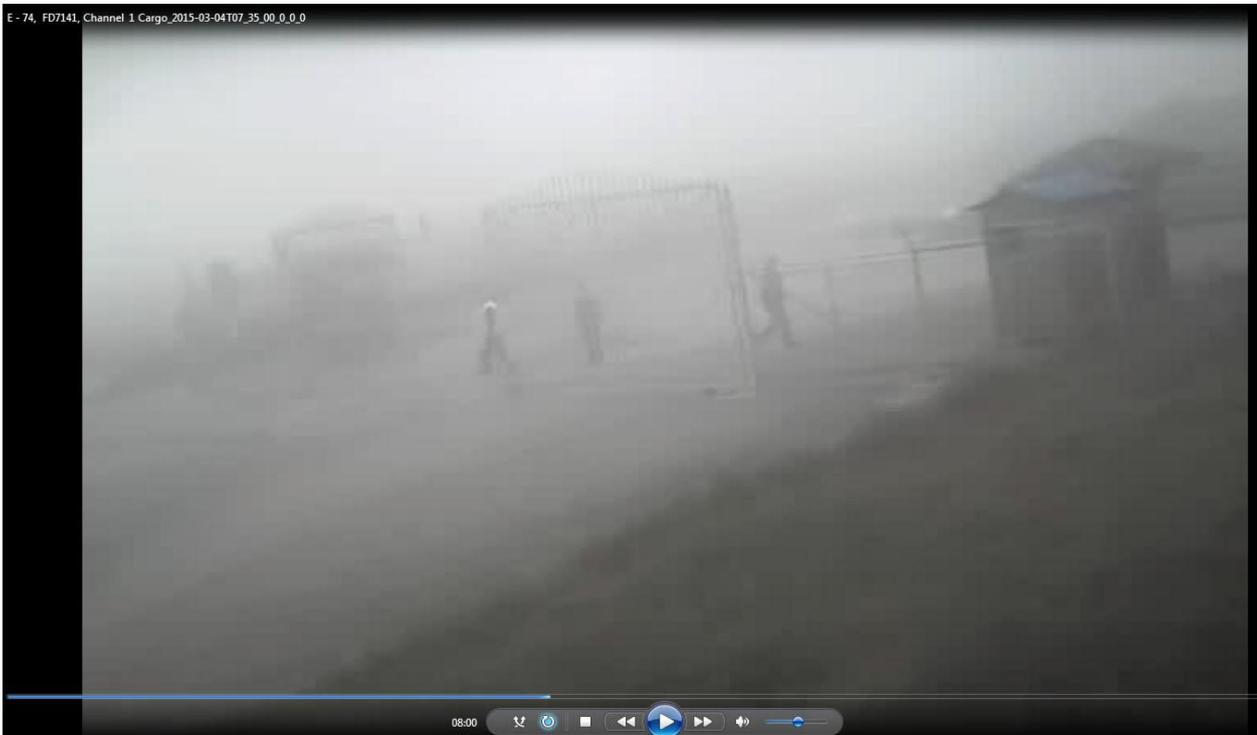
A review of CCTV camera footage, installed at different locations of airside areas, showed that the weather had deteriorated during the second approach into Kathmandu as compared to the first approach. Landing clearance was issued by the Kathmandu Tower at 01:55:48 hours. At that time it was observed from the CCTV camera footage that the visibility already started deteriorating and by the time of landing the visibility was well below the prescribed minima. The tower did not provide the deterioration in visibility to the aircraft

Picture by CCTV Footage E-74, FD 7141 Channel 1 Cargo at 01:58 Hours,
Weather Just before the Aircraft Landing

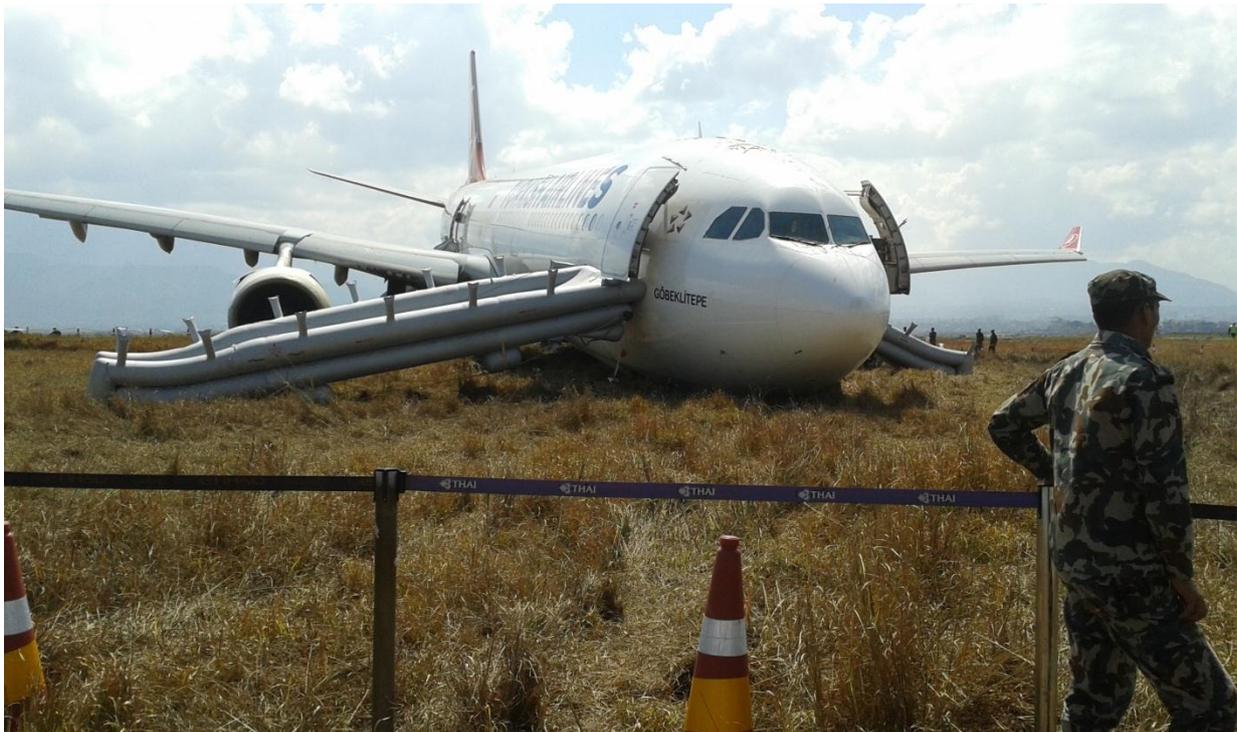
- Nose landing gear was completely collapsed and inserted into the nose well.
- Nose section of fuselage was dragged on the ground and multiple wrinkles were observed on fuselage from nose to angle of attack probe

Nose LG collapsed and inserted inside the wheel well

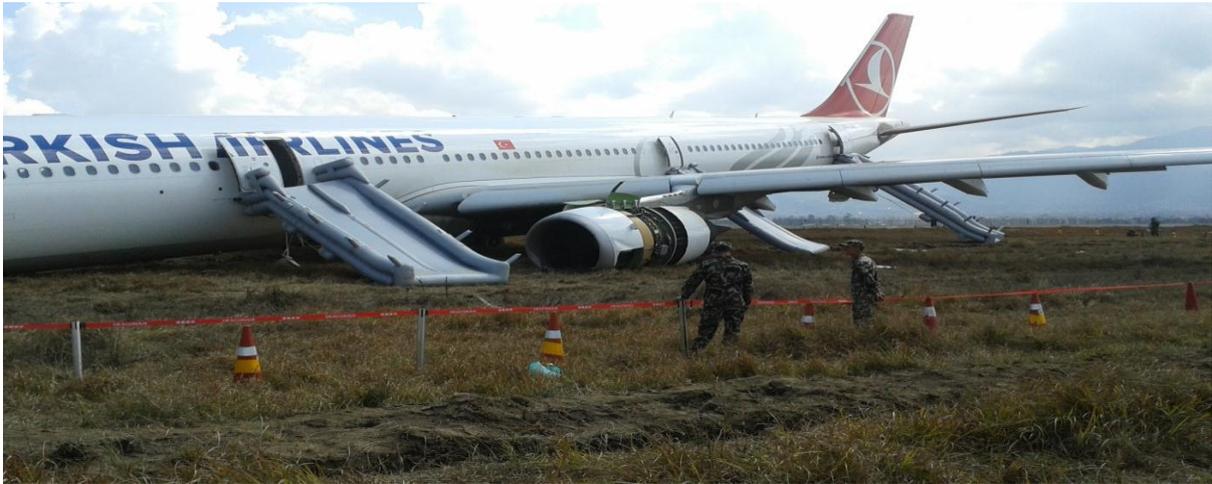
Left Engine of the Aircraft

- Belly fairings on both sides of fuselage were damaged.
- Multiple foreign objects damage was seen on the right hand inboard slat.
- Left & right engines had sustained major damage and pylon bended. Thrust reversers were fully deployed, left and right fan cowl were out from engine, inlet cowls were severe damaged, and severe damages were found on fan blades.
- On the left main landing gear all the wheels were broken and out from its hubs, hydraulic fluid leakage observed.
- On the right main landing gear, three wheels were severely damaged and flat, strut door had substantial damage.
- Aircraft was completely out from runway and lying on grass field.
- Significant holes were found on the top of the inboard wing

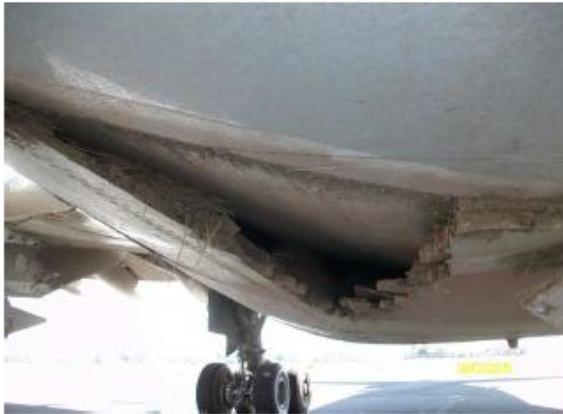
RH side of the Belly Fairing

behind of the NLG bay

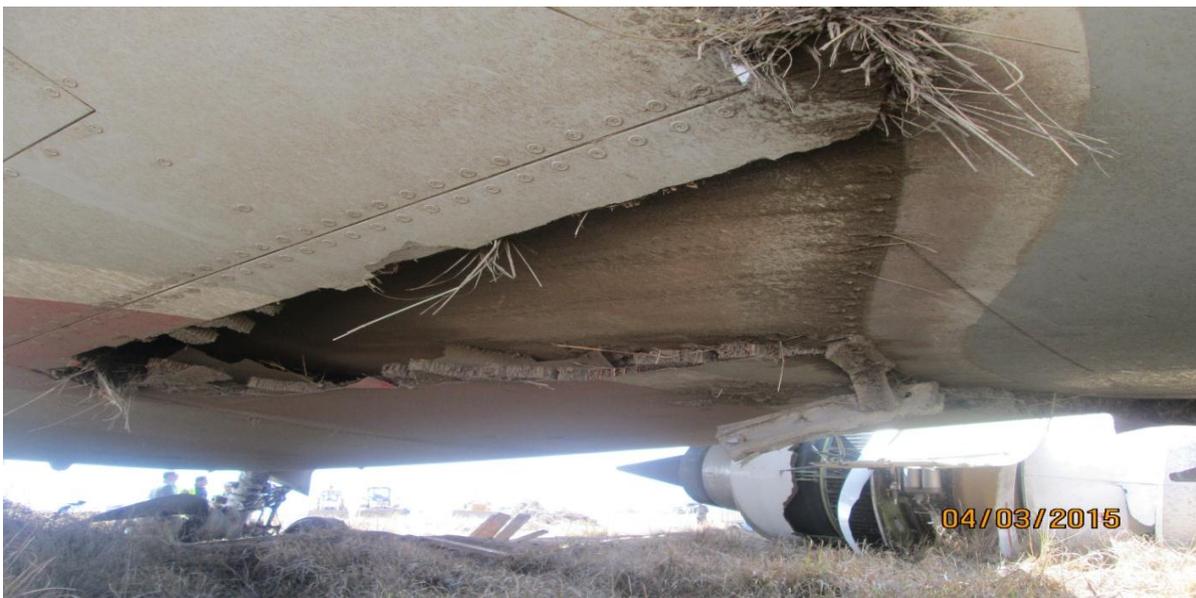
Belly of the aircraft--Fairing

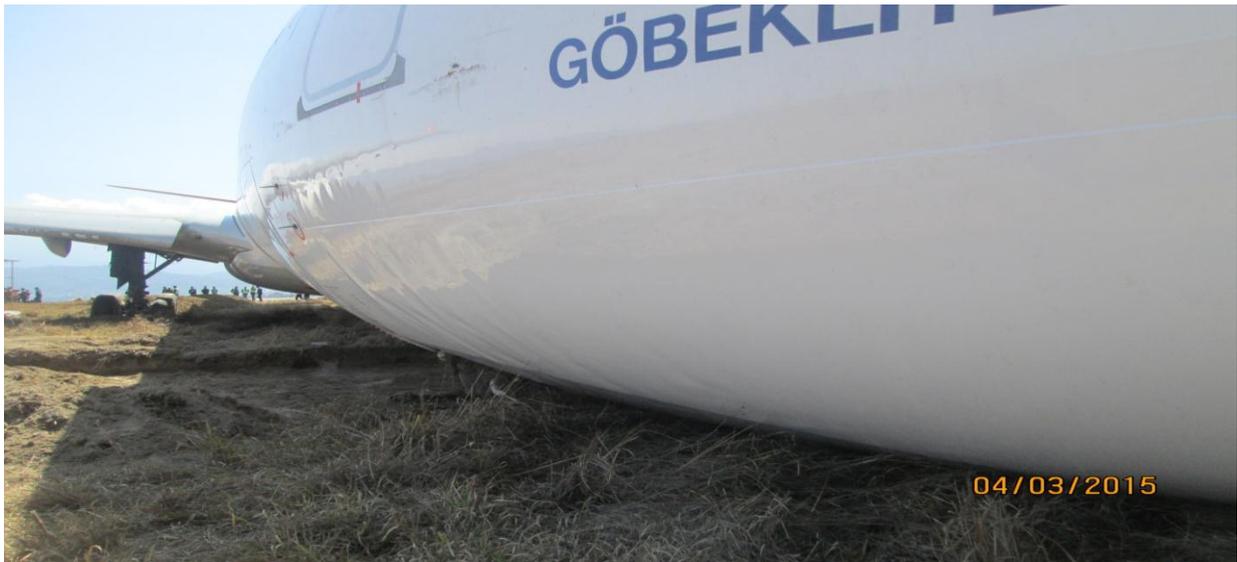
Wrinkles in the Body of the Aircraft

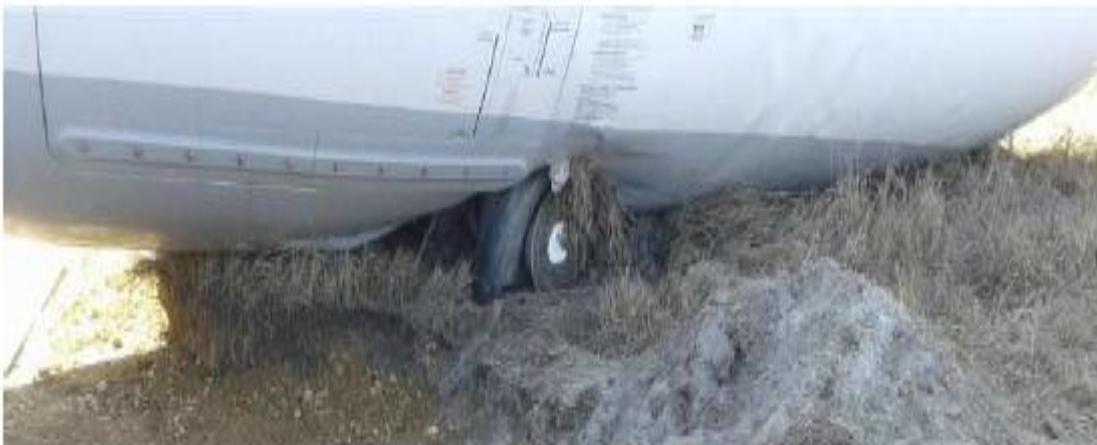
The NLG separated from aircraft (RH hinge pin sheared off):

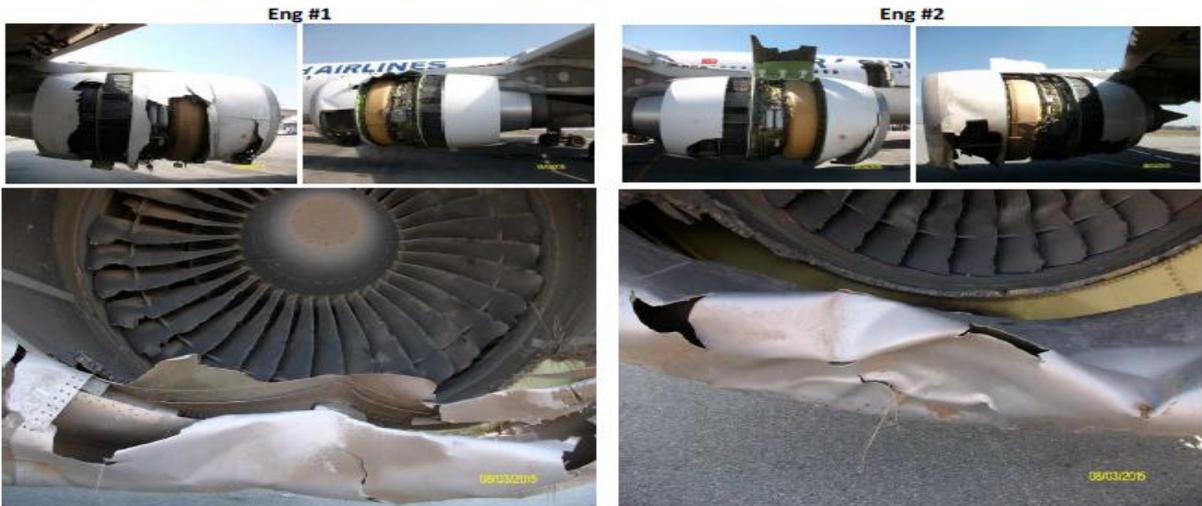
Inlet, fan and reverse cowls were sheared off on both Engines:

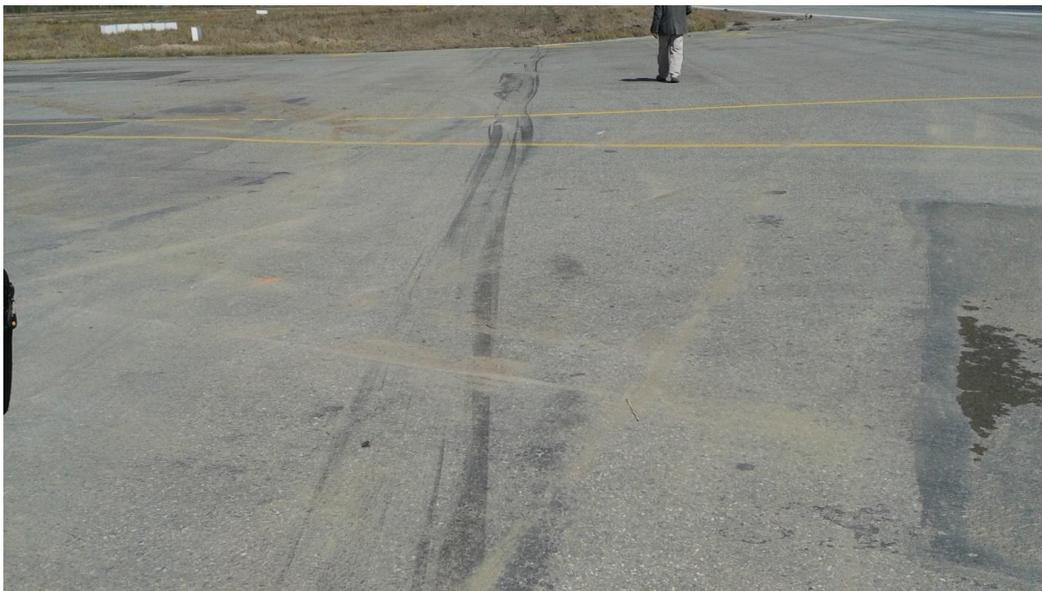
Right Landing gear Marking on the Runway just before entering into the grass area

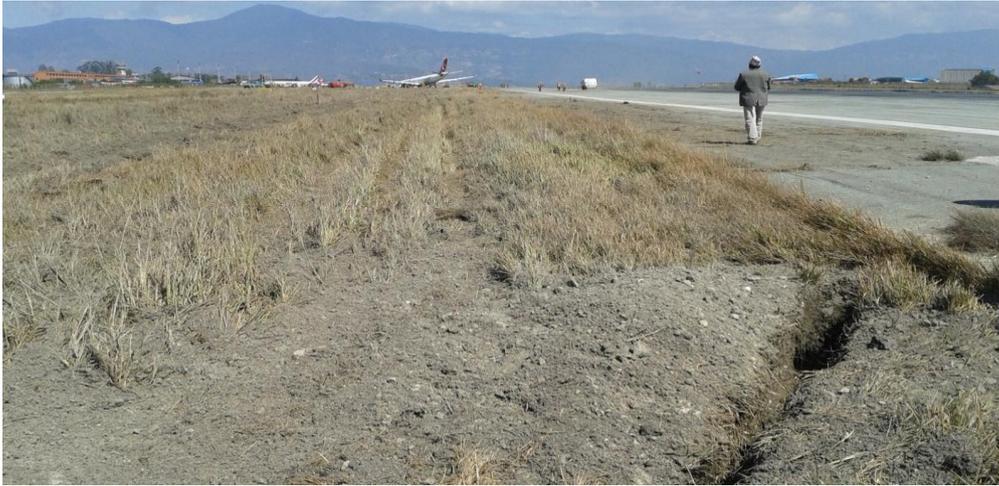
Both Landing Gears of aircraft rolling outside the runway in Grass area

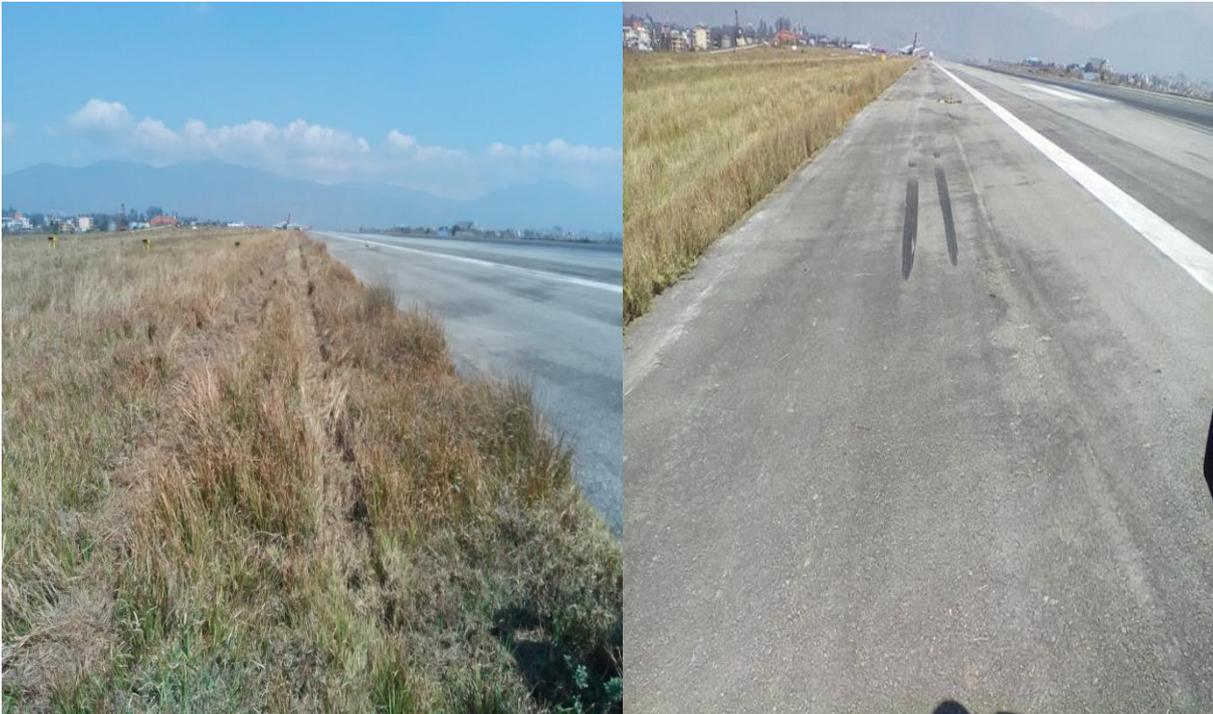
Initial touchdown of the right landing gear was 21.6 meters left from the runway centre line while the left landing gear was 32.1 meters left from runway centre line which was on unpaved field (grass field). The grass field was soft due to rain on previous day and night. The initial aircraft rollout after touchdown was with the right hand and nose landing gears on the paved runway and left landing gear on unpaved soft grass field. The maximum vertical acceleration recorded on the flight data recorder at touchdown was approximately 2.7G, so it was hard landing. The aircraft pitch at touchdown was 1.8 ° nose up.

Due to the soft and muddy grass field, the left landing gear dug into the grass field and the aircraft veered toward the left. Initial touchdown mark of wheels and grass field dug by left landing gear is shown below.

Initial touchdown points of Left and Nose landing Gears

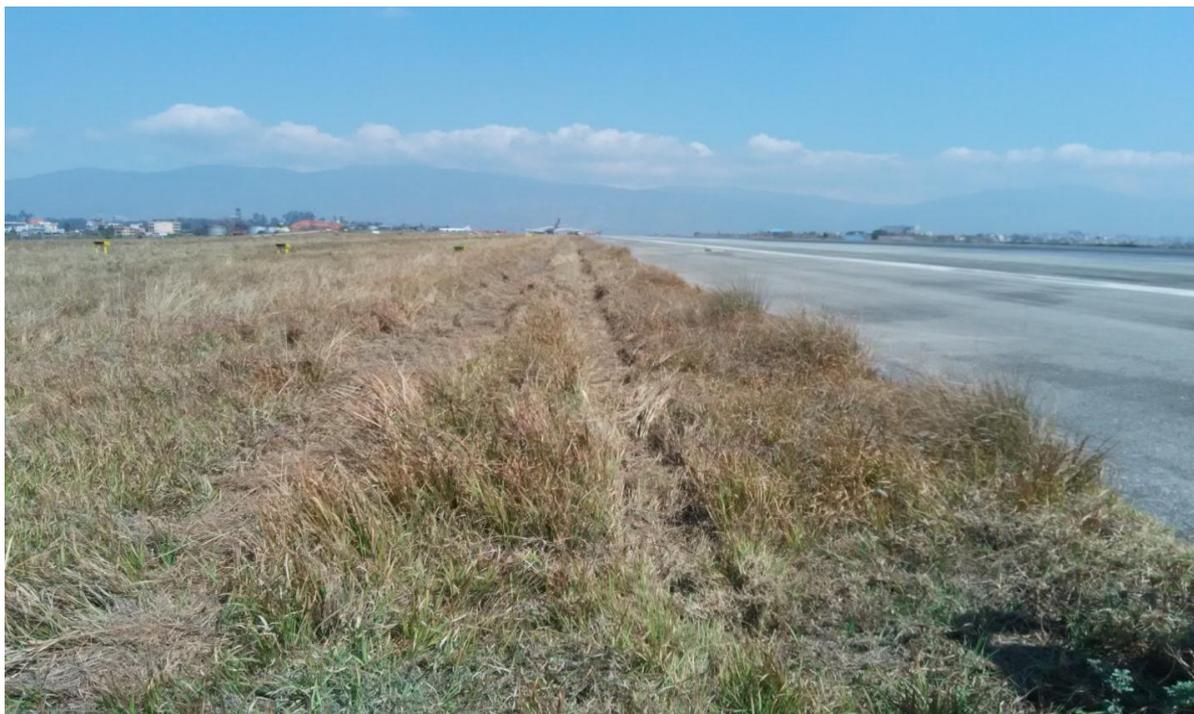
Initial touchdown point of left landing gear

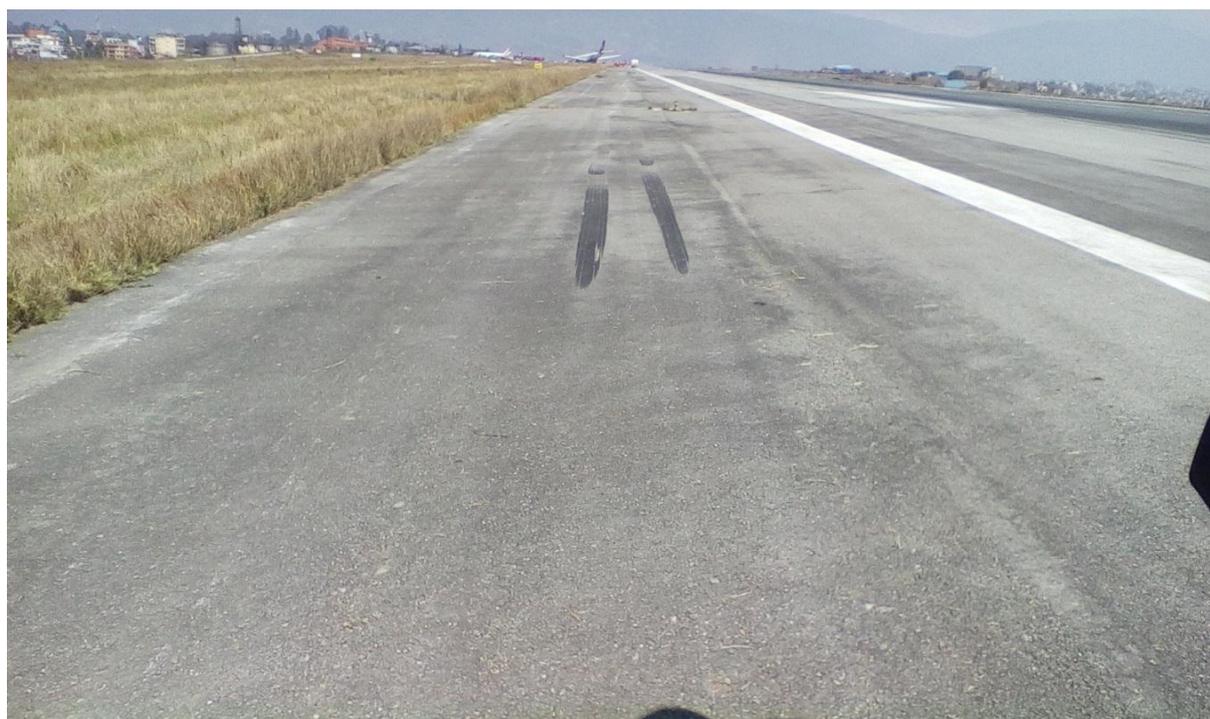
Initial touchdown point of Nose landing gear.

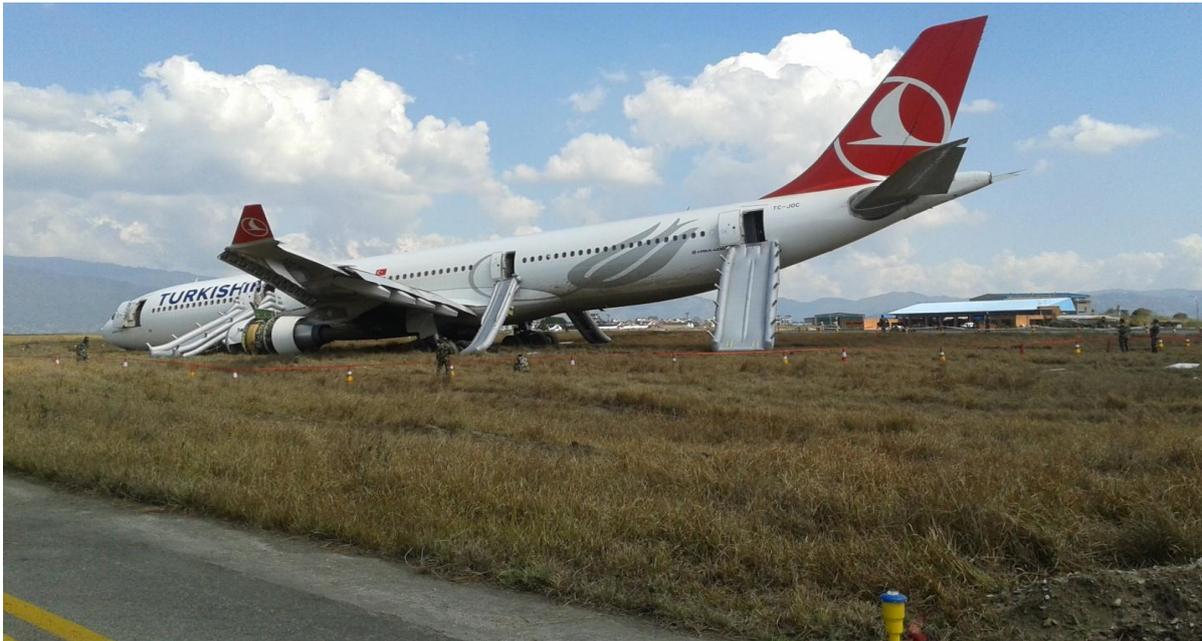
Aircraft Final position in the Grass area between Taxiway C and D

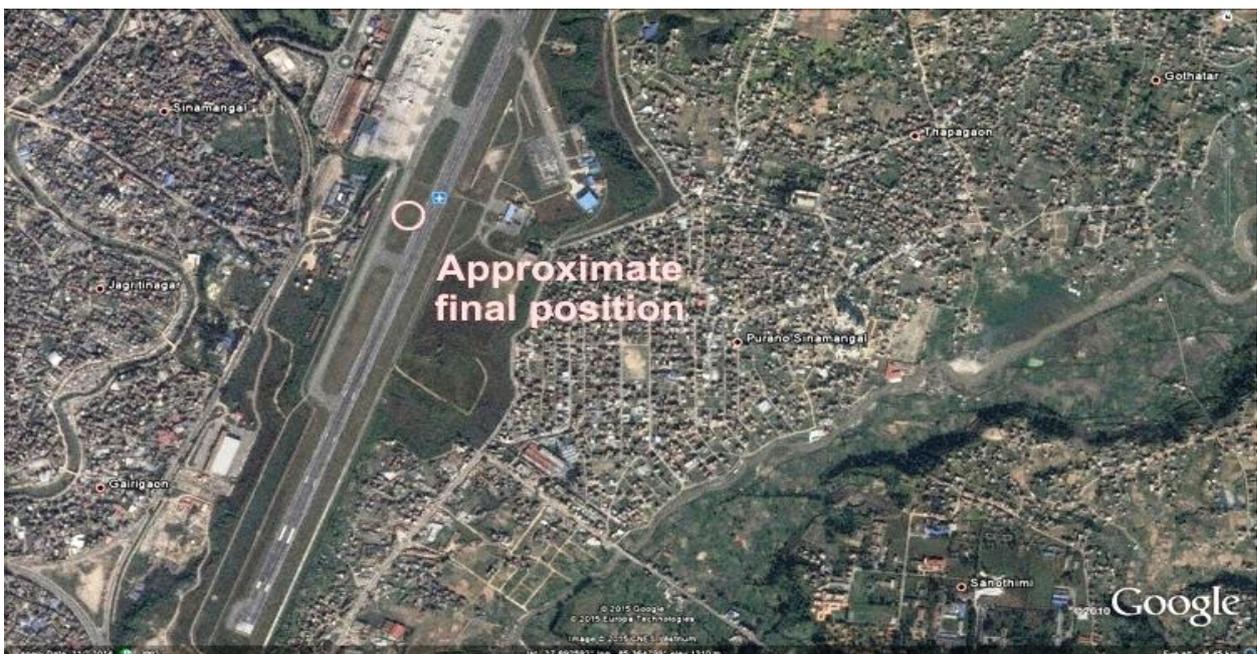
The nose landing gear entered the grass field at 683.5 meter from the threshold of Runway 02 and right landing gear entered the grass field at 872.5 m from the runway threshold. While crossing the taxiway "D" the nose landing gear collapsed and the forward part of the fuselage started dragging on the grass field. Both engines touched on the ground. The aircraft halted at the position in-between taxiway "D" & "C". There was substantial damage to the aircraft and engines. The passengers and crew were safely evacuated using emergency evacuation system of aircraft with the assistance of fire and rescue team. Fire did not occur on the aircraft.

Aircraft halted position

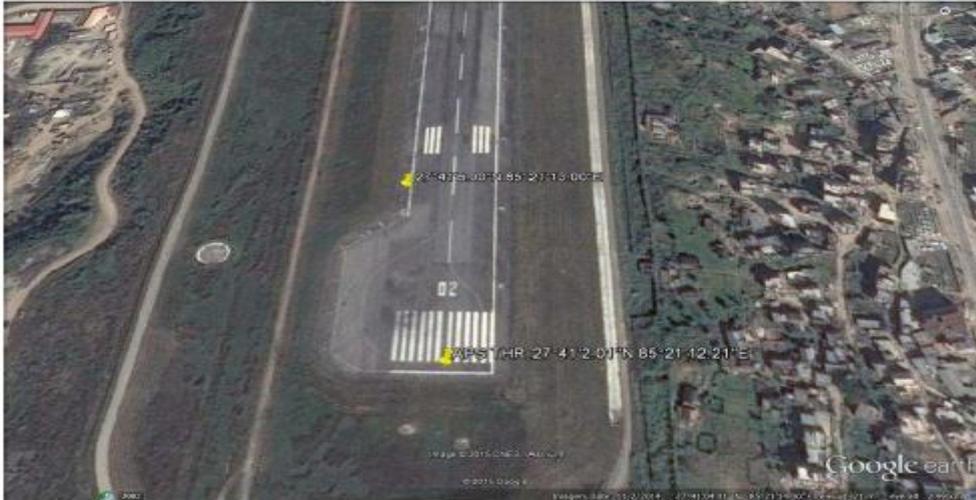
However, it appears that the coordinates of the displaced threshold were not on the runway centreline, but offset from about 26m on the left of the runway centreline. Below plot shows comparison between previous runway threshold coordinates with AIP supplement's based on Google Earth.
