Air Accident Investigation Unit Ireland

FACTUAL REPORT

**Boeing, 737-8AS, EI-DWE & EI-DYA
Taxiway LINK 2/F1, Dublin Airport, Ireland**

1 April 2015

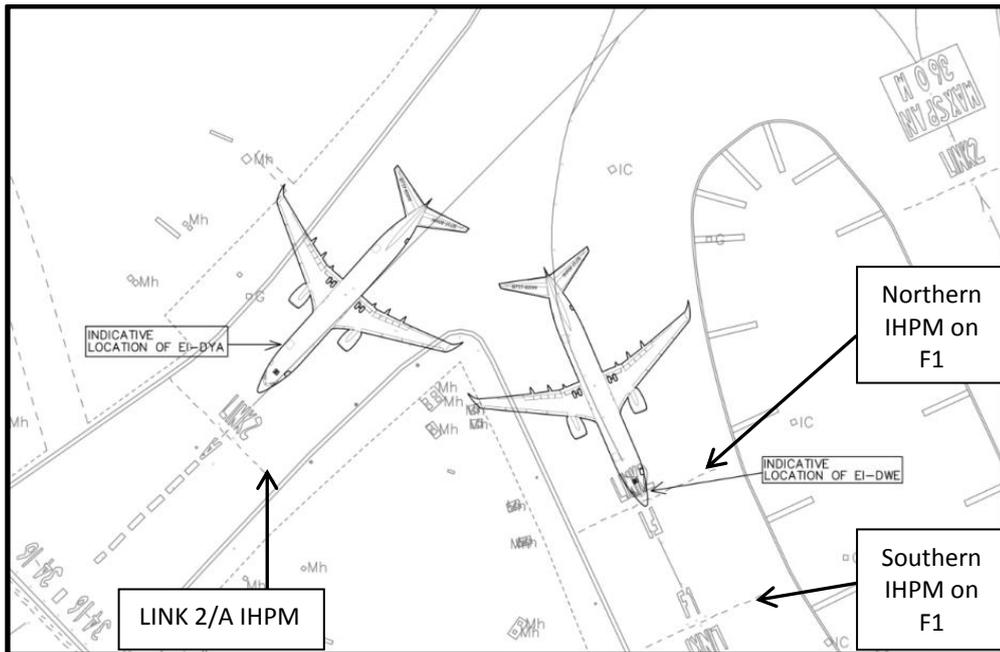
The first aircraft, EI-DWE, was found in its original parked position on LINK 2 with the nose wheels approximately 3.3 metres (m) short of the northern Intermediate Holding Position Marker (IHPM), delineating the start of TWY F1, with its nose tip protruding slightly into TWY F1 (**Figure No. 2**). The nose wheels were approximately 0.2 m left of the taxiway centreline.

The second aircraft, EI-DYA, was found a short distance (approximately 5 m) from its first point of contact with EI-DWE. The aircraft was positioned over the inbound STOPBAR lights for TWY Alpha/LINK 2 and was approximately 12.2 m short of the IHPM between LINK 2 and TWY Alpha. The nose wheels were approximately 0.7 m to the right of the taxiway centreline (**Figure No. 2**).

Figure No. 2: Final position of both aircraft, post impact

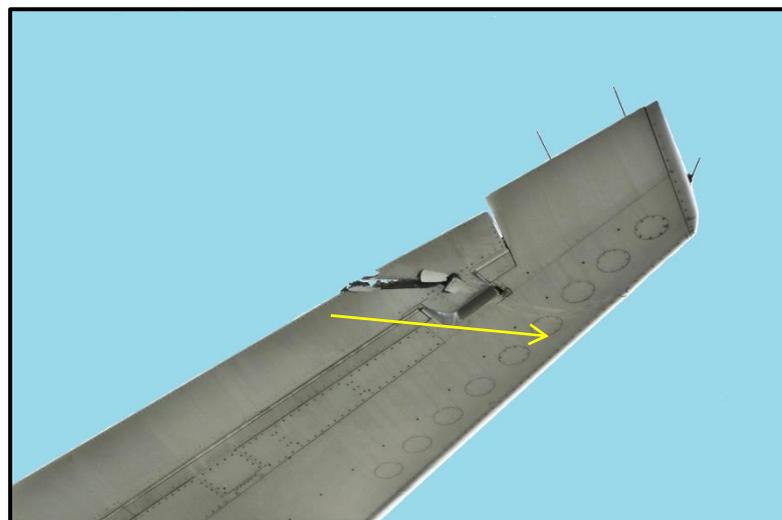
The tip section of the port side winglet of EI-DYA struck the outer portion of the starboard elevator of EI-DWE, causing substantial damage to the elevator. As EI-DYA continued forward, the tip then sheared from the main part of the winglet once it had reached the hinge point of the elevator of EI-DWE. The underside of the horizontal stabilizer of EI-DWE suffered scuff and scrape marks on its lower surface, as a result of the stub of the winglet remaining in contact with the aircraft structure as EI-DYA continued forward. Both the winglet of EI-DYA and elevator of EI-DWE were subsequently replaced.

Photo No. 1: Underside of right elevator of EI-DWE showing damage and scuff marks. Arrow indicates direction of travel of EI-DYA's Winglet.

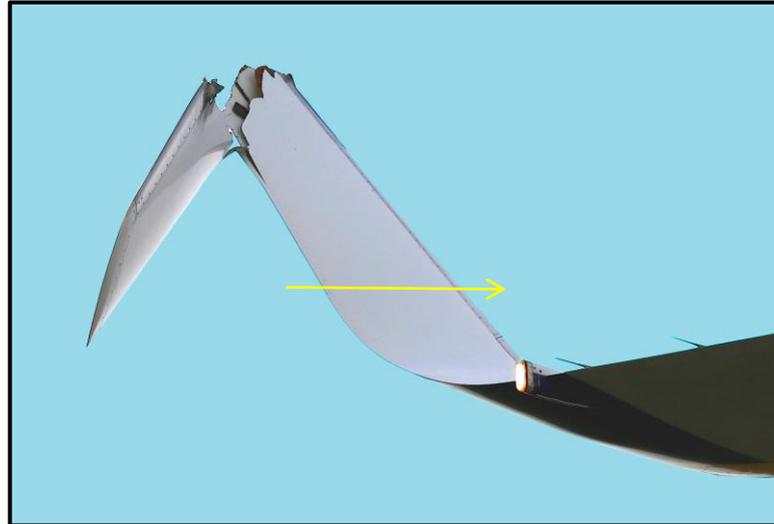
Photo No. 2: Left Winglet of EI-DYA showing damage to top section. Arrow indicates direction of travel.

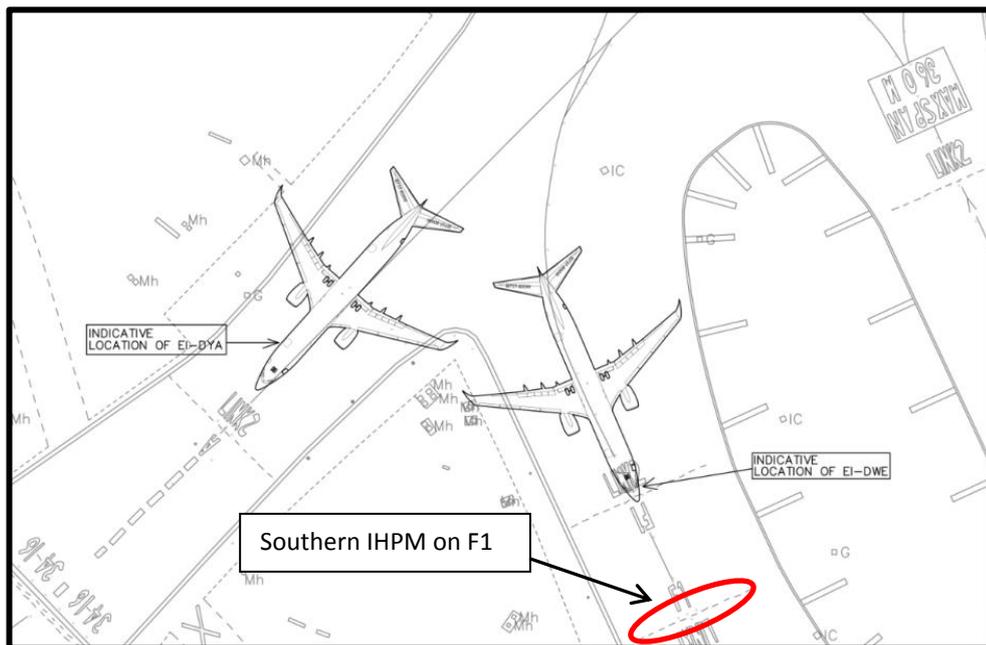
The first aircraft, EI-DWE, was found in its original parked position on LINK 2 with the nose wheels approximately 3.3 m aft of the northern Intermediate Holding Position Marker (IHPM), delineating the start of TWY F1 and with its nose tip protruding slightly into TWY F-1 (**Figure No. 3**). The nose wheel(s) were approximately 0.2 m left of the taxiway centreline. The left hand main wheels were approximately 3.3 m to the left side of the taxiway centreline, and the right hand main wheels were approximately 1.1 m to the right of the centreline as the aircraft tracked to complete the turn onto the centreline.

Figure No. 3: Approximate final position of both aircraft post collision

The second aircraft, EI-DYA, was found a short distance (approximately 5 m) from its first point of contact with EI-DWE. The aircraft was positioned over the inbound STOPBAR lights for TWY Alpha/LINK 2 and was approximately 12.2 m short of the marked demarcation line between LINK 2 and TWY Alpha. The nose wheel(s) were approximately 0.7 m to the right of the taxiway centreline. The right hand main wheels were approximately 4 m to the right of the taxiway centreline, whereas the left hand main wheels were approximately 0.5 m to the left of the centreline.

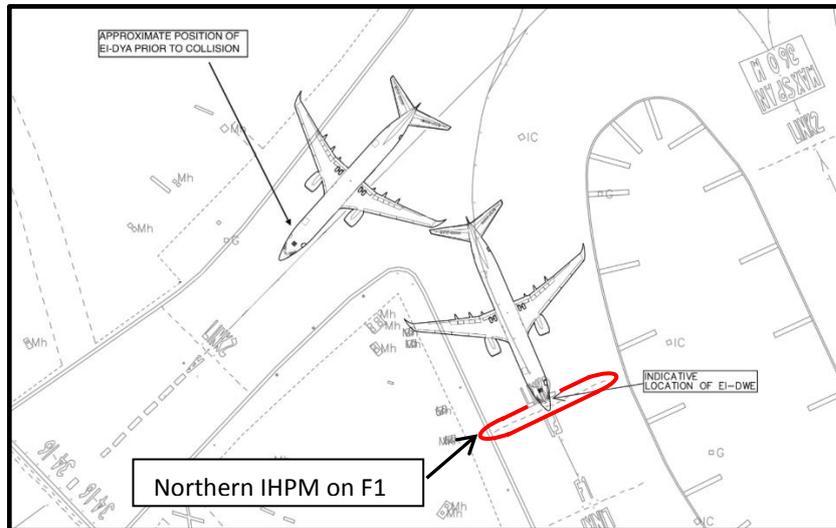
Figure No. 4 depicts, for indicative purposes only, the approximate position of both aircraft at the time of collision.

Figure No. 4: Approximate position of both aircraft at collision

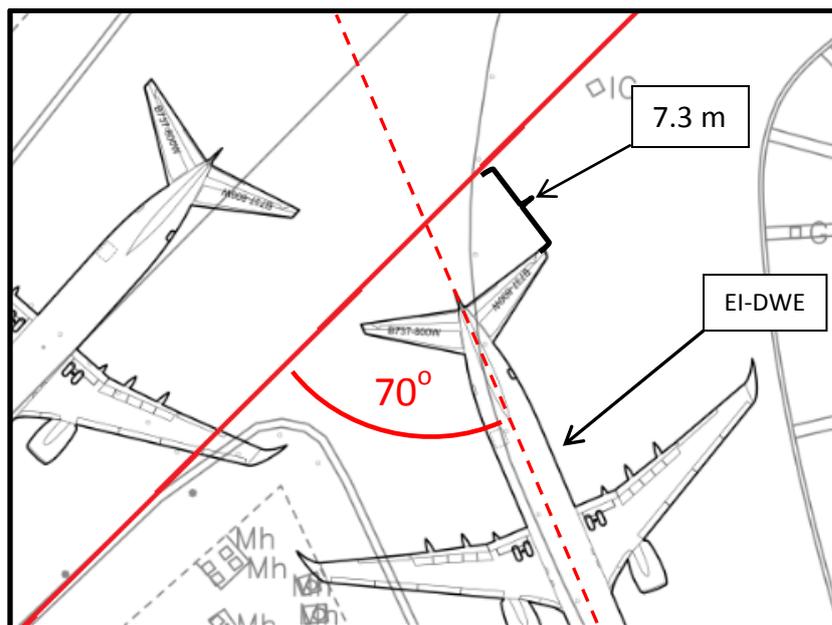
Figure No. 5 shows the disposition of EI-DWE relative to TWY LINK 2. The centreline of the aircraft was at an angle of 70° to the southern edge of TWY LINK 2. Consequently, the tip of the left-hand elevator was just over 19 m beyond the taxiway centreline of LINK 2. This placed the elevator approximately 7.3 m beyond the southern edge of TWY LINK 2. This would have been sufficient for a B737-8AS to pass. Due to the geometry of the empennage, the tip of the right-hand elevator was approximately 13.5 m beyond the centreline, and therefore only approximately 1.7 m beyond the southern edge of TWY LINK 2. This would not have been sufficient for a B737-8AS to pass.

Figure No. 5: Geometry of Empennage of EI-DWE relative to TWY A

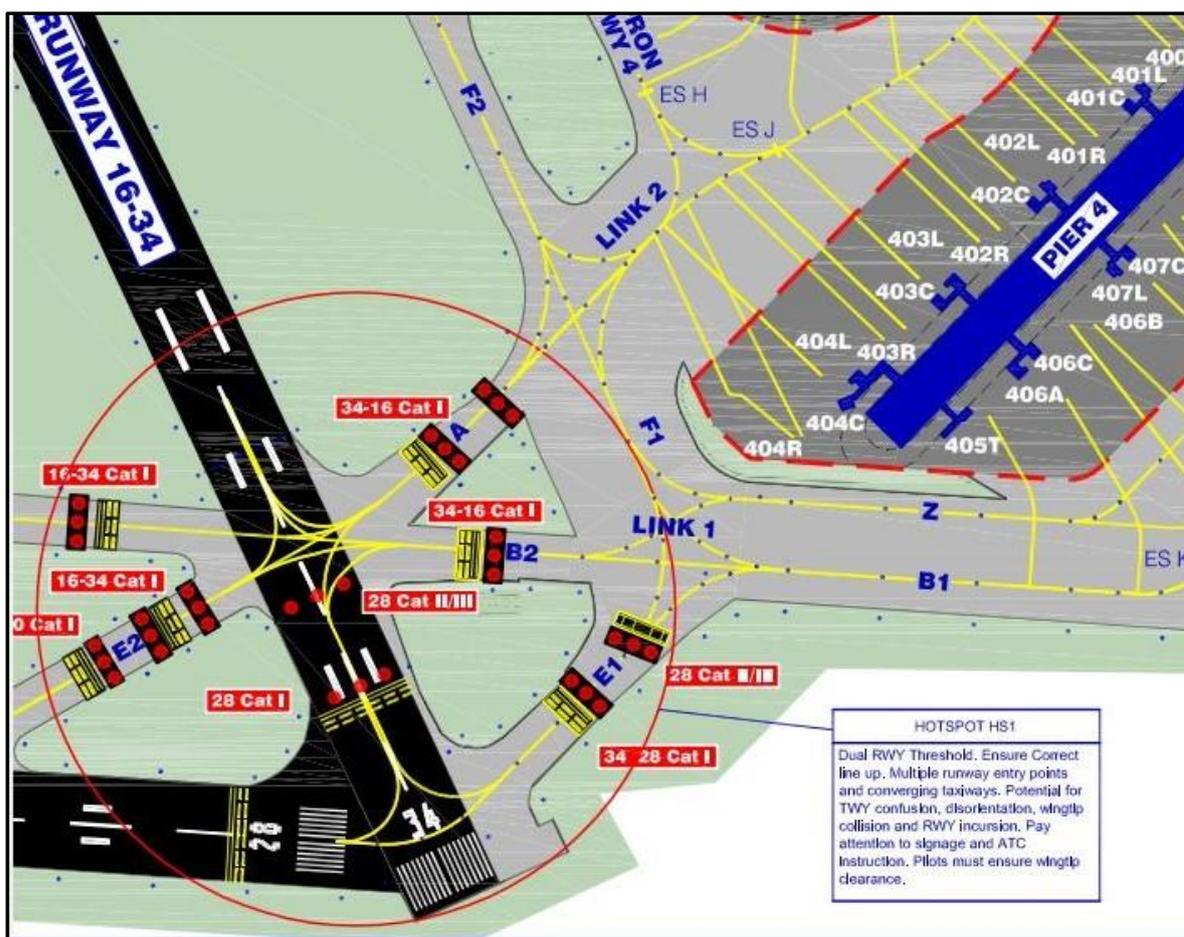
Figure No. 6: IAIP Chart showing realignment of TWYs F1 and F2

Figure No. 6, below, is an extract from EIDW Aircraft Parking/Docking Chart published in the Irish Integrated Aeronautical Information Package dated 12 November 2015, showing new location of taxiway F1. Text pertaining to Hotspot HS1 includes warnings on wingtip clearance.
