**AIRCRAFT ACCIDENT
INVESTIGATION REPORT**

**ASIANA AIRLINES, INC.
HL 7762**

**ASIANA AIRLINES, INC.
AIRBUS A320-200, HL7762
COLLISION WITH
THE AERONAUTICAL RADIO NAVIGATION AIDS
CAUSED BY UNDERSHOOTING
HIROSHIMA AIRPORT
AT 20:05 JST, APRIL 14, 2015**

November 18, 2016

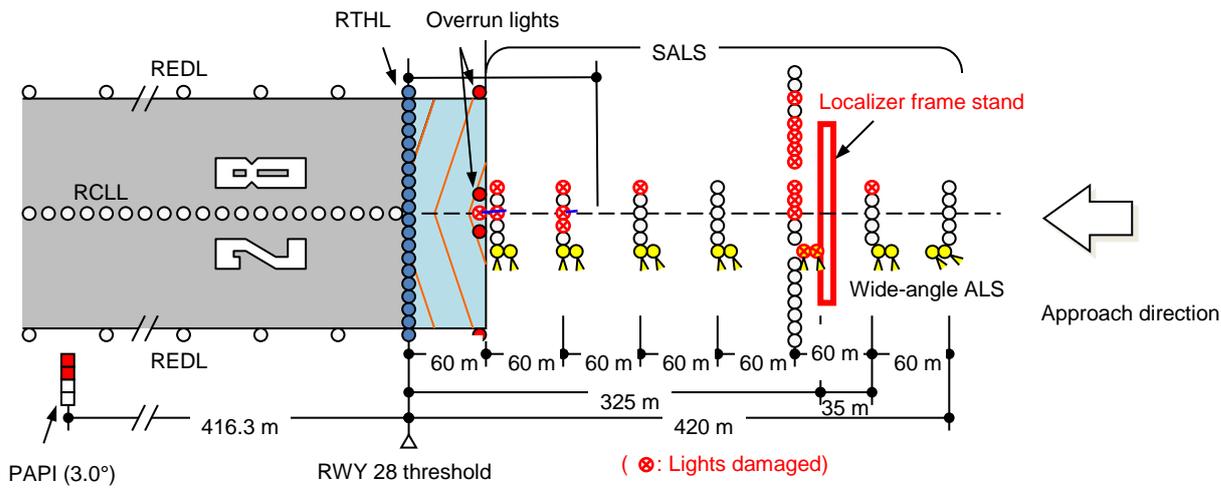
Figure 3: Aerodrome Lightings at RWY 28 Side

As shown in Figure 3, quite number of lights of SALS of RWY 28 were damaged: one of the five cross-bar lights at 360 m in front of RWY 28 threshold, eight of 21 cross-bar lights at 300 m, one of five cross-bar lights at 180 m, three of five cross-bar lights at 120 m, and two of five cross-bar lights at 60 m were damaged; accordingly, many of the poles of those lights were damaged. The two Wide Approach Lights^{*45} at 300 m in front of RWY28 threshold and one of overrun area edge lights (ORL) in RWY 28 were damaged.

Other than those, one RCLL (embedded type) at 465 m from RWY 28 threshold and one REDL in the south edge at 1,140 m from it were damaged.

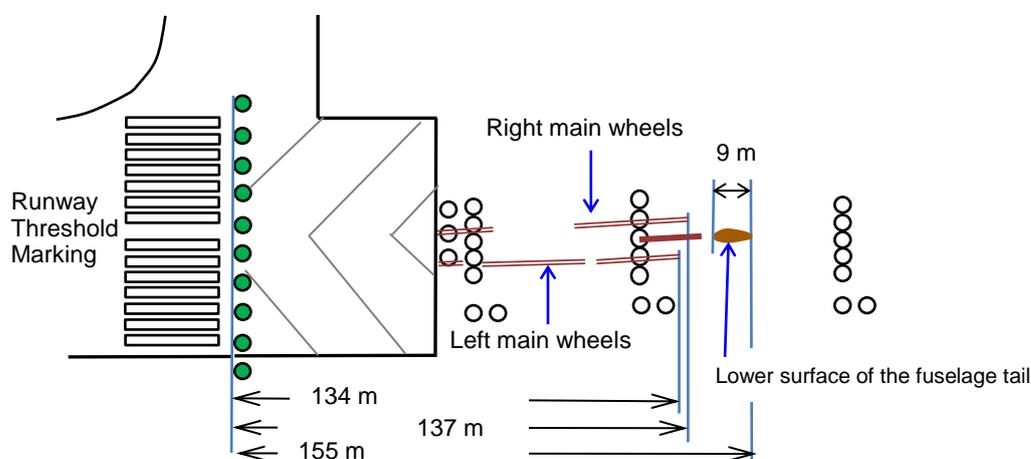
Figure 6: Traces in front of RWY 28 Threshold

around 150 m in front of RWY 28 threshold and there was a trace of painting of the Aircraft. The forward from there had been left traces of both main landing gears when the Aircraft landed, (the right one touched down slightly prior to the left one) continuously stretched to the overrun area of RWY 28. These traces continued to the slightly south from the runway track of 277°. Some lightings of the ALS near the grounding position and the overrun area, and lightings in the overrun area were damaged. A trace of the right main wheels stretched to and were heading to the runway through the centerline of the overrun area.

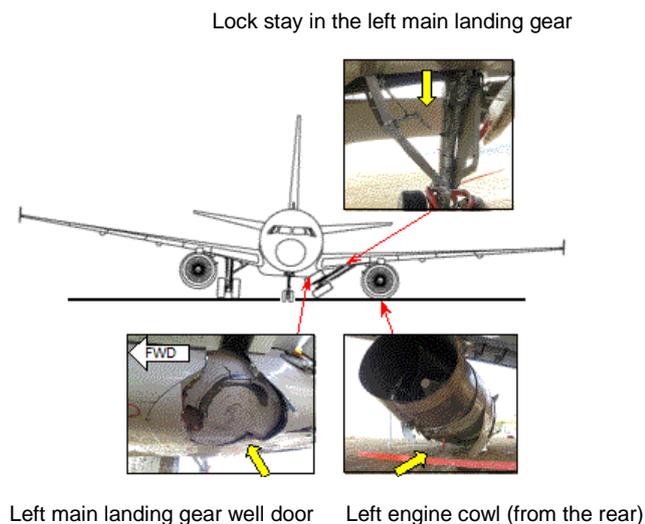
Figure 14: Appearance during Proceeding and the Damage

As mentioned above, the Aircraft finally came to a stop in the state of all landing gears extended nevertheless the left main landing gear did not fully extended. Judging from dug traces just in front of the stopped position, it is probable that the Aircraft, when proceeding on the grass area after veered off the runway, was gradually changing the direction to the left with skidding and the left engine was forced to bounce by the scratch resistance, then, from the reaction of its bouncing, the left main landing gear was temporarily allowed to extended and touched the ground there as it was when came to stop.

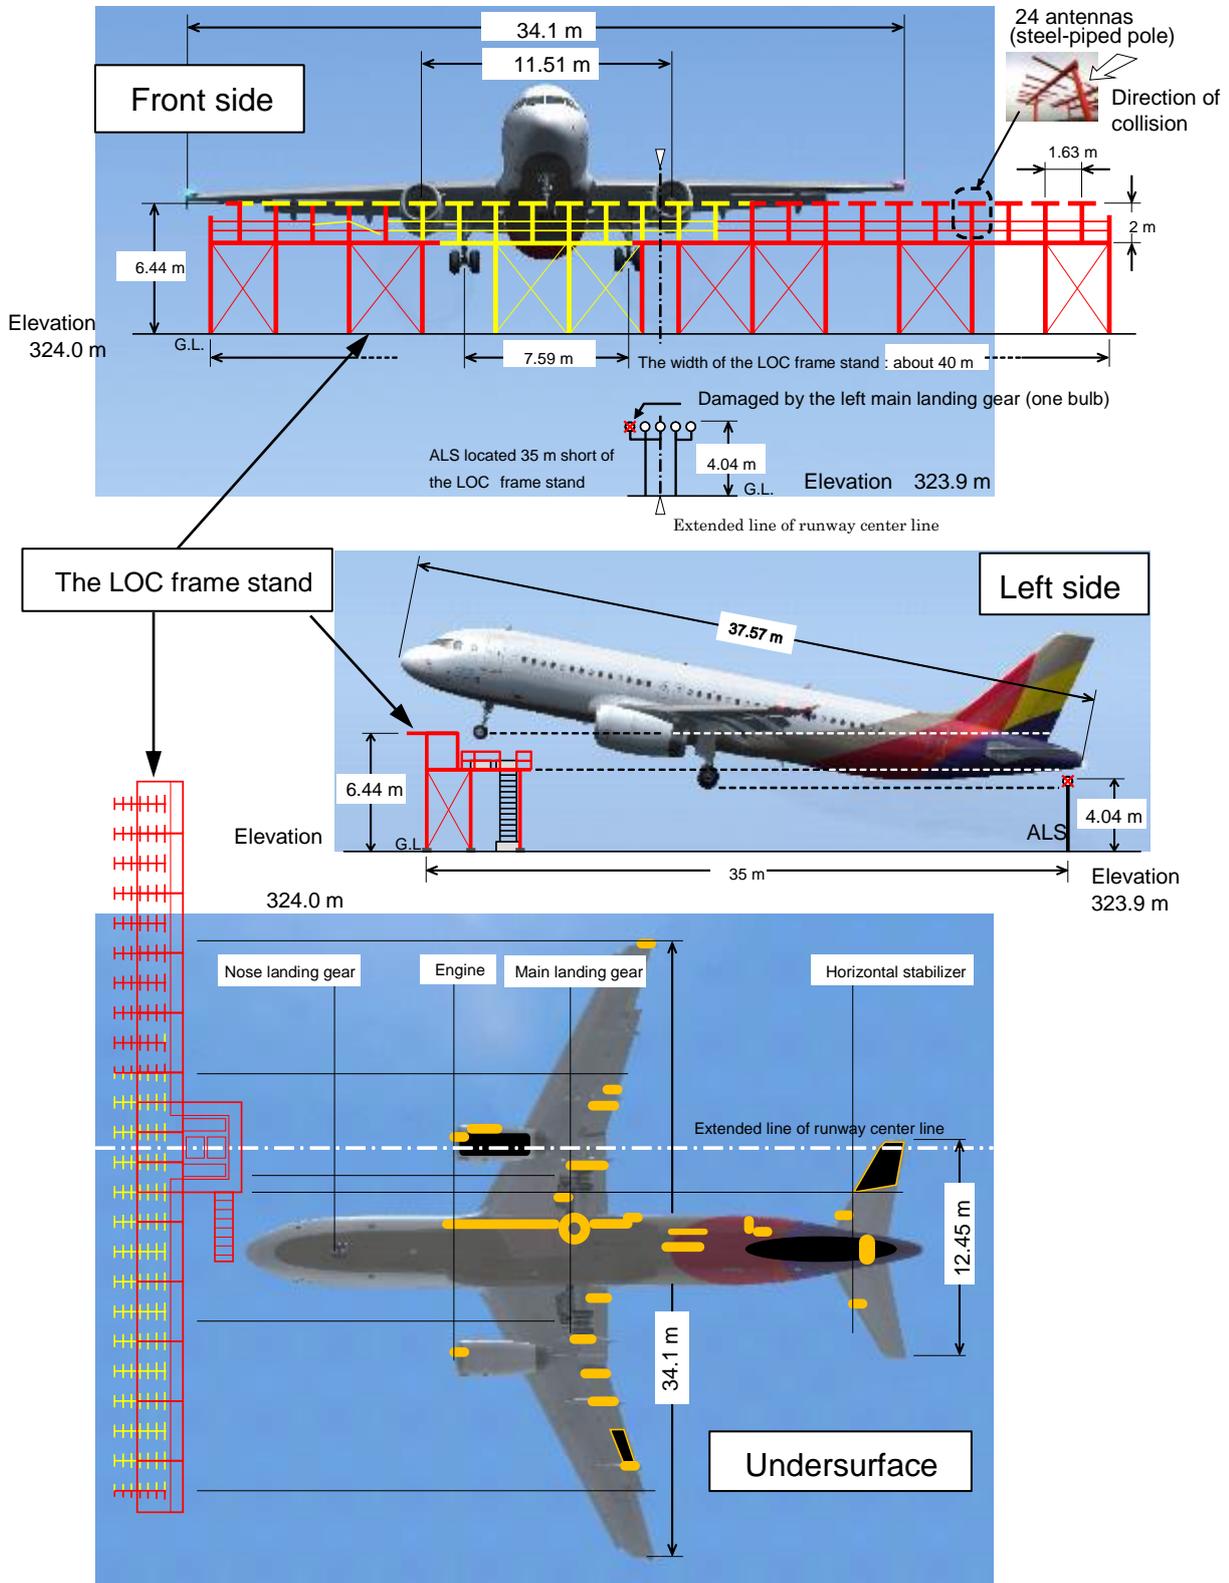
Appended Figure 4: Situation of Collision and the Parts Damaged

Light of SALS (15) and their poles	Damaged
Lights of wide-angle ALS (two) and their poles	Damaged
Runway edge light, runway centerline light and overrun area edge light	Damaged

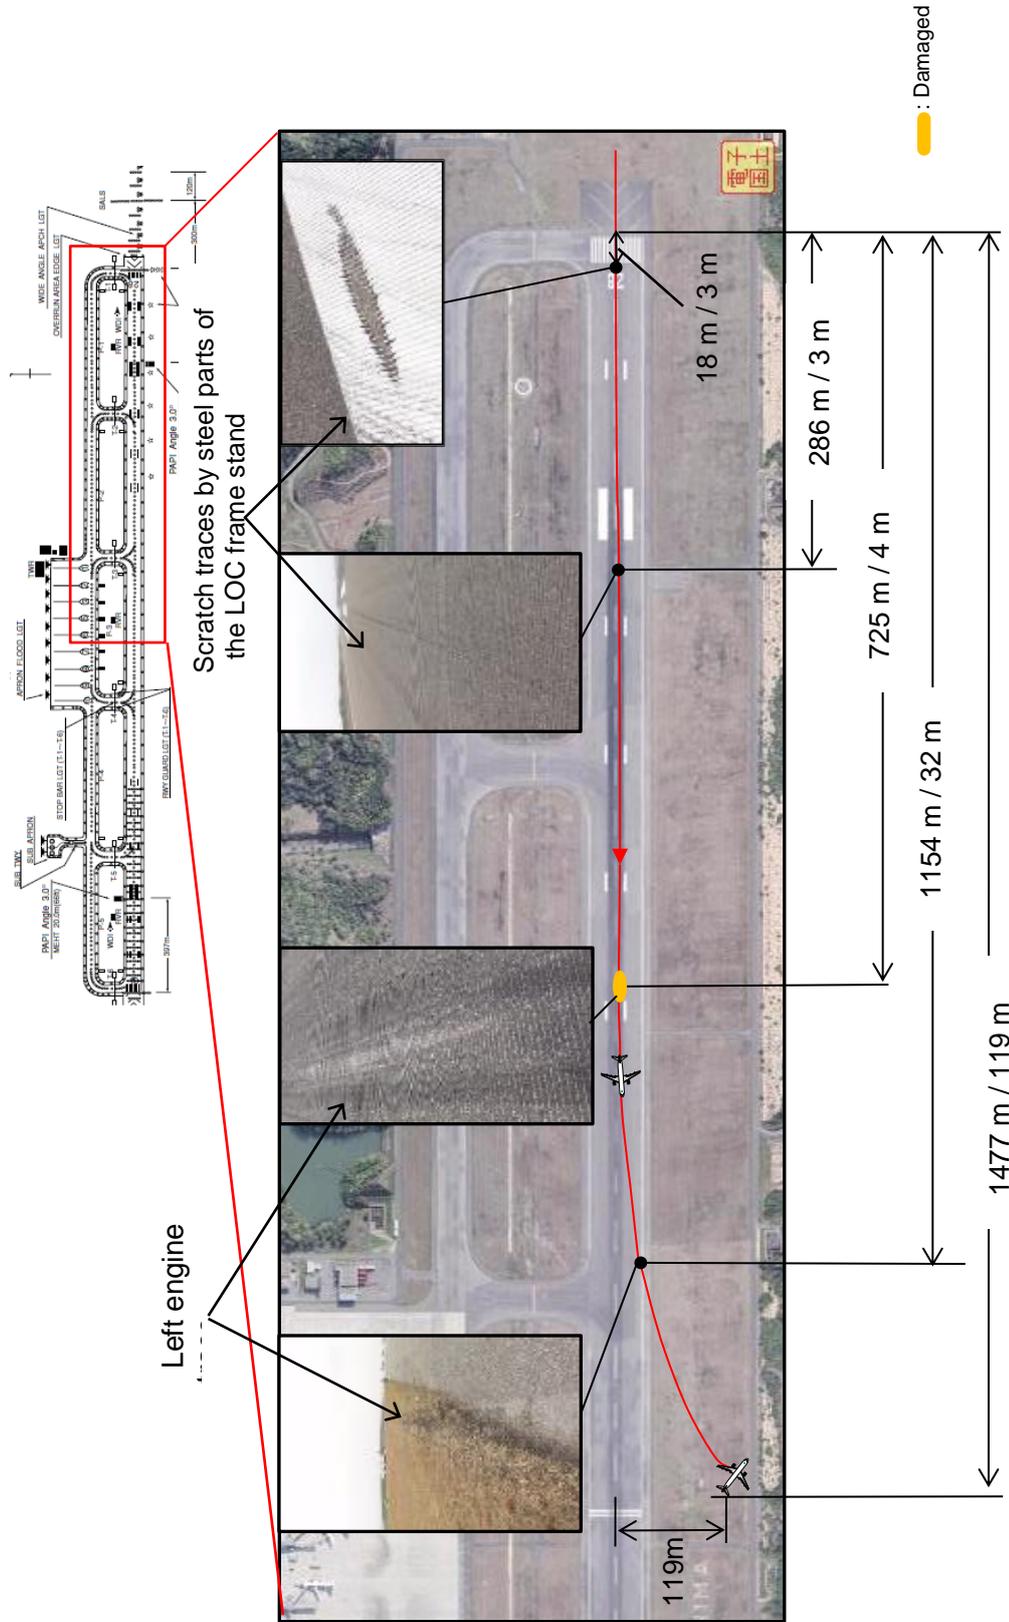
Appended Figure 5 Track and Traces on the

On the runway, there were several deep scratches and some debris of cables equipped with the LOC frame stand, aerodrome lightings and parts of the Aircraft and others were also found. Some steel parts of the LOC frame stand were there around the position of 500 m from RWY 28 threshold.

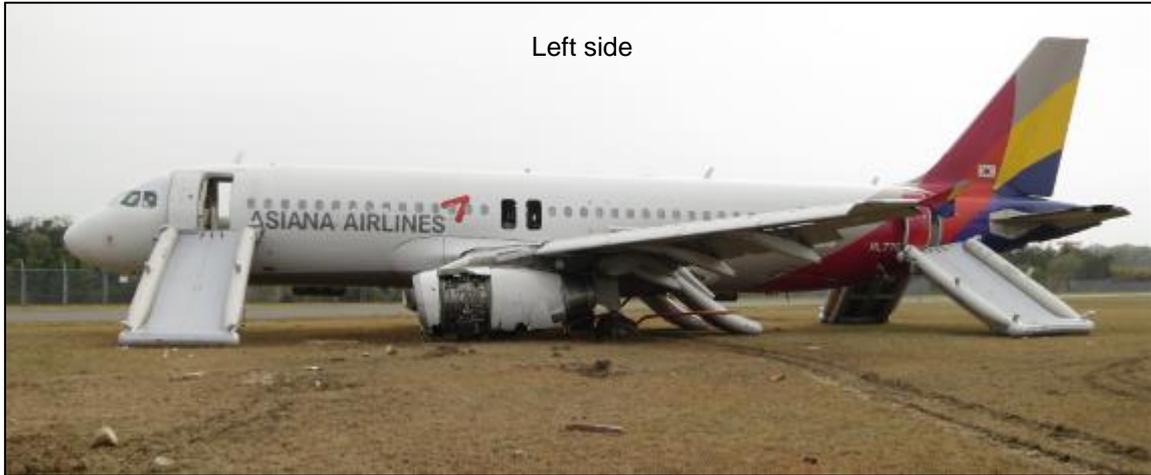
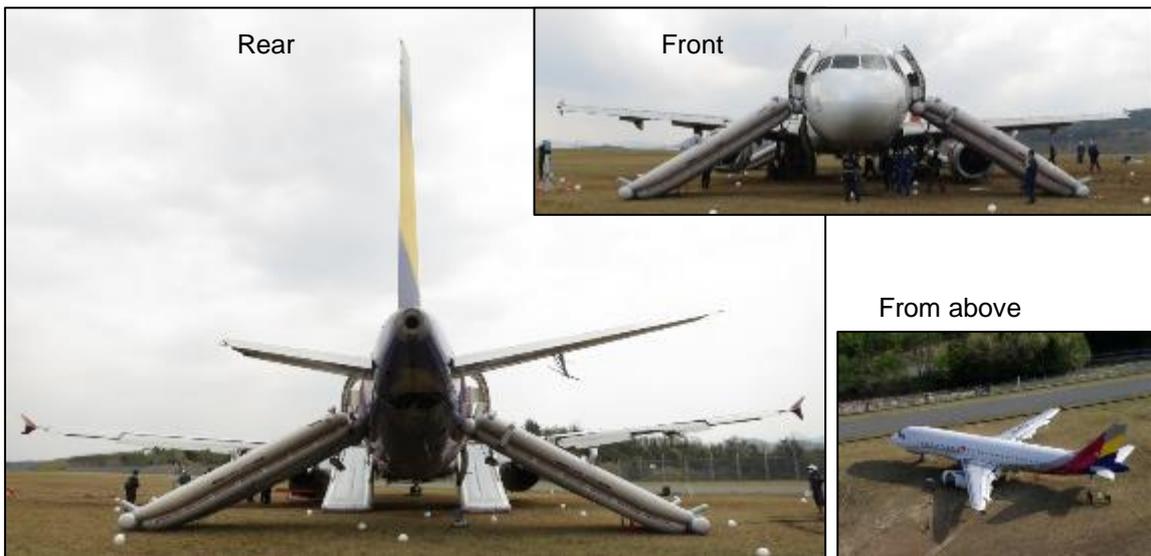
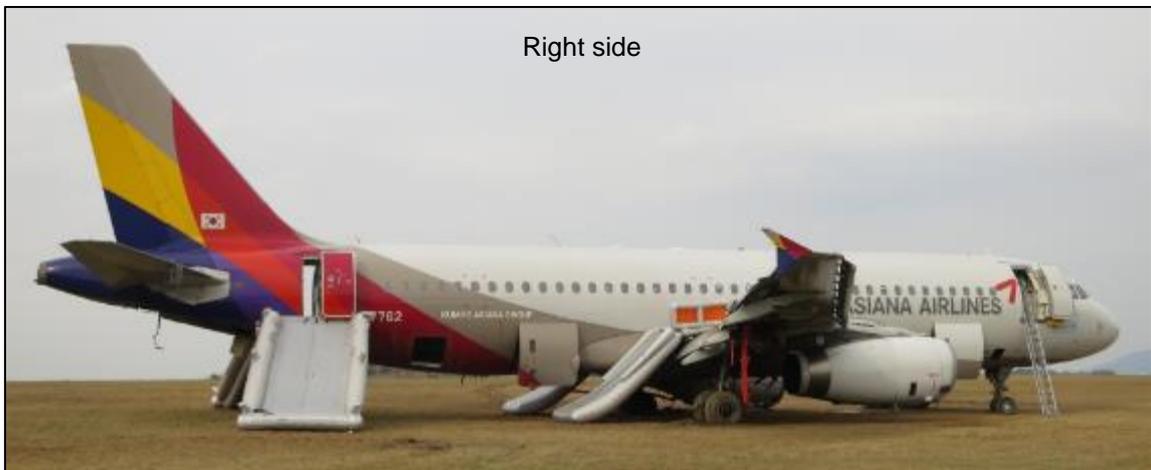
Photo 1: The Aircraft

The Aircraft was substantially damaged.

Fuselage:	Lower surface, Side surface and Tail:
	Broken extensively from around the center portion to the tail
Wing:	Flaps: Broken, partly fractured in right flap
	Left wing tip: Damaged
Main landing gears:	Both landing gears: Damaged

Gear well door and gear lock stay of the left main landing gear:	Broken
Engines:	Both engines and LH pylon:	Significantly Damaged
	Both engine cowls:	Damaged
Horizontal stabilizers:	Left horizontal stabilizer:	Fractured from around the center (external part detached from the Aircraft)
	: Right horizontal stabilizer:	Damaged in leading edge

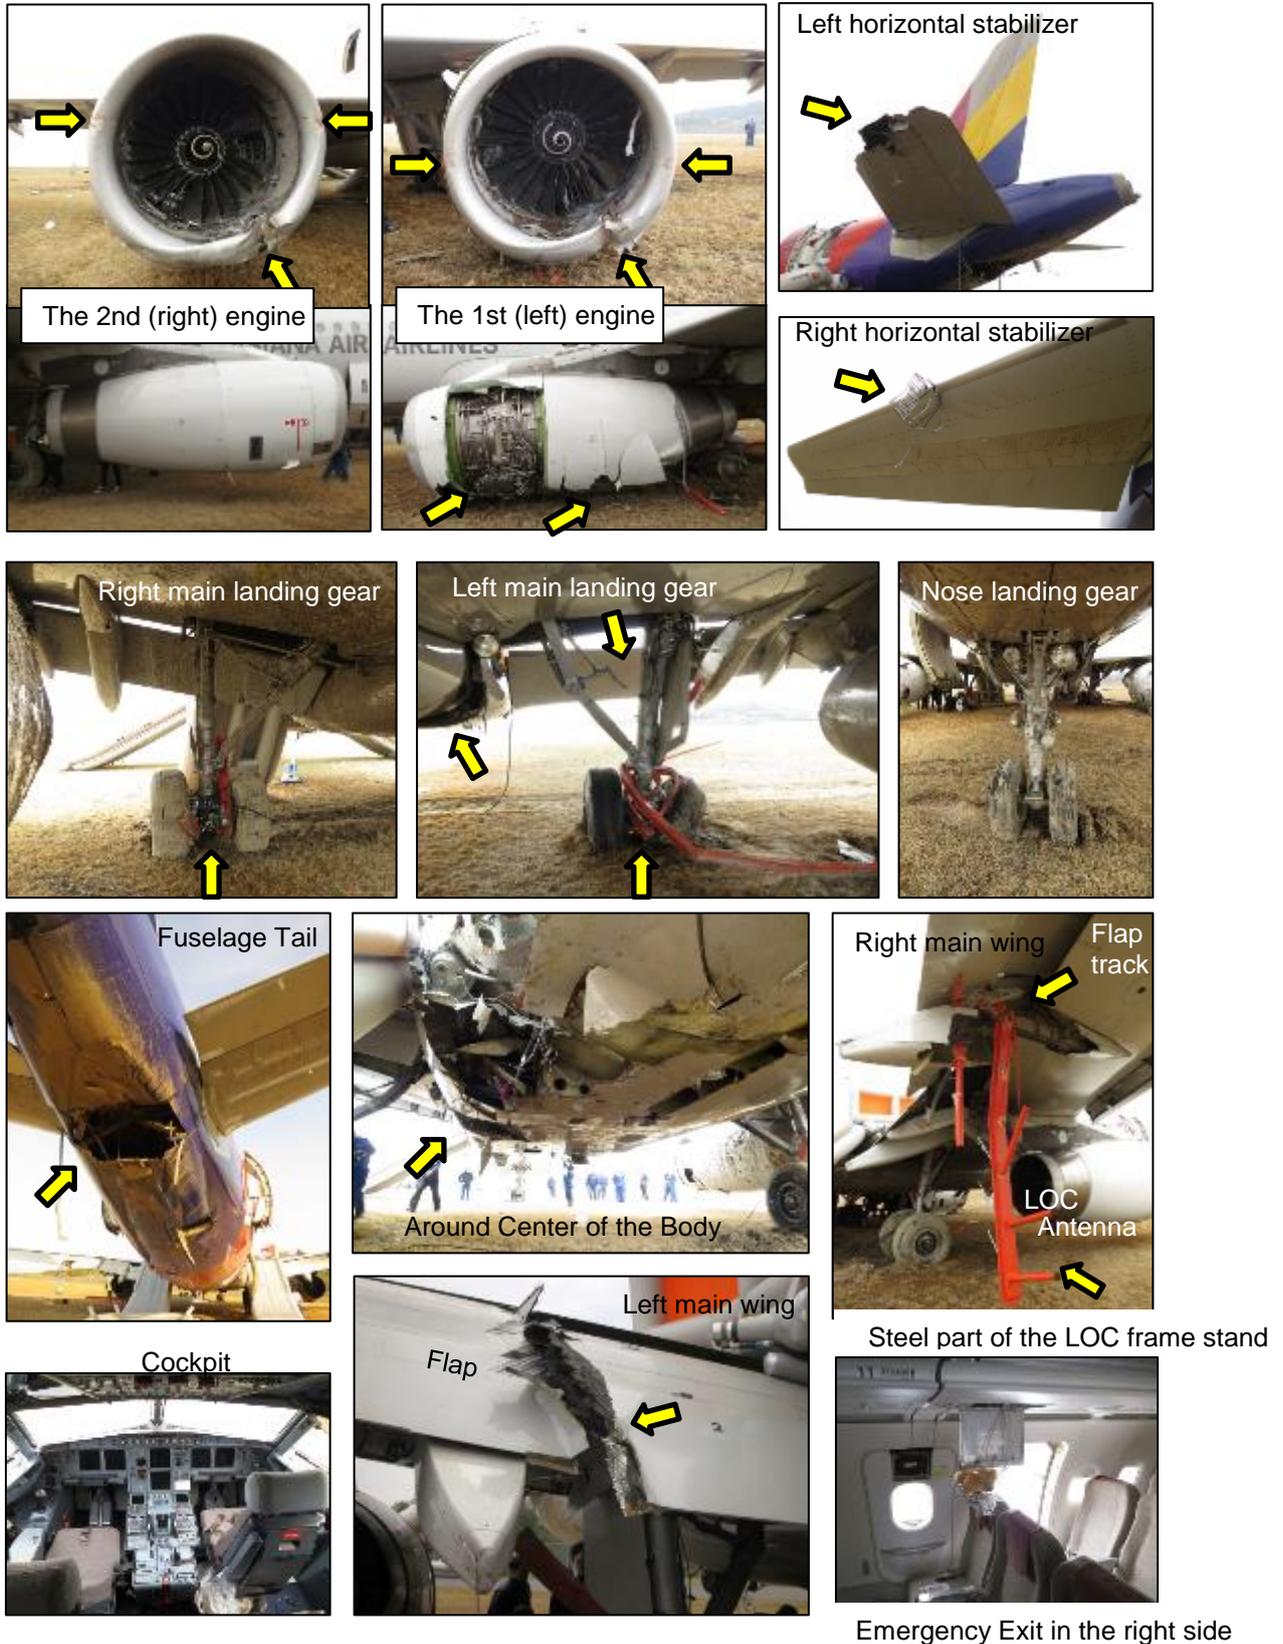
Photo 2: The Parts Damaged of the Aircraft

- There were considerable damages such as breakings, scratches, cracks, holes and dents.
- Electrical wirings were broken and damaged.
- The Aircraft Radio Altimeter antenna have been stripped out.
- Left side surface was damaged by a steel frame of the LOC frame stand stuck in.
- Some access doors were dropped off and damaged.

- Inboard and outboard of flaps and flap tracks were damaged.
- An outboard flap of right main wing was partially fractured, and a part of the LOC frame stand and antenna cables were wound around the right outboard flaps.

- Left main wing tip was damaged.

- Some steel frames of the LOC frame stand and the cables were wound around both main landing gears.
- Air-ground sensors of main landing gears were damaged and the electrical wirings of the gears were broken.

- Hydraulic lines (for brakes) were broken.
- Shock-struts of main landing gears were compressed to the bottom and had some cracks in the cylinders.
- Down-lock stay in the left main landing gear was broken. (Nose gears and the right main landing gear were secured in the down-locked position, while the left main landing gear was superficially extended nevertheless it was not secured in the down-locked position.)

- Gear well door of left main landing gear was damaged. Outside of it had a tire mark.
- Outboard tires of the left main landing gear was detached from the wheel and seriously damaged.

- Inboard tires of the left main landing gear rubber was peeled off.
- Inboard and outboard tires of the right main landing gear were damaged.

- There were some scars of impact with the LOC frame stand around the intake areas of both engines.
- Fan blades, low-pressure compressor blades and those circumferential parts in both engines were seriously damaged.
- The lower cowl of No. 1 (the left) Engine was seriously damaged.
- A left engine cowl of No.1 Engine was partially fallen off.
- The pylon of No. 1 Engine was damaged.
- The pylon of No. 2 (the right) Engine and its peripheral of the lower surface of the right main wing were blackened with soot.

- The left horizontal stabilizer was fractured.
- The leading edge of the right horizontal stabilizer was damaged. (Stuck with the steel frame of the LOC frame stand)

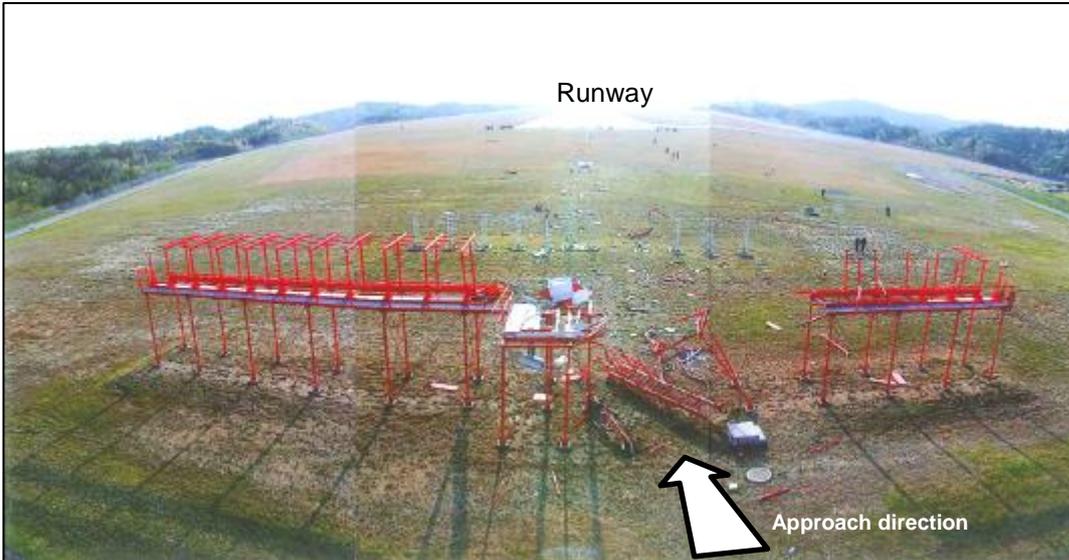
The LOC frame stand

A light of the ALS located at 360 m east from RWY 28 threshold had a damage and its post was twisted. The LOC frame stand, located at the position of 35 m from the ALS light closer to the runway, suffered from substantial damage of spreading to approximately 22 m width. Lots of debris of the localizer antenna and some parts of the Aircraft were scattered around in front of it (to the runway side).

Many of ALS lights and their posts located in front of the LOC frame stand were damaged as described in (5).
