UNITED STATES AIR FORCE
AIRCRAFT ACCIDENT INVESTIGATION
BOARD REPORT

AC-130J, T/N 09-5710

**413TH FLIGHT TEST SQUADRON
96TH TEST WING
EGLIN AIR FORCE BASE, FLORIDA**

DATE OF ACCIDENT: 21 APRIL 2015

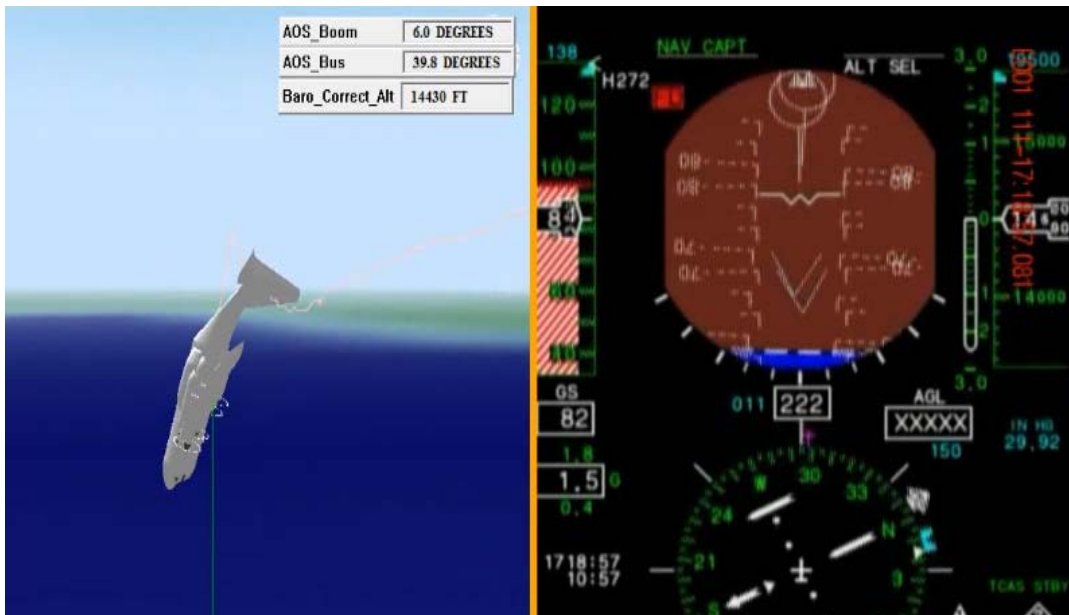
Figure 2

The MCP made several directive call outs to assist including “Nose down,” “Power out,” and “Let go, Let go” (Tab EE-8). The MA eventually inverted and recorded over 56° of sideslip although the instrumentation may be considered unreliable at those extreme conditions (Tab S-12). The MA violently dropped its nose, rolled and inverted (Tab S-12). The MP never applied corrective rudder (Tab S-12). Since only the left seat rudder pedals were instrumented, it is impossible to tell when or if the MCP began applying any corrective forces, but the rudder pedal position did not approach neutral or an “unlocked” state until 12:18:55L (Tab S-12). Just one second prior, the rudders were deflected to 55% of rudder pedal position (Tab S-12). The MP became distracted during the sequence of events when his checklist or some object from the cockpit hit him in the head and momentarily distracted him from recognizing the aircraft was recoverable Tab V-1.17).

The picture above is from animation produced by LM, created from flight data that shows the attitude of the MA and cockpit presentation after the MA went inverted during the departure (Tab S-12).

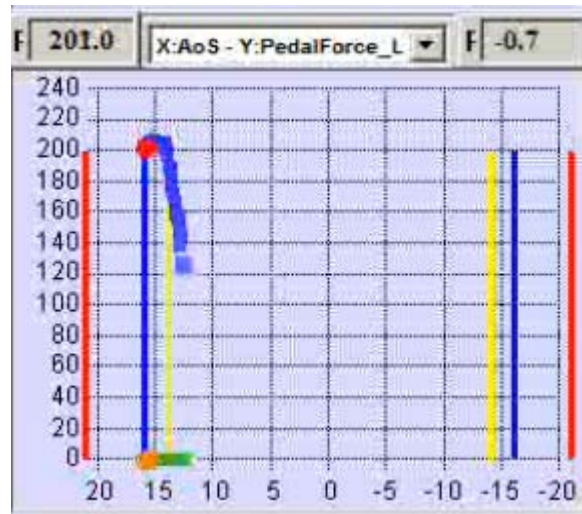
Test card 14 contained a table and chart that identified expected activation of the SIDESLIP Special Alert and the RUDDER Special Alert (Tab BB-57). These predictions would have the test crew not expect the RUDDER Special Alert for high power settings (greater than 10,000lb total horsepower) to activate prior to 16° AoS. In fact, the RUDDER Special Alert activates at 14° AoS for high power settings. The Board retrieved a document believed to be the source for test card 14 which identified a Lockheed Martin employee as the author (Tab BB-150). The data contained within the table and chart conflict with a subsequent version of expected alert activation Lockheed Martin provided after the mishap (Tab BB-38). The expected alert activations identified in the chart provided by Lockheed Martin after the mishap are 1.5° lower than the alert activations identified in test card 14 for both sideslip and rudder activation (Tab BB-38, BB-57).

Figure 3 is representative of a segment of the IADS display viewed by the Test Conductor and Safety of Test monitors (Tab S-11). The red line is the global test limit of 21° AoS (Tab BB-70). The yellow and blue lines are for awareness when the 1st and 2nd special alerts should activate (Tab BB-57). The Blue line should have been at 14.5° instead of 16° (Tab BB-38).
