Australian Government
Australian Transport Safety Bureau

Descent below minimum permitted altitude involving Airbus A319, VH-VCJ

Near Melbourne Airport, Victoria | 15 May 2015

ATSB Transport Safety Report
Aviation Occurrence Investigation
AO-2015-048
Final – 24 November 2017

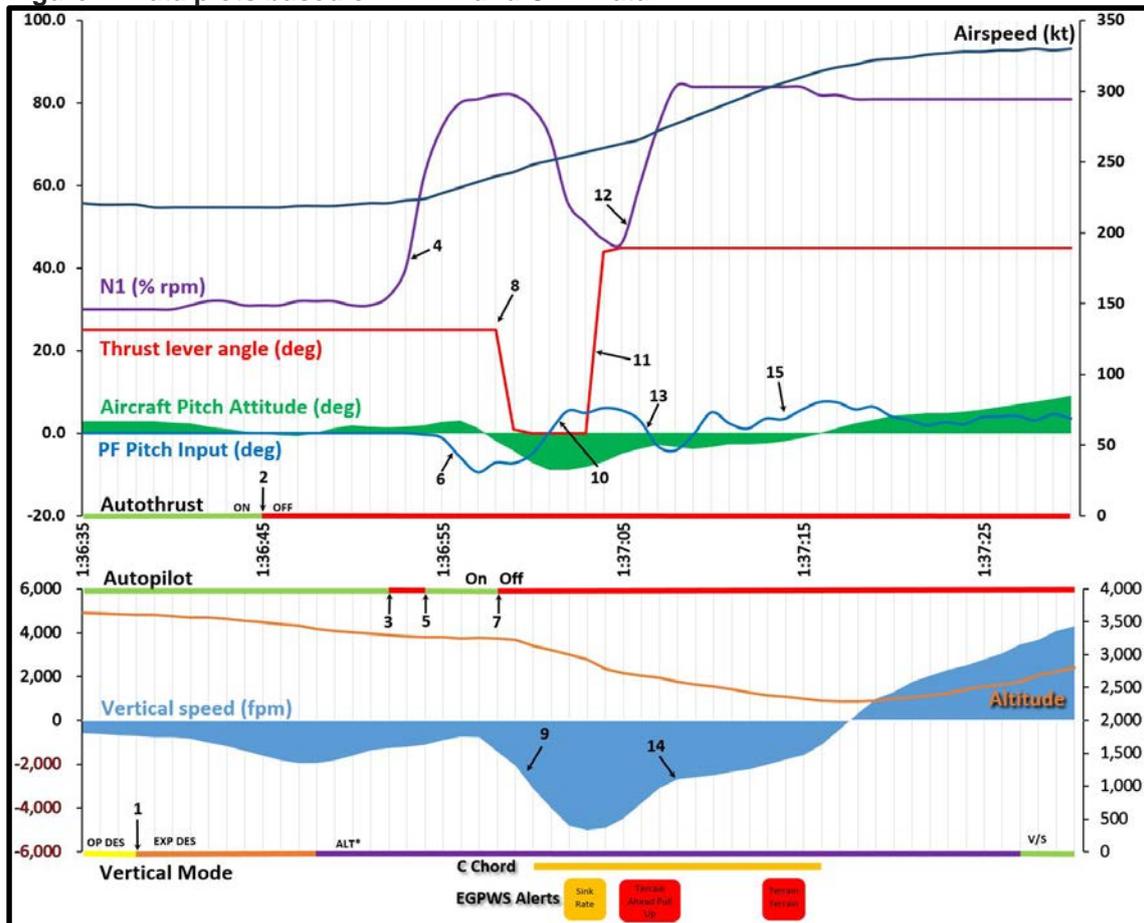
Figure 2: Data plots based on DFDR and CVR Data.

The sequence of events from 0136:35 is graphically presented in a data plot at Figure 2. Specific points on that data plot⁷ are identified to enable a clearer understanding of the rapidly changing events.

The arrowed numbers identify specific events referred to in the sequence of events. The vertical grid lines each represent 1 second. Source: ATSB

- The action of pressing the instinctive disconnect pushbutton on the sidestick disconnected the autopilot (point 3), which in turn triggered the autopilot disconnect aural alert ('CAVALRY CHARGE'). The CAVALRY CHARGE sounded for 1 second.
- The pressing of the thrust lever instinctive disconnect pushbutton caused the thrust lock condition to disengage. It also removed the THR LK message from the electronic centralised aircraft monitoring system and the pilots' flight mode annunciators. As the thrust levers remained set to the climb detent, the commanded thrust changed from idle to climb.

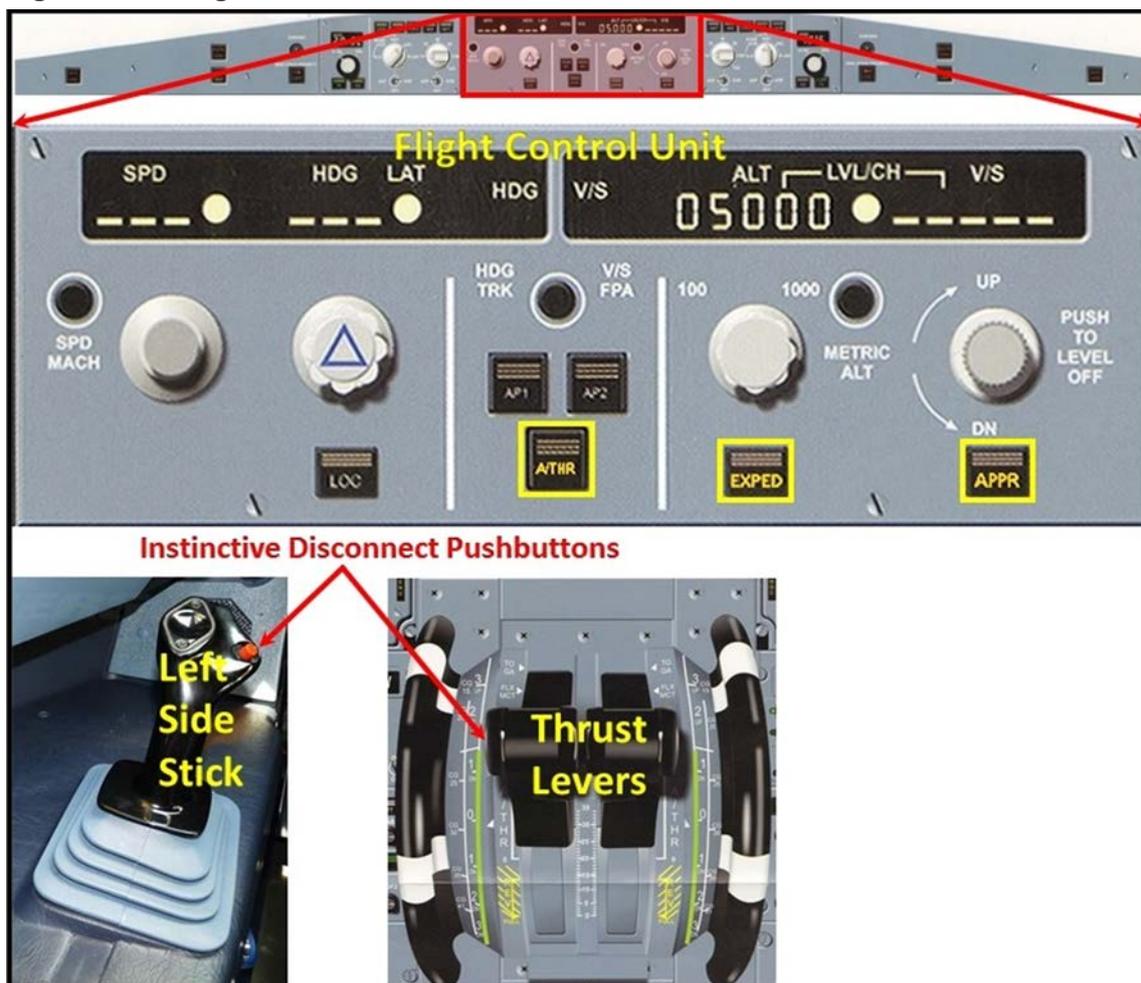
Figure 3: Autoflight controls.

The flight control unit is expanded and, from left to right, the A/THR, EXPED and APPR buttons highlighted. The PF's instinctive disconnect buttons on the side stick and thrust levers are also identified. Source: Airbus and ATSB

At 0136:51, the PM announced that the aircraft had captured the target altitude. At about the same time the PF recognised the thrust lock condition and pressed the 'instinctive disconnect' buttons on both the side stick and thrust levers (see Figure 3). The PF later recalled that the intent behind that action was to reduce the aircraft's airspeed and to retard the thrust levers. The use of the instinctive disconnect pushbuttons had the following effects:

The pressing of the A/THR was an apparent instinctive reaction to realising that an error had been made. Both selections were consistent with unintentional slips. Furthermore, the similar size, shape and colour of the EXPED and APPR buttons on the FCU, as well as their close proximity, may have contributed to the error. The lighting conditions in the flight deck may have increased the difficulty for the pilot monitoring (PM) to monitor the actions of the PF.

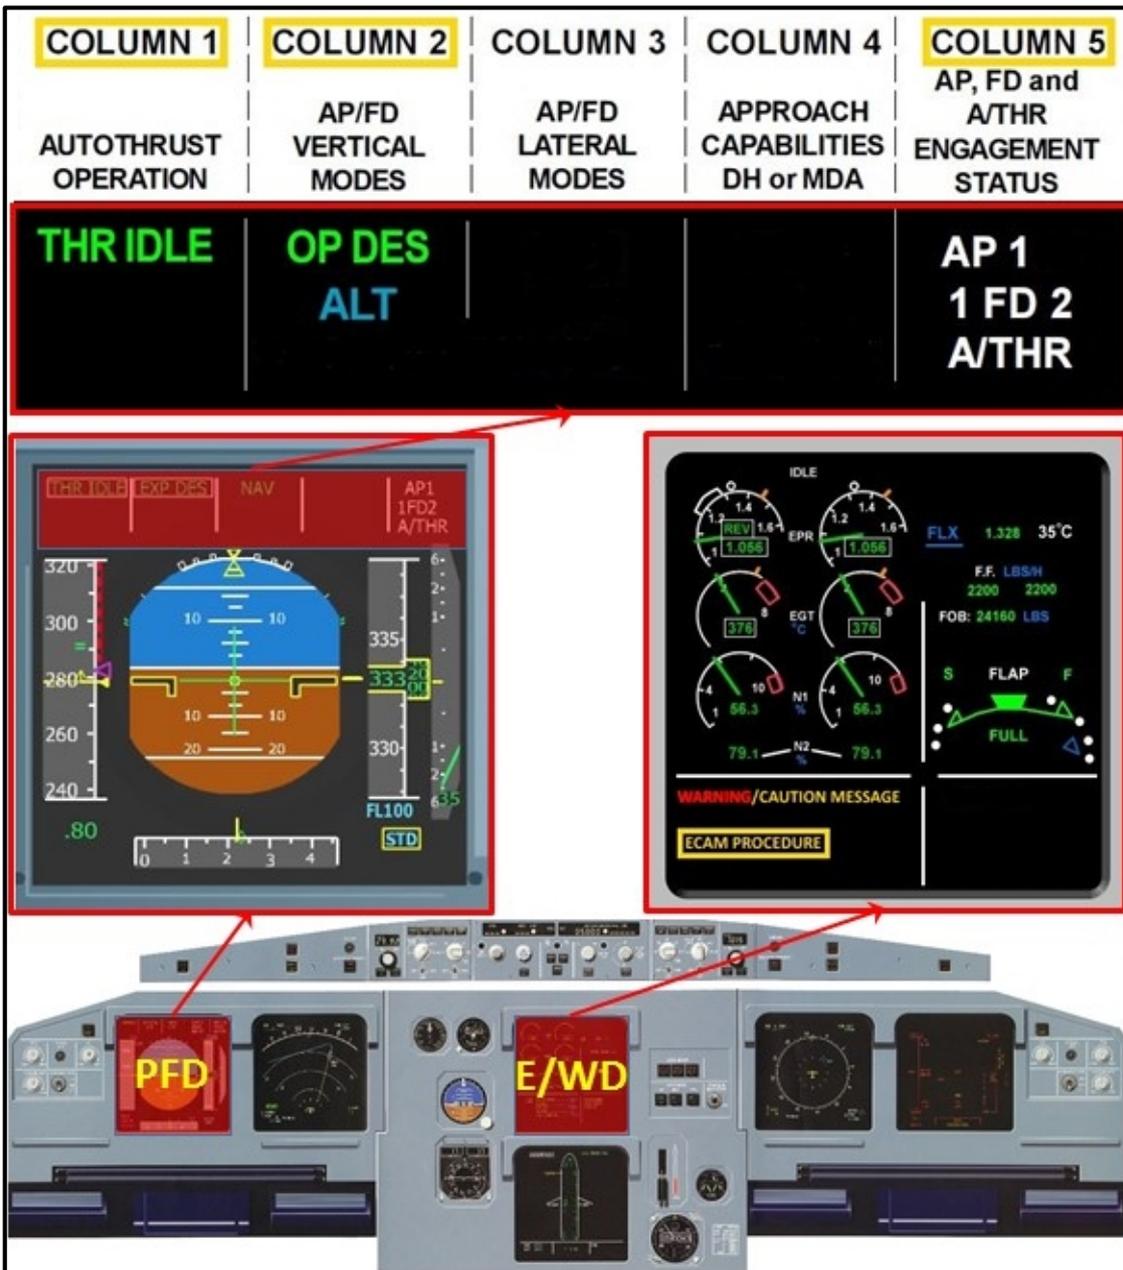
Figure 4: The PFD and E/WS displays expanded, with FMA highlighted

The selection of another managed or selected vertical guidance mode, or the selection of a higher altitude on the FCU, will disengage the expedite mode. The expedite mode will automatically disengage when the FMGS captures the target altitude set in the FCU altitude window. When this occurs, column 2 of the FMA (Figure 4) will display ALT*.

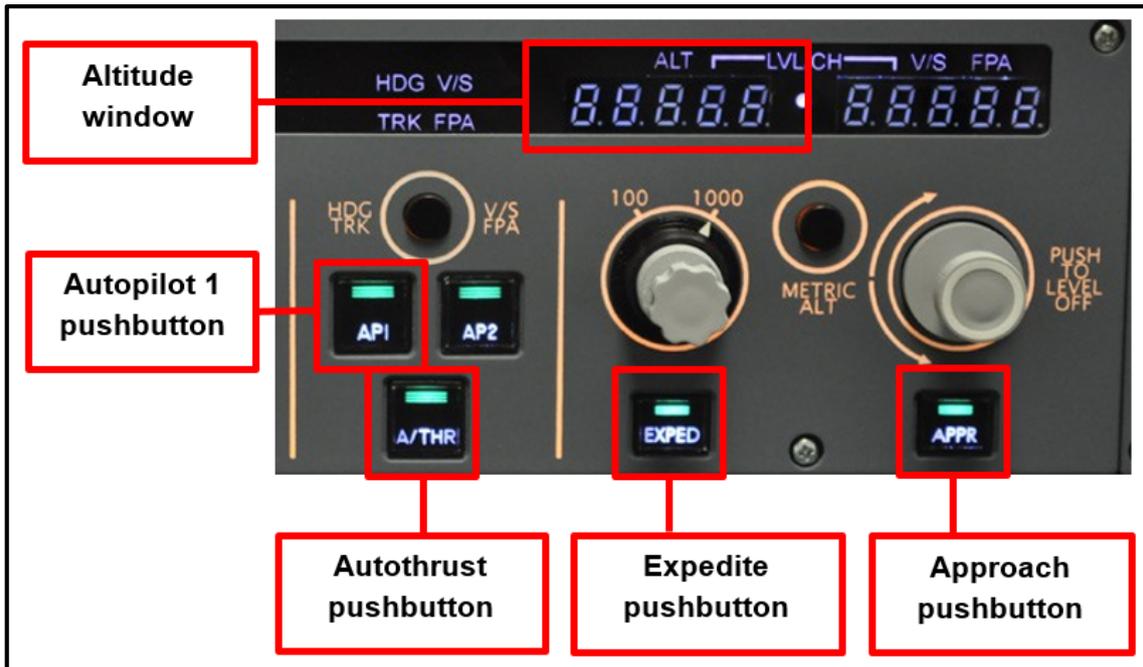
Figure 5: Part of the FCU with AP1, A/THR, EXPED and APP pushbuttons as well as the altitude window highlighted in red.

In the event of a failure of the instinctive disconnect pushbuttons, an alternative method of disconnecting autothrust is to press the A/THR pushbutton on the FCU (Figure 5). This is not a recommended method of disconnection as it will result in the engines entering the thrust lock mode. In the thrust lock mode:

- The pilot flying inadvertently selected the EXPED pushbutton instead of the APPR pushbutton, and, in an attempt to correct the error, pressed the A/THR pushbutton, creating a thrust lock condition.

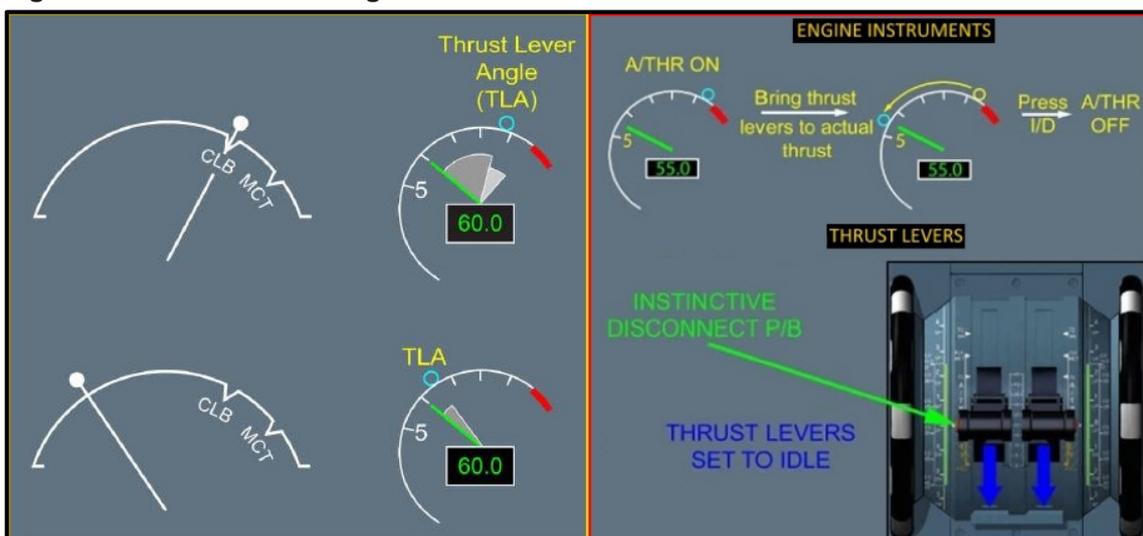
Figure 6: The thrust lever angle.

Engine instruments showing the relationship between the thrust lever angle and the TLA, (left hand diagram) and the autothrust disengagement procedure (right hand diagram).
Source: Airbus, modified by ATSB

The normal method for disconnecting autothrust is by pressing the instinctive disconnect pushbutton on the thrust levers (right side of Figure 6). Pressing the instinctive disconnect

However, in disconnecting the autothrust, the PF did not match the thrust levers to the current power, or set a desired power. This was likely to be a lapse, which is 'simply omitting to perform one of the required steps in a sequence of actions' (Harris, 2011). As to why this lapse occurred, the PF's incomplete response to the 'thrust lock' condition may have been a result of a response consistent with a perceived urgency to handle an undesirable state, particularly as the instinctive disconnect pushbuttons were designed for a quick response

- In attempting to remove the thrust lock condition, the pilot flying pressed the instinctive disconnect pushbutton but did not move the thrust levers to match the locked thrust setting. As the thrust was locked at idle while the thrust levers were set to climb thrust, this resulted in an unexpected, significant thrust increase.

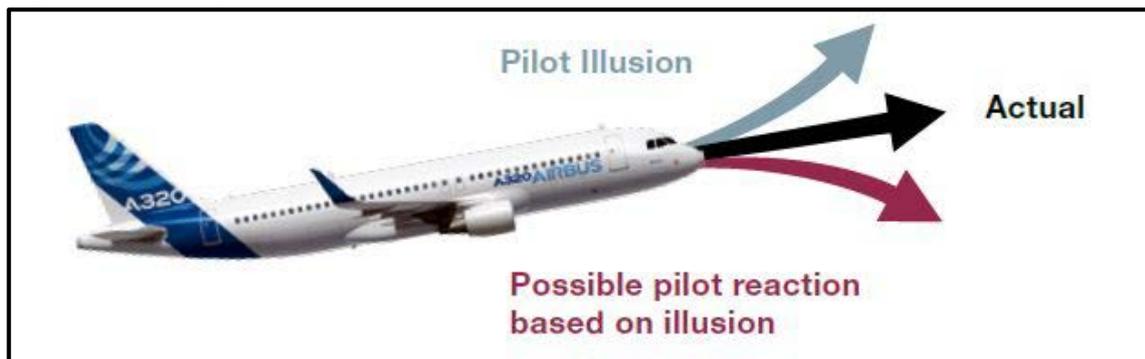
Figure 7: Pitch-up illusion.

Pitch-up (somatogravic) illusion, experienced as a result of acceleration during the go-around manoeuvre, showing the illusion as experienced by the pilot and the possible response to pitch-down.
Source: Airbus

During a manual Go Around, if the required pitch is not reached or maintained, linear acceleration will result. Research has shown that this may cause a “false climb illusion”. The false climb illusion may lead a pilot to believe that the aircraft is already above the required pitch. Consequently, a pilot may respond with an opposite and dangerous pitch-down input.

The PF did recall applying pitch-down side stick input during the rapid thrust increases and did not identify the increasing rate of descent, resulting from the nose-down attitude. The PF did, however, recall thinking that the aircraft was pitching up. Throughout the occurrence, the night conditions and operations within cloud resulted in the absence of a natural horizon. It was therefore likely that the PF's pitch-down side stick inputs were in response to pitch-up (somatogravic) illusions caused by the unexpected and rapid increase in thrust. The PF's susceptibility to the effects of pitch-up illusions was possibly exacerbated by also experiencing a high workload, which would likely reduce monitoring of flight instruments.
